**Pipeline Rupture and Subsequent Fire  
in Bellingham, Washington  
June 10, 1999**

# **Pipeline Accident Report**

**NTSB/PAR-02/02  
PB2002-916502  
Notation 7264A  
Adopted October 8, 2002**

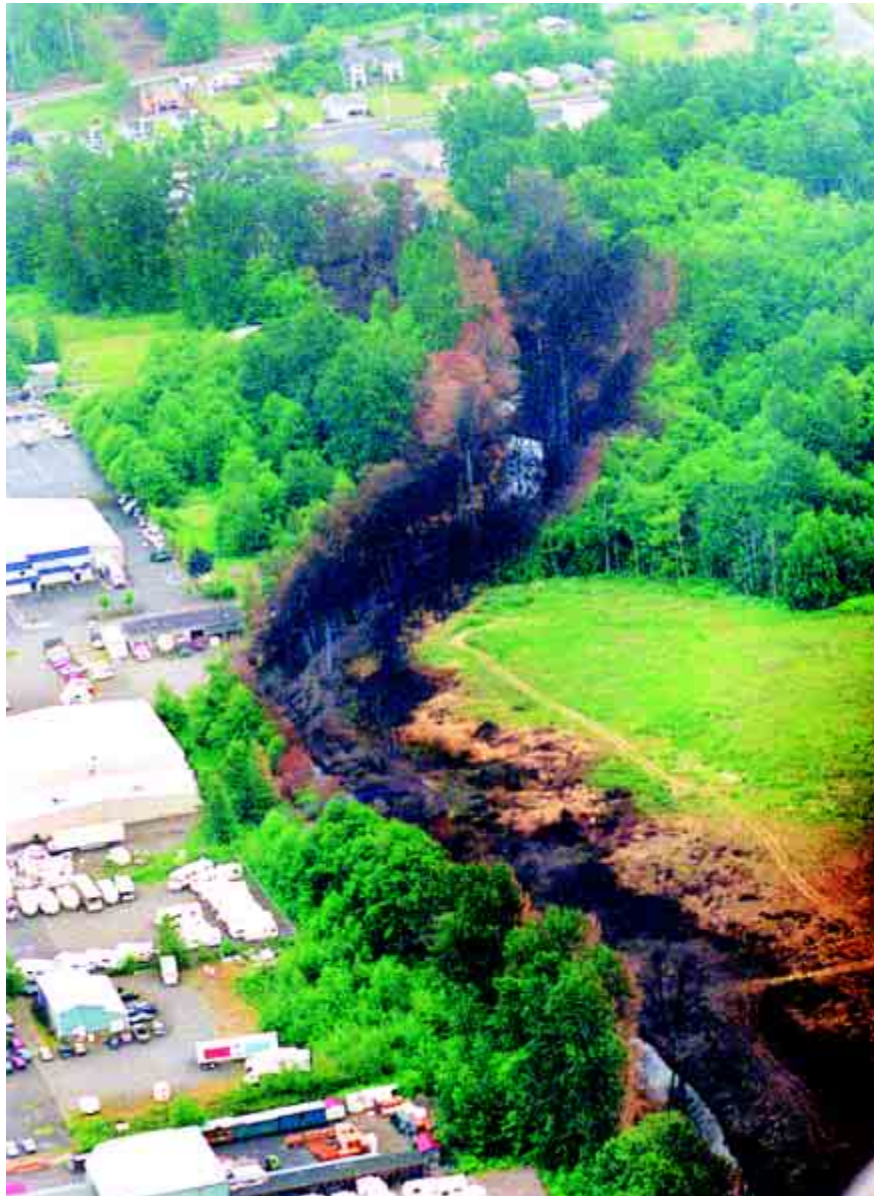
**Figure 1.** Postaccident aerial view of portion of Whatcom Creek showing fire damage.

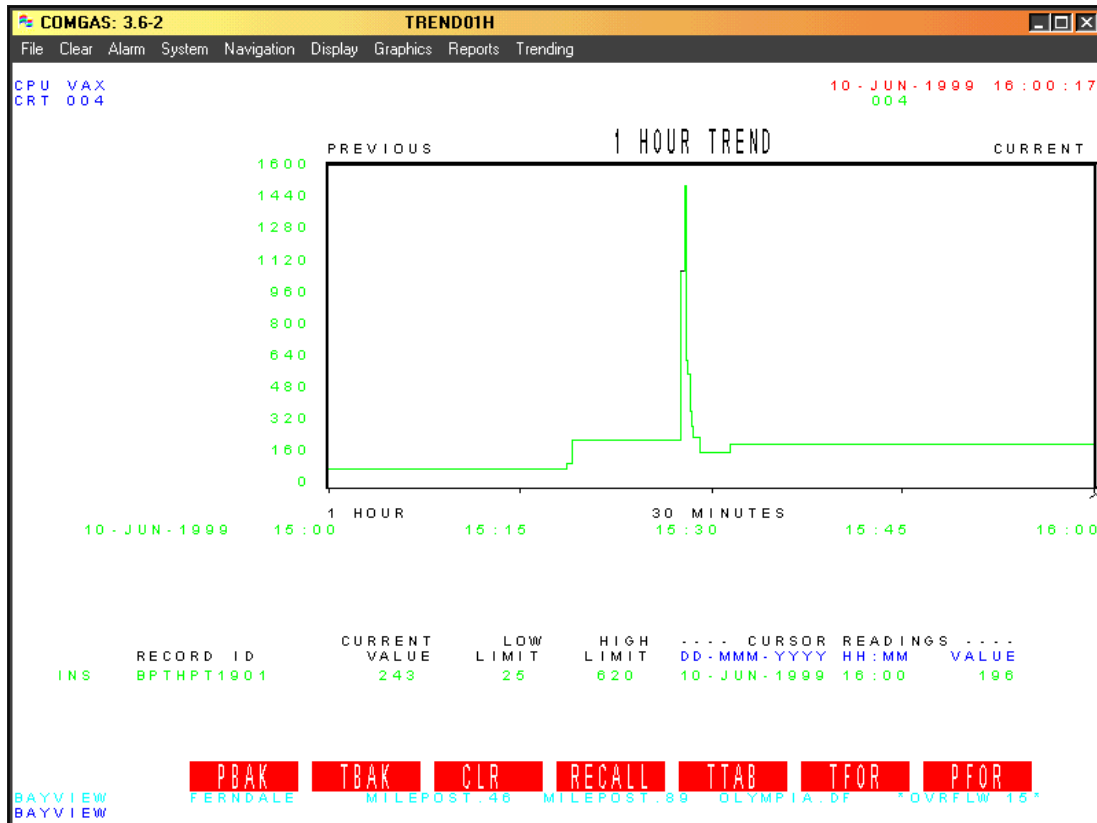
As the block valve closed and stopped product flow into Bayview, the SCADA system captured pressure data upstream of this inlet block valve that indicated a pressure increase from 215 psig at 3:27 to 1,494 psig at 3:28 (as the block valve closed). At 3:29, the system recorded the pressure at this location dropping back down to 230 psig. (It would later be determined that this pressure drop was the result of a rupture in the pipeline that occurred between the Ferndale and Bayview stations at about 3:28.)<sup>8</sup> (See figure 3.)

**Figure 3.** Graph displaying pressure trend upstream of Bayview terminal at time of accident. Note pressure spike and subsequent drop as pipe ruptured. (Graph generated by the Safety Board based on Olympic SCADA data. Such a display had not been developed for the controller to readily access on the day of the accident, and investigators could not determine precisely when the information would have been available to the controller if he had attempted to display it.)

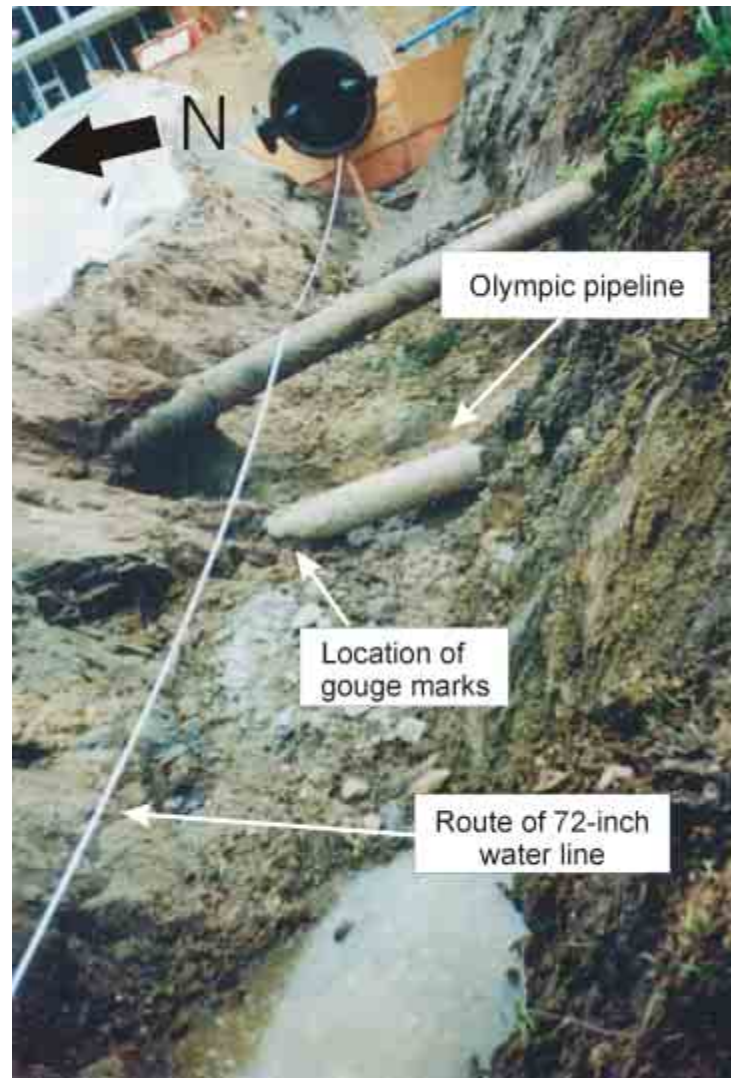
**Figure 5.** Excavation for installation of 72-inch-diameter water pipeline as part of water treatment plant modification.

inches below the bottom of Olympic's pipeline. The diagram of changes further indicates that there was 18 inches of clearance to the 2-inch PVC line and 25 inches of clearance to the 4-inch PVC line. Olympic records indicate that the coating on the bottom of the pipeline at this location was repaired on August 12, 1994.

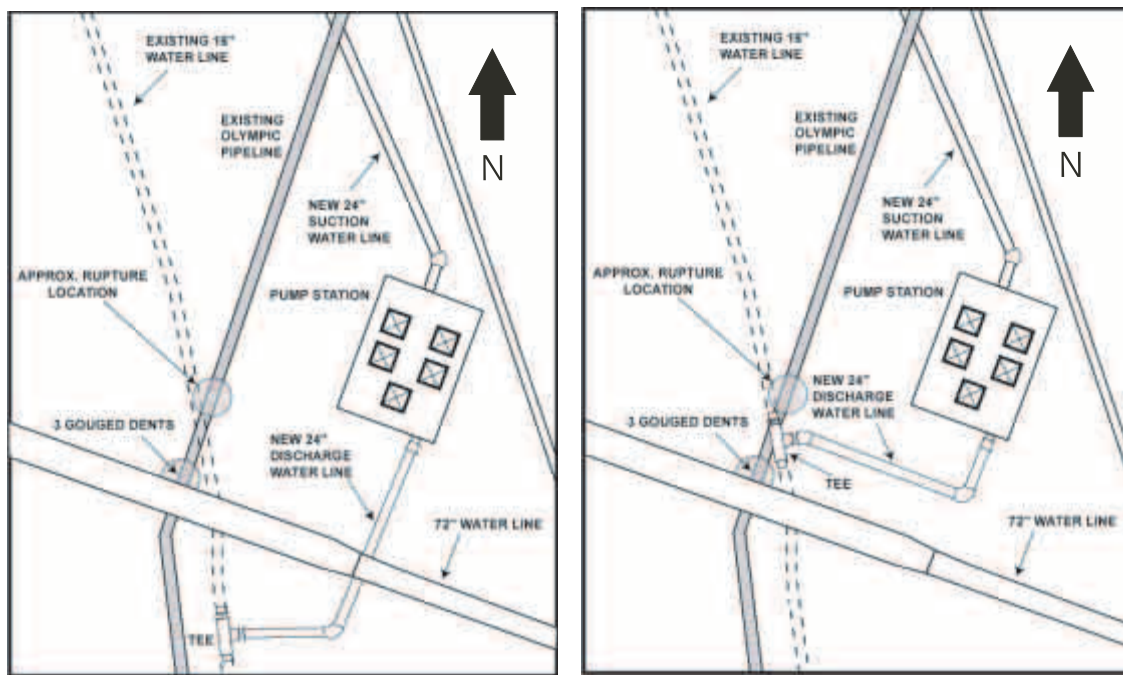
line, thus eliminating the need to cross beneath it. Once modified, the tie-in, or “tee,” connecting the new 24-inch line to the existing 16-inch line was about 21 inches directly above the Olympic pipeline.

The project plans were modified on May 13, 1994, to reflect the proposed design change in the discharge line’s location. The Barrett inspector stated that he thought he had given a plan showing the revisions to one of the Olympic inspectors. No documentation indicates that Olympic was provided with information concerning this design revision. None of the meeting minutes discussing the tee installation project mention providing Olympic with notice of the project or the scheduling changes. Both Olympic inspectors stated that they were unaware of the tee’s installation above the Olympic pipeline. A diagram-of-changes form documenting the tee’s installation was not located. (See figure 6.)

**Figure 6.** (Left) Planned location of “tee” connection joining new with existing water lines. (Right) Revised (actual) location of tee, which was installed above Olympic pipeline. (Not to scale.)

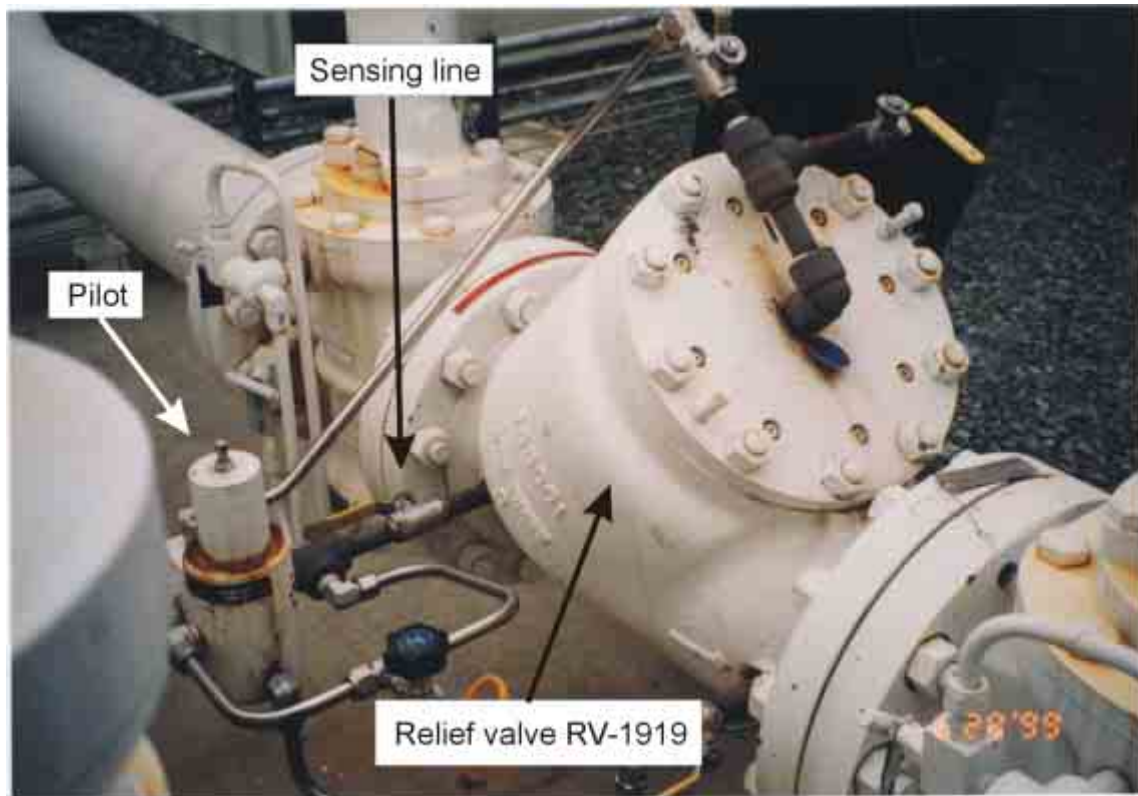
**Figure 9.** Closeup of relief valve RV-1919 and pilot.

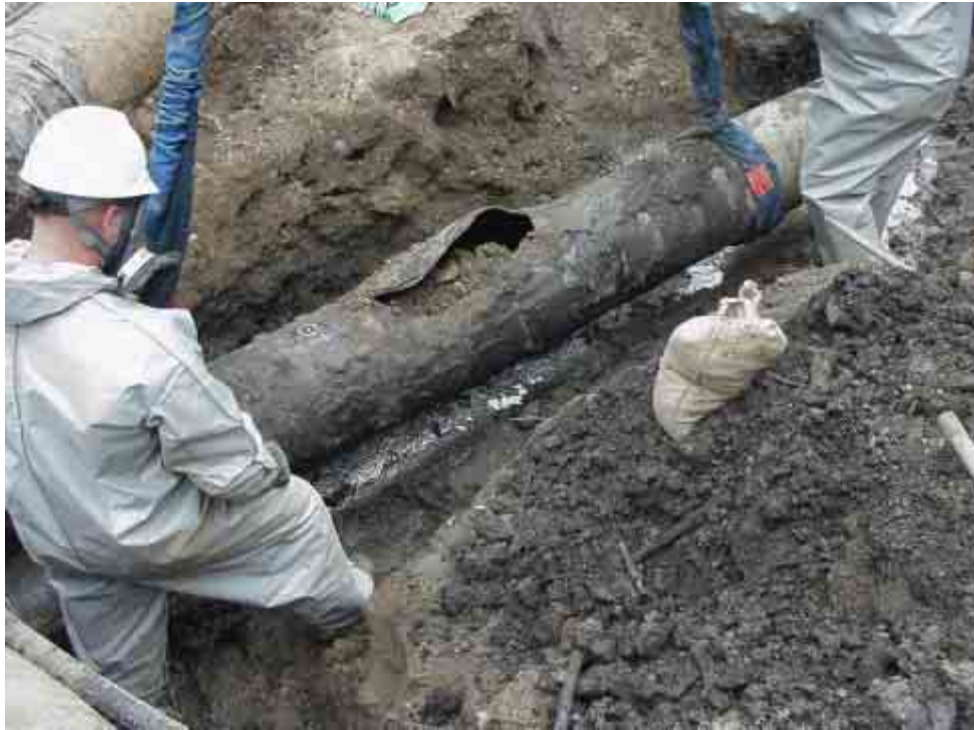
**Figure 10.** Removal of ruptured pipe section.

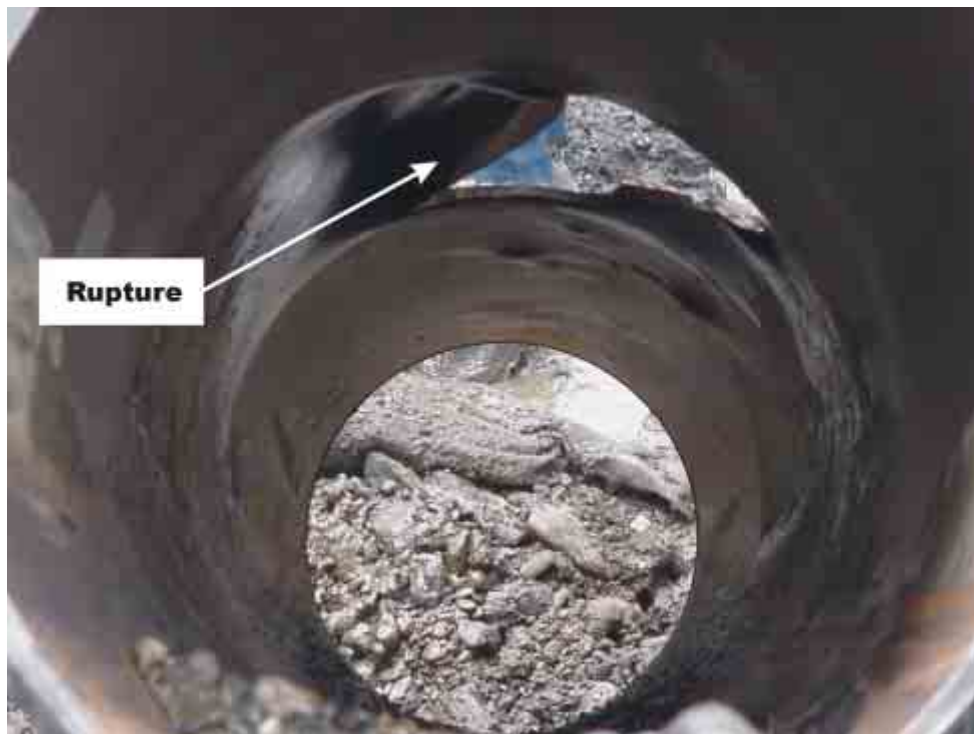
**Figure 11.** Inside view of ruptured pipe section.

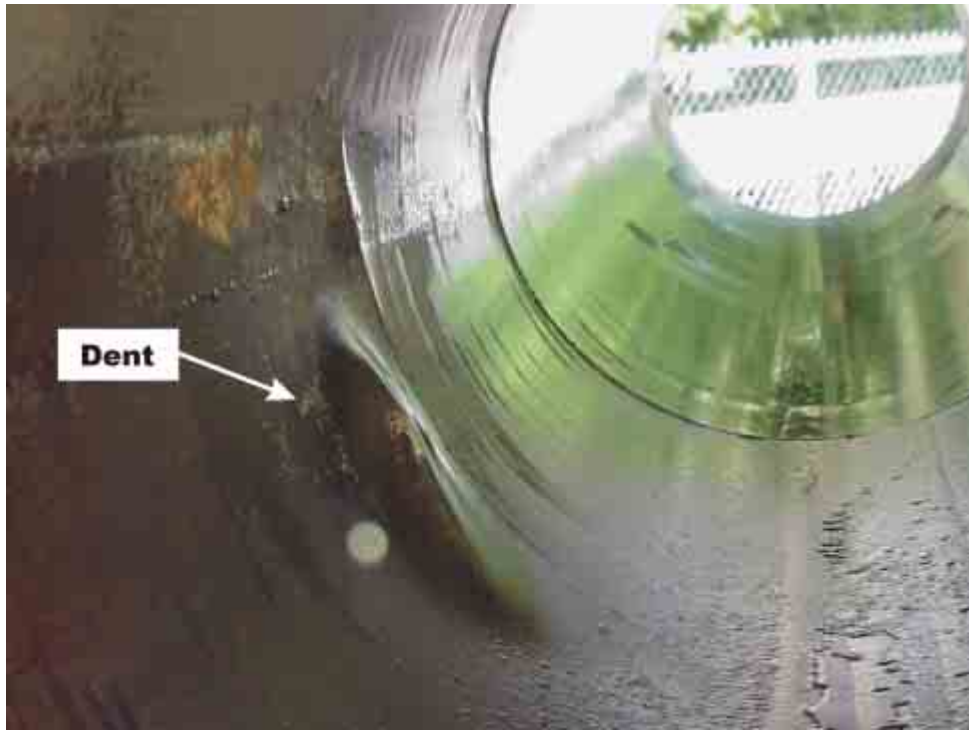
In addition to the ruptured section of pipe, a second section of pipeline that extended from the south (downstream) end of the ruptured section was also retrieved. Previous in-line inspections conducted by Olympic had identified this section of pipe as containing anomalies. On July 8, 1999, the second pipe section was removed, crated, and shipped to Safety Board headquarters for further examination. The pipe section, which was about 10 feet long, contained dents about 1 1/2 feet downstream of a girth weld. (See figure 12.)

**Figure 12.** Inside view of second removed pipe section showing dent.

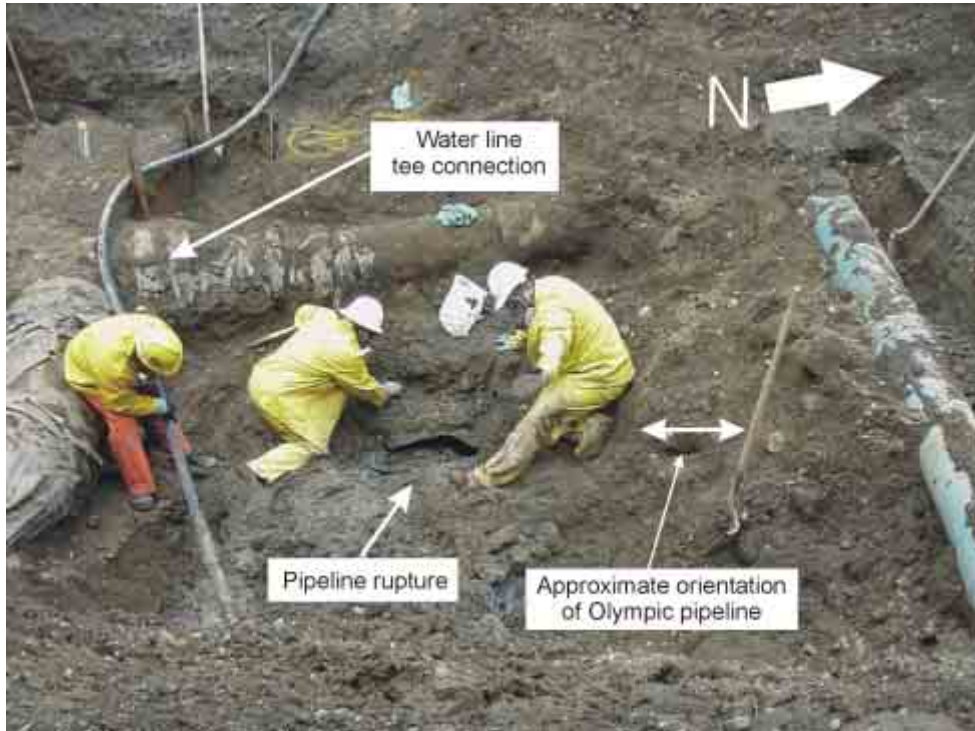
A 12-inch-diameter PVC utility conduit crossed about 31 inches above Olympic's pipeline, with its centerline approximately 9 feet north of the rupture. (See figure 13.)

**Figure 13.** Rupture location before removal of pipe showing proximity of water line tee connection.

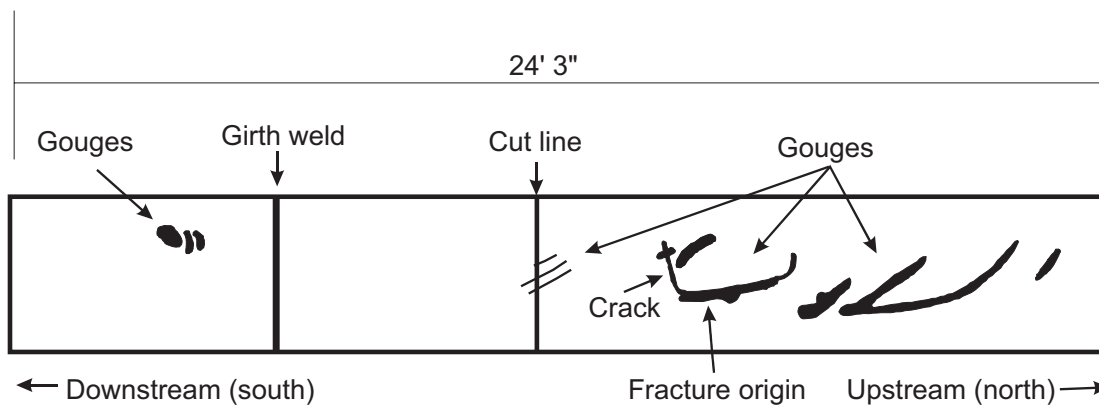
gouge mark revealed metal flow consistent with an object moving upstream relative to the pipe. (See figure 14.)

**Figure 14.** Sketch (not to scale) of the two pipe sections removed after the accident showing rupture site in relation to gouge marks. Gouges at left were near the point at which 72-inch water line crossed over the pipeline. (Only a small number of the gouge marks found on the pipeline sections are shown.)

The 27-inch gaping fracture intersected two other gouge marks. These two gouge marks extended upstream from the upstream end of the origin gouge mark at an approximate orientation of 20 percent from the longitudinal axis. These two gouge marks were 4 1/2 and 5 inches long, respectively. An inward dent was evident on the inside surface of the pipe coexistent with one of these gouge marks. One of these gouges was slightly deeper than the gouge at the rupture origin, with a remaining wall thickness of approximately 0.23 inches. The three gouge marks were connected and followed the contour of the fracture. The combined lengths of the three gouge marks (18 inches) intersected a major portion of the fracture.

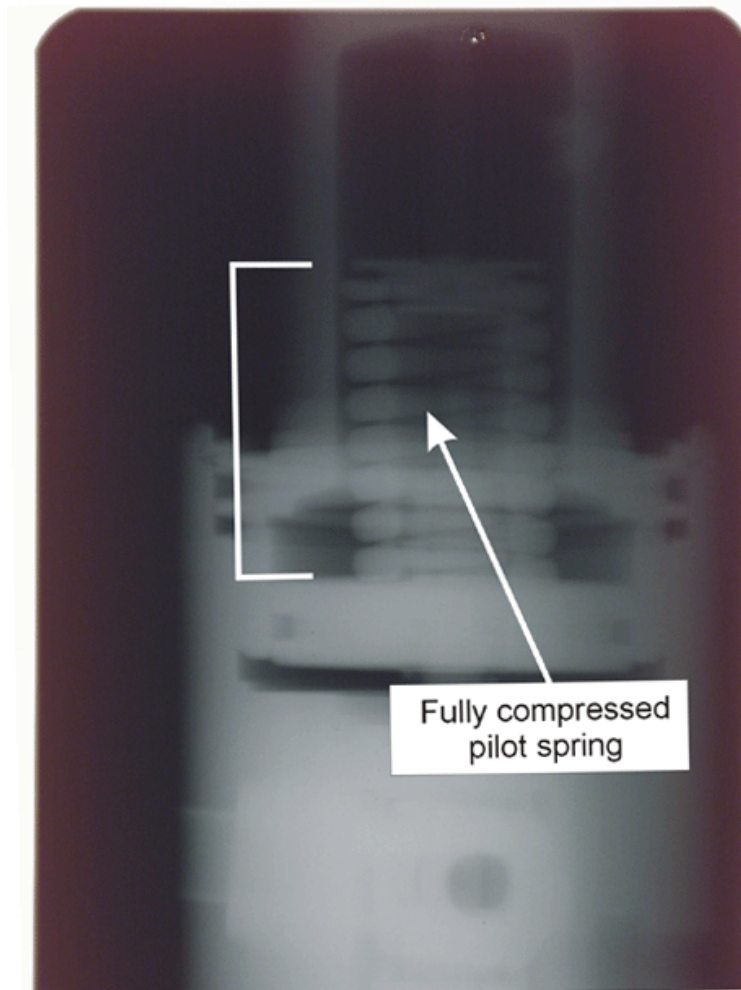
**Figure 15.** X-ray photograph showing that when the original low-pressure pilot for relief valve RV-1919 was set to 650 psig or higher, the pilot spring was fully compressed.

- When fitted with an exemplar high-pressure pilot, the relief valve operated properly. In each test, the relief valve operated whenever the inlet pressure exceeded the set point of the high-pressure pilot.

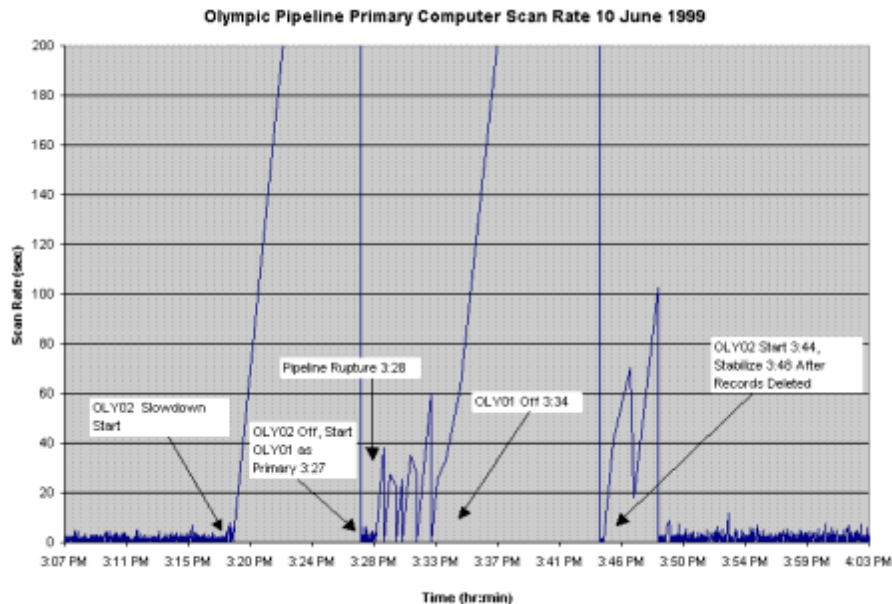
The historical files showed that the scan rate was consistent, scanning for data at about 3-second intervals, up until 3:19. At that time, the scan rate changed to about 30 seconds. This lasted for 2 minutes, after which the scan rate changed again to more than 400 seconds. The system briefly recovered to a normal scan rate at 3:27 (as OLY01 was coming on line) for almost a minute, after which it virtually stopped scanning any new data. The scan rate briefly returned to normal at 3:42 (when OLY02 came on line again) before changing to about 100 seconds. At 3:48, the scan rate again returned to normal. The behavior of the scan rate was consistent with the controller and system administrator observations and was also consistent with the changeover times from OLY02 to OLY01 and back to OLY02. (See figure 16.)

**Figure 16.** Changes in SCADA scan rate (for pipeline data) during period of slow response or non-response of the Olympic SCADA system on the day of the accident.

The slowing/stopping of the sensor scan pattern was the only abnormality found that indicated that there was a problem with the SCADA computer control system. None of the host VAX computer logs or any of the error logs associated with the SCADA system captured any data that indicated that the system was having a problem completing its assigned tasks.
