# Rupture of Enbridge Pipeline and Release of Crude Oil near Cohasset, Minnesota July 4, 2002

## Pipeline Accident Report NTSB/PAR-04/01

## **Rupture of Enbridge Pipeline and Release of Crude Oil near Cohasset, Minnesota July 4, 2002**

**NTSB/PAR-04/01  
PB2004-916501  
Notation 7514A  
Adopted June 23, 2004**

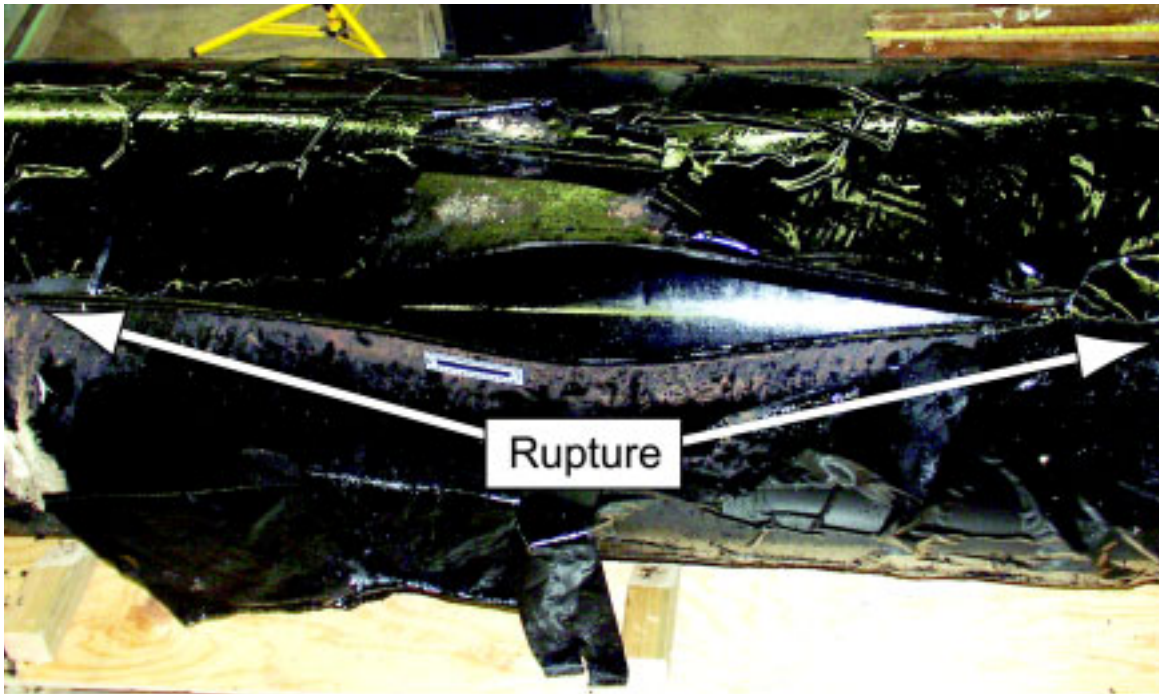
**Figure 5.** Rupture in accident pipe.

On July 6, after vacuum trucks had removed the remaining oil and water, the ruptured pipe was exposed. The pipe was fractured along the edge of a longitudinal weld. When the pipe that failed was installed, the longitudinal weld was at the 5:30 clock position when viewed facing downstream (eastward). The rupture was about 69 inches long and gapped open about 6 1/4 inches at the center. (See figure 5.) At the rupture location, the pipeline was rated for a regulatory maximum operating pressure of 687 pounds per square inch, gauge (psig). The pressure at this location at the time of failure was calculated to be 526 psig. The United States Steel Corporation (U.S. Steel) manufactured the pipe at its National Tube Works in McKeesport, Pennsylvania.

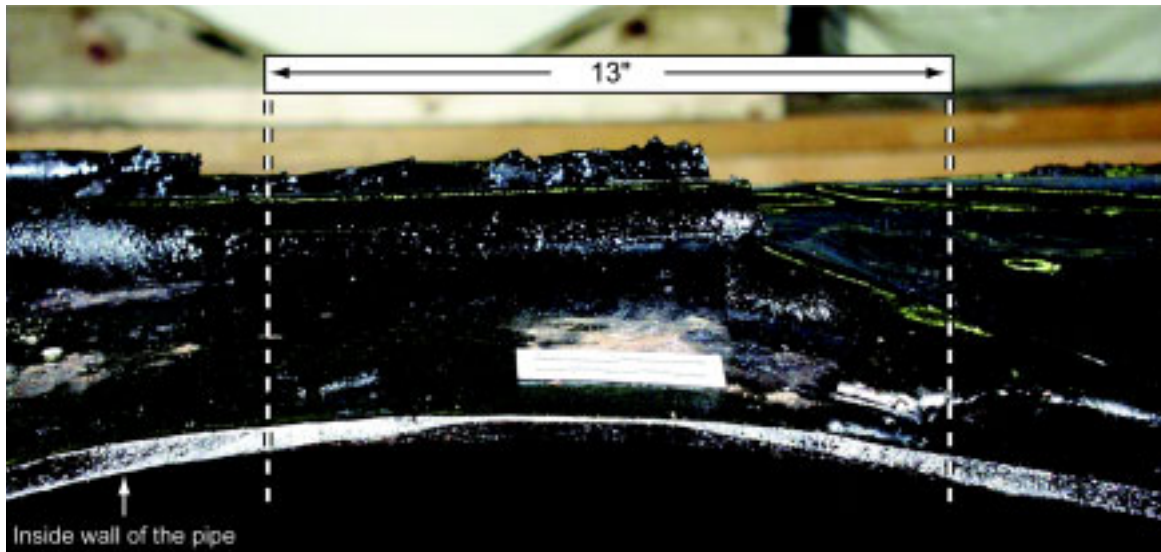
Initial examination of the rupture revealed a preexisting fatigue region at the center of the rupture. The fatigue region was 13 inches long adjacent to the inside surface of the pipe and did not extend all the way through the pipe wall. (See figure 6.) More detailed examination showed that the fatigue cracking initiated at multiple locations along the inside surface (see figure 7) at the toe of the longitudinal weld bead. (See figure 8.) Examination of the cleaned fracture surface revealed a darker, more heavily oxidized band adjacent to the inside surface of the pipe that extended the entire length of the fatigue area. The more heavily oxidized portion of the fatigue area penetrated a maximum of about 0.04 inch deep at the center of the rupture. The oxidized band was visible for almost the entire length of the fatigue area. Near its ends, the oxidized portion of the fatigue crack extended about 0.010 inch into the pipe wall. The remainder of the fatigue crack was less oxidized and extended more deeply into the pipe wall over the central 6 inches of the fatigue region. Along approximately 2.5 inches in the central region, the fatigue crack almost penetrated the pipe wall. At its maximum depth, the fatigue crack penetrated through 0.270

inch of the 0.297-inch measured wall thickness.<sup>7</sup> Measurement and testing of the pipe showed that it met thickness and strength requirements. The pipe fracture beyond the fatigue crack contained features typical of overstress fracture.

**Figure 6.** View of top fracture surface of 13-inch-long crack, showing penetration nearly through pipe wall in center.

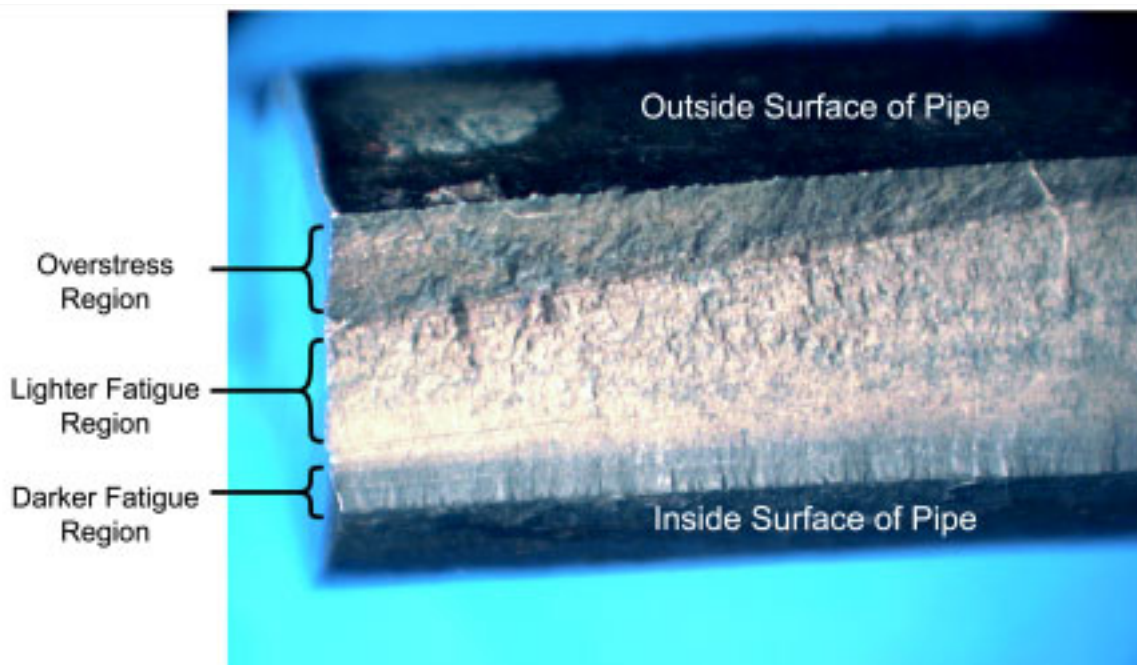
**Figure 7.** Face of fracture in accident pipe.

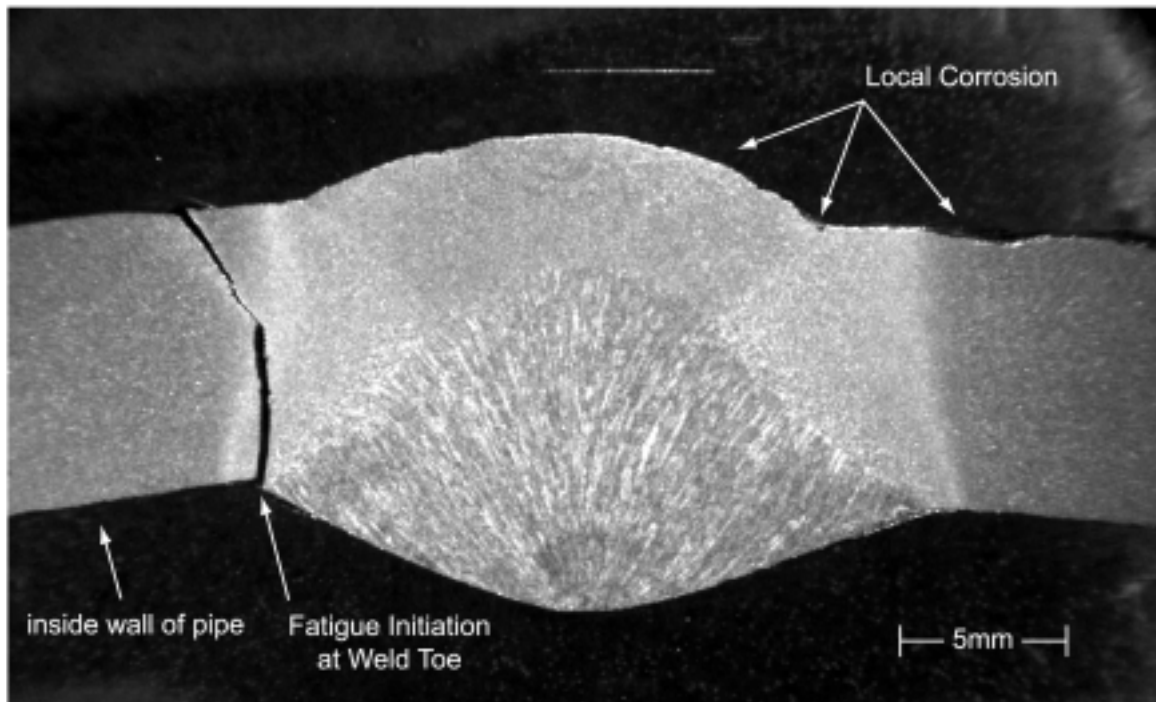
**Figure 8.** Fatigue initiating at toe of weld on interior surface of pipe.

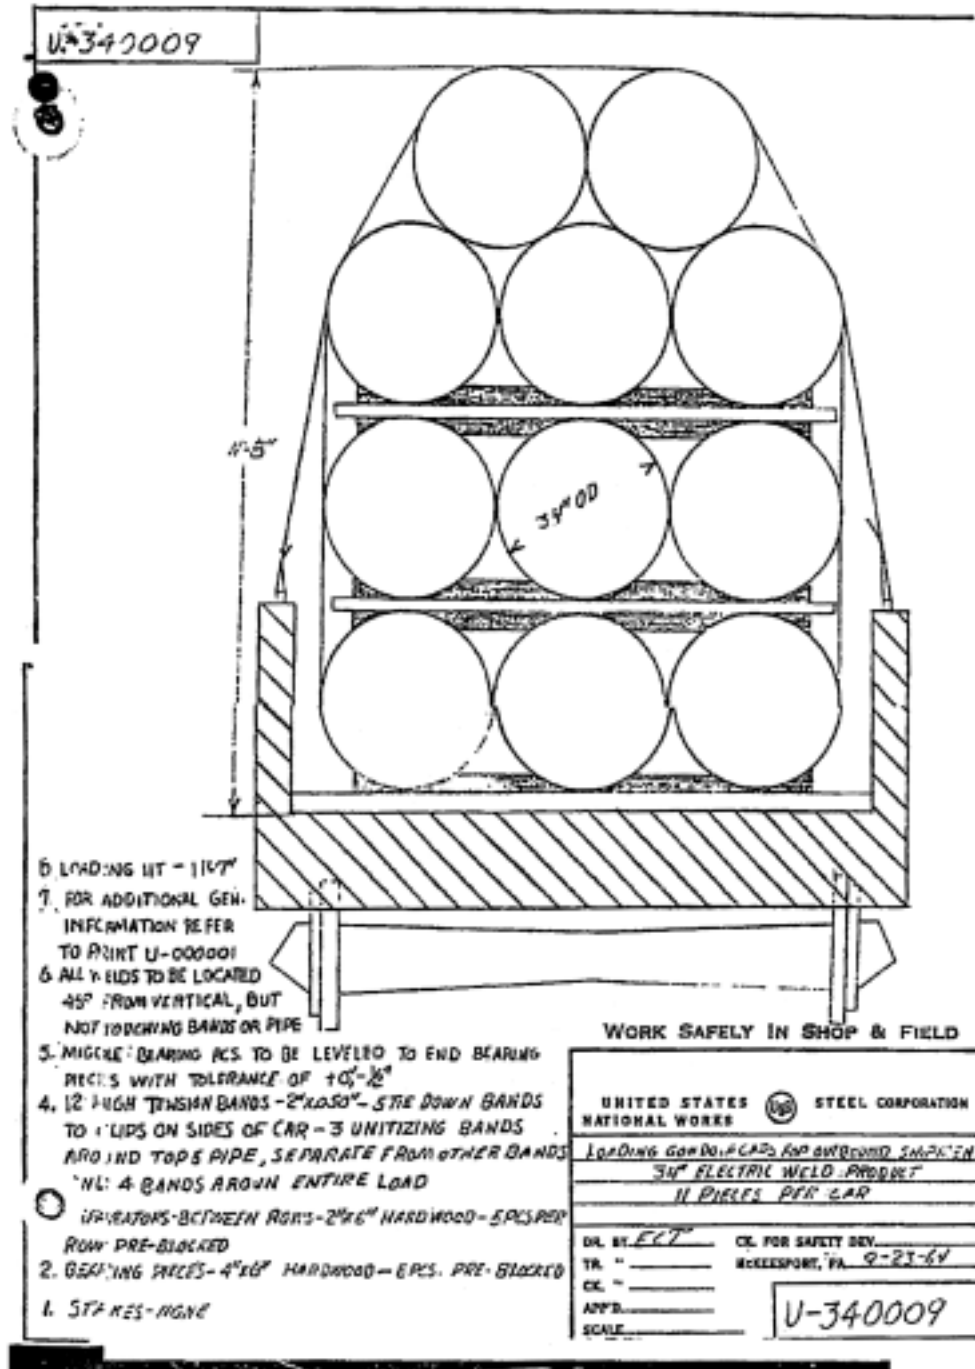
The section of pipeline where the rupture occurred was constructed in 1967. The Enbridge 1966 purchase specification for the pipe included a requirement that pipe loading details be provided subject to its approval. In its quotation, U.S. Steel provided a diagram for railroad car loading (see figure 9), which Enbridge subsequently approved. The railcar loading instructions consisted of a drawing with notes specifying the blocking supports and banding to be used under and around the pipe and the required positioning of the longitudinal weld. U.S. Steel also noted in its specifications that the purchaser would spot-check railcar loadings at the mill before transportation. U.S. Steel transported the pipe by railcar to its storage facility near the mill, where it was unloaded and stored. Later, U.S. Steel loaded the pipe for transportation by rail. Finally, the pipe was loaded on trucks for transportation to the construction sites.<sup>17</sup> Enbridge had arranged with Moody Engineering Company (Moody) to inspect the manufacturing of the pipe. The handling and loading of the pipe for transportation from the mill to storage was a part of that inspection. These activities were summarized in Moody's final report. The Moody report indicates that the pipe was periodically inspected at a nearby storage facility to ensure that the pipe was being handled and unloaded with care. The report indicates that the pipe was accepted for shipment subject to the operator's shipping instructions. U.S. Steel did not document inspections of pipe loading. No records were found to indicate that the engineering company or the pipeline operator inspected the loading of the pipe on railroad cars for transportation from the U.S. Steel storage facility.

Figure 9. U.S. Steel loading diagram for railcars.

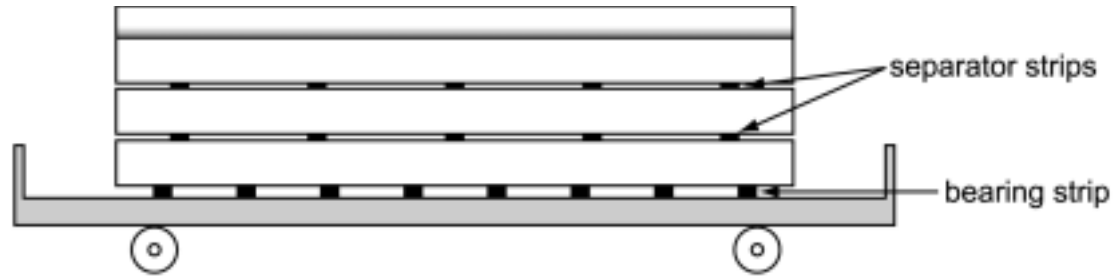
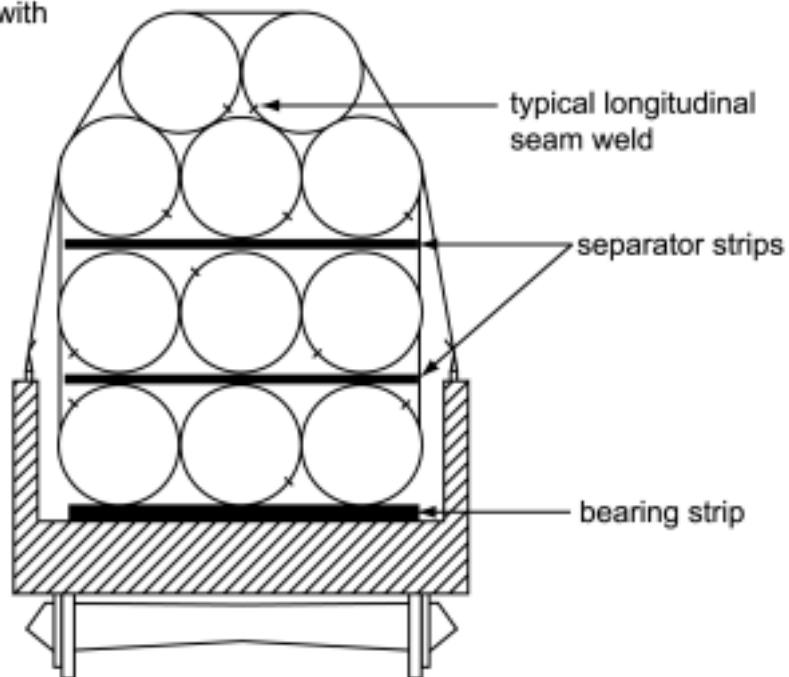
indicated that the circumferential tensile stresses decreased rapidly away from the bearing or separator strips. Aligning the welded seams at 45° to the vertical results in very small levels of circumferential tensile stress at the welds during transport. (See figure 10.) The results of the finite element model also indicate that aligning the welds at the 2, 4, 8, or 10 o'clock positions instead of exactly 45° from vertical does not increase the stress levels significantly.

Note:  
Pipes randomly loaded with  
longitudinal seam weld  
at 45° to the vertical.
