Evaluation of New Home Energy Efficiency

An assessment of the 1996 Fort Collins residential energy code and benchmark study of design, construction and performance for homes built between 1994 and 1999.

Summary Report

June 2002

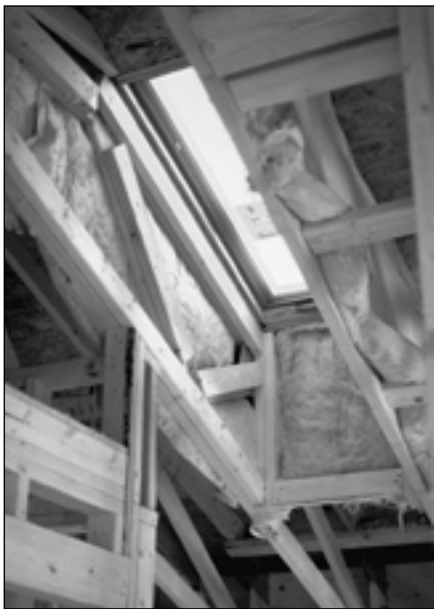
The code requires insulation to be in substantial contact with the wallboard and a vapor barrier to be installed on the warm side of the insulation. At this skylight well, insulation was held several inches back from the wallboard by framing. The vapor barrier was on the cold side of the insulation, a potential moisture trap.

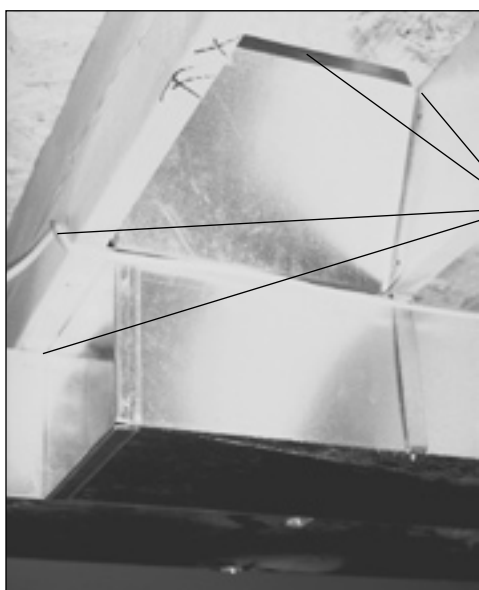
Typical leakage locations in return ductwork

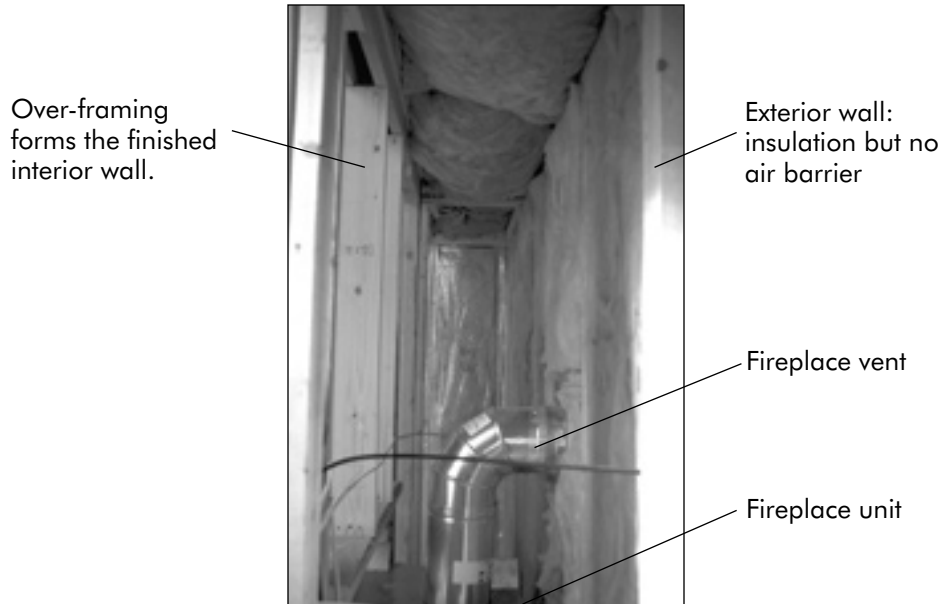
In this example, there was no air barrier at the exterior wall. This will allow outdoor air to move from the wall into the cavity around the fireplace unit and then, through cracks and holes, into the living space.

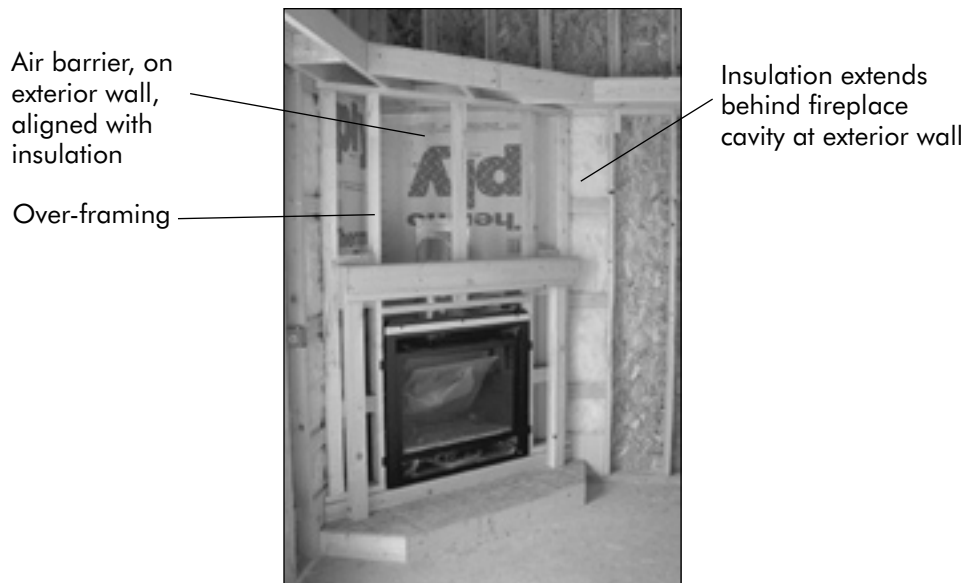
In this example, the insulation and air barrier, aligned at the exterior wall, were installed before over-framing was built and before the fireplace unit was installed. This approach will stop drafts and help the insulation perform effectively.

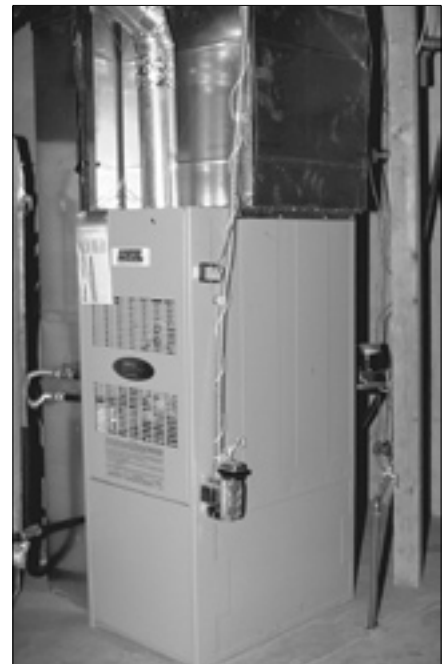
About one-quarter of study home furnaces operated near or outside of manufacturers' limits for pressure and heat rise.

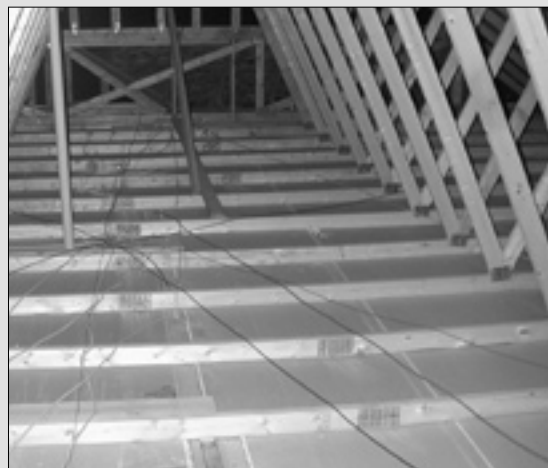
Several months after occupancy: no insulation in the attic.

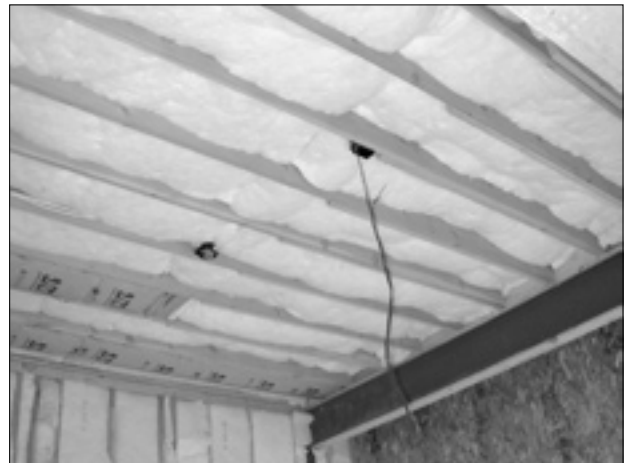
Code requires minimum R-19 insulation in floors above garages. The insulation must be in substantial contact with the subfloor above, permanently supported using one of several approved means. In this example, 6-inch thick R-19 fiberglass batts, installed in 9.25-inch joist cavities, were held in place only with staples—not an approved method. Some of the staples had failed prior to wallboard installation.

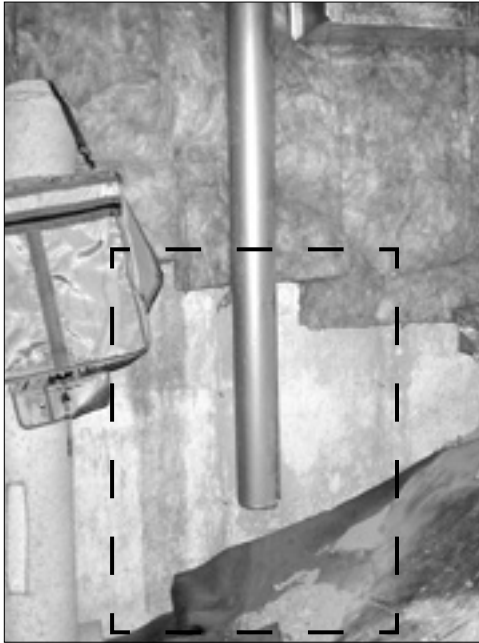
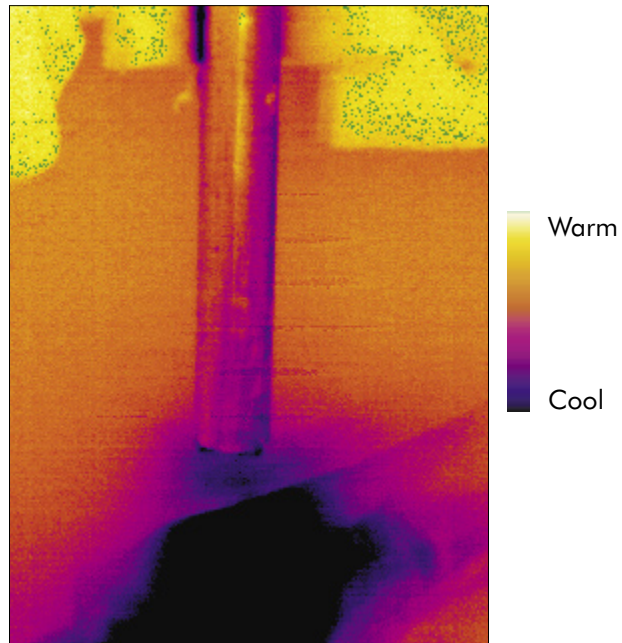
Code-required combustion air ducts, such as the one shown above, are direct openings to outside. An infrared photo of the same area (above right) demonstrates a typical winter problem: cold air is continually drawn in to replace air lost through other cracks and holes high in the house. This phenomenon contributed to cold basements and crawl spaces. In response, it was not unusual to see combustion air ducts plugged by homeowners—despite prominent labels warning against tampering with these safety devices.

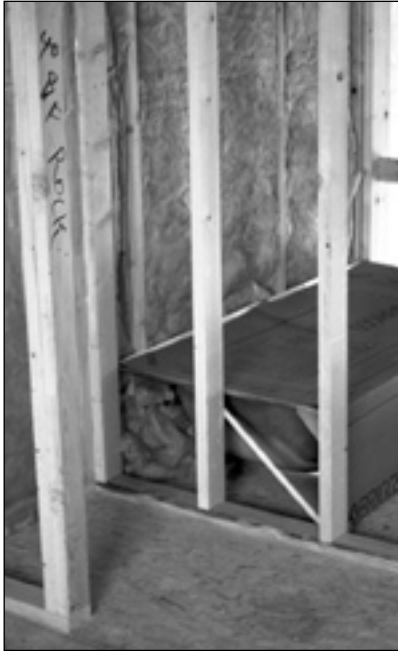
This bathtub had more than enough insulation at the exterior wall. But there was no air barrier to stop air from the outside wall from flowing through the insulation and circulating beneath the tub. From there, connections through partition walls and holes around the plumbing connected this leak to the rest of the house.

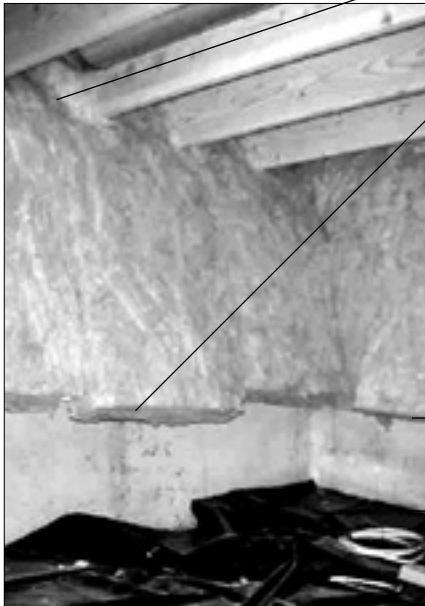
The batts hung away from the foundation by as much as 6 inches, allowing warm crawl space air to bypass the insulation.

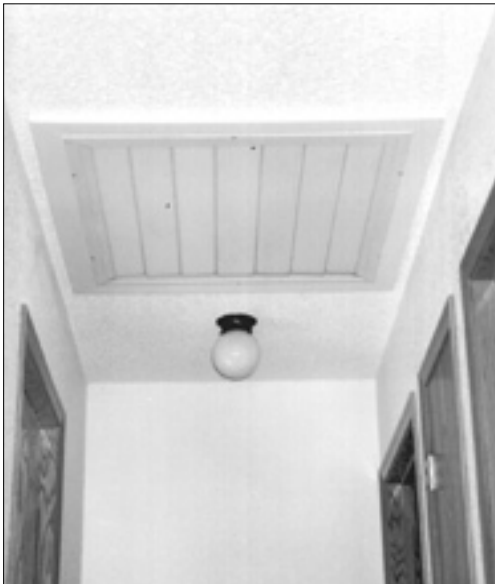
Whole house fan louvers were quite leaky even when closed. Code-required winter covers were provided to owners of two of the five post-group homes with whole house fans.

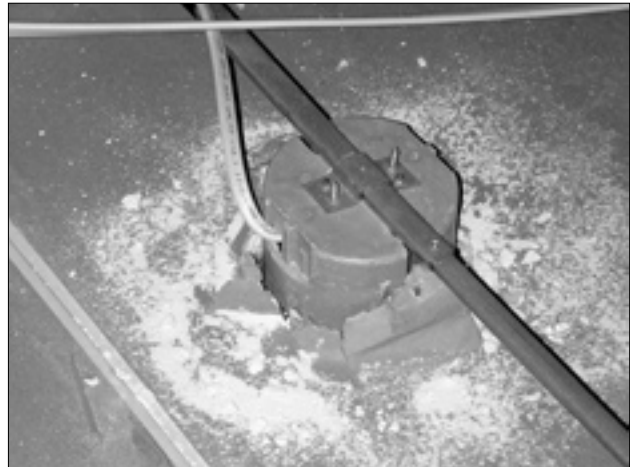
Air leaked around electrical boxes and through wiring penetrations.

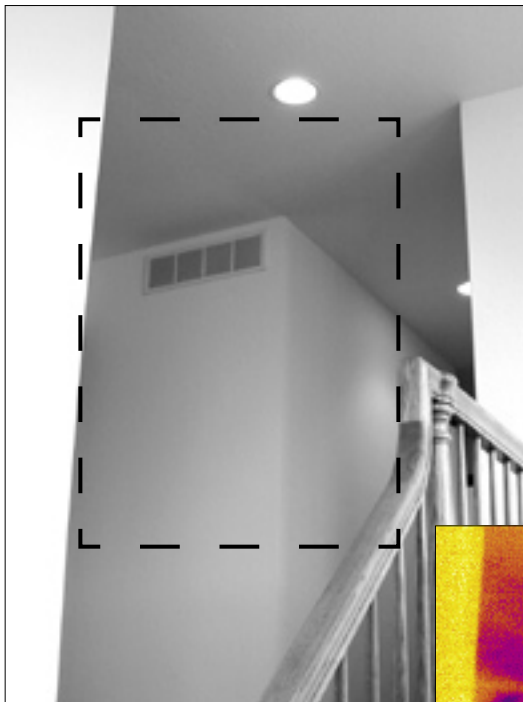
Air leaks through gaps between wallboard and framing. These gaps are skinny (1/16" to 1/8" typical) but extend many lineal feet.

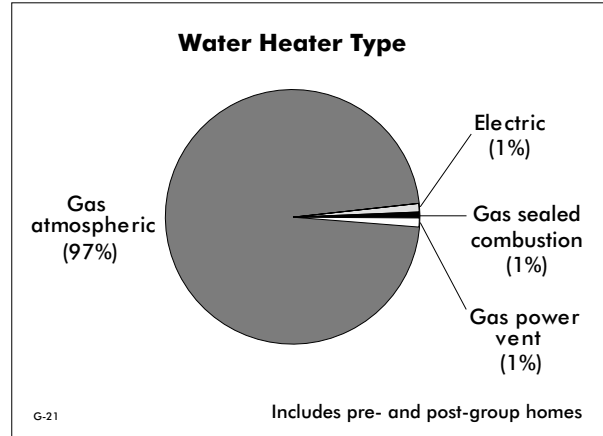
Gas-fired, atmospheric water heaters were the norm, raising concerns about combustion safety.

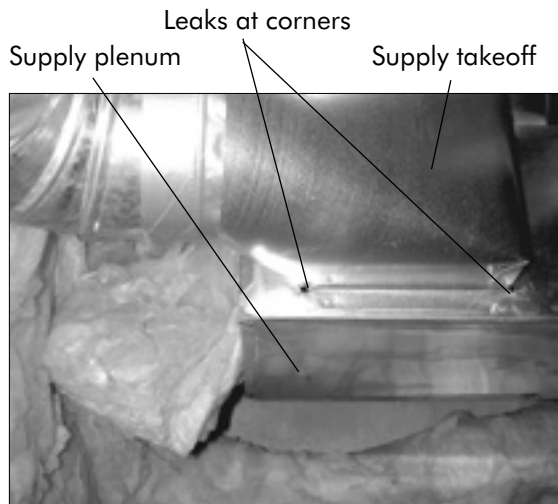
This joint between a takeoff fitting and a plenum is an example of small supply duct leaks. Some takeoffs were much leakier.

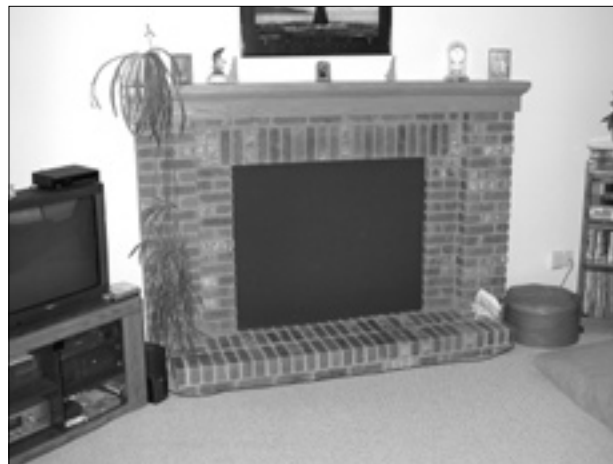
The owners of this house made a removable, fabric-coated foam insert to block drafts through the fireplace and make their living room more comfortable.
