HIGHWAY ACCIDENT REPORT

COLLISION OF CSXT FREIGHT TRAIN
AND MURRAY COUNTY SCHOOL
DISTRICT SCHOOL BUS
AT RAILROAD/HIGHWAY
GRADE CROSSING
CONASAUGA, TENNESSEE
MARCH 28, 2000

**NTSB/HAR-01/03
PB2001-916203
Notation 7415
Adopted December 11, 2001**

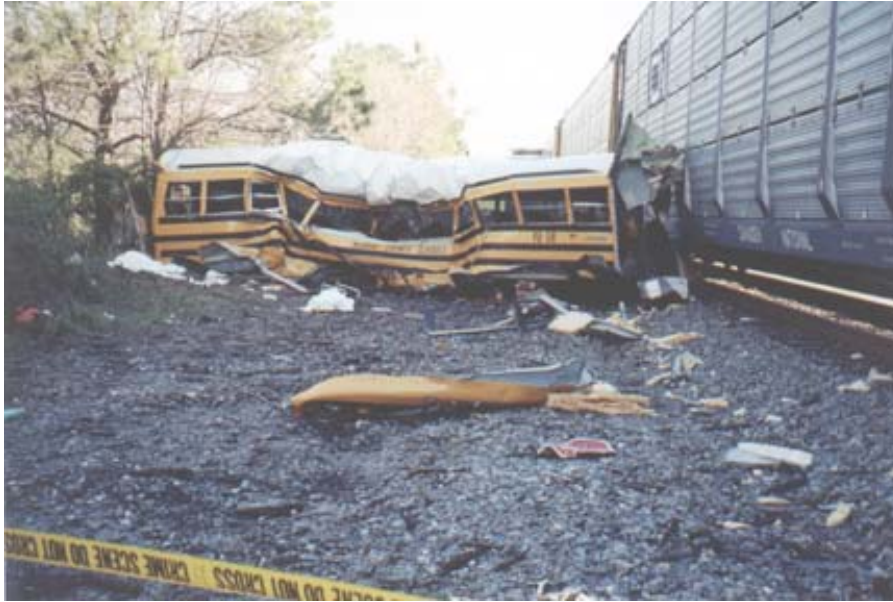
Figure 4. Accident bus.

The train struck the school bus on the passenger side between the axles. During the accident sequence, the bus body and its chassis struck the crossbucks and separated, and the chassis came to rest 64 feet west-southwest of the center of the grade crossing; the chassis was facing east. The front of the bus body, including the section to which the driver's seat was attached, separated from the rest of the body and remained with the chassis, which rolled on its passenger side and later rolled back upright. The body, pushed down the tracks by the locomotive before pivoting off and rotating clockwise about 180 degrees, came to rest 192 feet west-southwest of the center of the crossing (see figure 3). That part of the bus body immediately behind the separation point was flush with the train body (see figure 4). Broken branches and scrape marks were found on rows of trees approximately 112 feet and 157 feet from the grade crossing. The train did not derail, and the locomotive came to rest about 1,990 feet from the crossing. During the accident sequence, the bus body scraped several branches and struck a tree near the area where the bus came to rest. Bus tire rub marks were found on the inside of the rail.

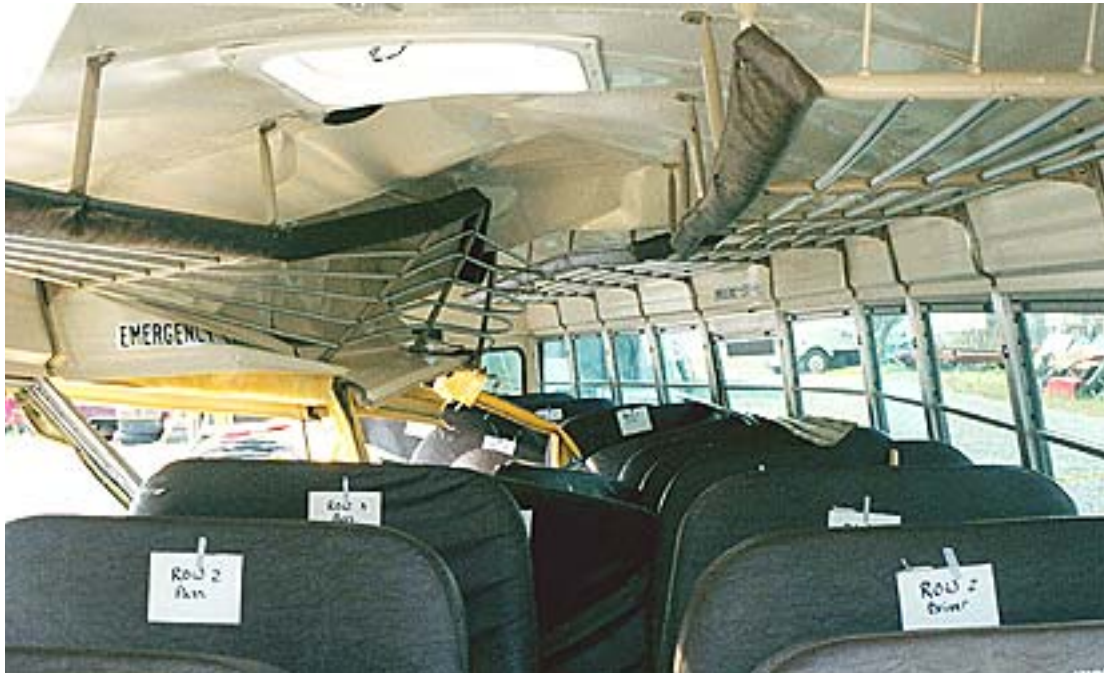
Figure 6. Roof rack.

Severe damage to the roof rack was noted on the passenger side of the bus. Damage to the sidewall and roof of the bus caused the rack to rotate approximately 90 degrees, with the opening into the rack facing the top of the roof. Although twisted and bent after the accident, the racks remained securely attached to the bus body. The rack on the driver side of the bus was almost completely intact, except near seats 6 and 7, where induced deformation was present. This deformation was near the area of maximum intrusion.

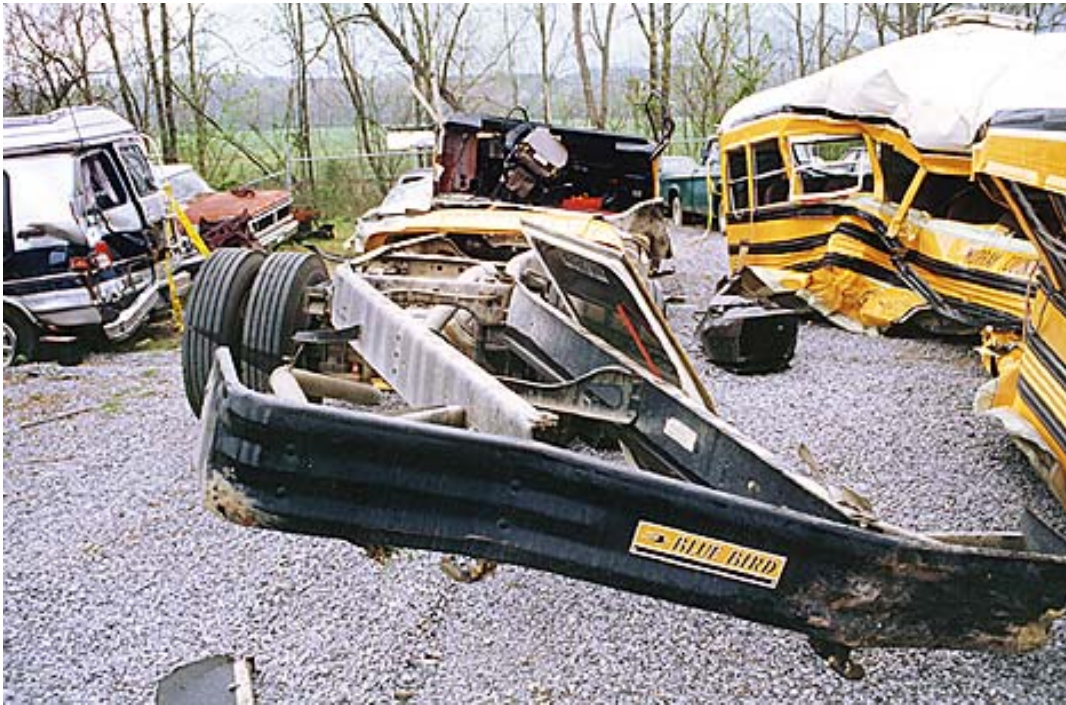
Figure 7. Bus chassis.

The school bus body separated from the chassis at the engine compartment cowling²³ and the forward roof panel above the windshield. The driver's seat, windshield, engine cowling, entrance stairwell, firewall, and dash controls remained attached to the part of the bus body still attached to the chassis. The chassis' main frame rails were deformed rightward from the drive axle rearward; maximum deformation was 44.63 inches. The drive axle was displaced leftward 7.8 inches. Frame rail cross members and rear bumper supports were also damaged (see figure 7).

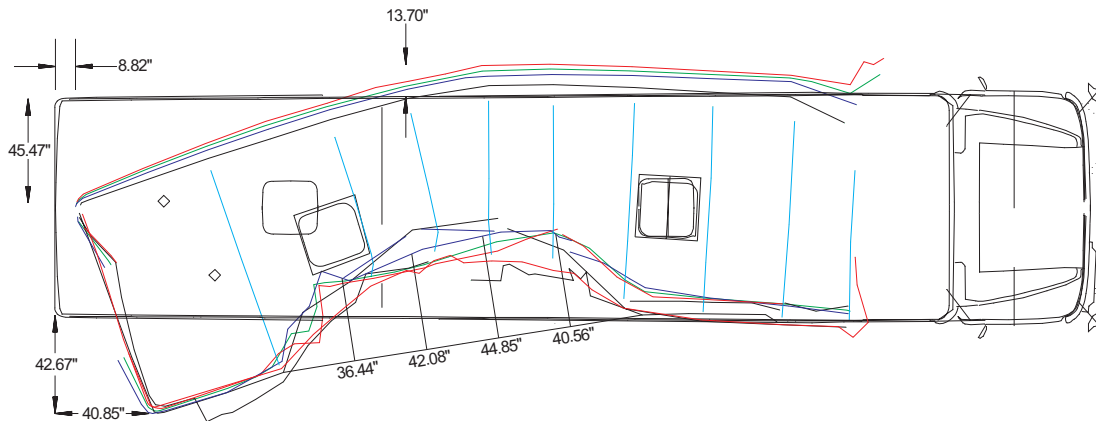
Figure 8. Bus body deformation.

Damage to the bus body was extensive in the immediate area of impact; maximum intrusion was 44.85 inches (figure 8). In addition, induced damage, in the form of bowing of the body structure, was substantial. The right rear corner of the bus was skewed rightward 42.67 inches and forward 40.85 inches (see figures 9 and 10).

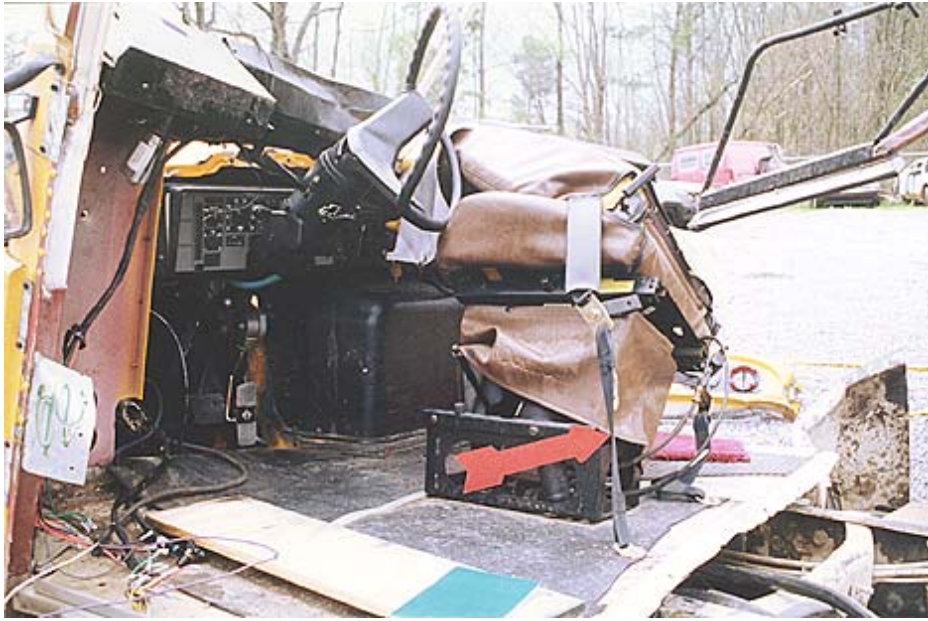
Figure 11. Driver's seat.

Postaccident inspection showed the driver's seat tilted toward the passenger side of the bus (see figure 11). The left lap belt segment extended from the edge of the seat cushion to the floor of the bus and was taut, while the right lap belt segment extended from the edge of the seat cushion to the floor of the bus and was slack. The driver's seat and the floor anchorages remained attached to the body flooring, which was in turn attached to the chassis. The shoulder belt passed through the D-ring, and the D-ring and the emergency retractor were located on the sidewall of the bus body (see figure 12). The shoulder belt webbing was torn, some of it remained with the driver's seat, and the rest remained with the sidewall-mounted retractor.

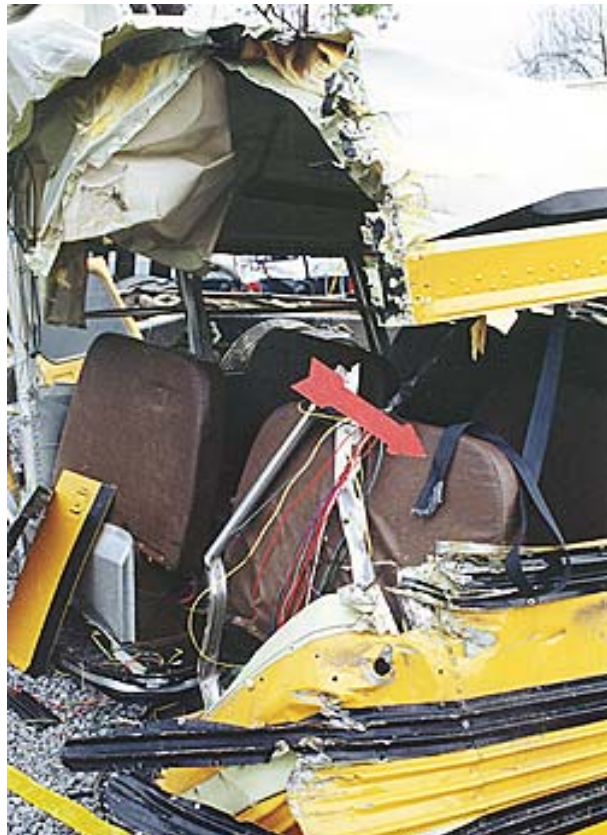
Figure 12. Portion of driver's shoulder belt attached to bus body.

The driver's lap/shoulder belt webbing was severed near where it passed through the free-sliding latch plate, which remained secured in the latch plate receiver on the chassis. Loading marks³³ were noted on the latch plate of the lap/shoulder belt and were visible on the D-ring. Striations in the plastic cover where the webbing passed through the latch were present along the length of the plastic.
