NTSB National Transportation Safety Board

Office of Marine Safety

Empress of the North **Events Leading to** **Grounding**

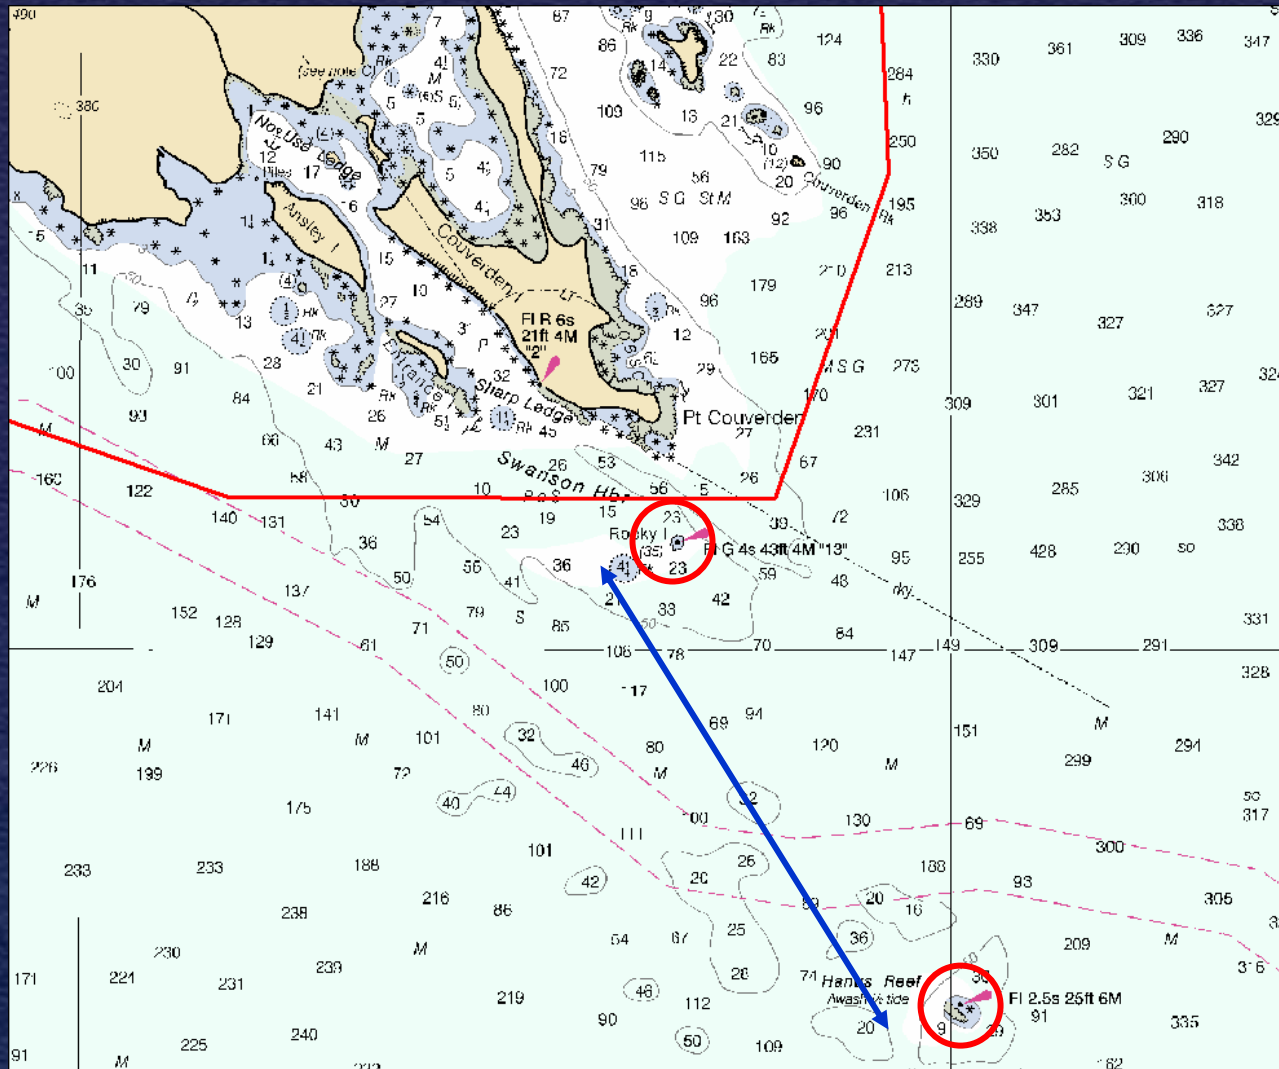
Safe Water

- Only 0.5 mile of water between obstructions
- Only one clear visible reference at night
- Poor radar echoes
- Coast Pilot warning
- 3.2 miles of open water to the south
