NTSB National Transportation Safety Board

Office of Marine Safety

Survival Factors

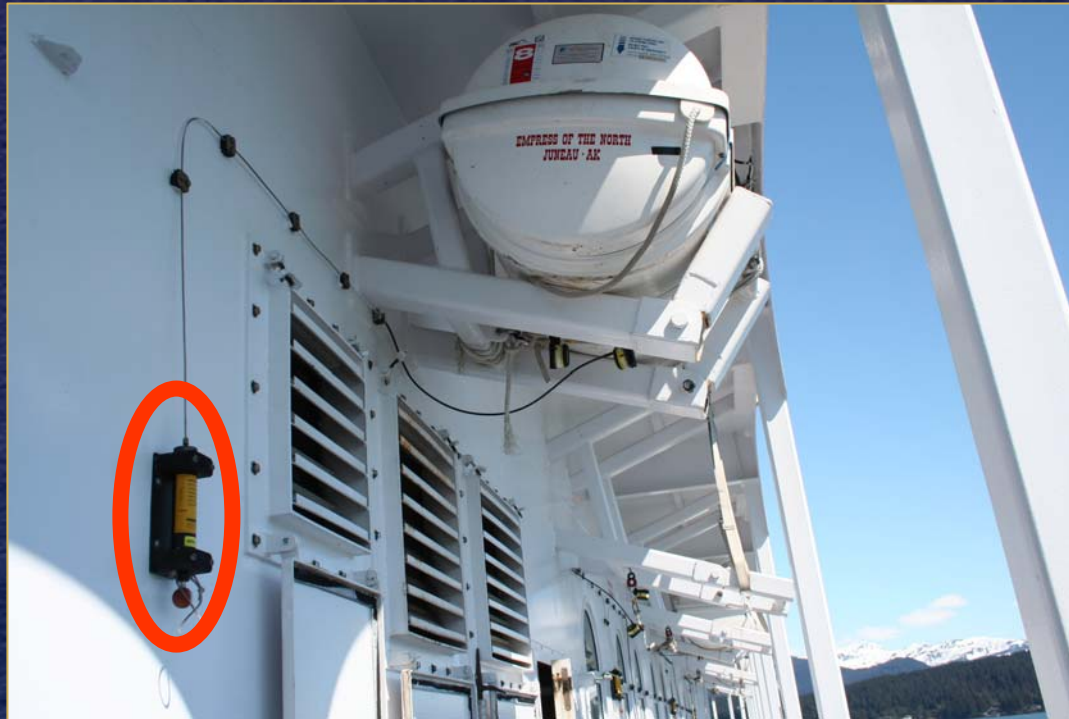
Lifesaving Equipment Issues

- Remote release units
 - Approximately half failed

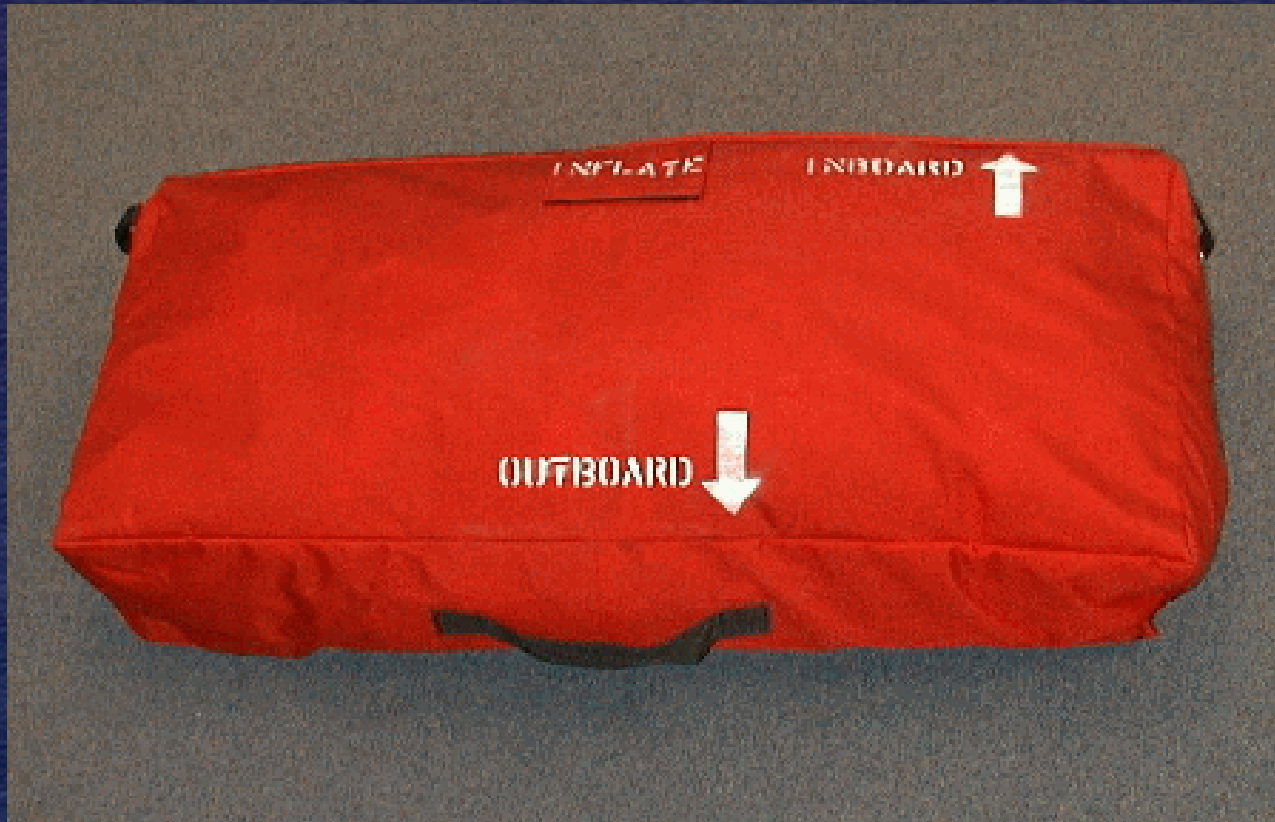
Lifesaving Equipment Issues

- Inflatable Evacuation Slides

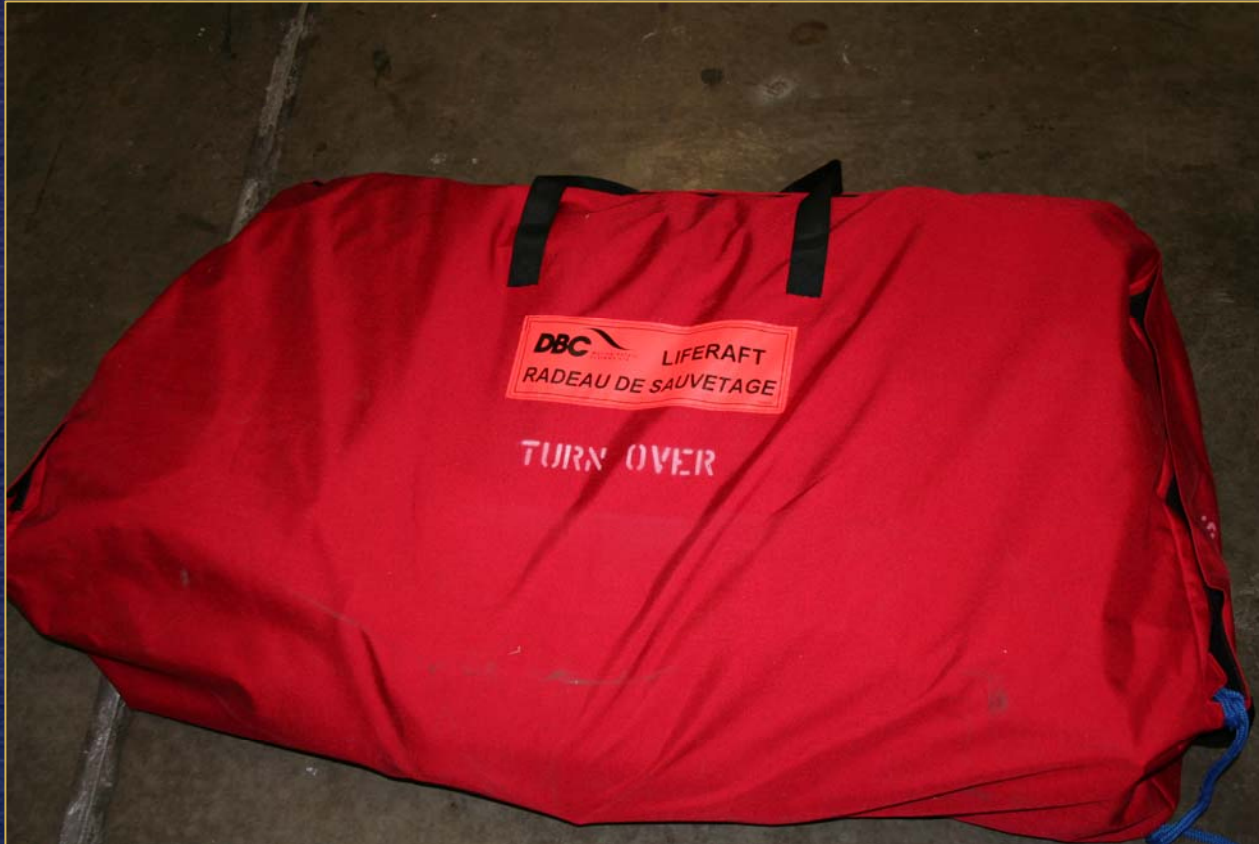
Valise Upside down

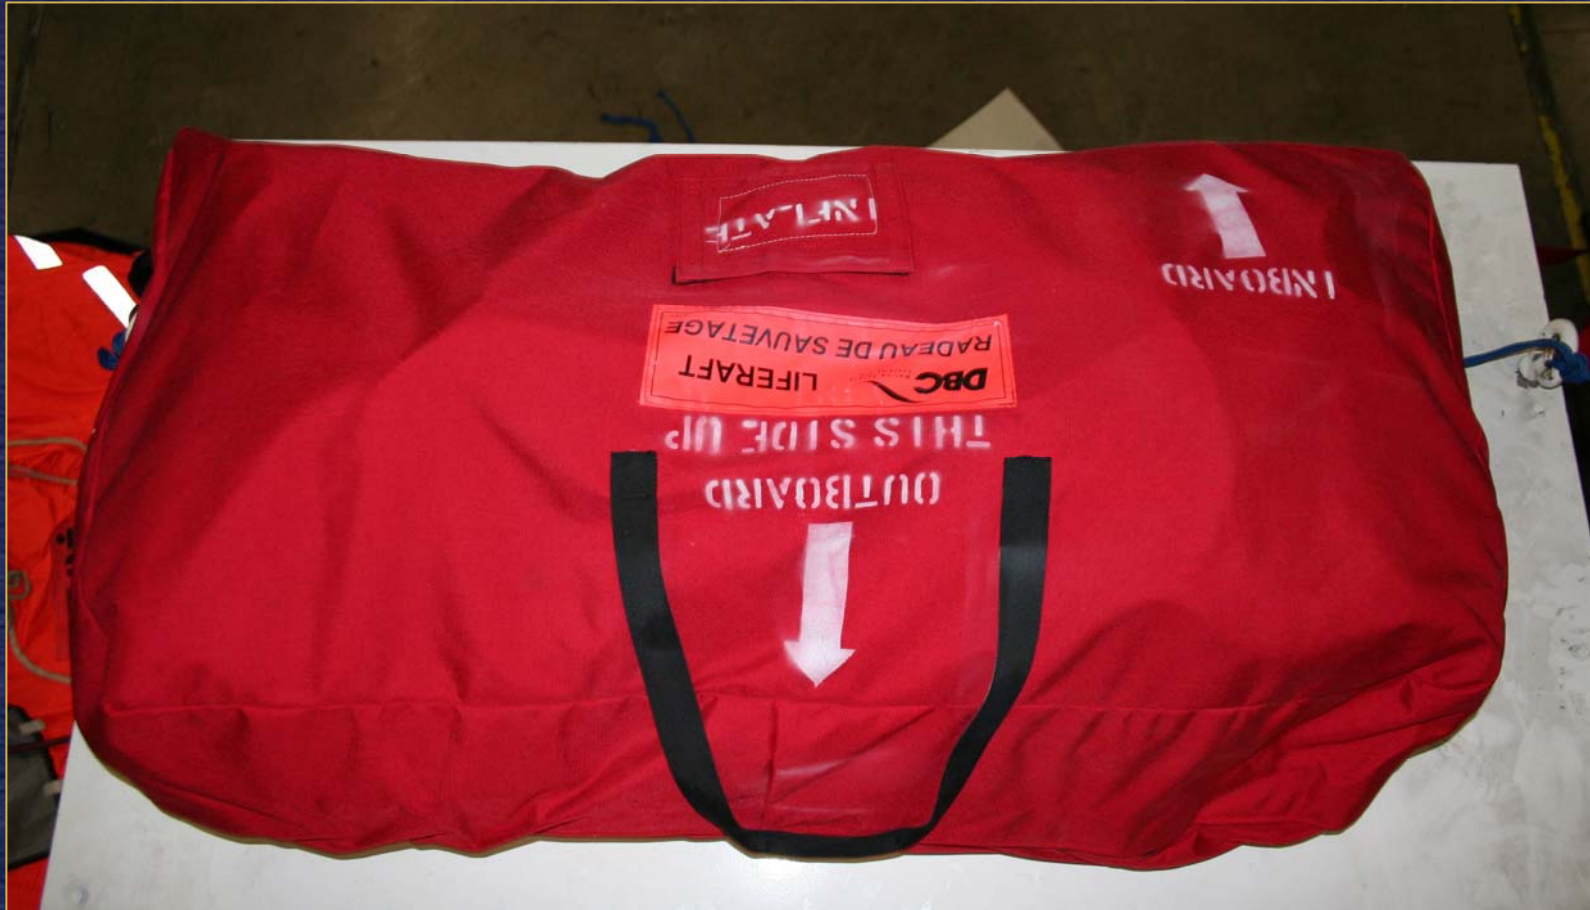
Valise Backwards

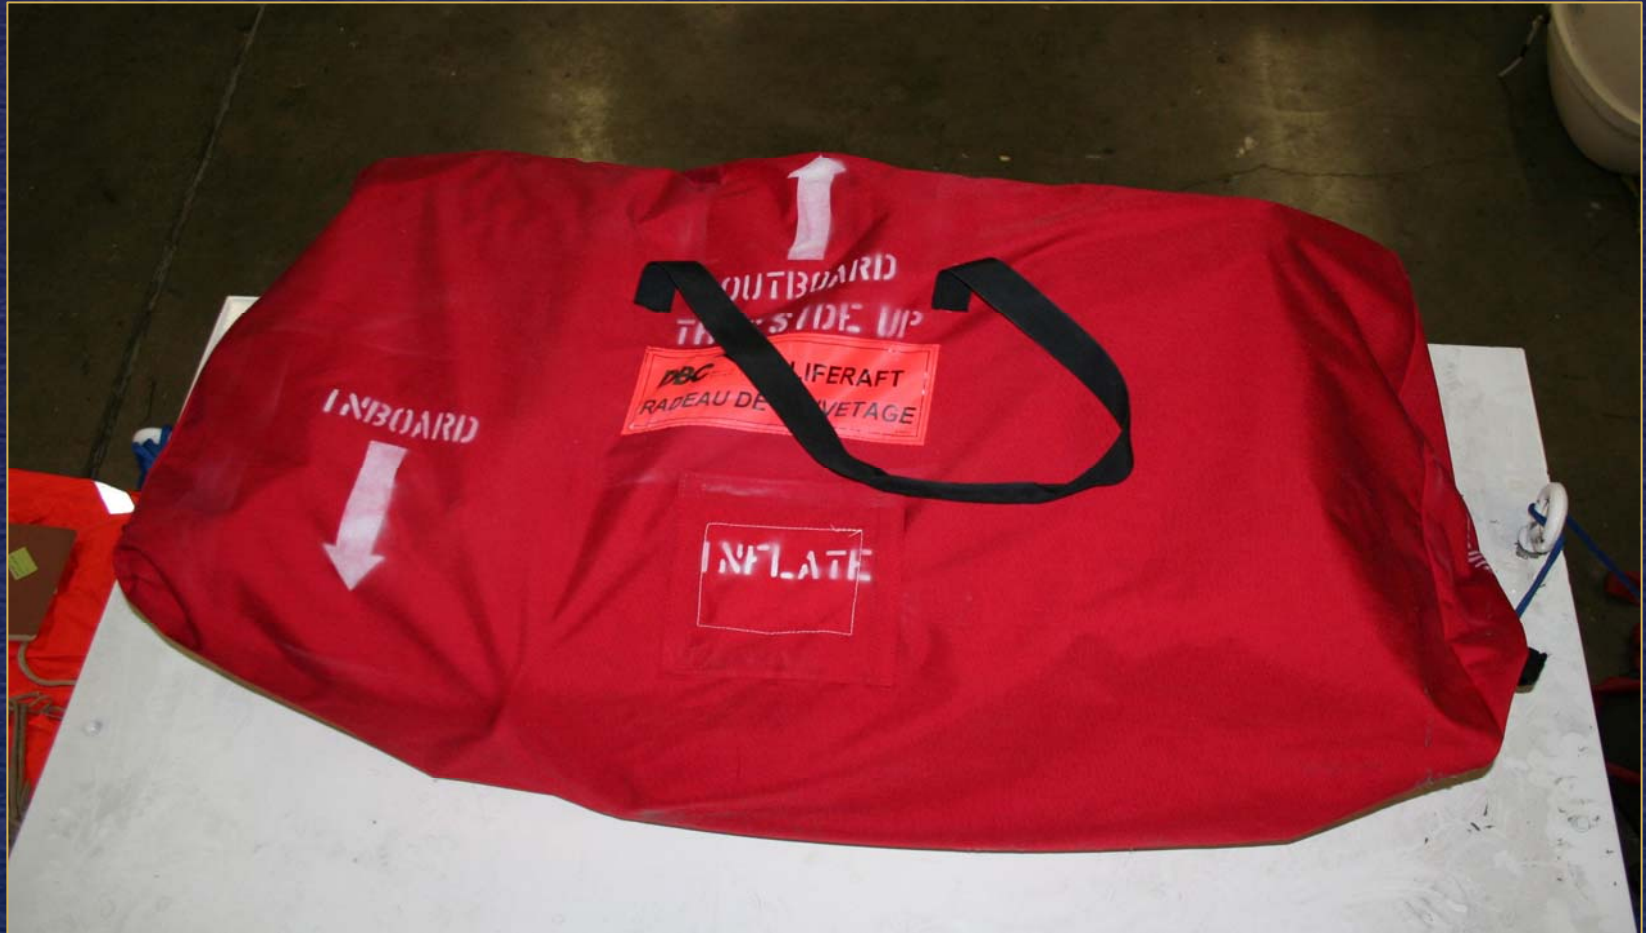
Valise Packed Incorrectly
