**NTSB** National Transportation Safety Board

# **Bridge Description and Collapse**

Jim Wildey

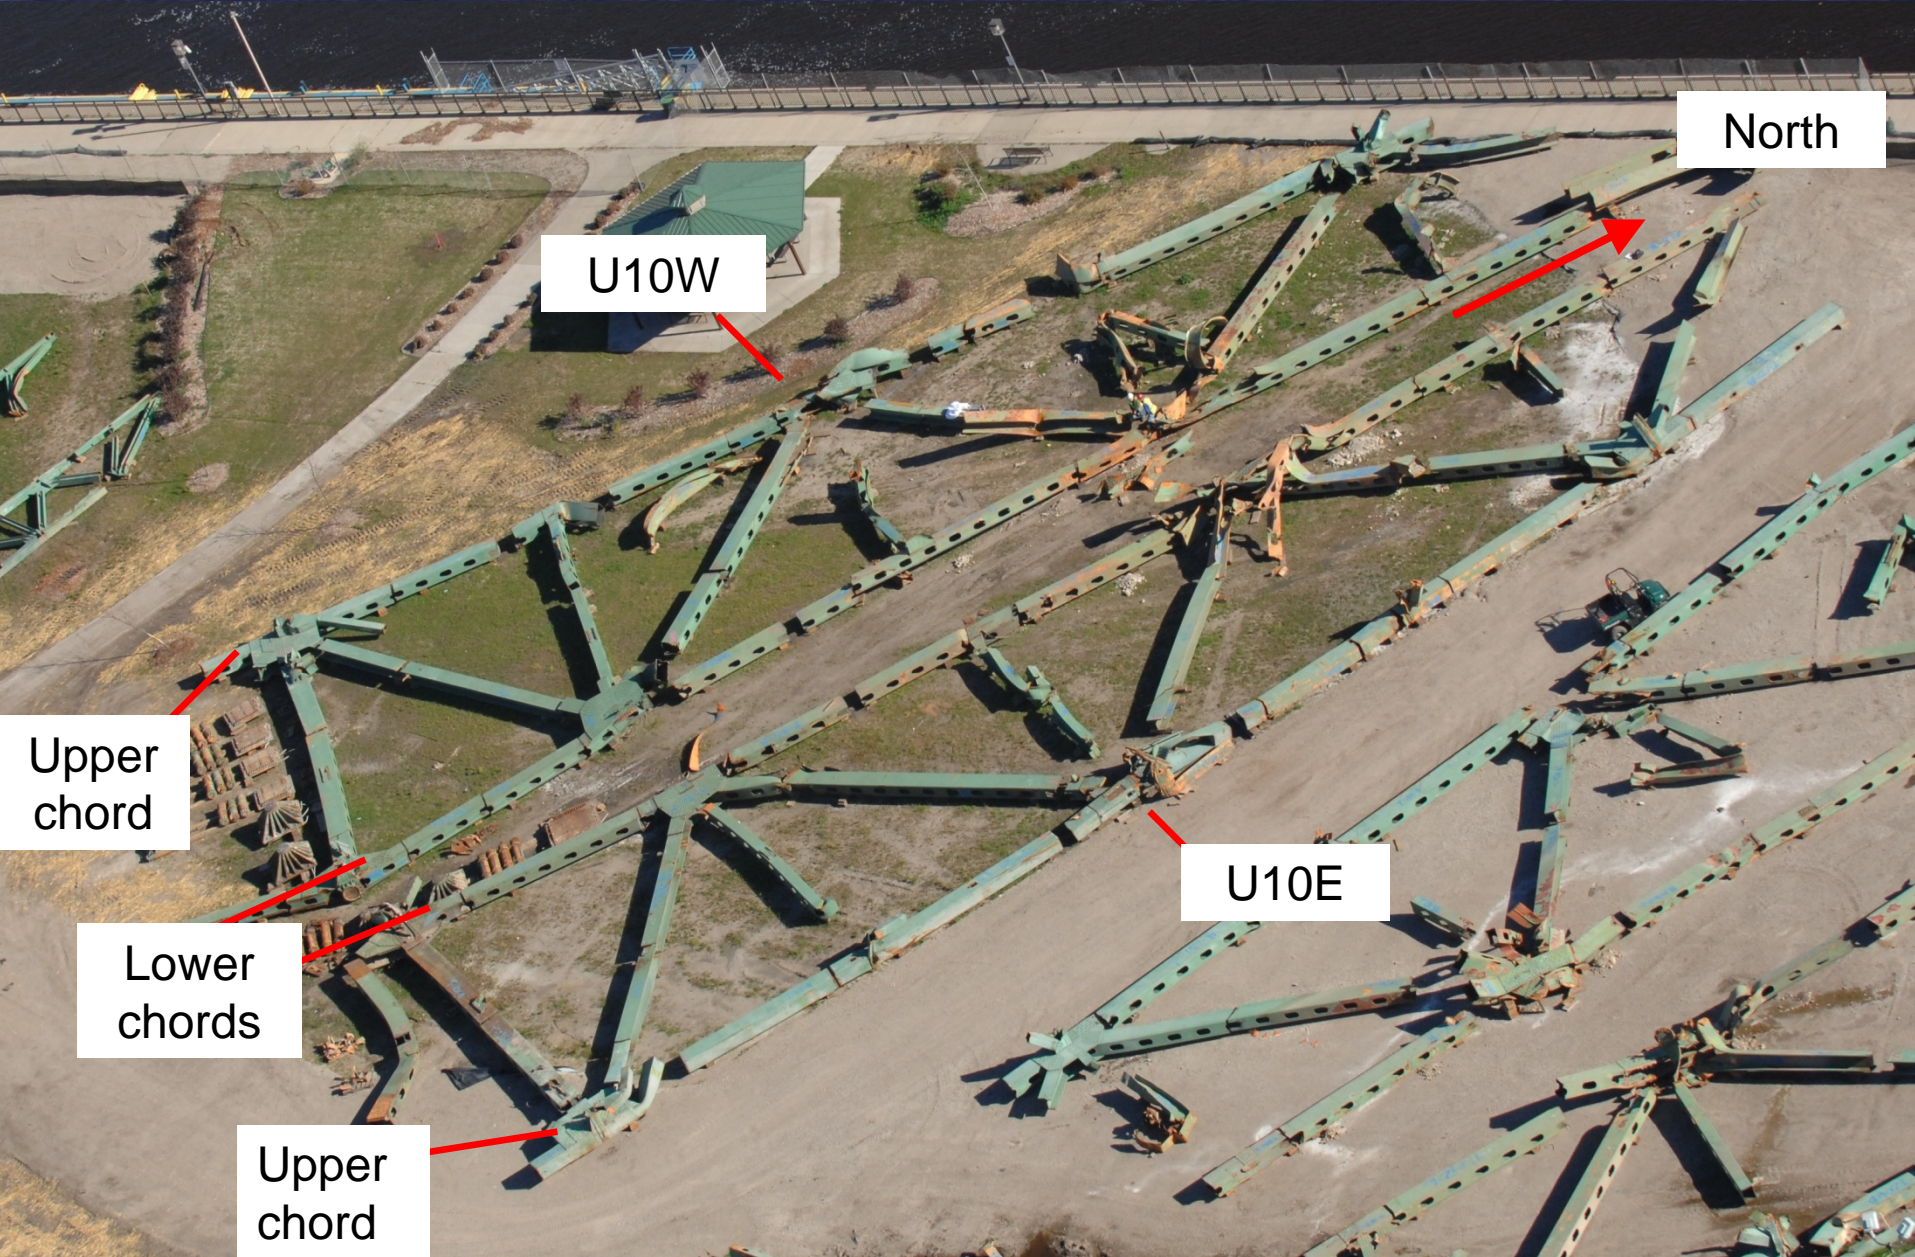
# Fracture and Deformation

- Main trusses fractured between nodes 9 and 10
- Fractures in node U10 gusset plates met initial event criteria

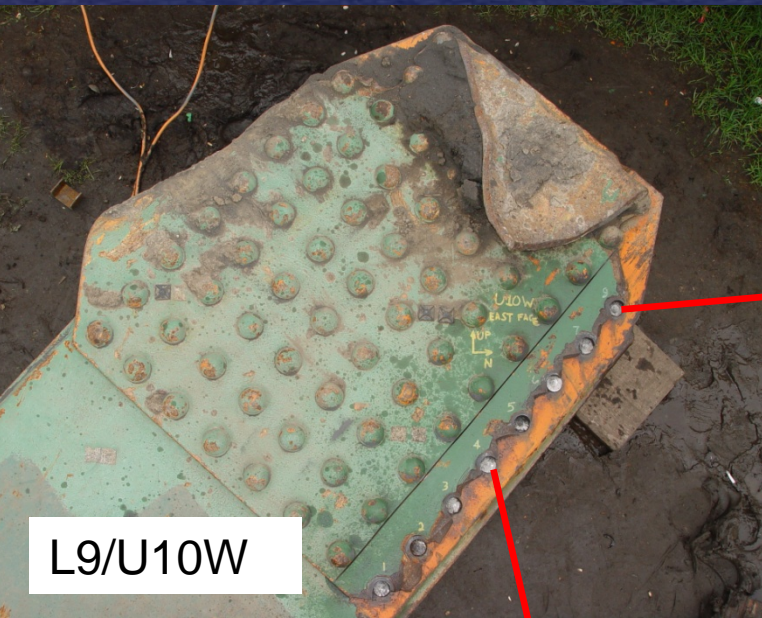
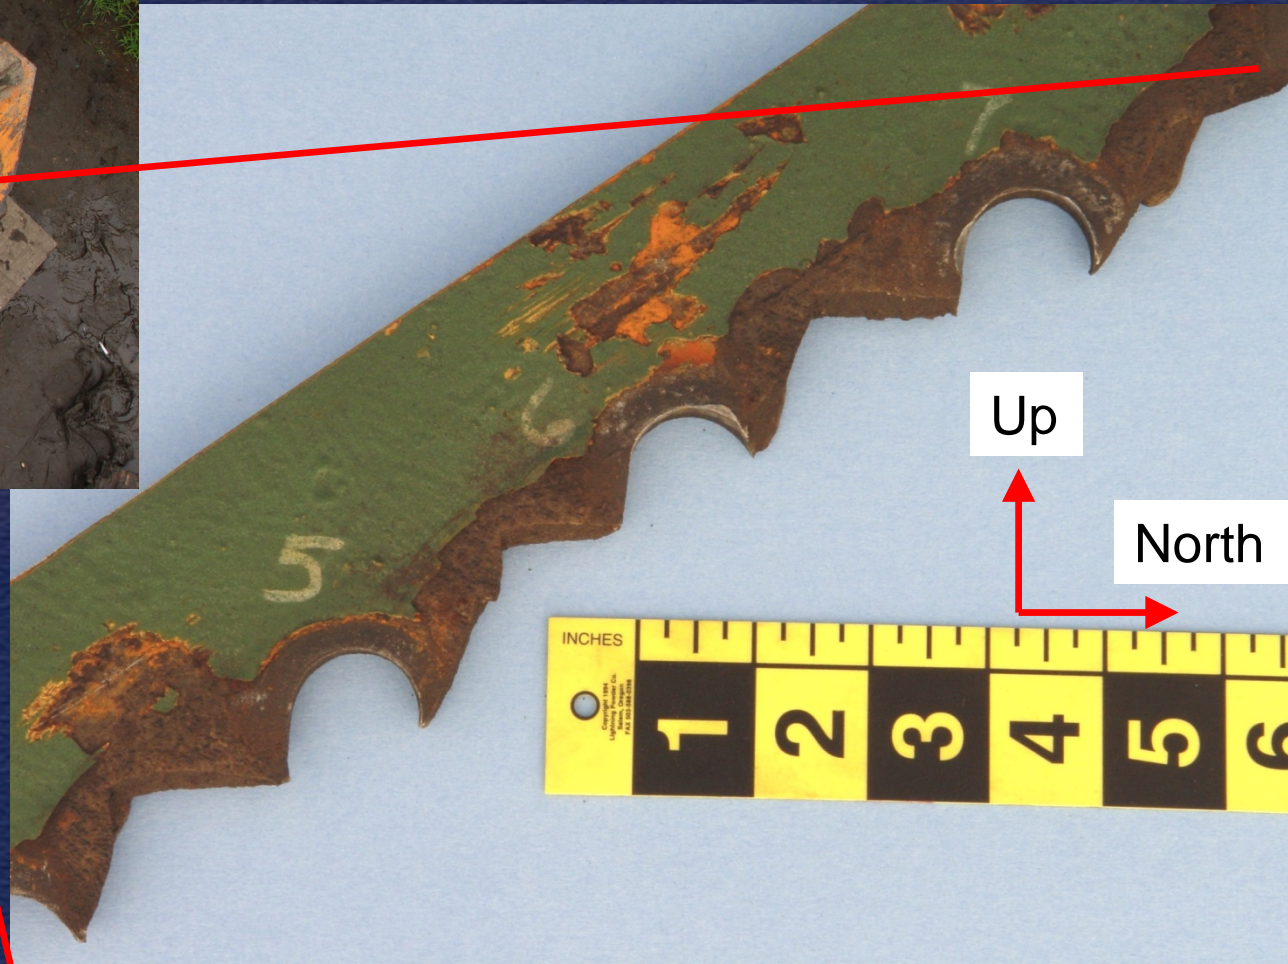
# Initial Tension Fracture U10 West

- Initial failure in U10 gusset plates
  - Compression failure above compression diagonal
  - Tension fracture
- Collapse was unavoidable once gusset plates failed at node U10

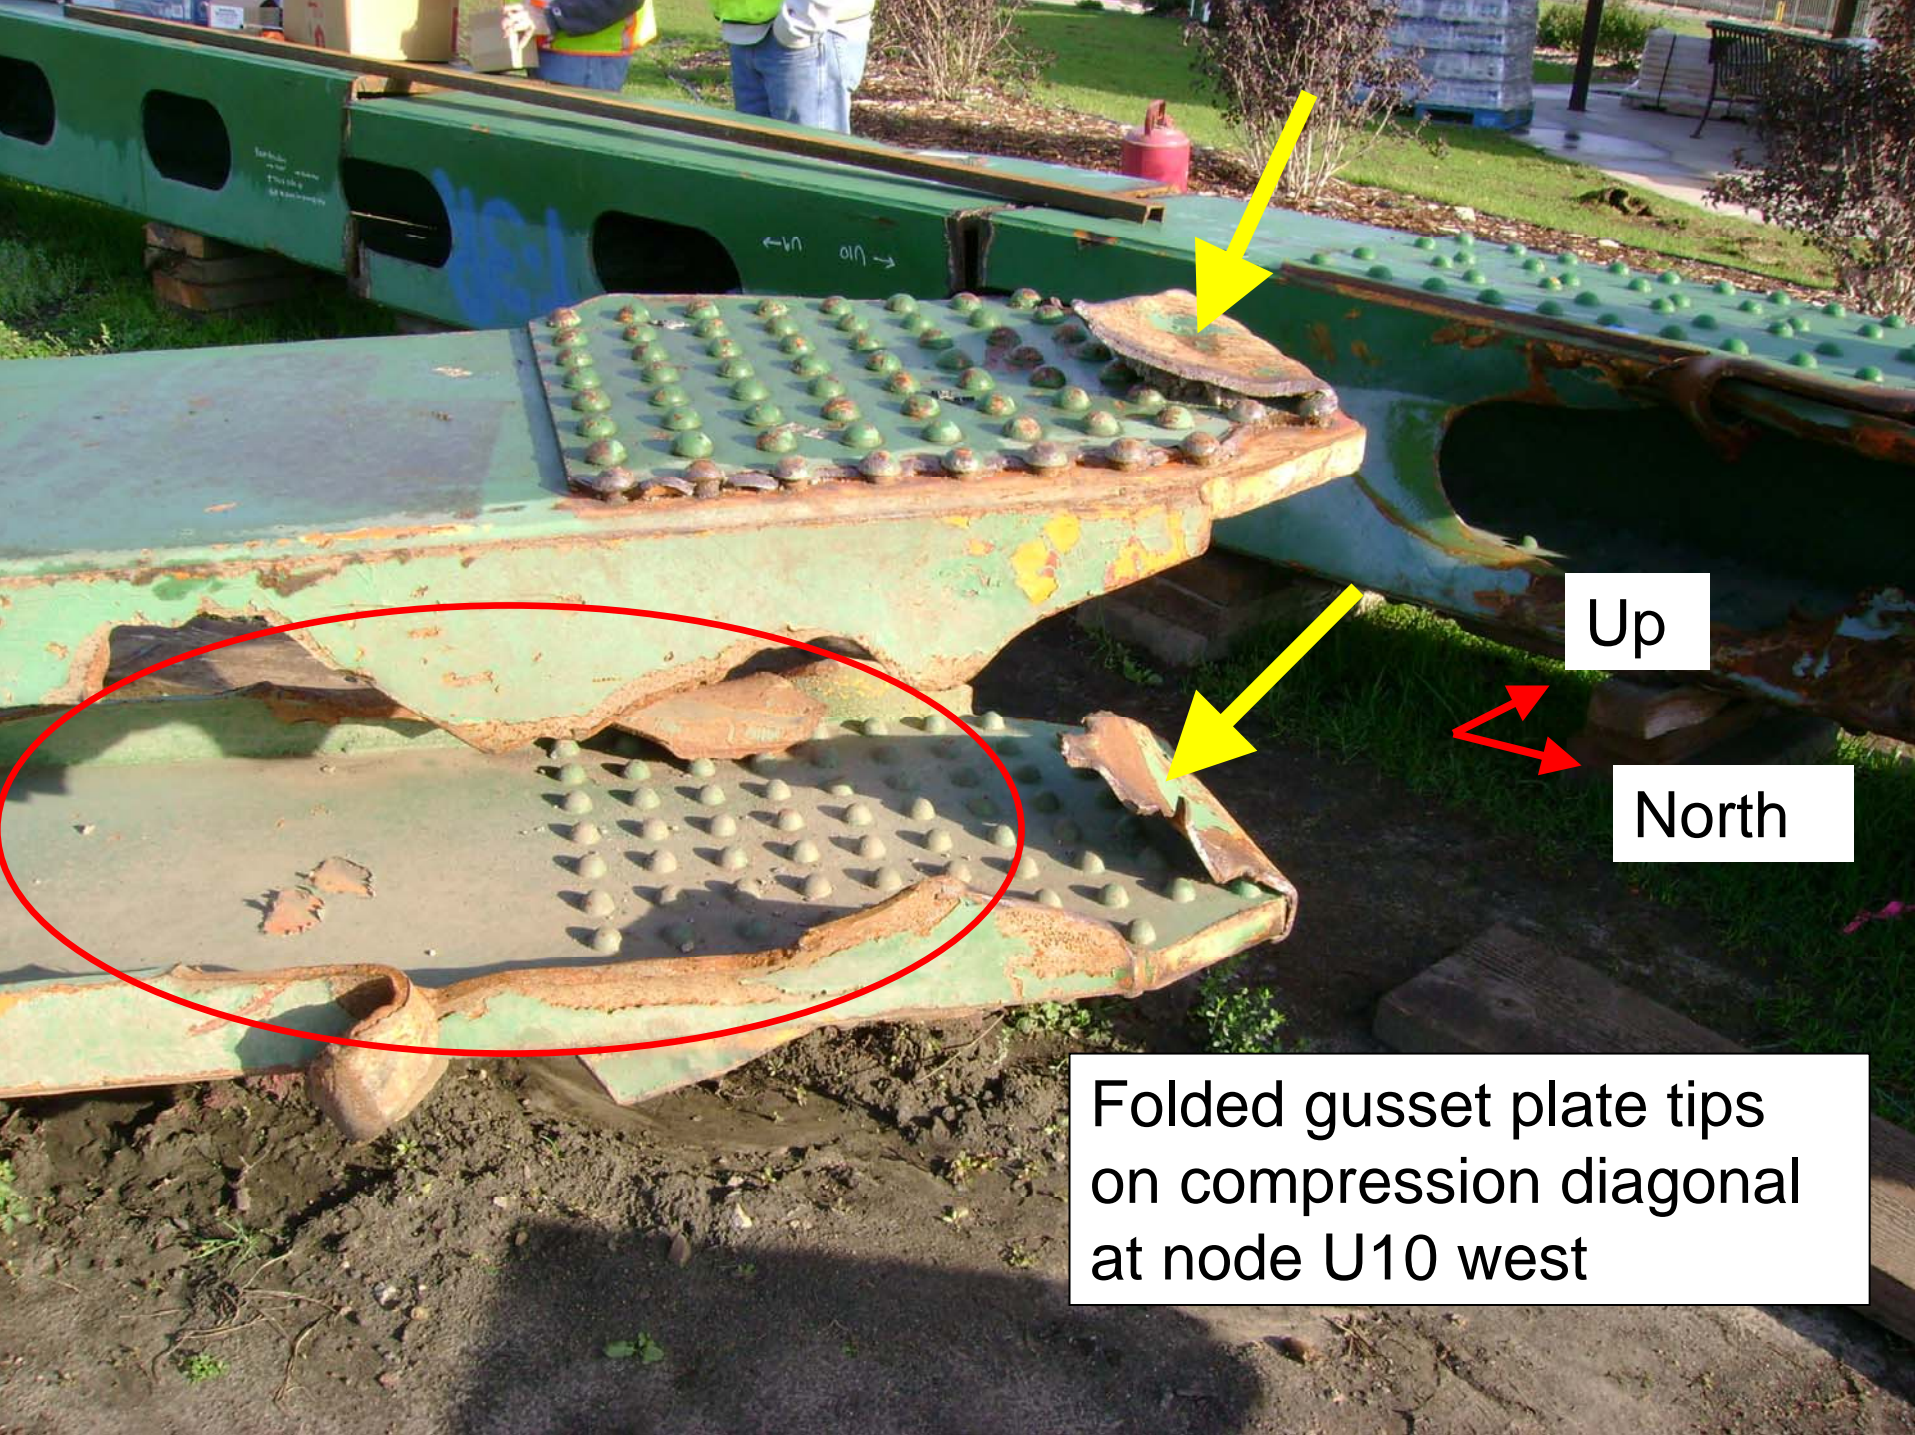
2003 Photo

Folded gusset plate tips on compression diagonal at node U10 west

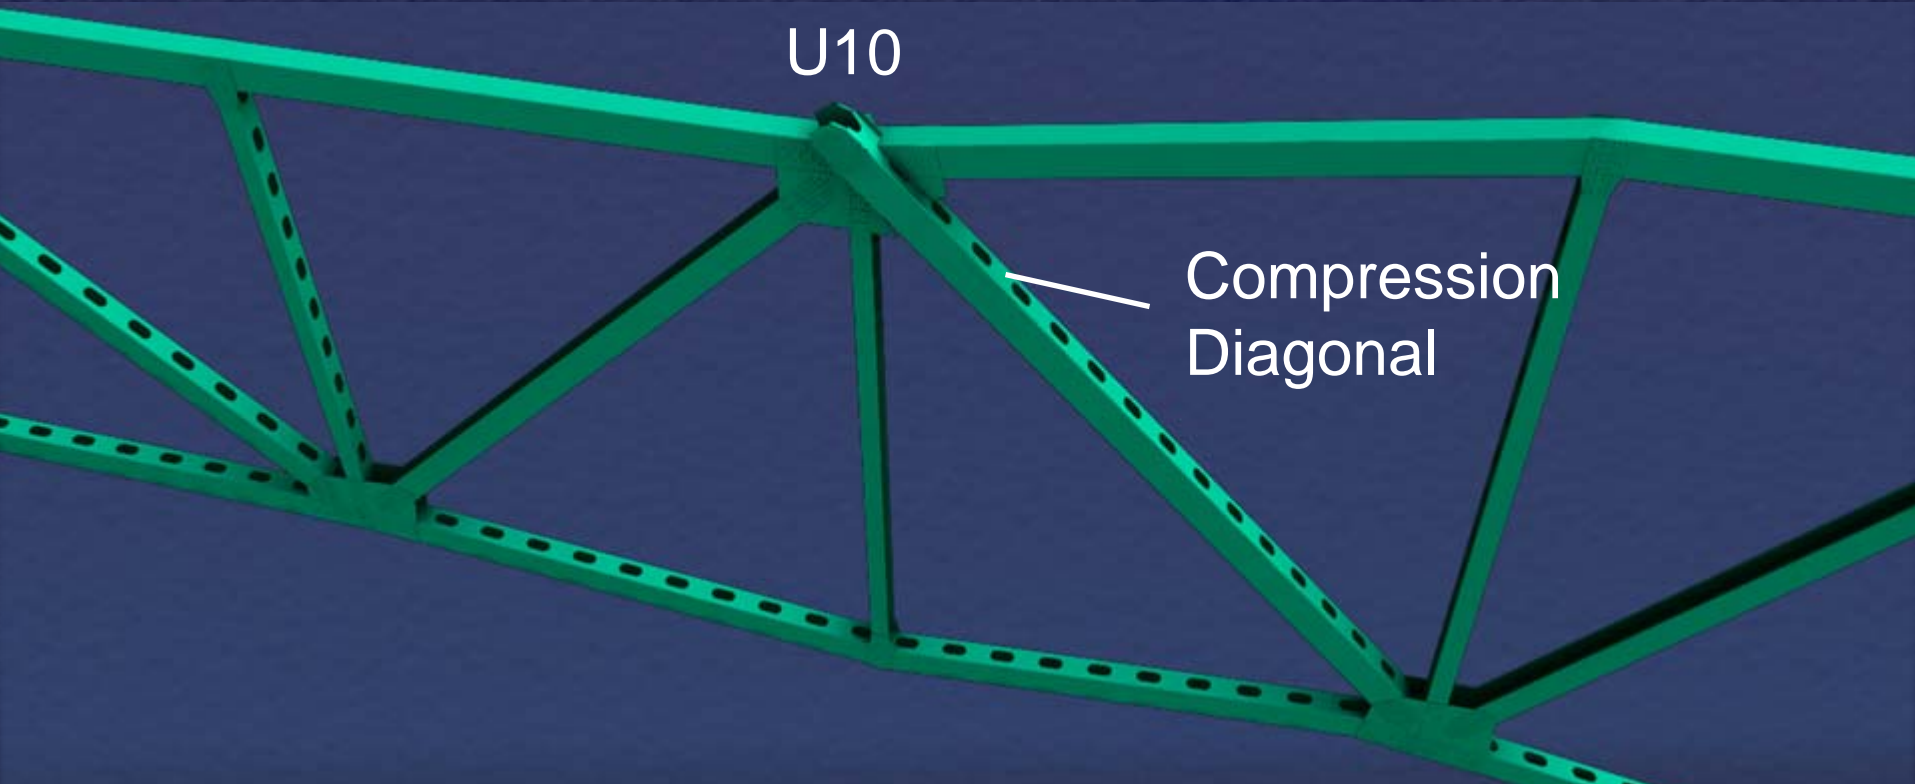
1. Gusset plates at nodes U10 failed, compression diagonals translated to the west, and remaining portions of nodes U10 were pulled down and through diagonals

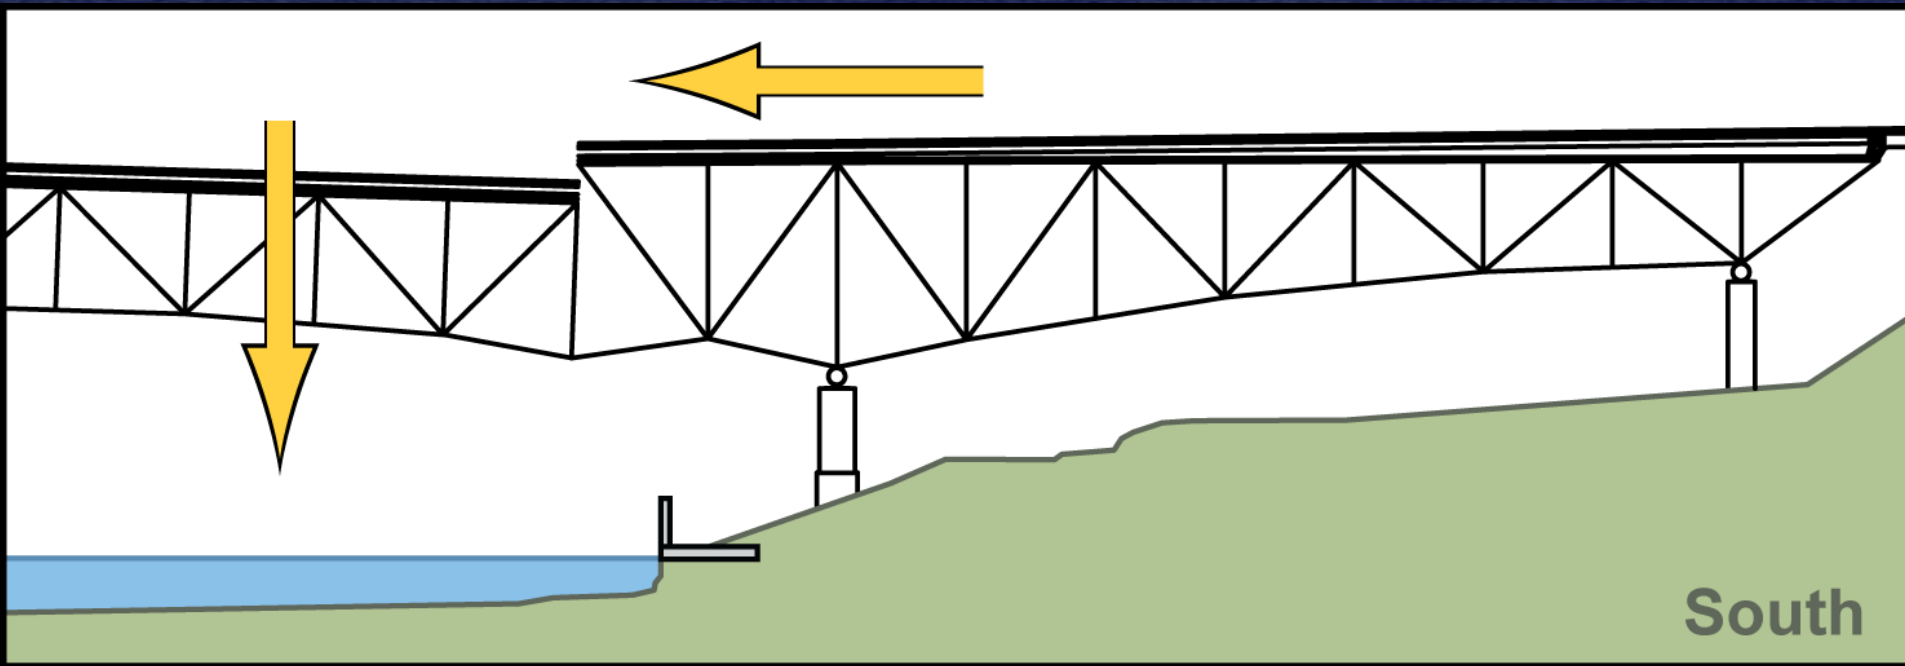
2. Dropping of center span created tension loading in main truss lower chords and secondary structural members. This loading pulled south portion of deck truss to the north, off pier 5, causing loss of support for south approach spans

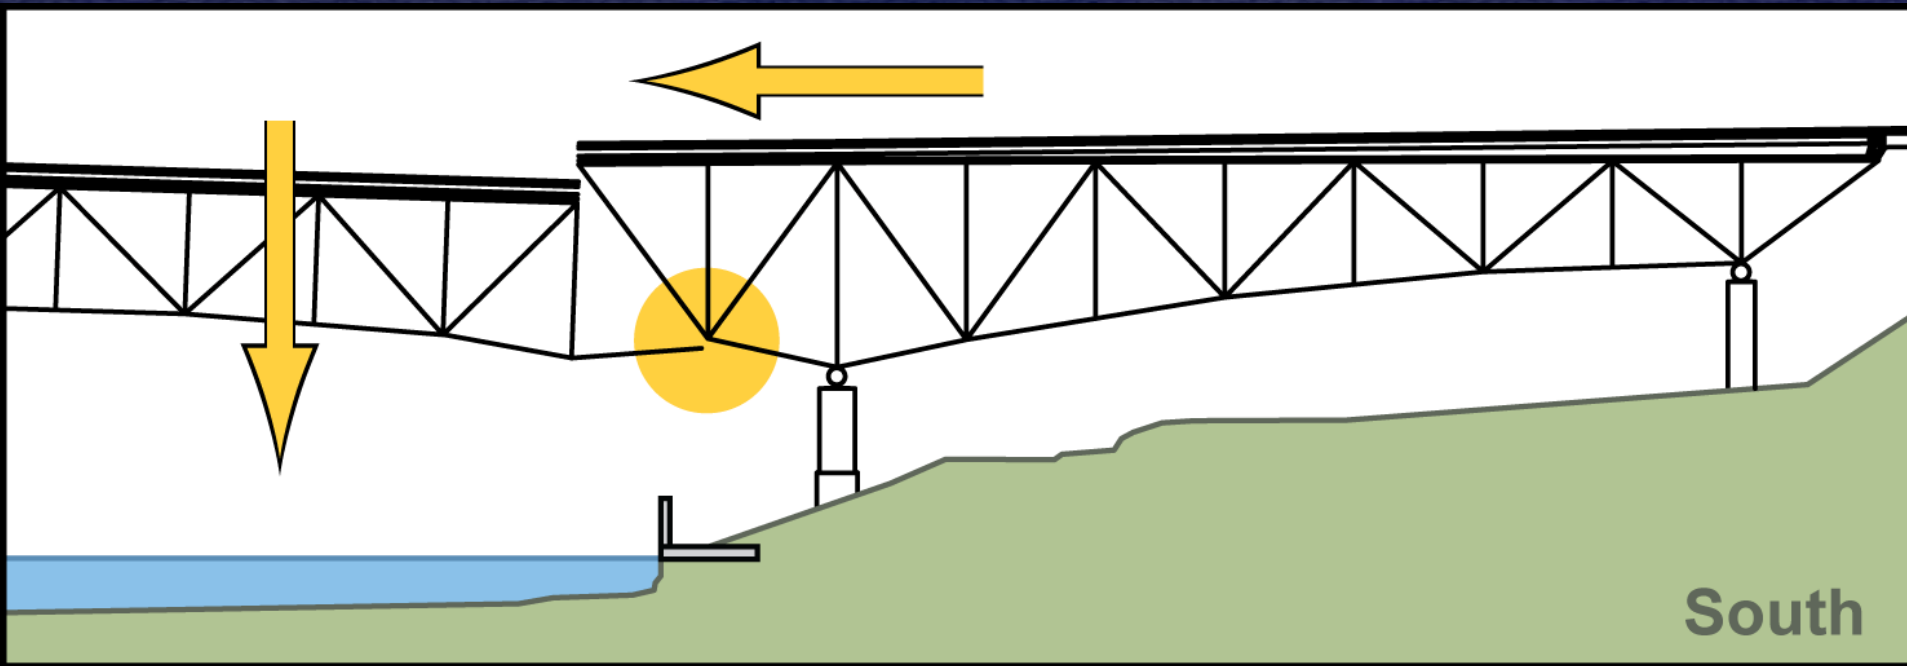
3. Other main truss members fractured in bending

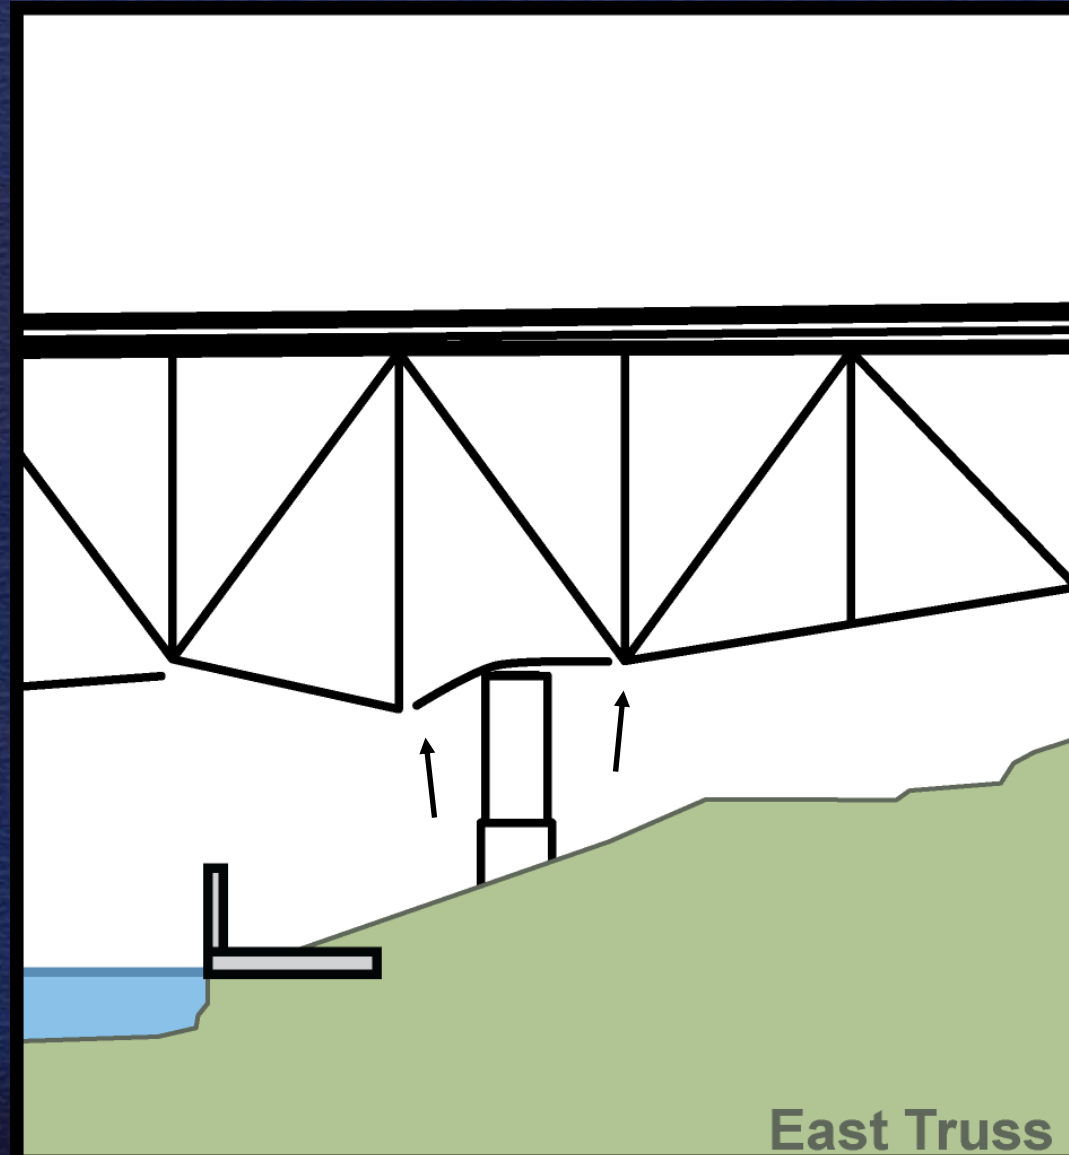
4. Lower chord L7/L8 east fractured from its nodes, allowing south portion of truss to topple to the east

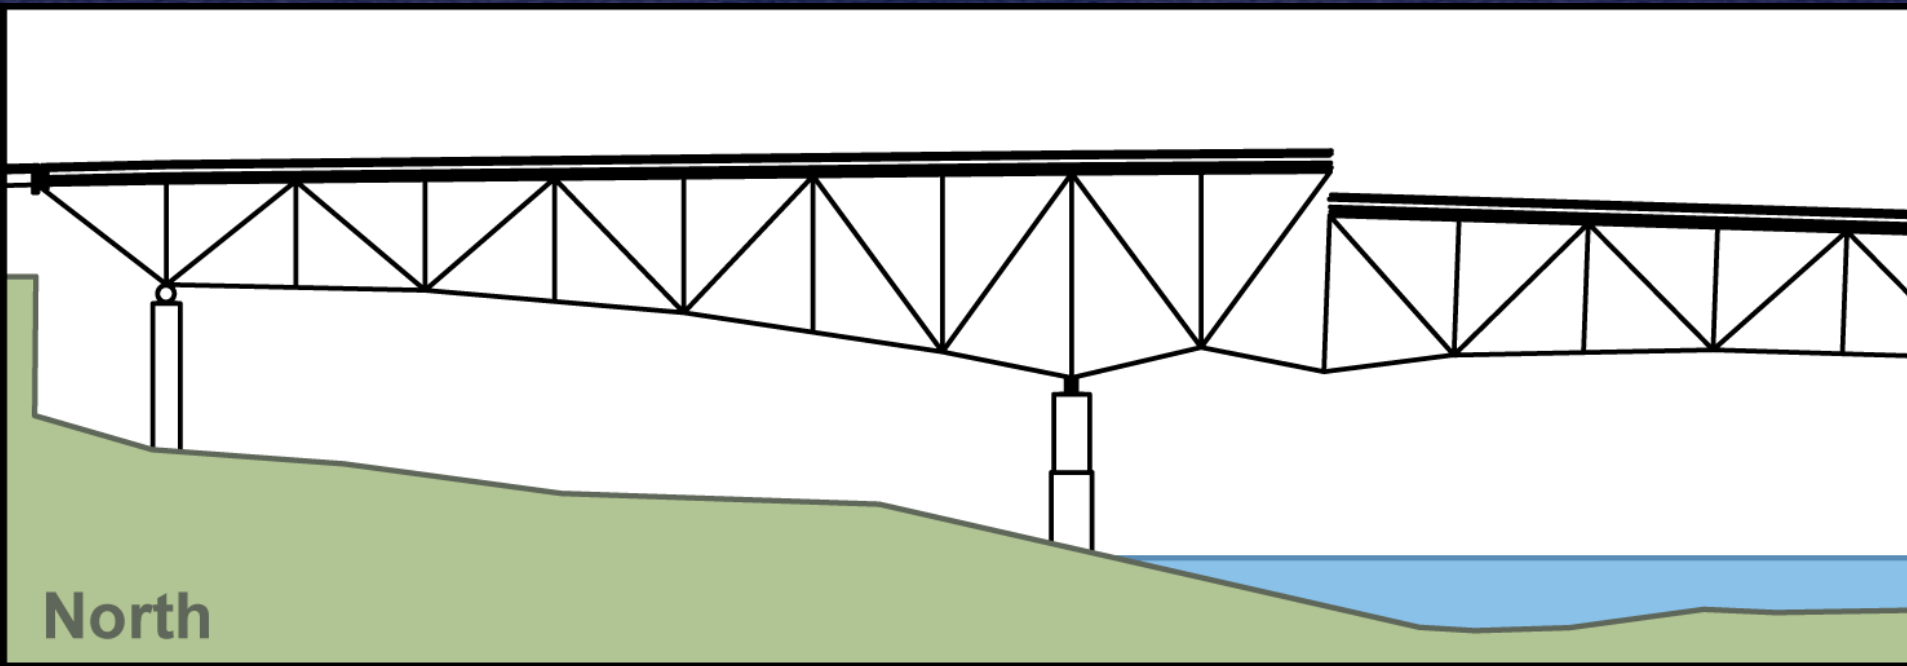
5. Gusset plates at node U10' failed, and additional secondary failures in this portion of the truss completely separated the center section of the center span from remainder of deck truss

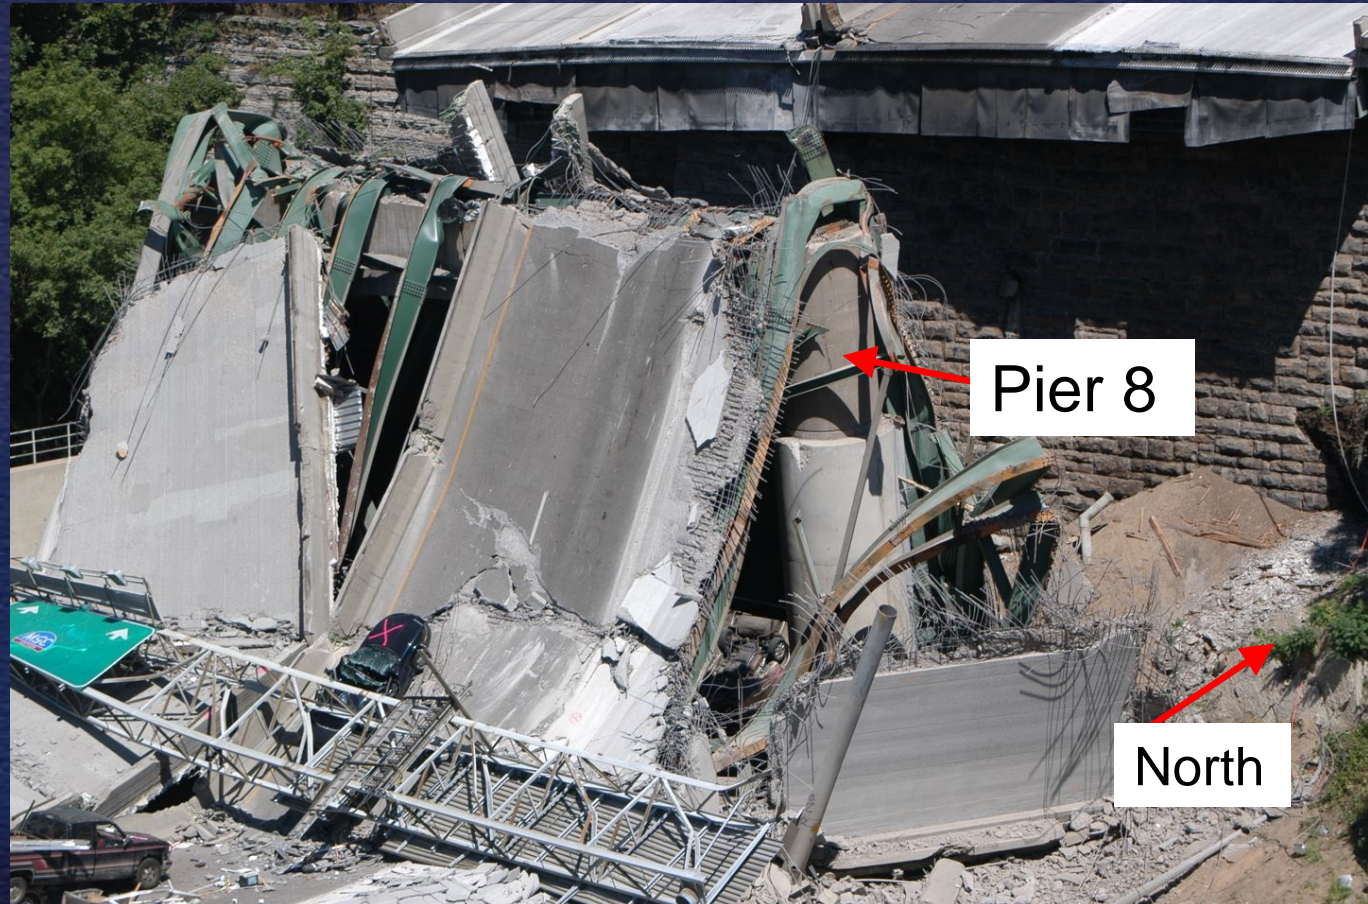
- Deck truss collapsed above pier 8, causing loss of support for north approach spans, and this collapse spread southward toward pier 7

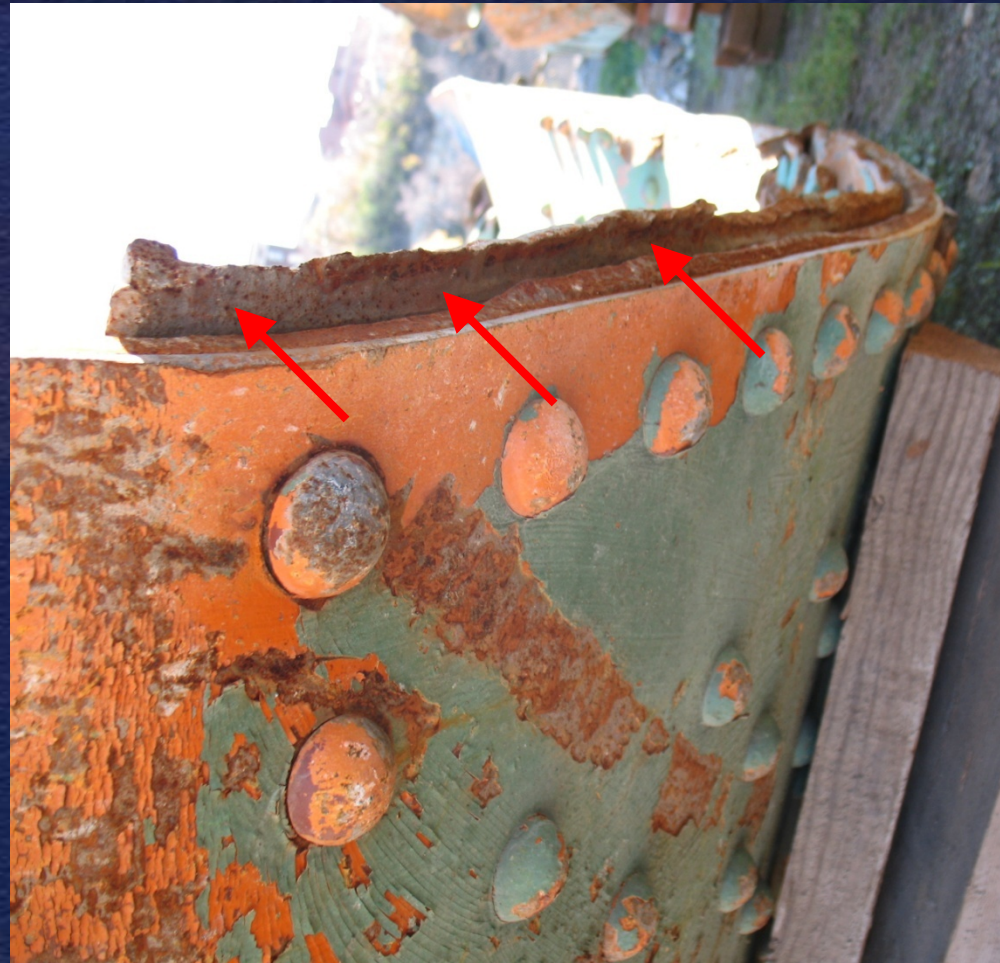
# Corrosion Damage

- Some corrosion present
  - Secondary members
  - Lower chord gusset plates
- Inspection records documented corrosion

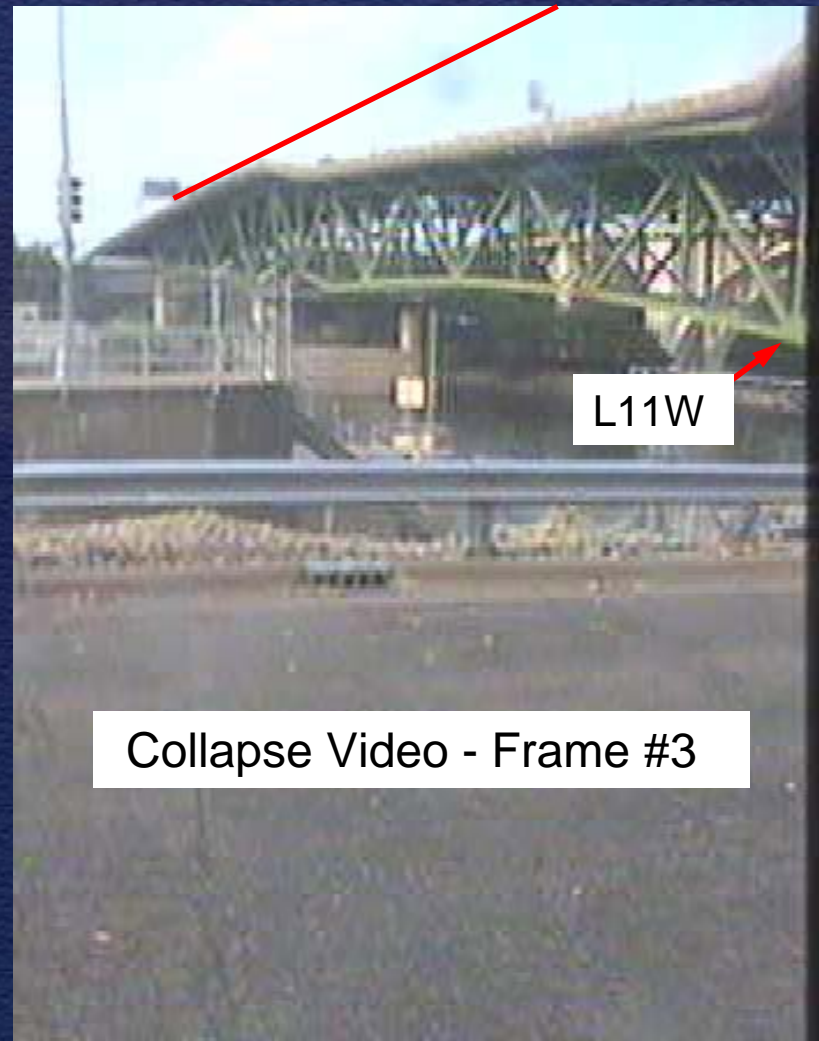
# Corrosion Did Not Contribute

L11 gusset plates failure eliminated as factor as shown by:

- Fracture and deformation patterns
- Video recording
- Finite element analysis

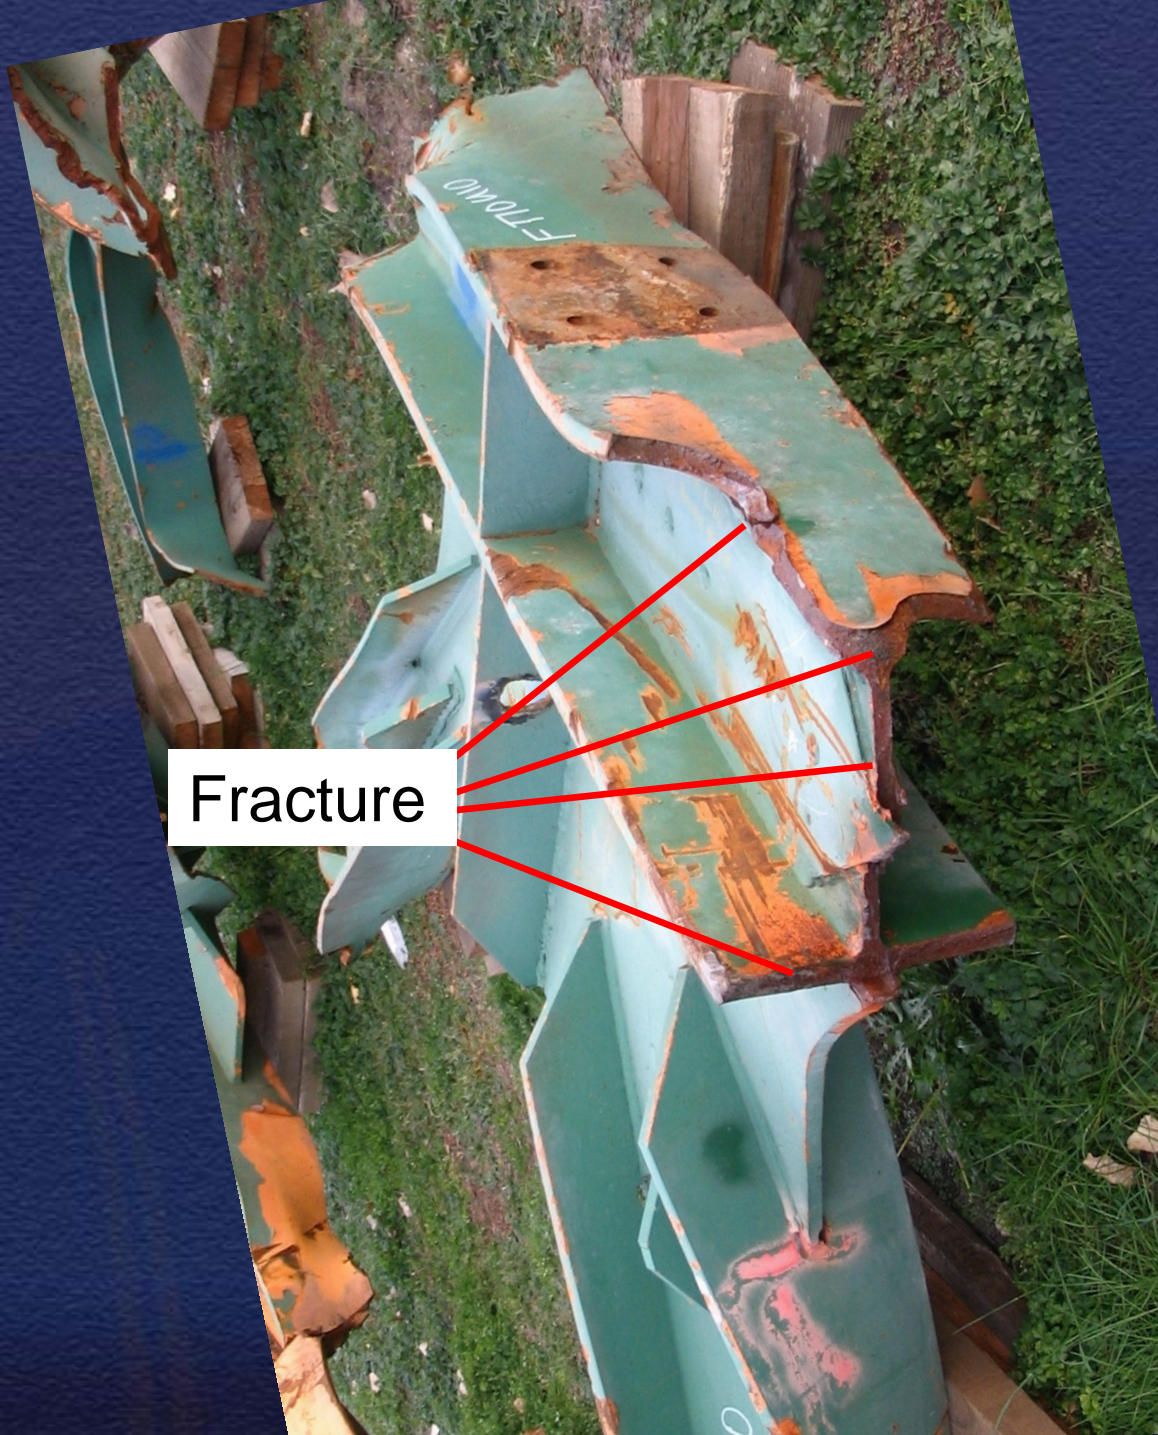
Floor truss 10 –  
secondary  
damage

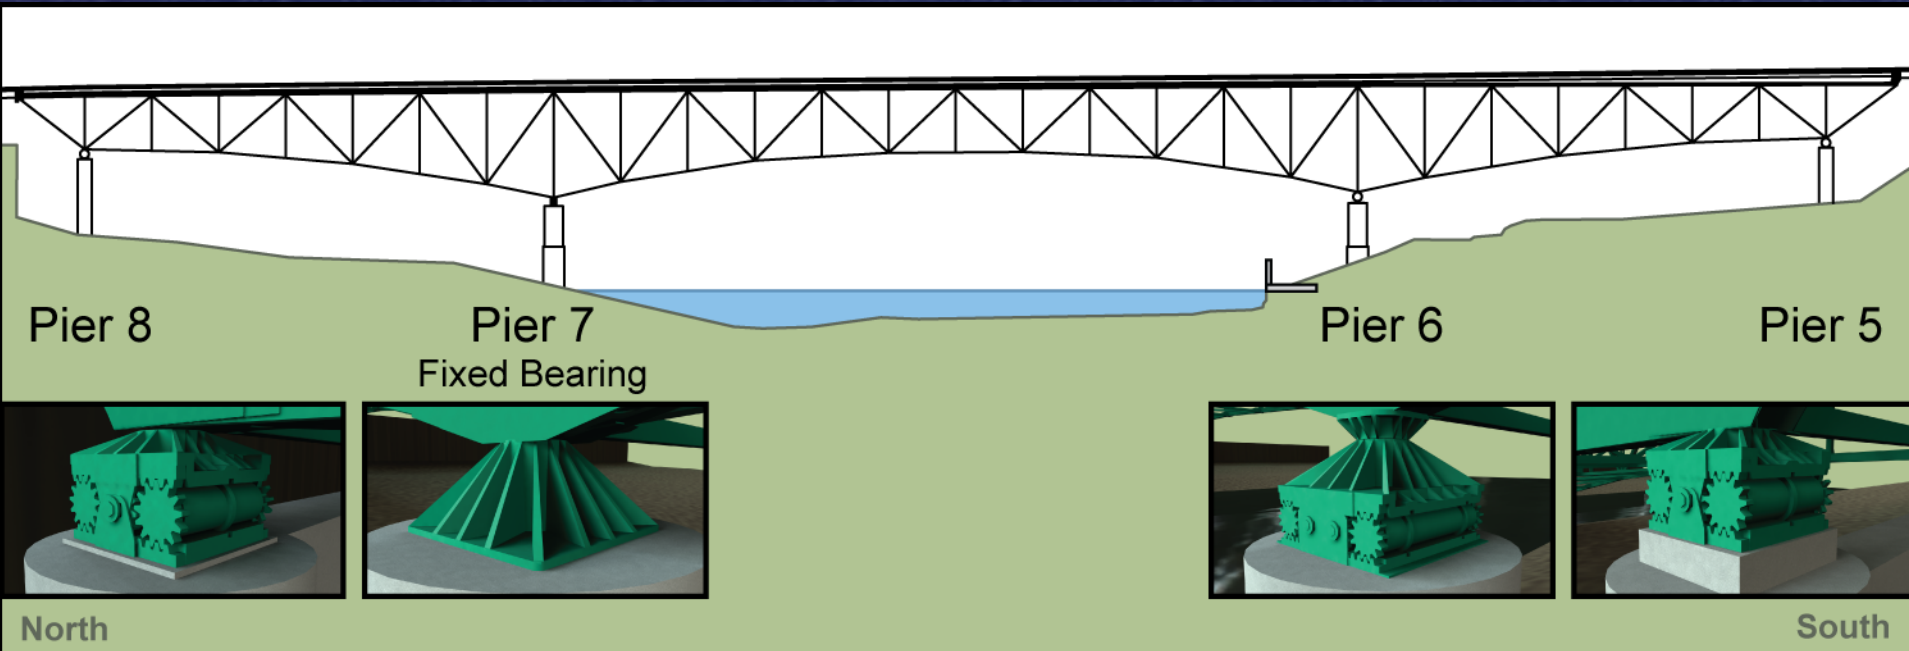
# Bearings and Piers

- Rollers were moving
- Wear in center of contact plates
- No horizontal shifting of piers
