NTSB National Transportation Safety Board

Office of Research and Engineering

Design Error

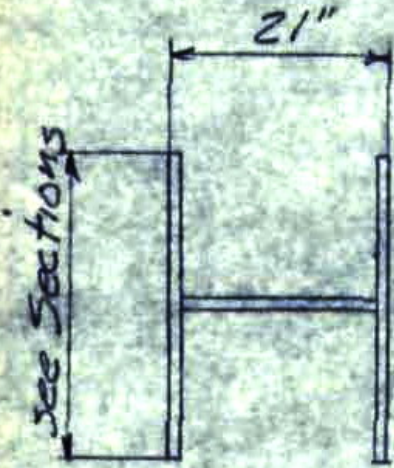
Typical Computation Sheet

S&P quality assurance process failed to detect omission of necessary gusset plate calculations
