NTSB National Transportation Safety Board

Gusset Plate Inspection Issues

Mark Bagnard

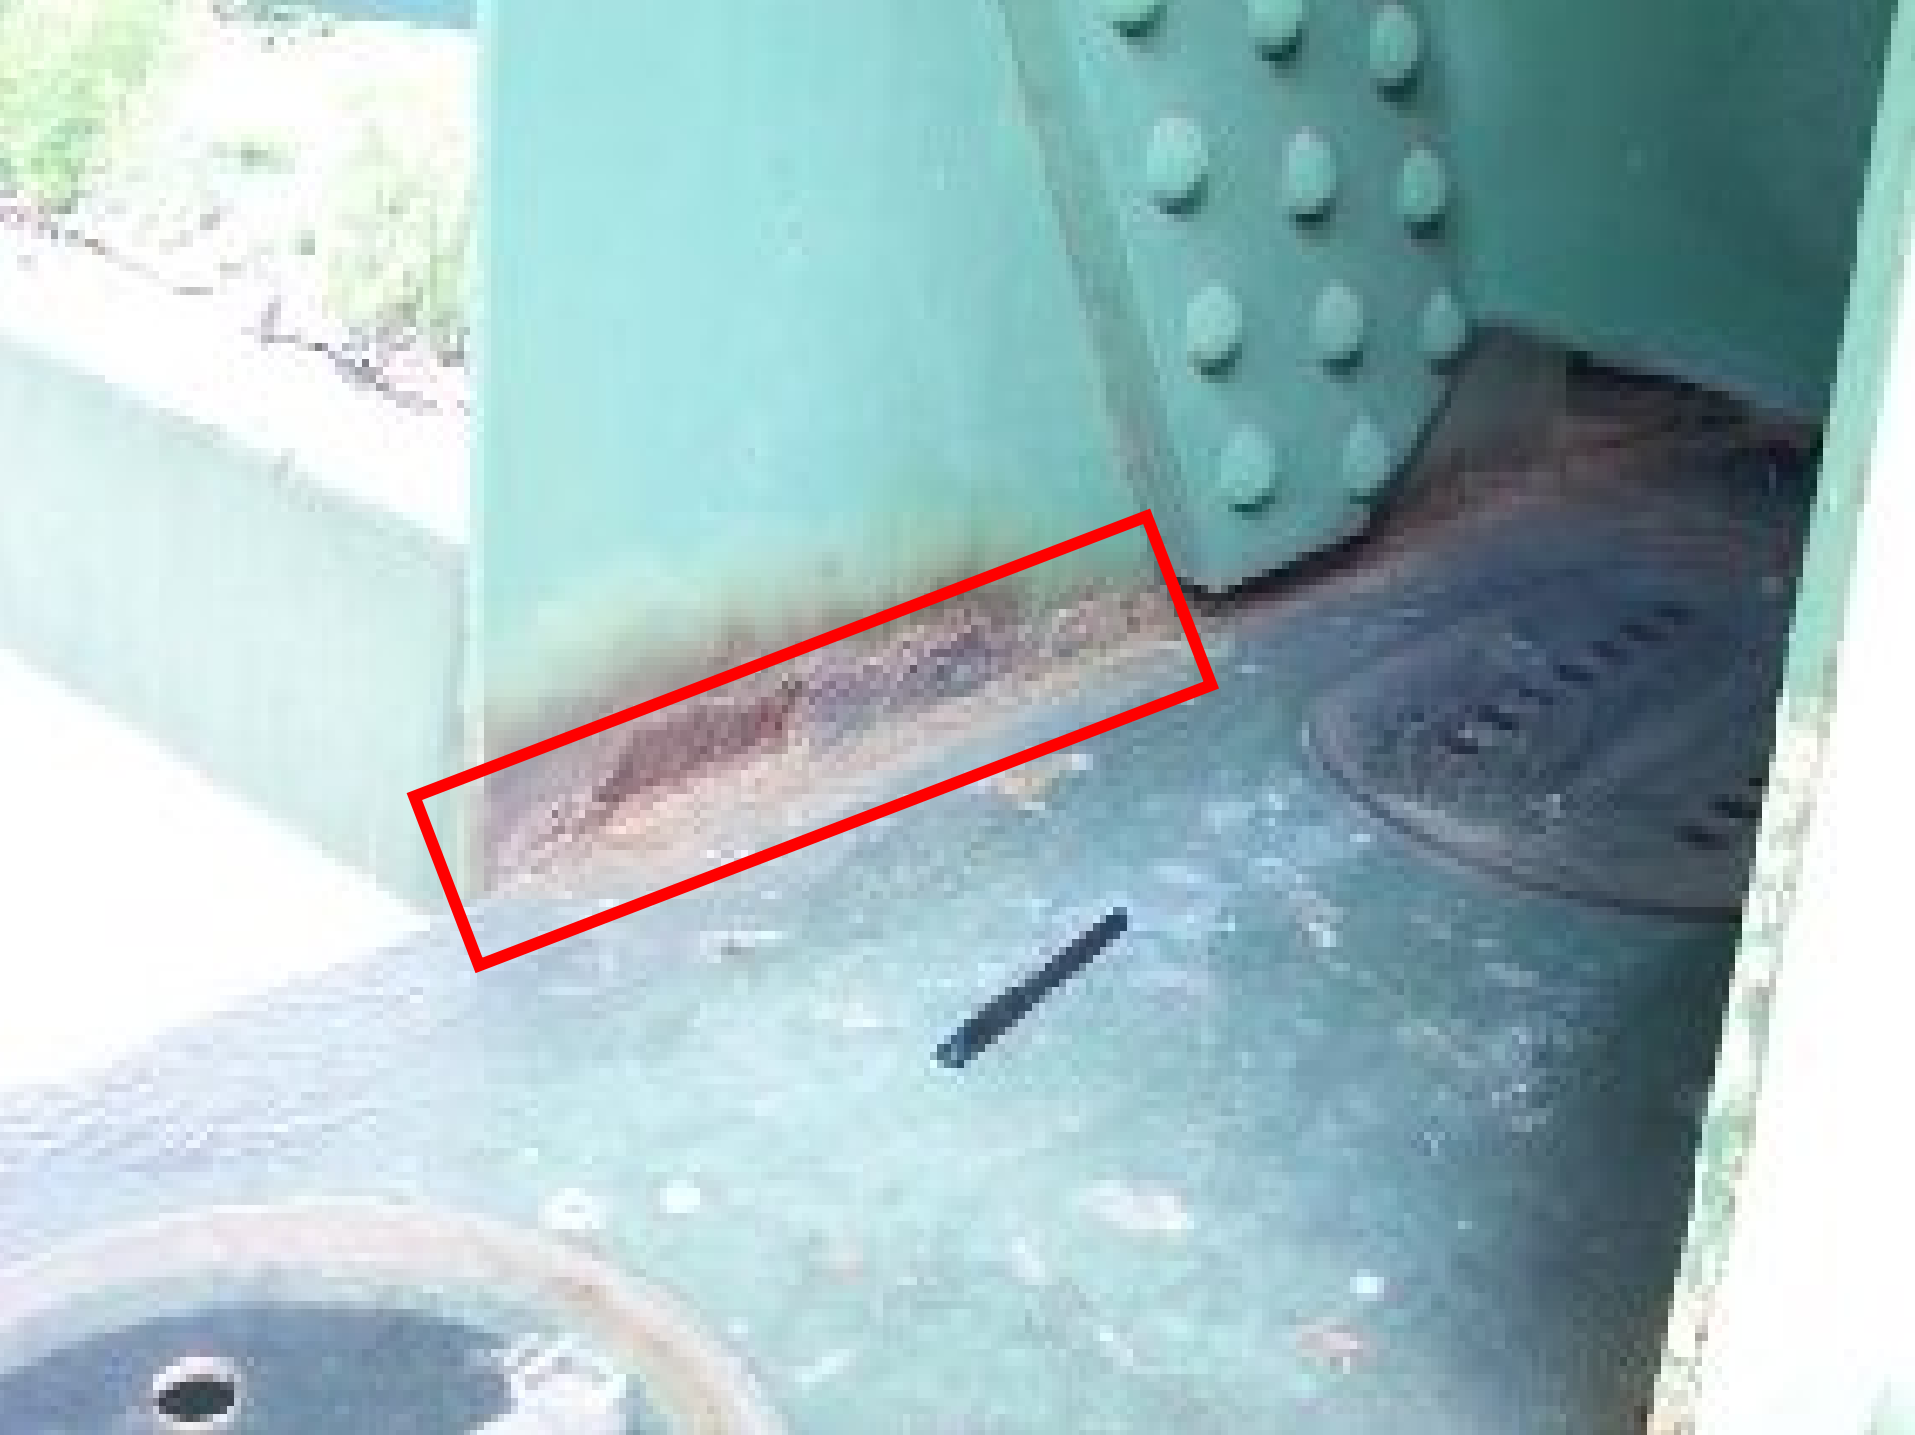
- Corrosion not a factor in I-35W bridge collapse
 - Amount of corrosion on node L11 East under-reported
 - Corrosion on gusset plate at L11 first reported in 1993
 - Amount of reported corrosion unchanged from 1994 — 2006

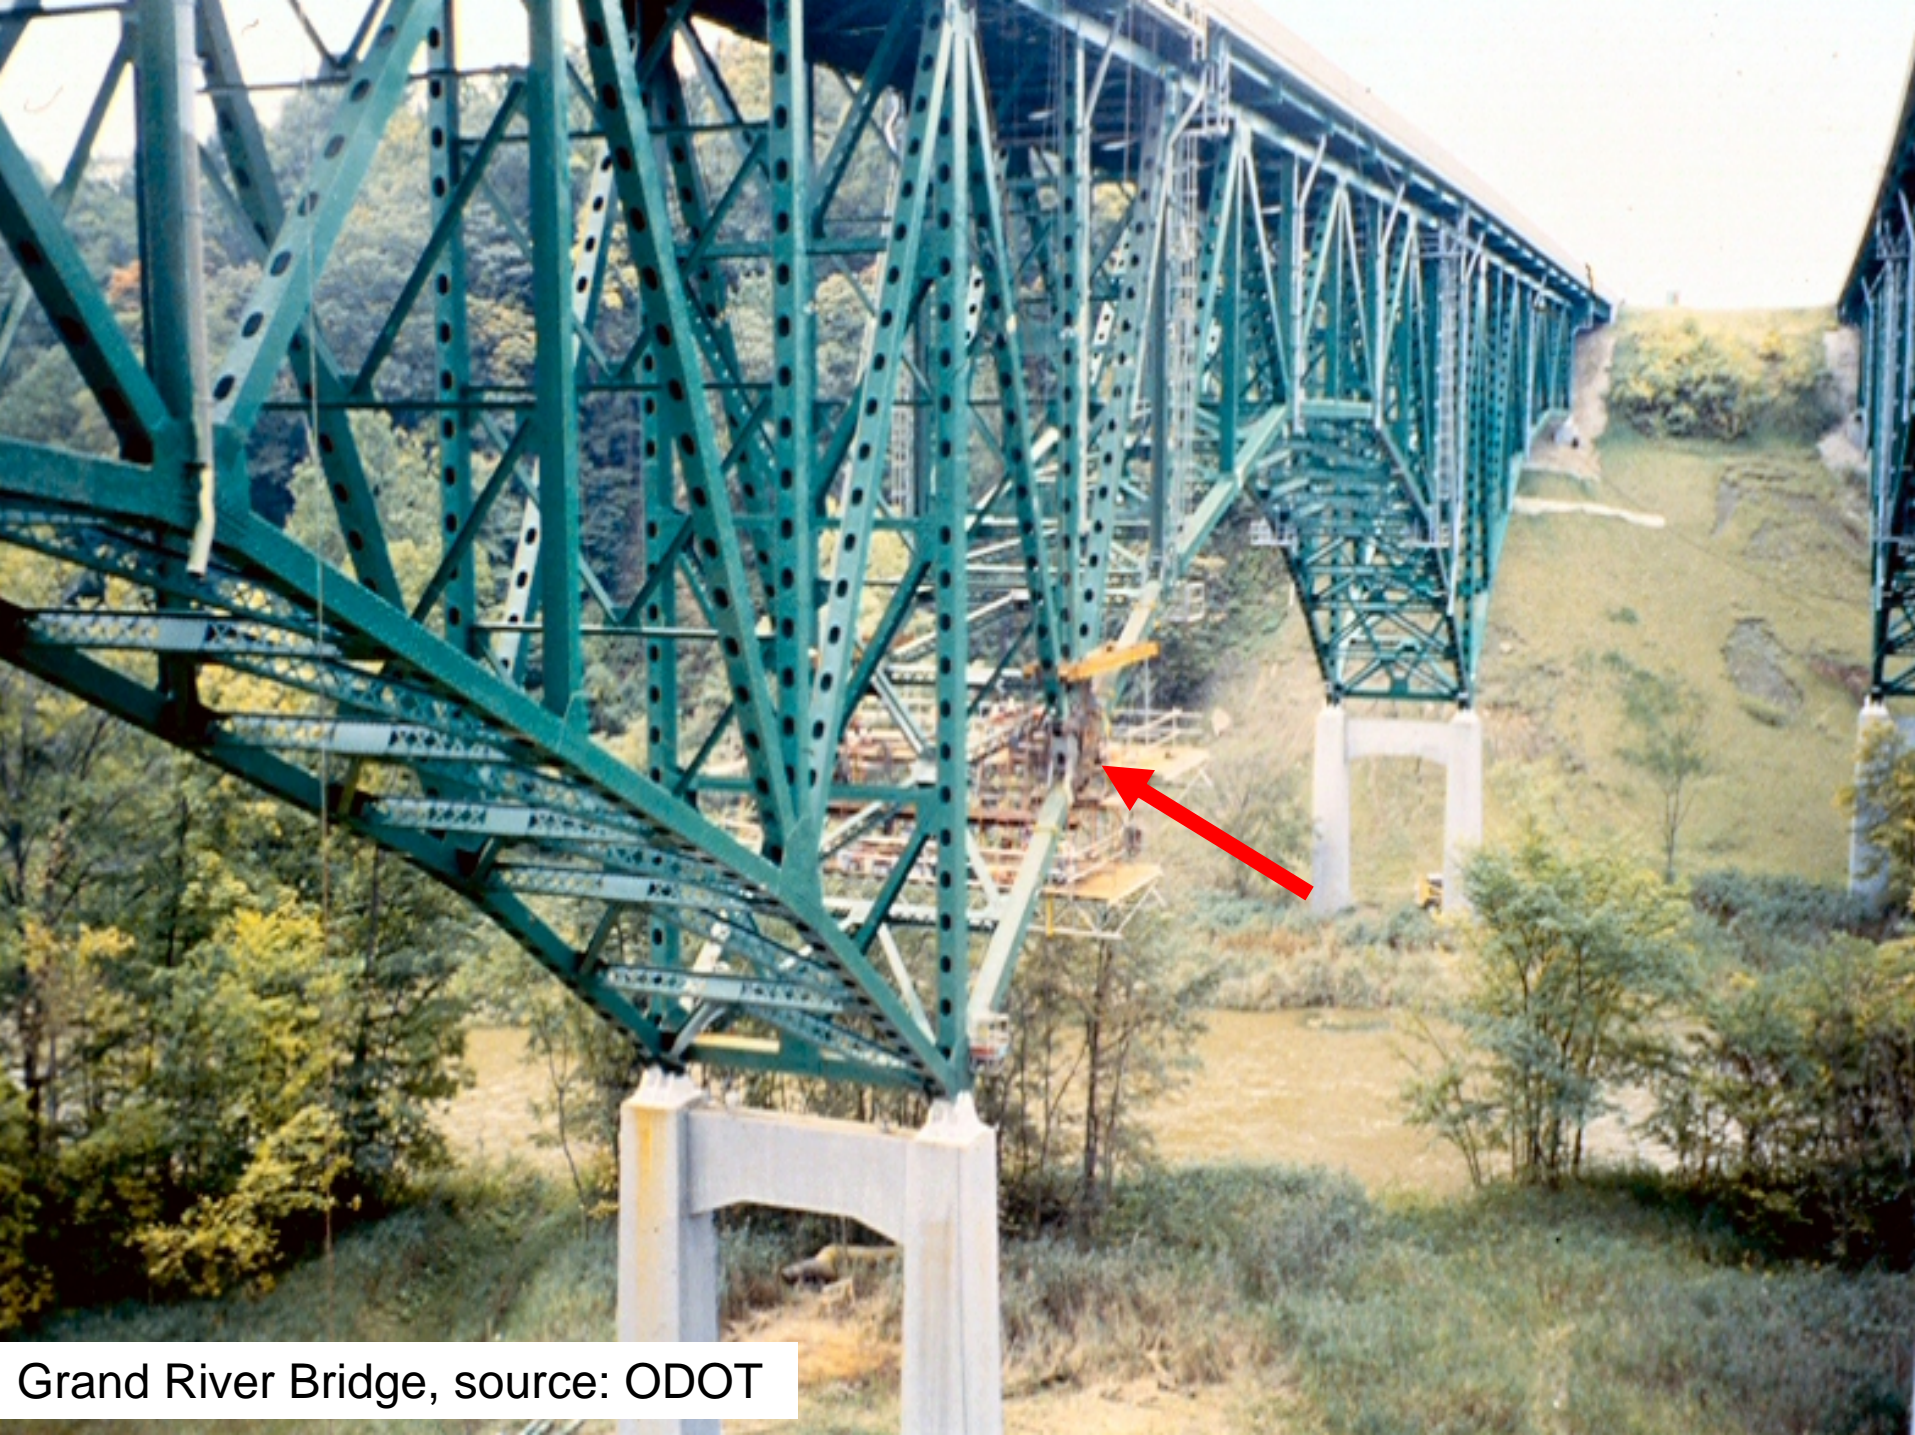
Grand River Bridge, source: ODOT

- Gusset plate failure of Grand River bridge in May 1996
 - Right lane and shoulder closed to traffic for repainting project
 - Maintenance vehicles and equipment parked in closed traffic lane
 - Truck traversing bridge in open traffic lane caused buckling of several gusset plates below work zone

- Gusset plate failure did not result in collapse of bridge
- Significant displacement of some superstructure members
- Failure attributed to corrosion and significant section loss

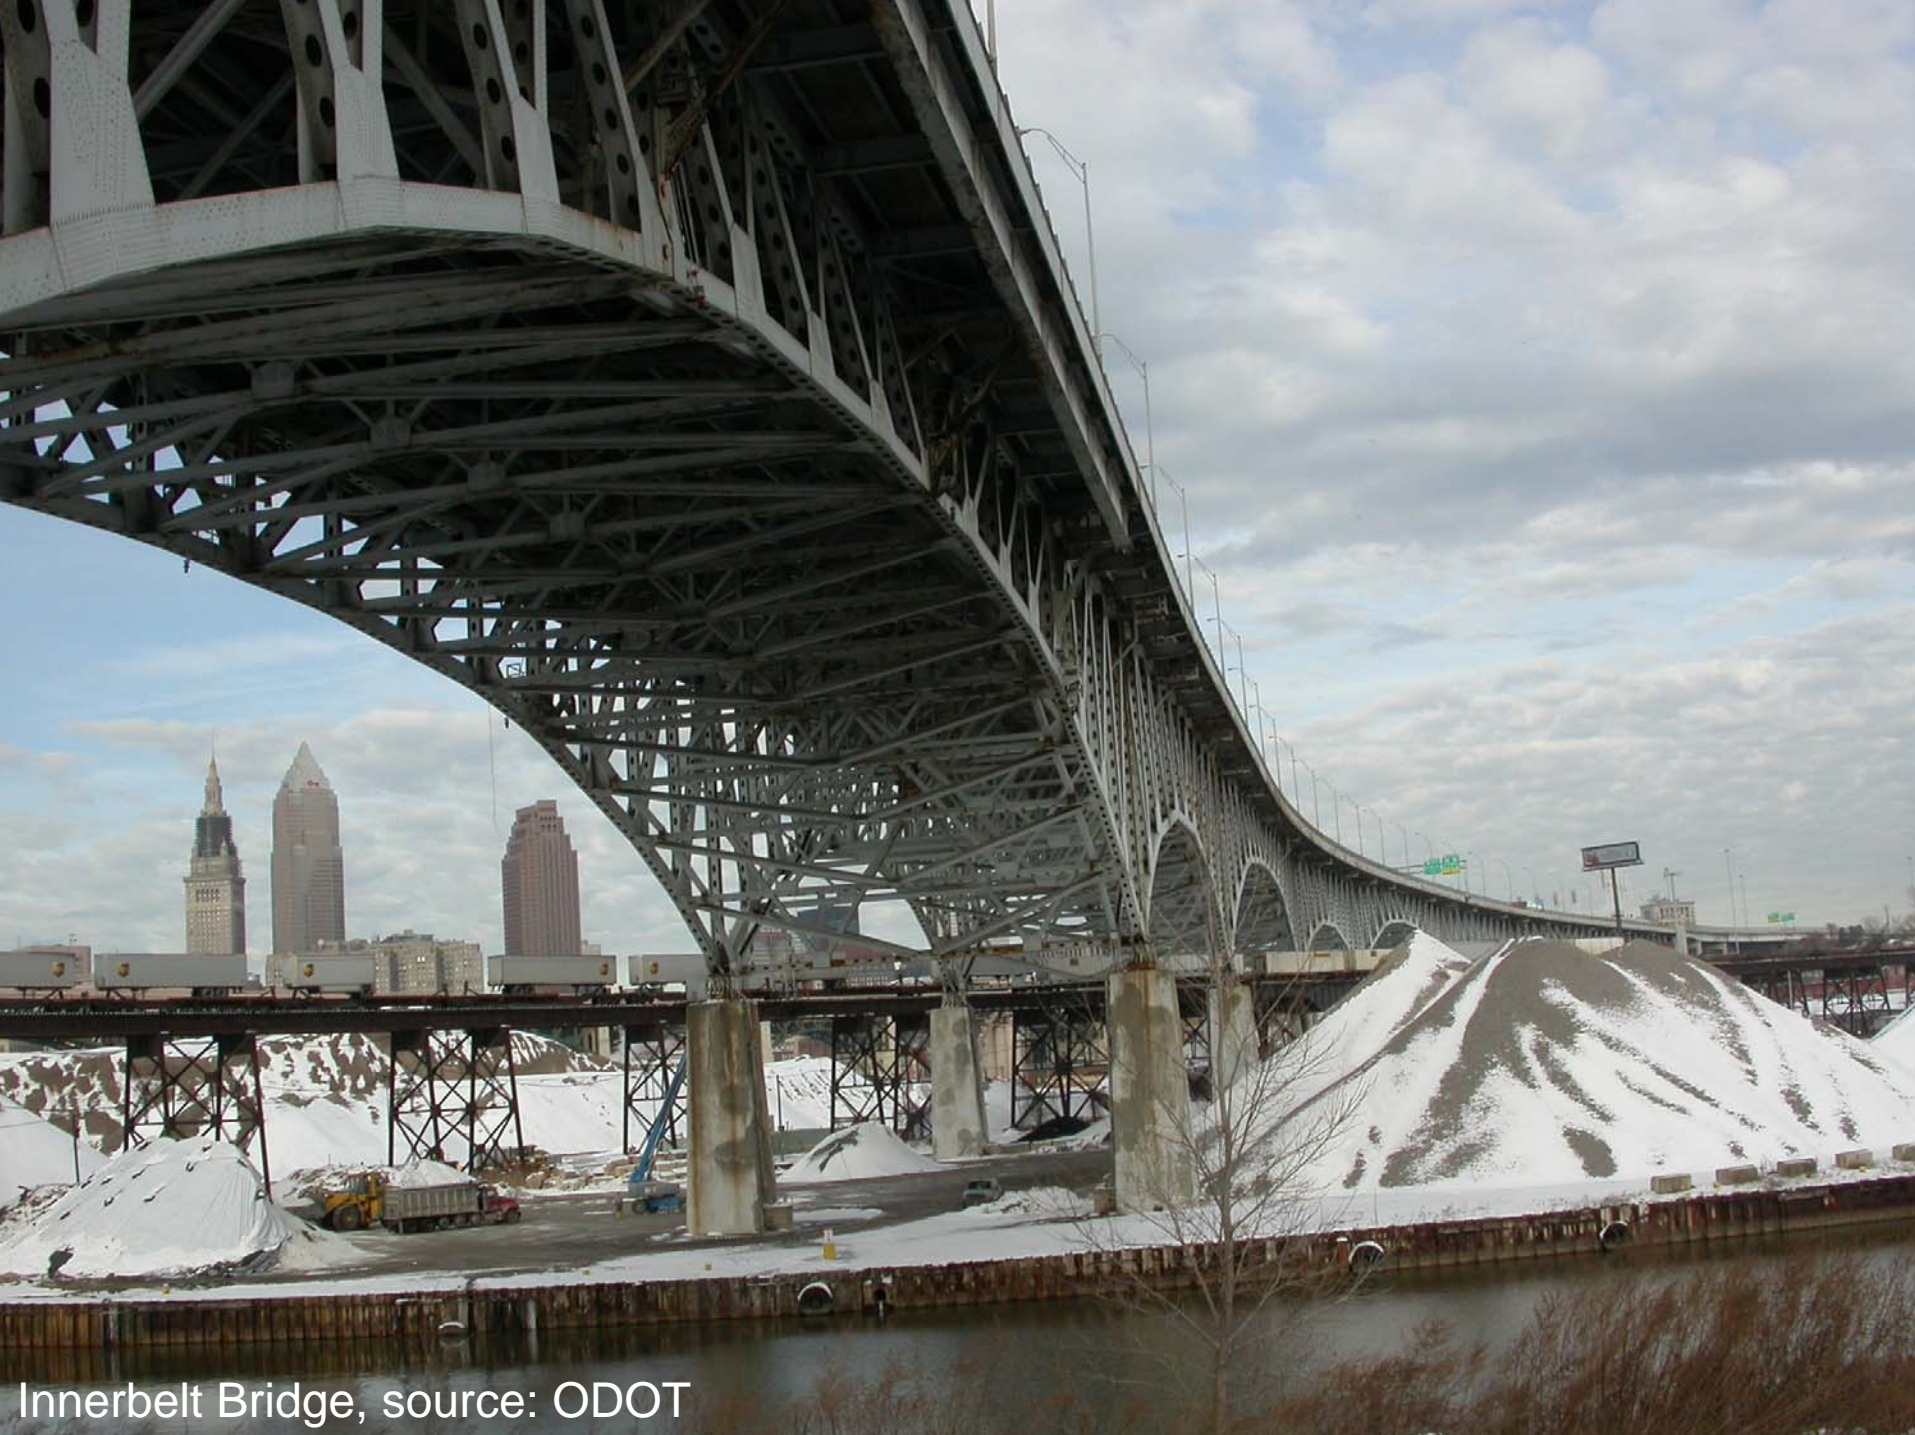
Innerbelt Bridge, source: ODOT

- Gusset plate corrosion on Innerbelt bridge reported during October 2007 inspection
- Follow-up evaluation used NDE methods
 - Original visual inspections grossly underestimated section loss

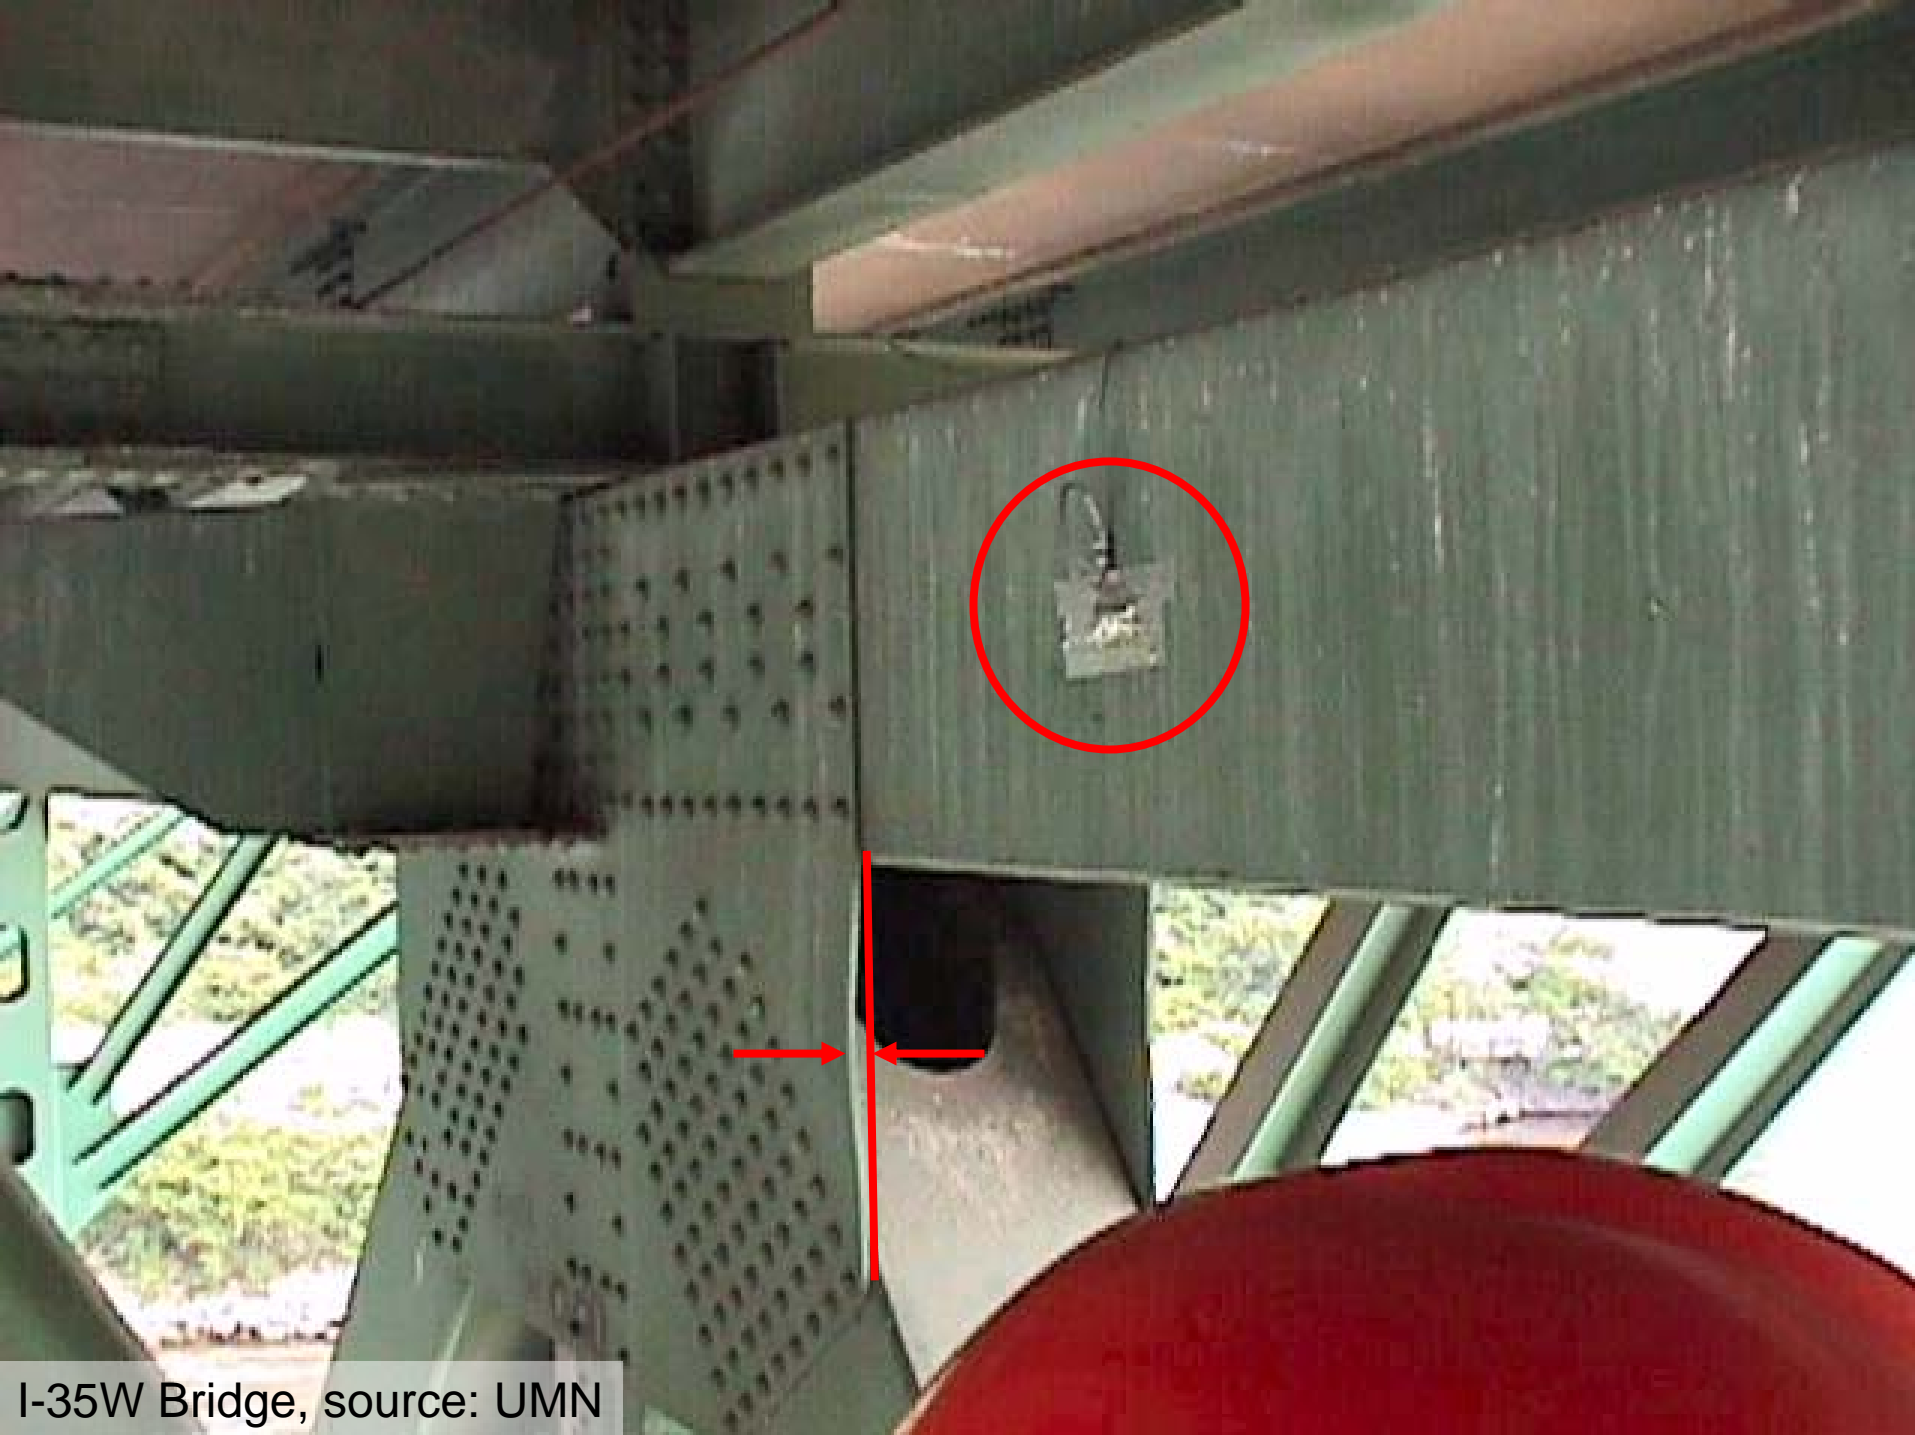
I-35W Bridge, source: UMN

- Fatigue crack studies of I-35W bridge
 - University of Minnesota, 1999, no reference to bowing
 - URS Corporation, 2003, no reference to bowing
- Reviews of state bridge inspection reports found no entries for bowed gusset plates

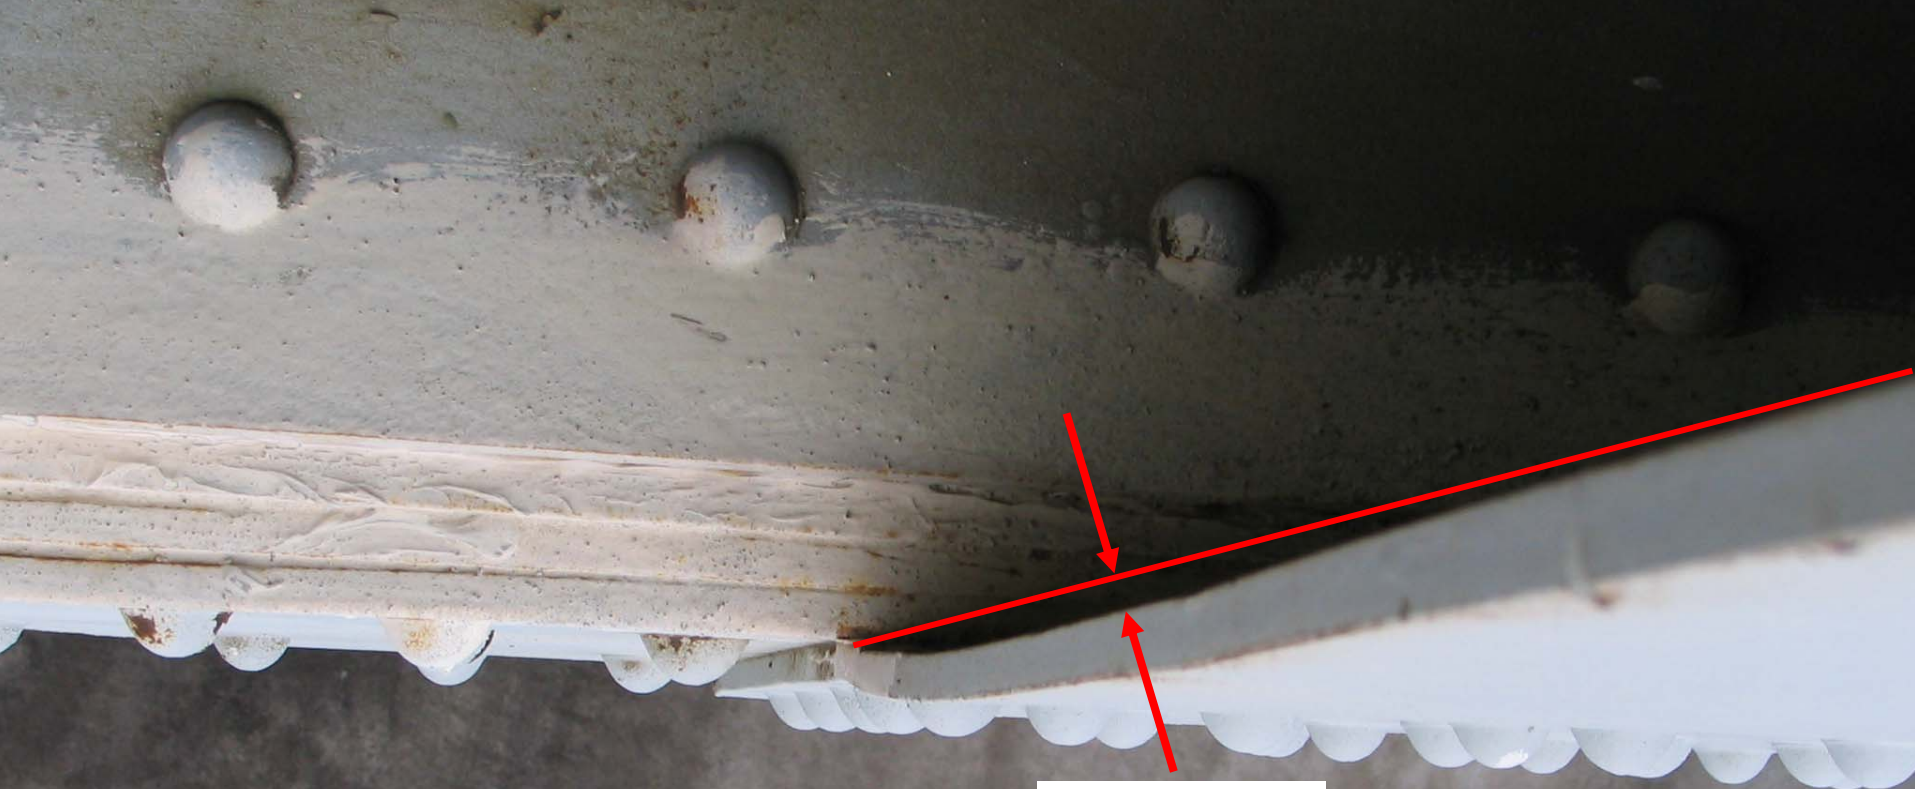
1/4-inch

- At least one Mn/DOT inspector had observed bowing
- He concluded bowing resulted from original construction
- Because of his training, he believed gusset plates were oversized

- Connection did not have other signs of distress
 - Peeling paint
 - Elongation of rivet holes
 - Cracked tack welds
 - Cracking or crushing of bridge deck
- Inspections addressed deteriorations, not construction or design problems

- Bowed gusset plates on I-35W bridge were not addressed through inspections
- Bowing may indicate out-of-design condition and should be subjected to further engineering analysis
- Lack of specific training references to bowing could cause bridge inspectors to give inadequate attention to this condition

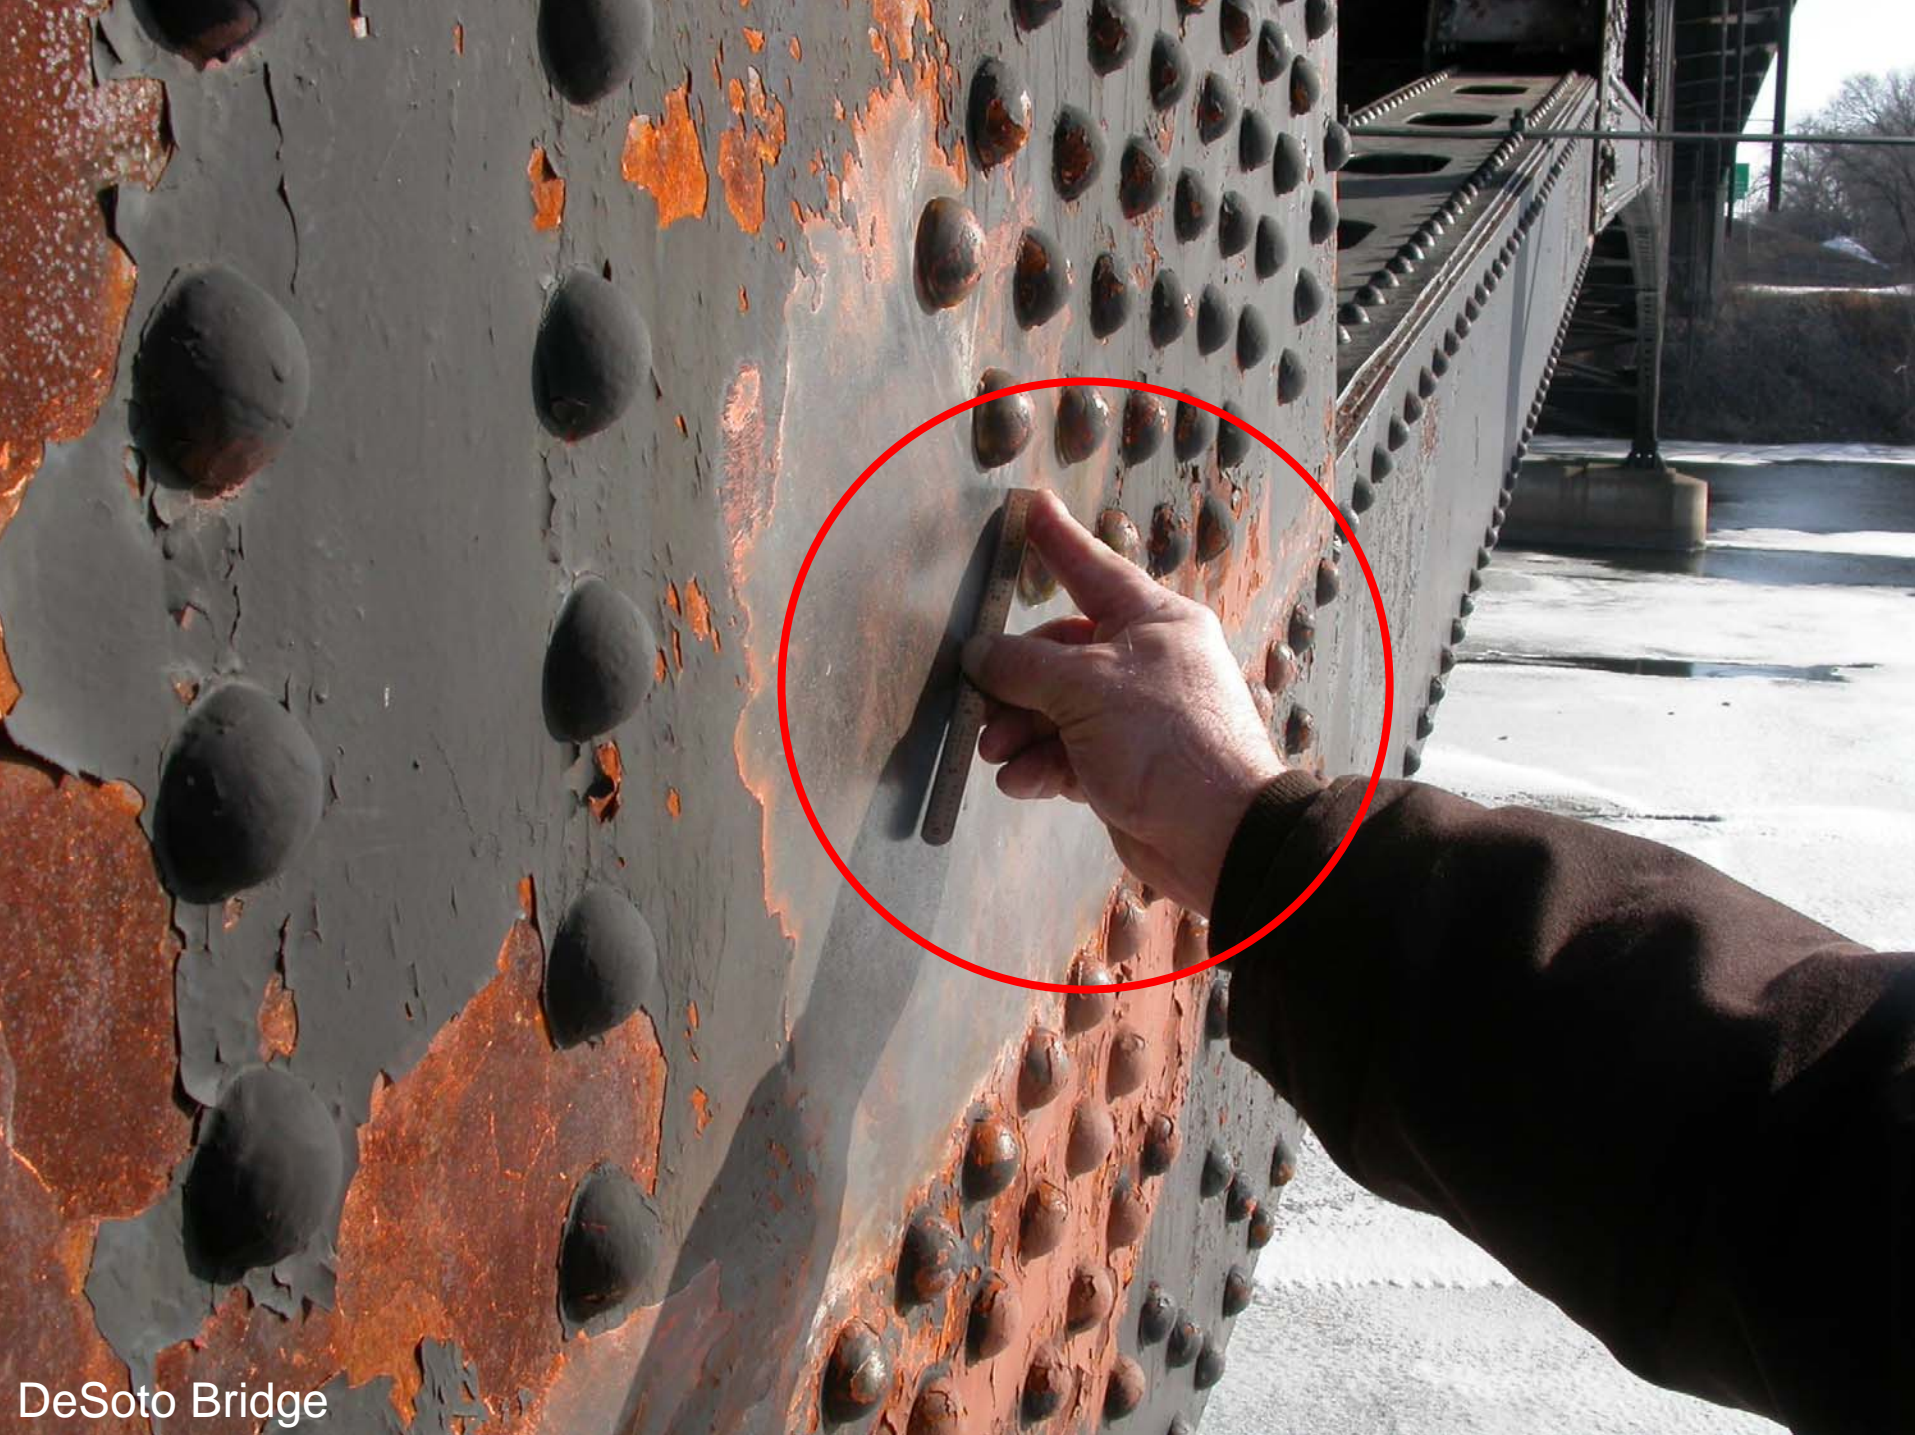
DeSoto Bridge

- Gusset plate distortion found on DeSoto bridge in Saint Cloud, MN
 - Distortion believed to have occurred during original construction in 1957
 - Distortion not discovered for 50 years
 - Discovered only with inspections that emphasized condition of gusset plates
