# National Transportation Safety Board

Washington, D.C. 20594  
Safety Recommendation

Date: June 27, 1989

In reply refer to: H-89-24 and -25

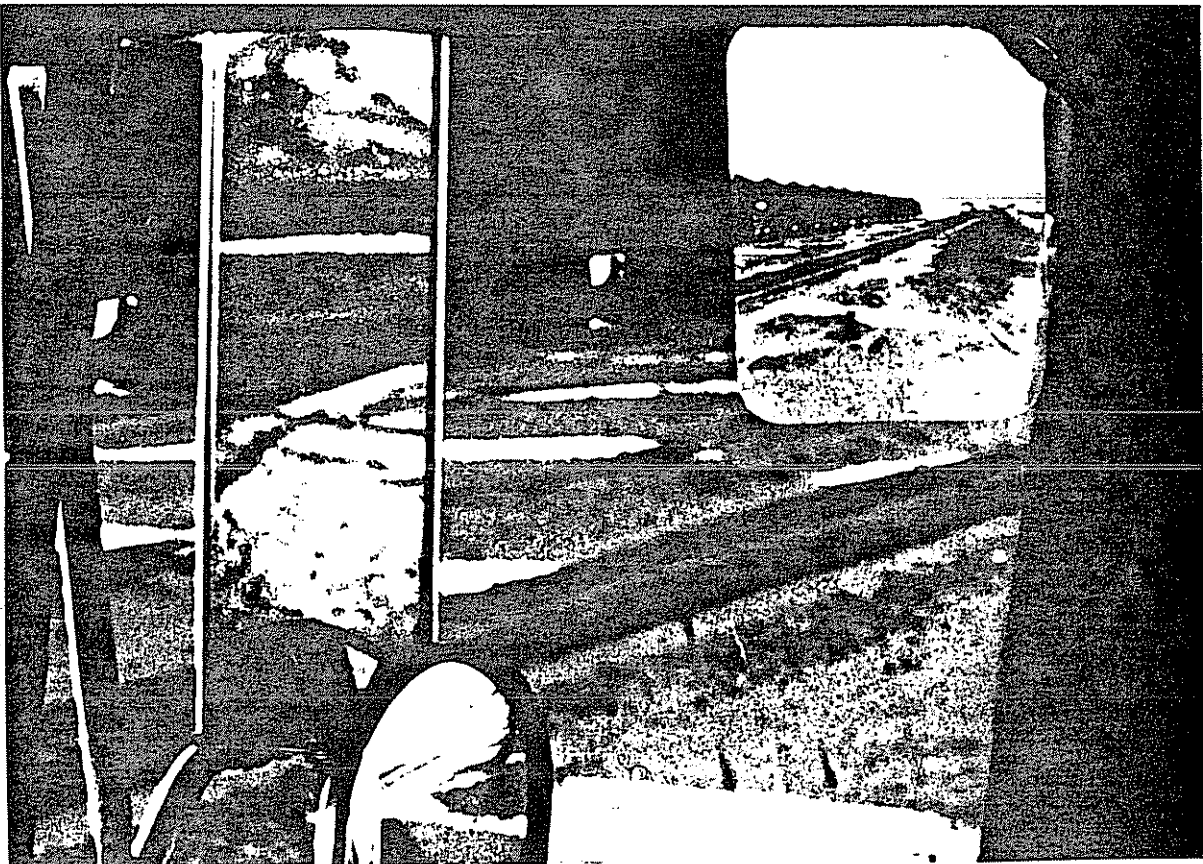
As part of the accident investigation, exploratory tests were conducted with a wide-angle window lens mounted on the right-side window of the cab. The driver's visibility was increased to the extent that the approaching train could easily be seen without the driver changing positions (see figure 2). If a wide-angle window lens had been mounted on the right-side window, the driver might have been able to see the approaching train while looking at his mirror when he turned the corner.

Figure 2.--View of grade crossing through side window with wide-angle lens.

Evaluate the effectiveness of a wide-angle window lens insert for the right-side window of trucks weighing more than 10,000 pounds to circumvent the visual obstructions that may occur as a result of vehicle construction and/or modification. (Class II, Priority Action) (H-89-24)

If the wide-angle window lens insert identified in Safety Recommendation H-89-24 is determined to be effective in improving driver visibility, amend the Federal Motor Vehicle Safety Standards for medium and large trucks to require installation of the device on such vehicles. (Class II, Priority Action) (H-89-25)
