National Transportation Safety Board

Washington, D.C. 20594
Safety Recommendation

Date: September 2, 1987

In reply refer to: P-87-35 through -38

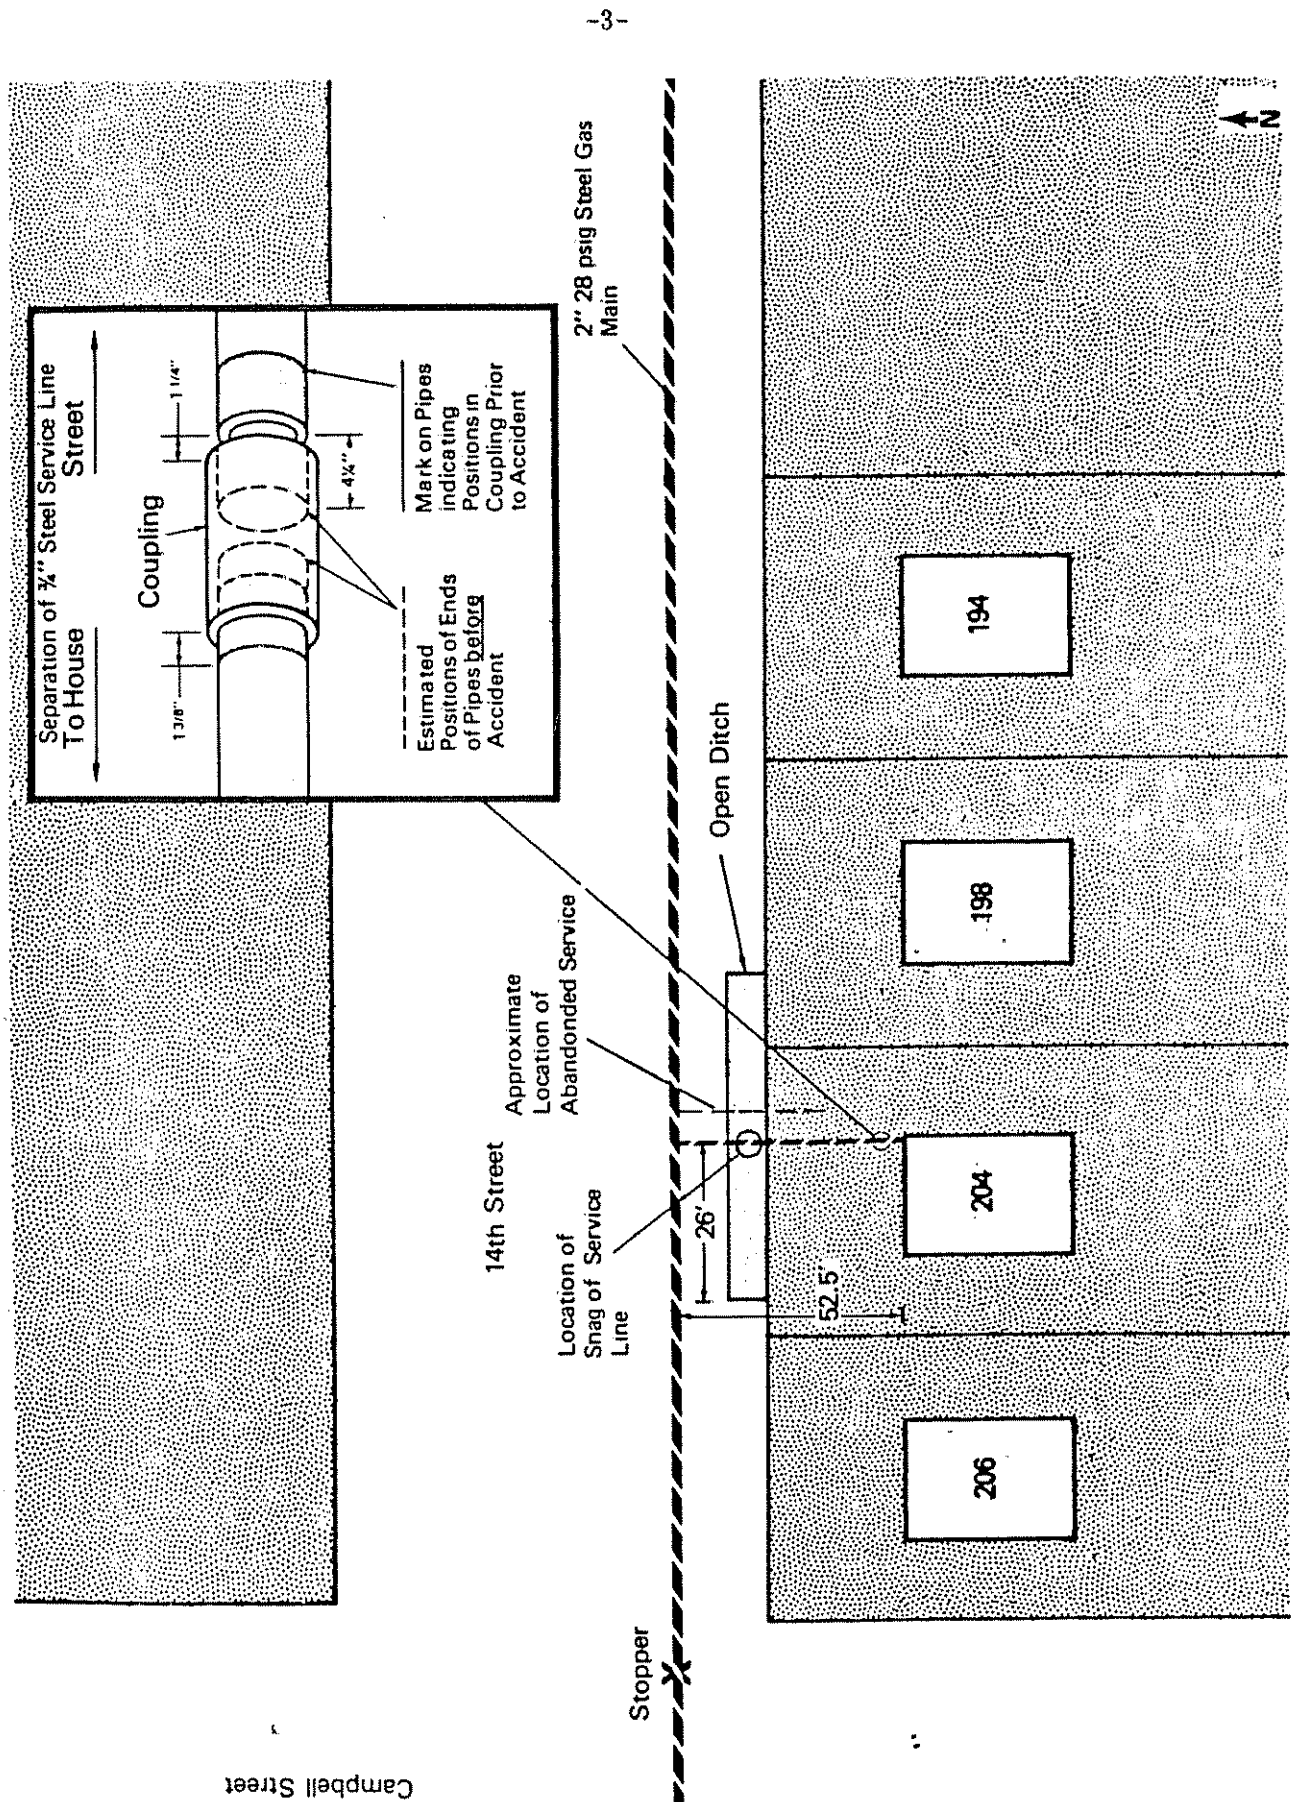
Excavation after the accident revealed that the service line for 204 14th Street was fitted with a compression coupling near the service riser located at the northeast corner of the basement of the house. The backhoe pulled the pipe from this coupling. Measurements indicate that the pipe had been moved 4 1/4 inches away from its pre-accident position on the street side of the coupling and 1 3/8 inches away on the house side. The service line had separated 1 1/4 inches on the street side but was still connected to the coupling on the house side. (See figure 1.) The walls of the basement were masonry and had several cracks any of which could have served as a path for the gas to enter the basement of the house.

Figure 1.—View of accident location and detail.
