NATIONAL TRANSPORTATION SAFETY BOARD  
WASHINGTON, D.C.

} SAFETY RECOMMENDATION(S)  
H-74-1 through 3

CATASTROPHIC FAILURES DUE TO USE OF CUTTING TORCH  
TO REMOVE BUSHINGS FROM EQUALIZER BEAMS

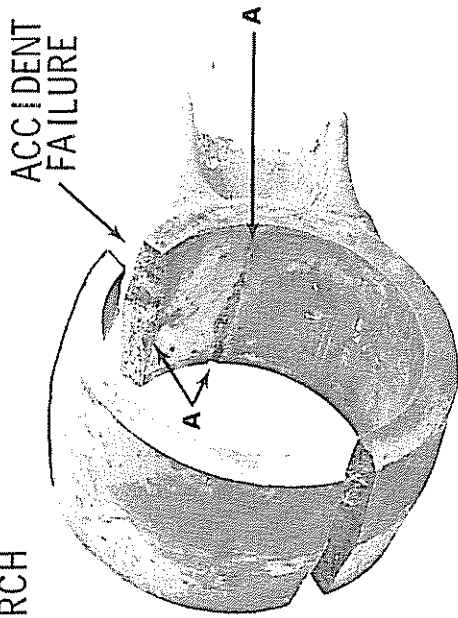
Inspection of the equalizer beams from both of the tractors revealed cavities in the surface of the equalizer beam bushing holes. These cavities were oriented in a groove-like alinement, roughly parallel to the axis of

the holes. (See Photographs 2 and 3.) Metallurgical examination of the failed bushing holes confirmed that the cavities in the surface of the parent material resulted from use of a cutting torch. Since the other bushing holes had similar cavities, it is concluded that a cutting torch had been used to remove the old bushings. The cavities in the parent material created stress raisers which initiated the failure of the equalizer beam. After this inappropriate maintenance, the tractors were returned to use. At the time of each accident, cold weather and impact loadings, caused by minor road surface depressions, contributed to the failure of the equalizer beams.

Photograph 2. Equalizer beam rear attachment point - (Braintree accident).

NOTE: Arrows on Photographs 2 and 3 indicate location of cutting torch induced cavities

1. All commercial-motor-vehicle maintenance and repair personnel:
  - (a) Not use cutting torches to remove equalizer beam bushings. (Recommendation H-74-1)
  - (b) Follow the instructions in the maintenance manuals and bulletins provided by the equipment manufacturers and use appropriate mechanical devices (presses, pullers, etc.) when removing and installing all bushings and bearings. (Recommendation H-74-2)

2. All commercial-motor-vehicle operators review their past maintenance records to determine if there has been any bushing or bearing removal and replacement, and thoroughly examine those components to ascertain if they have been heated, if cavities have been produced, or otherwise damaged by a cutting torch, and if so, replace any components which have been subjected to a cutting torch.  
(Recommendation H-74-3)

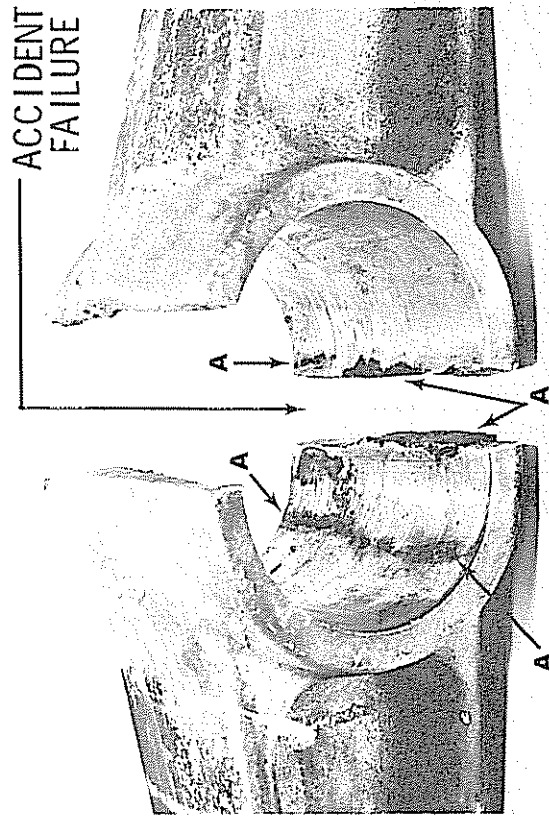
Photograph 3. Equalizer beam center attachment point - (Dunstable accident).
