National Transportation Safety Board

Safety Recommendation

In reply refer to: A-03-04

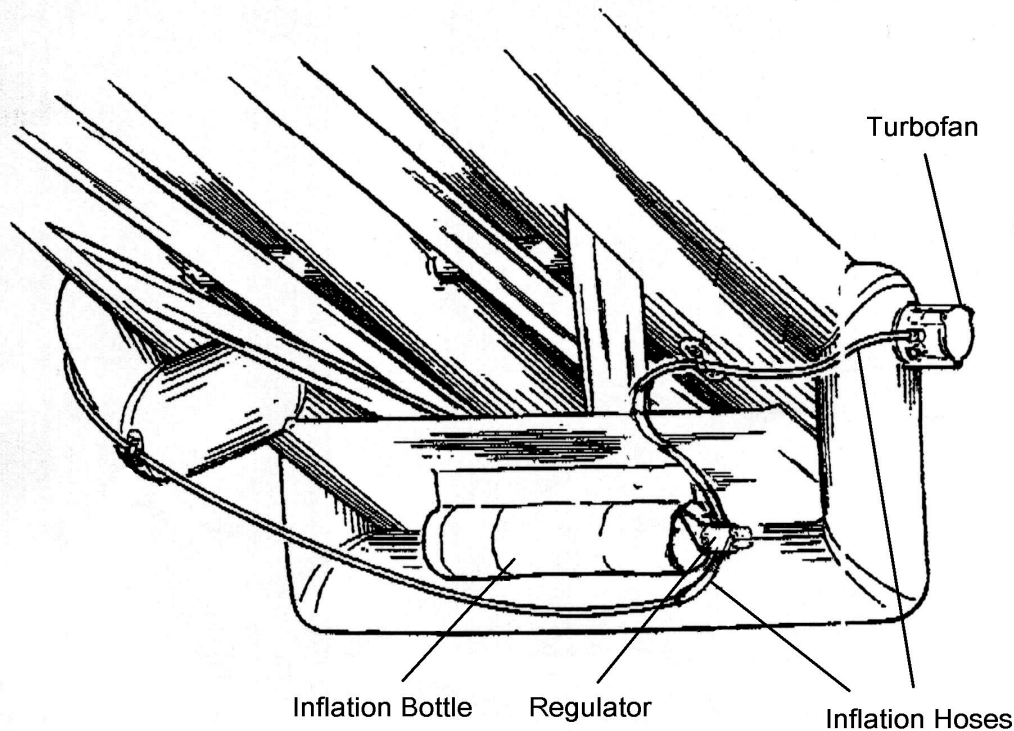
Figure 1. The underside of Goodrich dual-lane slide/raft P/N 7A1238 or 7A1239

Although the cause of the 5R slide/raft underinflation has not been identified, the investigation revealed that the 4R slide/raft underinflated because one of its two inflation hoses had fractured at the hose fitting's connection to the inflation bottle's regulator. The area of the fracture is known as the swivel (lock) wire groove.

Issue an airworthiness directive to require operators of Boeing 747-100, -200, -300, and -SP airplanes to implement Goodrich Service Bulletin 25-241 if they have not already done so. (A-03-04)
