National Transportation Safety Board

Safety Recommendation

In reply refer to: A-01-27 and -28

On March 17, 2001, about 0708 eastern standard time, an Airbus Industrie A320-200, N357NW, manufacturer serial number (MSN) 830, operated by Northwest Airlines as flight 985, ran off the runway and onto terrain during a rejected takeoff at the Detroit Metropolitan Wayne County Airport, Detroit, Michigan. The captain, copilot, 4 flight attendants, and 145 passengers were not injured. Three passengers reported minor injuries that occurred during the emergency evacuation. The airplane sustained substantial damage. The 14 *Code of Federal Regulations* Part 121 flight was operating in instrument meteorological conditions, and an instrument flight rules flight plan was filed. The flight was destined for Miami, Florida.

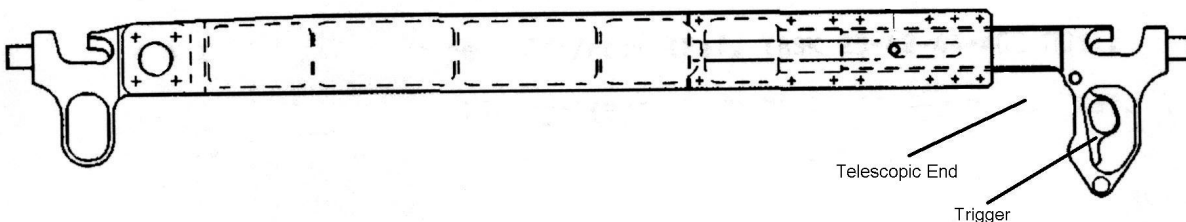
Airbus Industrie A319, A320, and A321 airplanes that are overwater equipped, like the accident airplane, have a slide/raft at each floor-level emergency exit that is attached to the door by a packboard. Attached to the slide/raft are a fabric girt and telescopic girt bar. The telescopic girt bar enables the slide/raft pack to be removed from one floor-level exit's floor fittings and deployed outside the airplane from another door, if necessary, in the event of a ditching and emergency evacuation in the water.³ (Figure 1 shows a girt bar on Airbus Industrie A319, A320, and A321 airplanes.) When the door is "armed," the girt bar is attached to the floor fittings on the doorsill so that when the door is opened, the girt bar will pull on the slide/raft and initiate its deployment. When the door is "disarmed" and opened, the girt bar remains attached to and moves with the door, thereby preventing the slide/raft from deploying.

Figure 1. Girt Bar on Airbus Industrie A319, A320, and A321 Airplanes

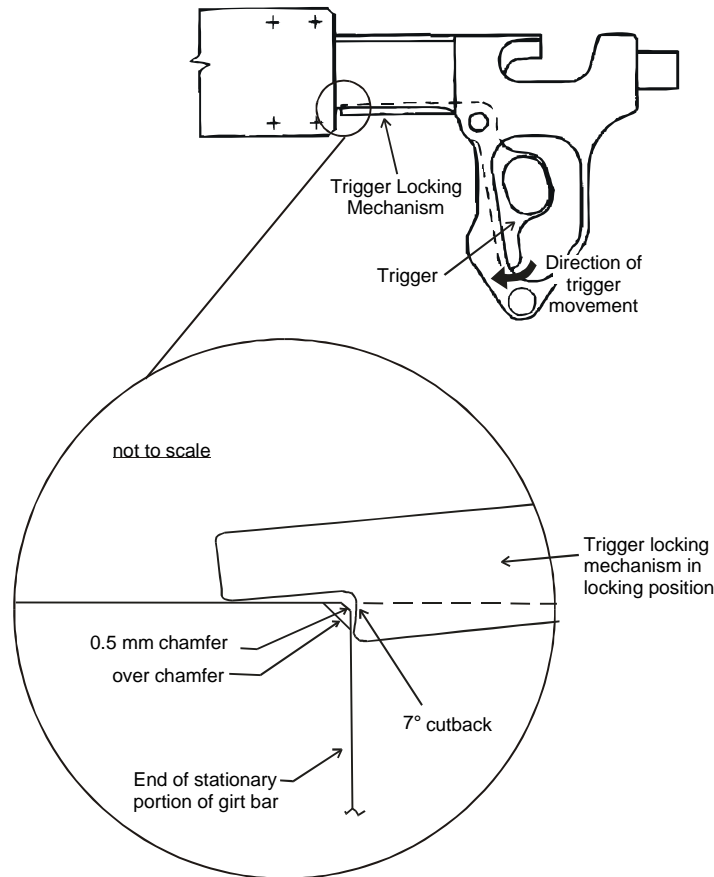
The telescopic end of the girt bar is locked in the extended position by a spring-loaded trigger. (Figure 2 shows the telescopic end of the girt bar.) Squeezing the trigger causes the trigger locking mechanism to retract within the telescopic end of the girt bar, allowing it to slide into the stationary portion of the girt bar and shorten the overall length of the girt bar so that the slide/raft can be removed from the floor fittings. The stationary portion of the girt bar is designed to have a chamfer (beveled edge) that measures 0.50 millimeter (mm) on the horizontal surface by 0.50 mm on the vertical surface, +/- 0.10 mm, where the end of the trigger locking mechanism contacts this portion of the girt bar. In addition, the end of the trigger locking mechanism is designed to have a 7° cutback to provide for better contact with the stationary portion of the girt bar when it is locked in the extended position.

Figure 2. Telescopic End of Girt Bar

The girt bar is designed so that the exposed end of the trigger locking mechanism overlaps and will contact the stationary portion of the girt bar to prevent retraction. The Safety Board's investigation determined that the amount of chamfer on the stationary portion of the girt bar can directly impact the effectiveness of the engagement between the trigger locking mechanism and the stationary portion of the girt bar. Specifically, an increase in the amount of chamfer reduces the amount of overlap between the two surfaces and thus reduces the likelihood of a secure engagement between the two surfaces and increases the possibility of an unintended retraction of the telescopic girt bar.

Postaccident examination of the accident airplane's 2L telescopic girt bar⁴ revealed that its chamfer was approximately 0.77 mm on the horizontal surface by 0.93 mm on the vertical surface instead of 0.50 mm by 0.50 mm. When the 2L door was opened in the "armed" mode, the force of the door opening apparently caused the trigger locking mechanism to slide over the improperly chamfered surface, which allowed the telescopic end of the girt bar to retract within the stationary portion of the girt bar. This retraction allowed the aft end of the girt bar to slip from its floor fitting and rotate forward. This movement and the weight of the slide/raft pulled the forward end of the girt bar from its floor fitting and caused the uninflated slide/raft pack to separate completely from the airplane and fall to the ground. Although the 1L and 2R doors opened and the slides/rafts deployed normally, the Safety Board's investigation also revealed the presence of improperly chamfered girt bars on those two doors.⁵ The Board is concerned that the potential existed for slide/raft separations at these doors as well. If this had occurred, three of the four floor-level emergency exits on the accident airplane would have been unusable by passengers during the evacuation.

- (1) Ensure that the dimensions of the trigger locking mechanism and the stationary portion of the girt bars conform to the design specifications;

- (2) Perform a reliable functional test to demonstrate the proper engagement of manually chamfered girt bars under realistic door opening conditions; and
- (3) Repair or replace any girt bars that do not meet the dimensional requirements or do not pass the functional test, before the airplanes are returned to service. (A-01-27) (Urgent)
