National Transportation Safety Board

Safety Recommendation

Date: August 20, 2001

In reply refer to: A-01-30 through -34

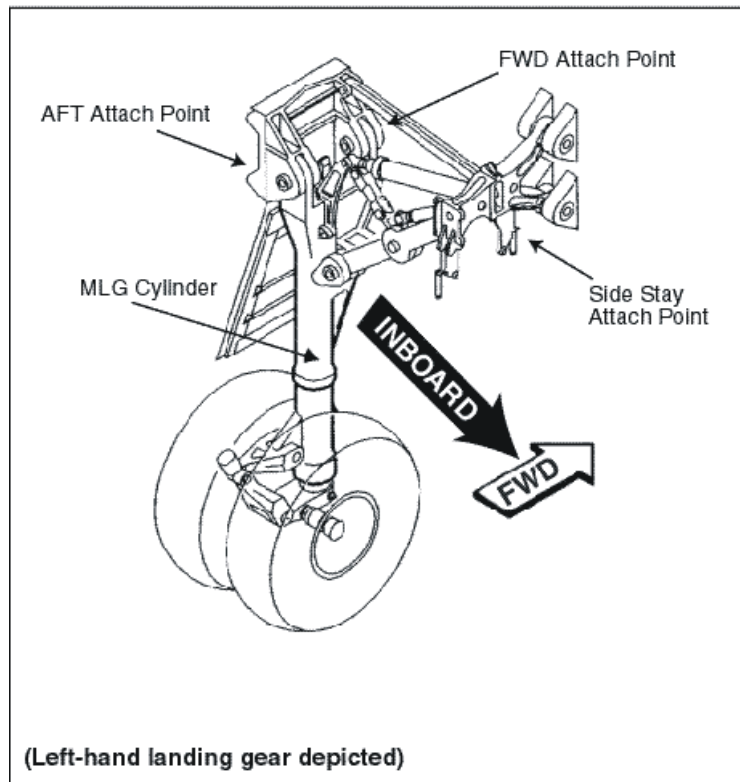
Figure 1. F.100 MLG assembly

The F.100's right MLG is a two-wheel landing gear that has three support points—the forward attach, the aft attach, and the side stay strut attach (see figure 1). The accident airplane's right MLG was part of the original equipment installed on the airplane and had accumulated 15,380 cycles in 21,589 hours over a period of 8 years and 11 months of service. Postaccident examination of the airplane revealed that the right MLG cylinder had fractured into five pieces. The MLG cylinder was manufactured by Messier-Dowty Limited¹ from a forged block of an aluminum alloy.² Further examination at the Safety Board's materials laboratory revealed that one of the fractures stemmed from a preexisting crack that measured 2.5 mm in depth and 12 mm in length.³ The crack was located on the forward face of the MLG above a dowel pin bushing and forward of the up-stop damper abutment (see figure 2). Metallographic examination of a section that was made through the crack origin area revealed that the microstructure contained features typical of a forging fold.⁴

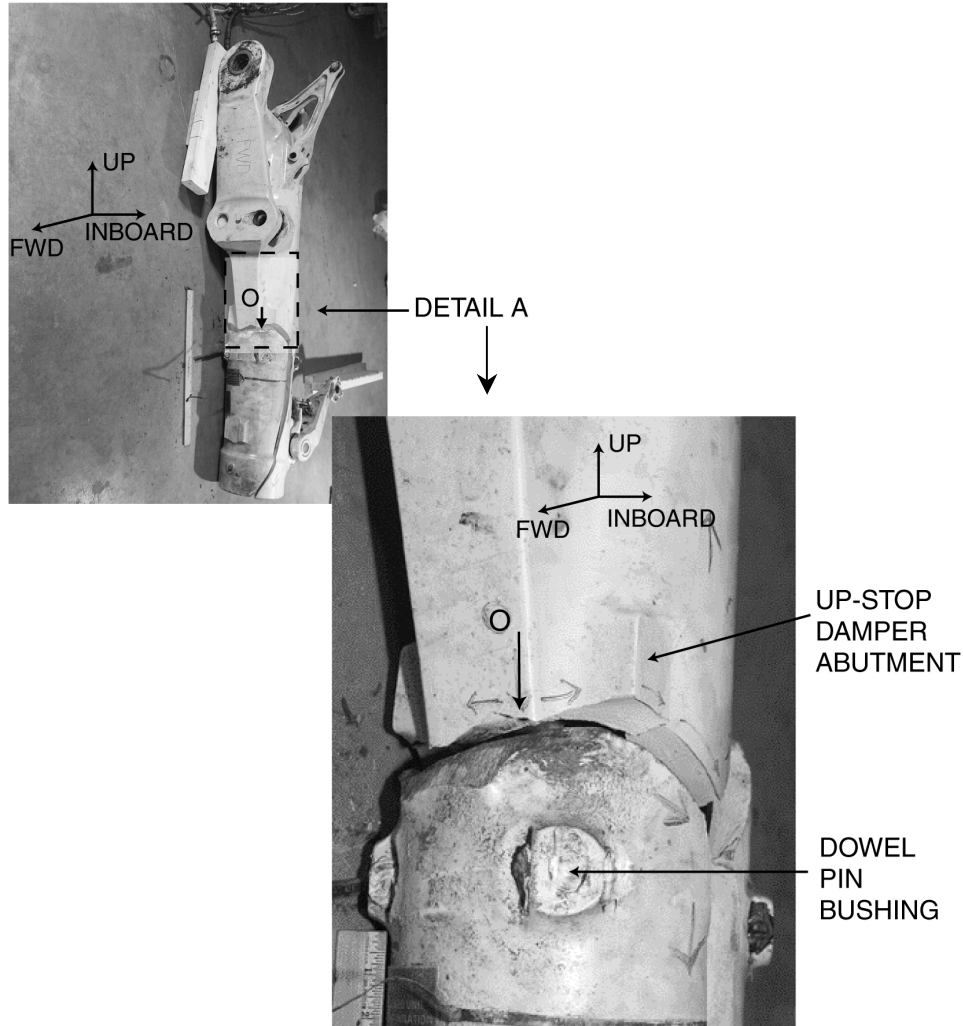
Figure 2. Photographs of the accident MLG and the crack origin area

³ More than 65 striations typical of fatigue cracking were found at the perimeter of the preexisting crack on the fracture surface.

⁴ A forging fold is a defect that can be caused by hot metal that flows back onto itself while it is flowing into the die cavity.

Note: Arrows indicate direction of fracture propagation and arrow “O” indicates fracture origin.

Require all operators of Fokker F.100 series airplanes equipped with the main landing gear (MLG) that are identified in Messier-Dowty Service Bulletin (SB) F100-32-100 Revision 1 to immediately conduct an eddy current inspection of the MLG cylinders for forging folds and fatigue cracks as described in the most recent revision of Fokker Services SBF100-32-128 and to remove from service all landing gear in which such forging folds or cracks are found until they are returned to an airworthy condition. (Urgent) (A-01-30)

Require Fokker Services to immediately determine a repetitive inspection interval that will prevent structural cracks in main landing gear that are identified in Messier-Dowty Service Bulletin F100-32-100 Revision 1 from propagating to failure between inspections. (Urgent) (A-01-31)

Require all operators of Fokker F.100 series airplanes equipped with the main landing gear (MLG) that are identified in Messier-Dowty Service Bulletin (SB) F100-32-100 Revision 1 to periodically conduct eddy current inspections of MLG cylinders for forging folds or fatigue cracks, as described in the most recent revision of Fokker Services SBF100-32-128, at the interval identified in response to Safety Recommendation A-01-31. (A-01-32)
