National Transportation Safety Board

Safety Recommendation

Date: April 16, 2001

In reply refer to: A-01-6 through -8

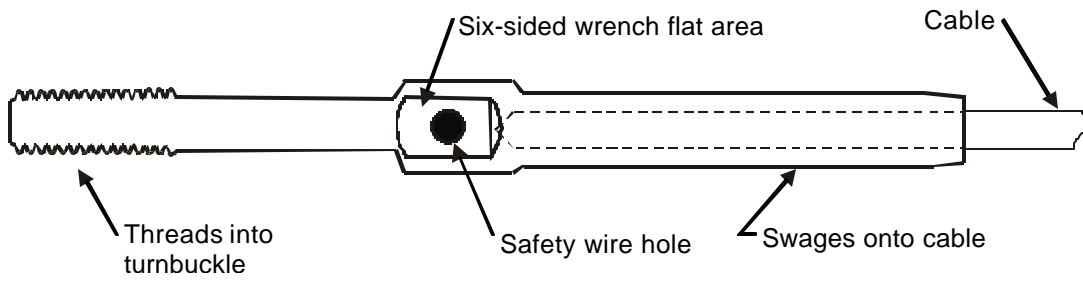
Figure 1. An MS21260-S4 terminal, drawn larger than actual size.
