NATIONAL TRANSPORTATION SAFETY BOARD
WASHINGTON, D.C.

ISSUED: April 28, 1982

SAFETY RECOMMENDATION(S)

I-82-5

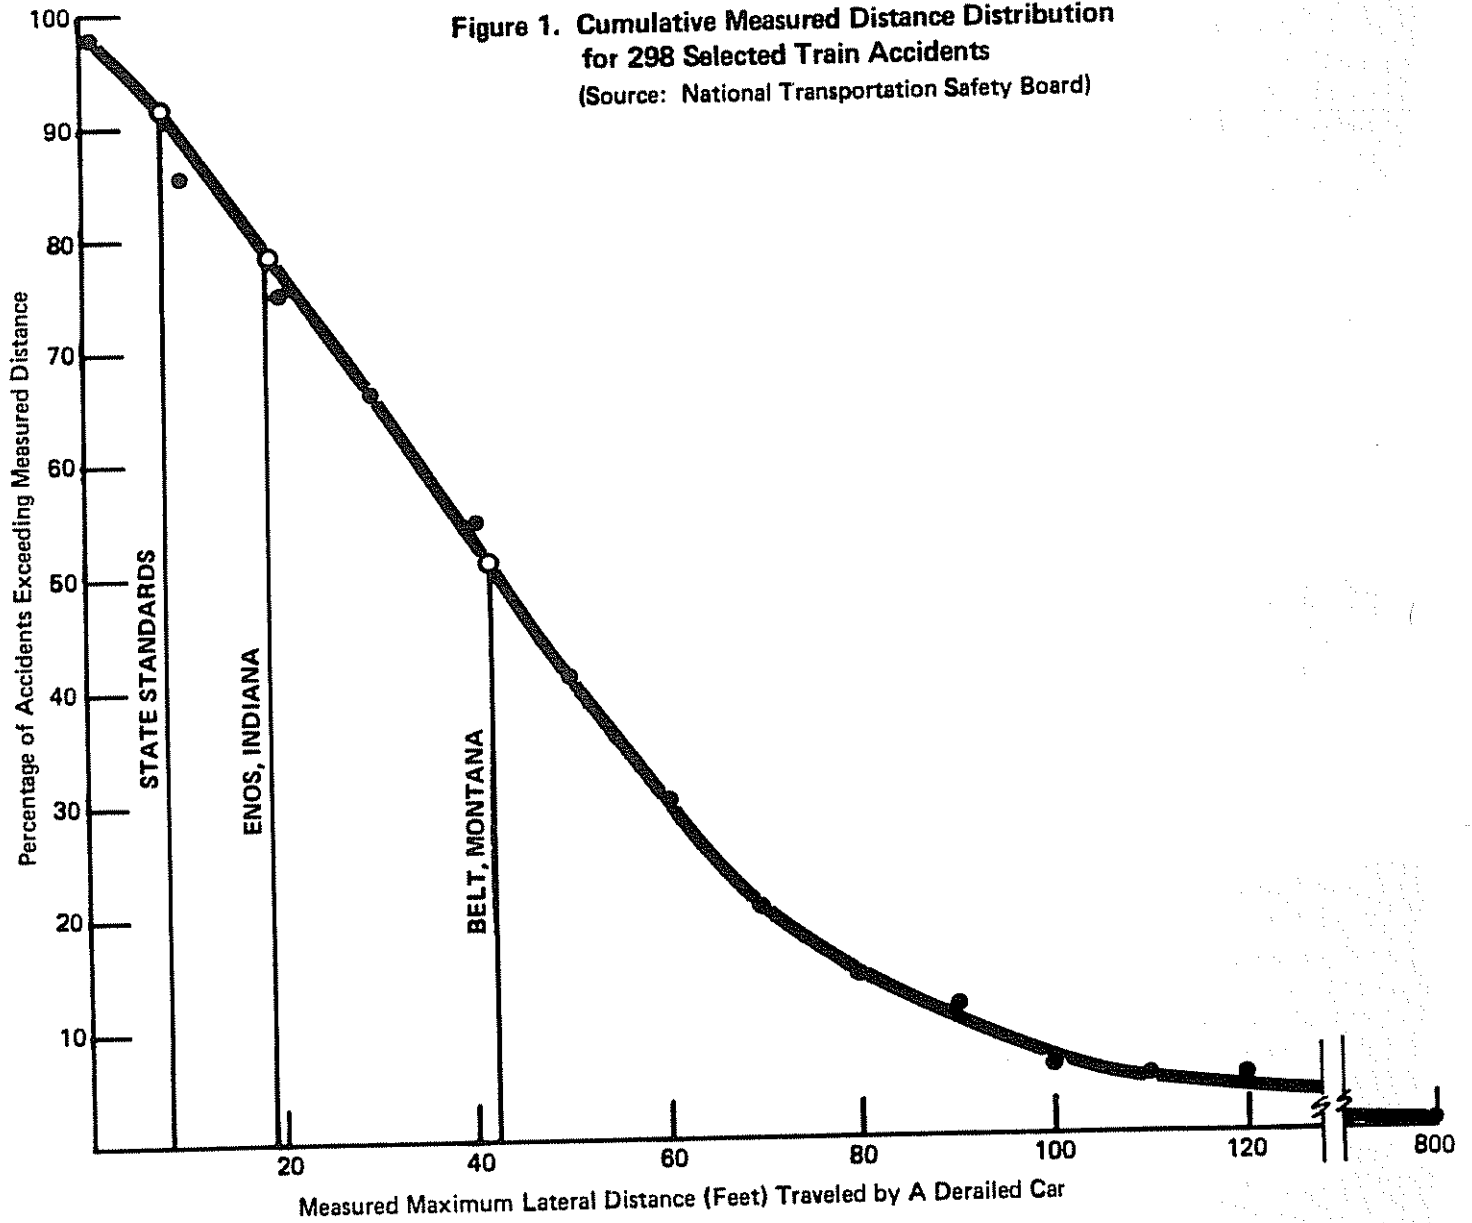
Figure 1. Cumulative Measured Distance Distribution for 298 Selected Train Accidents
(Source: National Transportation Safety Board)

Based on the Safety Board's measurements, in more than half of these derailments hazardous materials placed as close to the tracks as the hazardous materials in Belt could have been struck. Had hazardous materials been placed as close as those at Enos, they could have been struck by derailed cars in three-fourths of the accidents. Storage tanks 8 feet from tracks would have been vulnerable to damage by derailed cars in over 90 percent of the 298 accidents investigated by the Safety Board. (See figure 1.)

Reevaluate State statutes and administrative orders to identify action States might take to improve protection of hazardous materials storage near railroad right-of-way against damage by derailed railroad cars in train accidents, and develop guidelines for State actions if needed. (Class III, Longer Term Followup) (I-81-5)
