NATIONAL TRANSPORTATION SAFETY BOARD  
WASHINGTON, D.C.

SAFETY RECOMMENDATION(S)

I-82-6

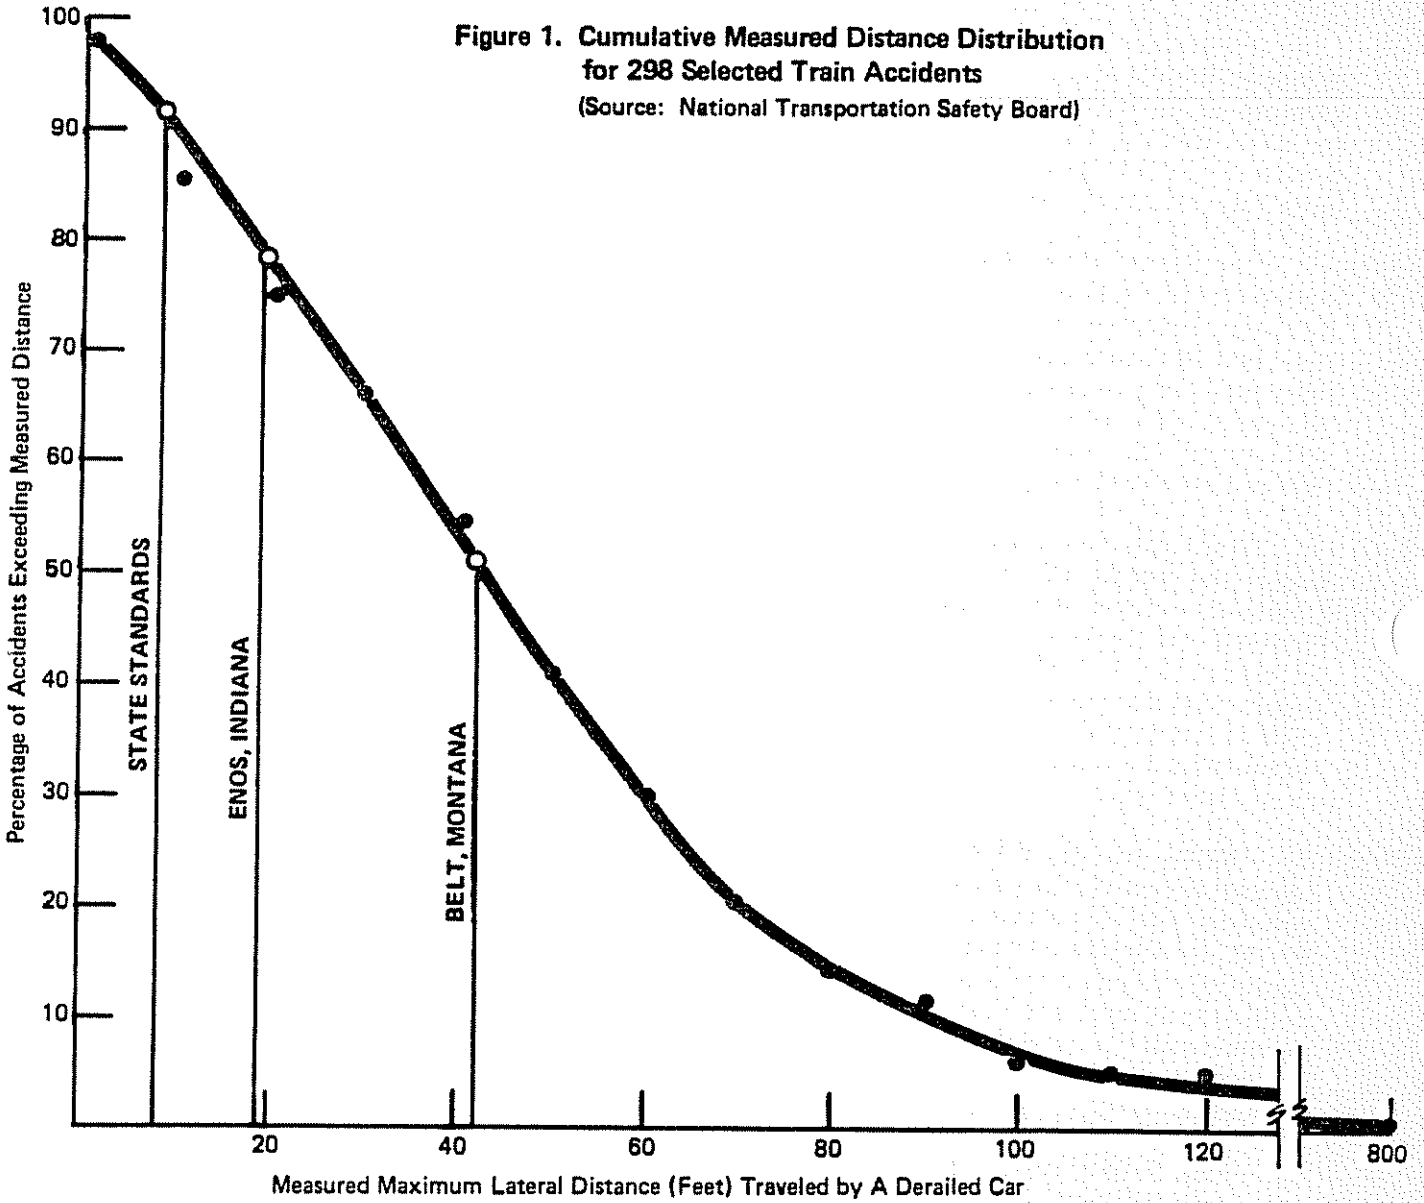
Figure 1. Cumulative Measured Distance Distribution for 298 Selected Train Accidents  
(Source: National Transportation Safety Board)

Based on The Safety Board's measurements, in more than half of these derailments hazardous materials placed as close to the tracks as the hazardous materials in Belt could have been struck. Had hazardous materials been placed as close as those at Enos, they could have been struck by derailed cars in three-fourths of the accidents. Storage tanks 8 feet from tracks would have been vulnerable to damage by derailed cars in over 90 percent of the 298 accidents investigated by the Safety Board. (See figure 1.)

Reevaluate National Fire Protection Association No. 30 "Flammable and Combustible Liquids Code" to assure adequate protection of hazardous materials storage located near mainline railroad tracks against derailed railroad cars in train accidents. (Class III, Longer Term Followup) (I-82-6)
