NATIONAL TRANSPORTATION SAFETY BOARD
WASHINGTON, D.C.

SAFETY RECOMMENDATION(S)

I-82-7

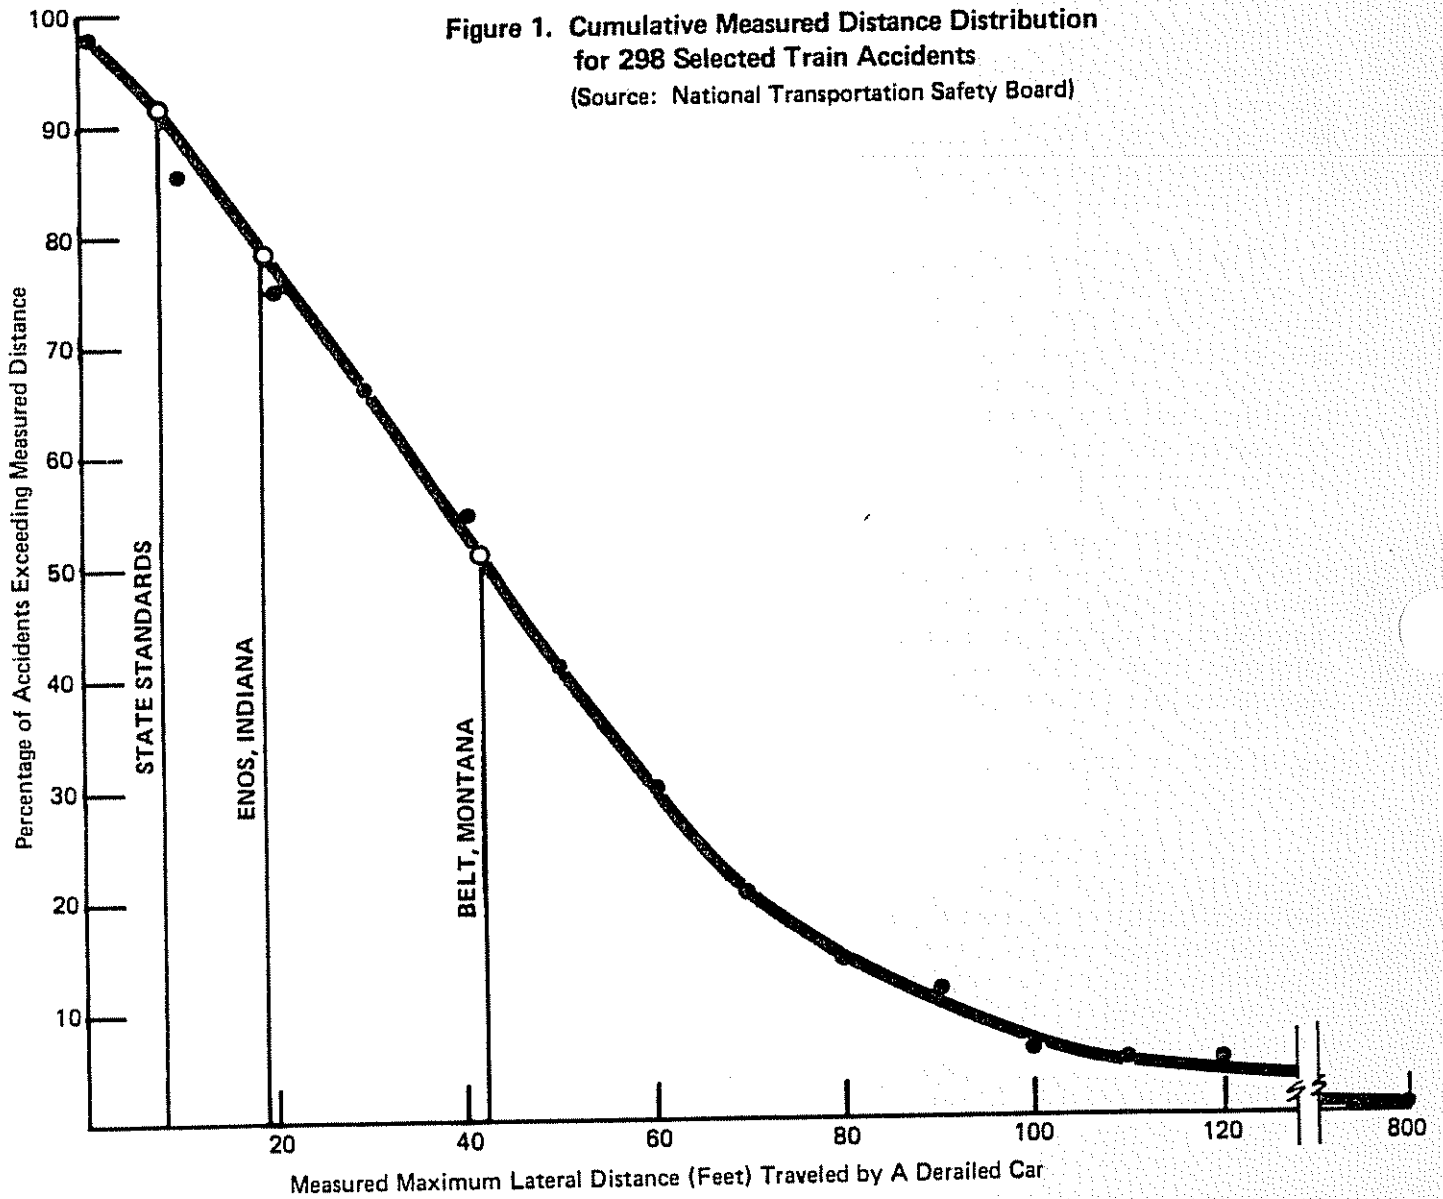
Figure 1. Cumulative Measured Distance Distribution for 298 Selected Train Accidents
(Source: National Transportation Safety Board)

Based on the Safety Board's measurements, in more than half of these derailments hazardous materials placed as close to the tracks as the hazardous materials in Belt could have been struck. Had hazardous materials been placed as close as those at Enos, they could have been struck by derailed cars in three-fourths of the accidents. Storage tanks 8 feet from tracks would have been vulnerable to damage by derailed cars in over 90 percent of the 298 accidents investigated by the Safety Board. (See figure 1.)

Reevaluate and amend as necessary American National Standards Institute Standard K61.1-1972, "Safety Requirements for the Storage and Handling of Anhydrous Ammonia," to provide adequate protection of hazardous materials containers located near mainline railroad tracks against derailed railroad cars in train accidents. (Class III, Longer Term Followup) (I-82-7).
