NATIONAL TRANSPORTATION SAFETY BOARD WASHINGTON, D.C.

SAFETY RECOMMENDATION(S)

H-81-17 and -18

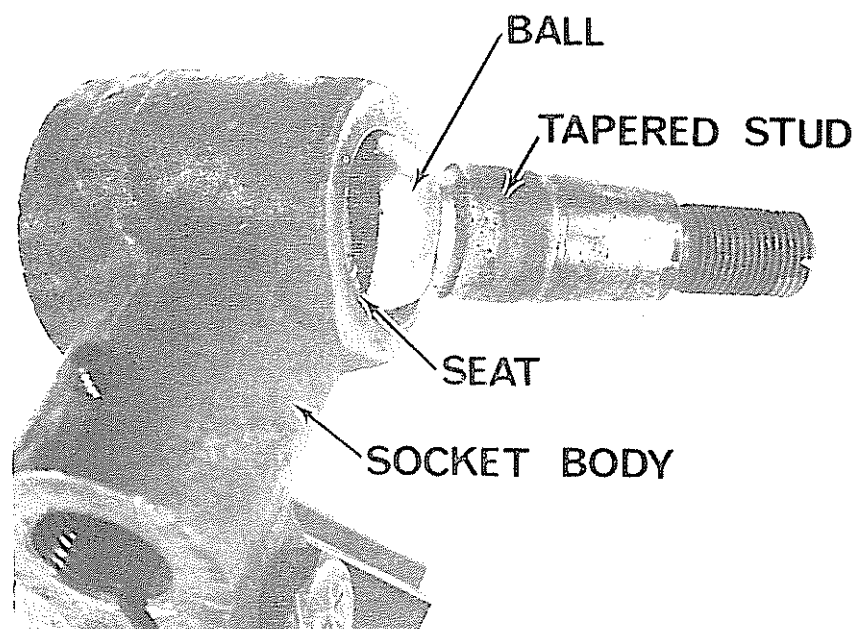
The crash severely damaged the front axle and steering linkage components of the bus. However, in examining these components, it was found that the ball joint which attaches the piston rod end of the power steering actuator to the vehicle's suspension was separated. This ball joint is a standard type commonly found in heavy vehicles of different manufacture. Six such fittings were incorporated in the steering linkage of the accident bus. Detailed inspection revealed that all mating parts of the ball joint (ball, ball seat, and socket body) were severely worn. The wear was such that the ball could be pulled by hand, with little effort, through the ball seat and socket body. The ball seat itself was worn to the extent that the lubrication grooves were completely obliterated. (See photograph attached.) The Safety Board is concerned that this ball joint wear was not detected during routine vehicle maintenance or inspection; it apparently did not manifest itself as a steering problem to the drivers of the bus.

PHOTOGRAPH NO. 1 - Steering Linkage End Assembly.

Issue an ON-GUARD Bulletin and other appropriate material to alert both interstate and intrastate operators of large commercial vehicles to the preliminary findings of this accident investigation and point out that worn ball joint assemblies and end fittings on power assist mechanisms may not be detectable using the procedures prescribed in the National Highway Traffic Safety Administration inspection standards. (Class I, Urgent Action) (H-81-17)

Develop, in coordination with the National Highway Traffic Safety Administration, steering mechanism inspection procedures and inspection intervals that will ensure the detection of all worn ball joint assemblies and end fittings in the steering linkages with particular attention to those vehicles equipped with power assist mechanisms. (Class II, Priority Action) (H-81-18)

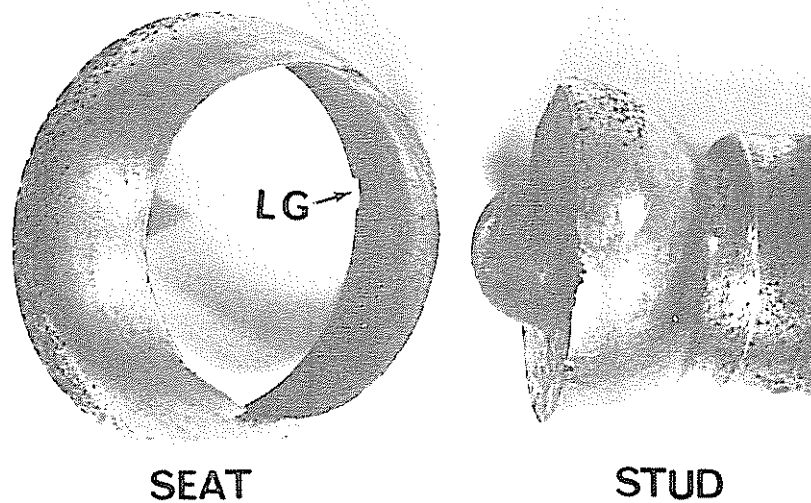
PHOTOGRAPH NO. 2 - Close Up of Stud and Seat (LG is the obliterated lubrication groove).
