NATIONAL TRANSPORTATION SAFETY BOARD WASHINGTON, D.C.

SAFETY RECOMMENDATION(S)

H-81-19

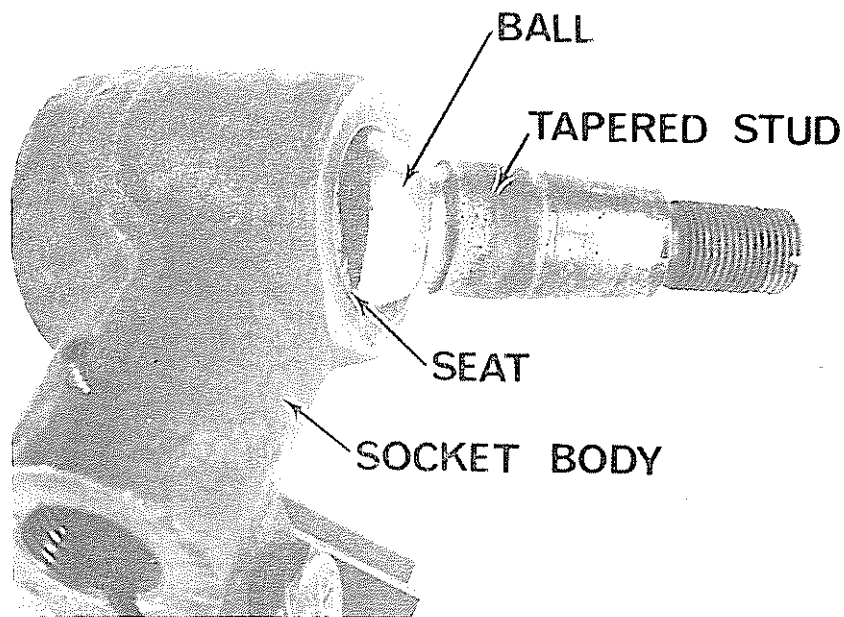
PHOTOGRAPH NO. 1 - Steering Linkage End Assembly.

The crash severely damaged the front axle and steering linkage components of the bus. However, in examining these components, it was found that the ball joint which attaches the piston rod end of the power steering actuator to the vehicle's suspension was separated. This ball joint is a standard type commonly found in heavy vehicles of different manufacture. Six such fittings were incorporated in the steering linkage of the accident bus. Detailed inspection revealed that all mating parts of the ball joint (ball, ball seat, and socket body) were severely worn. The wear was such that the ball could be pulled by hand, with little effort, through the ball seat and socket body. The ball seat itself was worn to the extent that the lubrication grooves were completely obliterated. (See photograph attached.) The Safety Board is concerned that this ball joint wear was not detected during routine vehicle maintenance or inspection; it apparently did not manifest itself as a steering problem to the drivers of the bus.

In coordination with the manufacturers, develop standards prescribing inspection procedures and intervals which will ensure detection of all worn ball joint assemblies and end fittings in the steering linkage of large commercial vehicles, with particular attention to those equipped with power steering mechanisms, and coordinate with the Bureau of Motor Carrier Safety in disseminating such standards to the motor carrier industry. (Class II, Priority Action) (H-81-19).

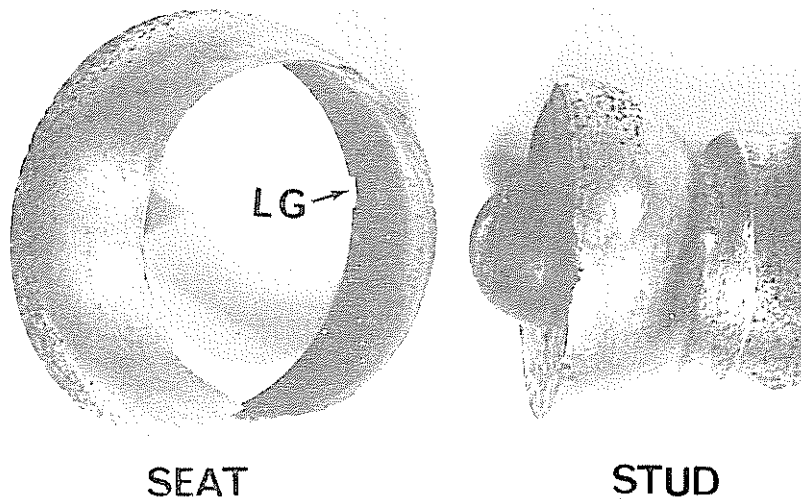
PHOTOGRAPH NO. 2 - Close Up of Stud and Seat (LG is the obliterated lubrication groove).
