# National Transportation Safety Board

## Urgent Safety Recommendation

**Date:** October 21, 2004

**In reply refer to:** H-04-35 and -36

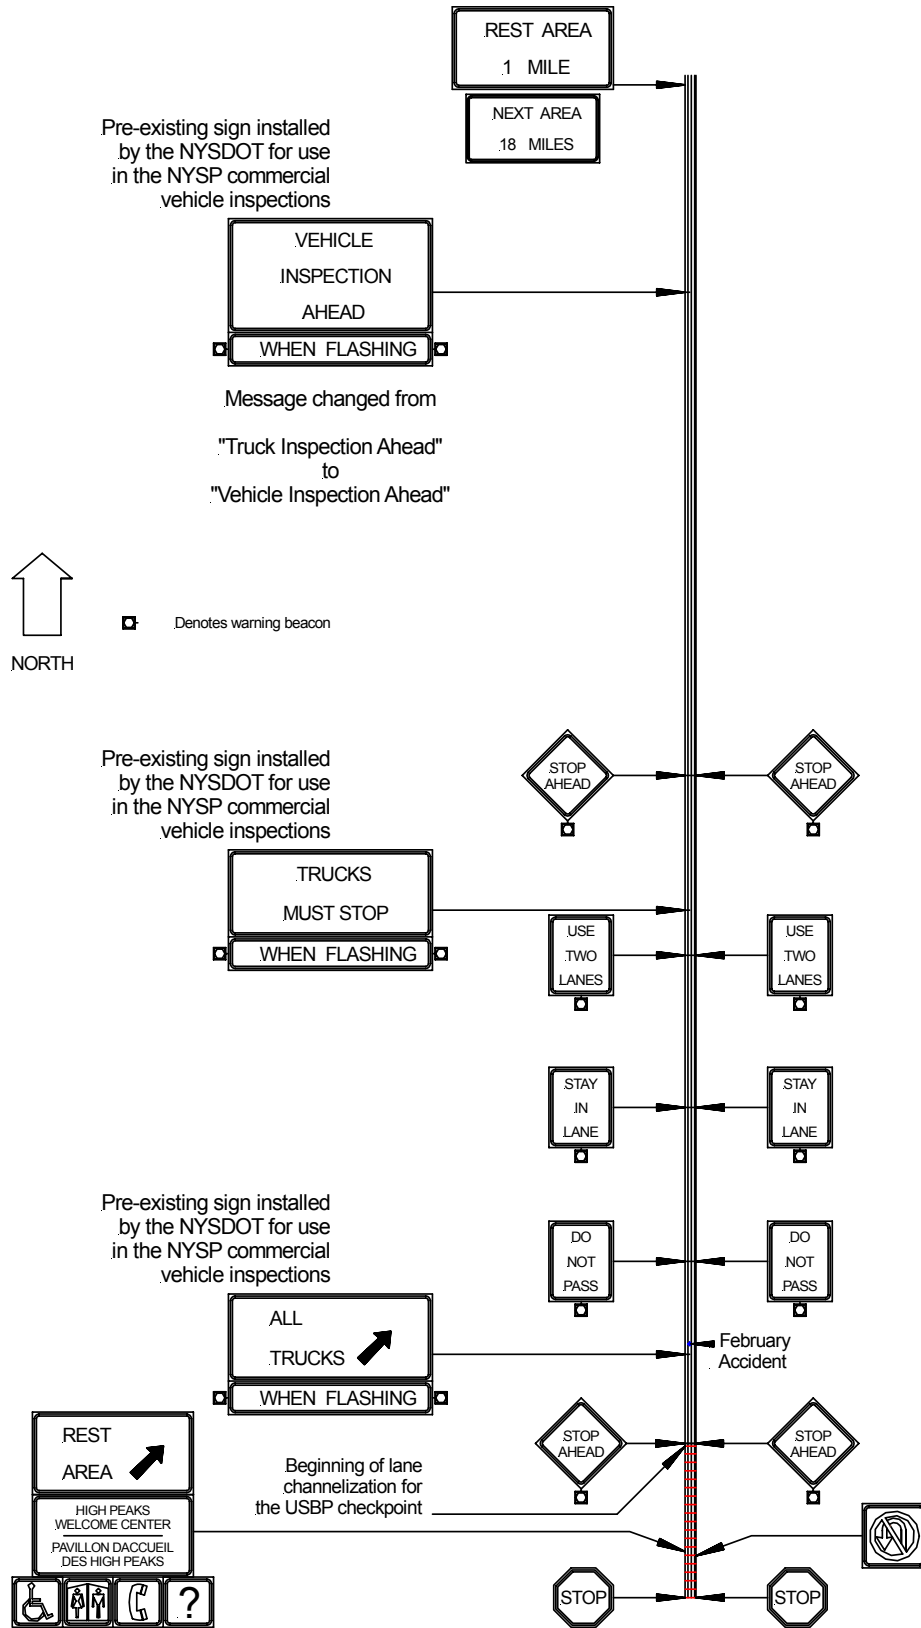
In addition to the USBP, the New York State Police (NYSP) uses the High Peaks rest area for commercial vehicle inspection and enforcement activities. The various uses of the facility resulted in a series of signs and flashing beacons being posted along the southbound interstate approaching the rest area (see figure 1). The first sign, “Vehicle Inspection Ahead When Flashing,” was located 4,631 feet (0.88 mile) before the checkpoint. None of the signs gave specific notice about traffic ahead being stopped in the roadway.

Figure 1. Signage at approach to USBP checkpoint on February 22, 2004.

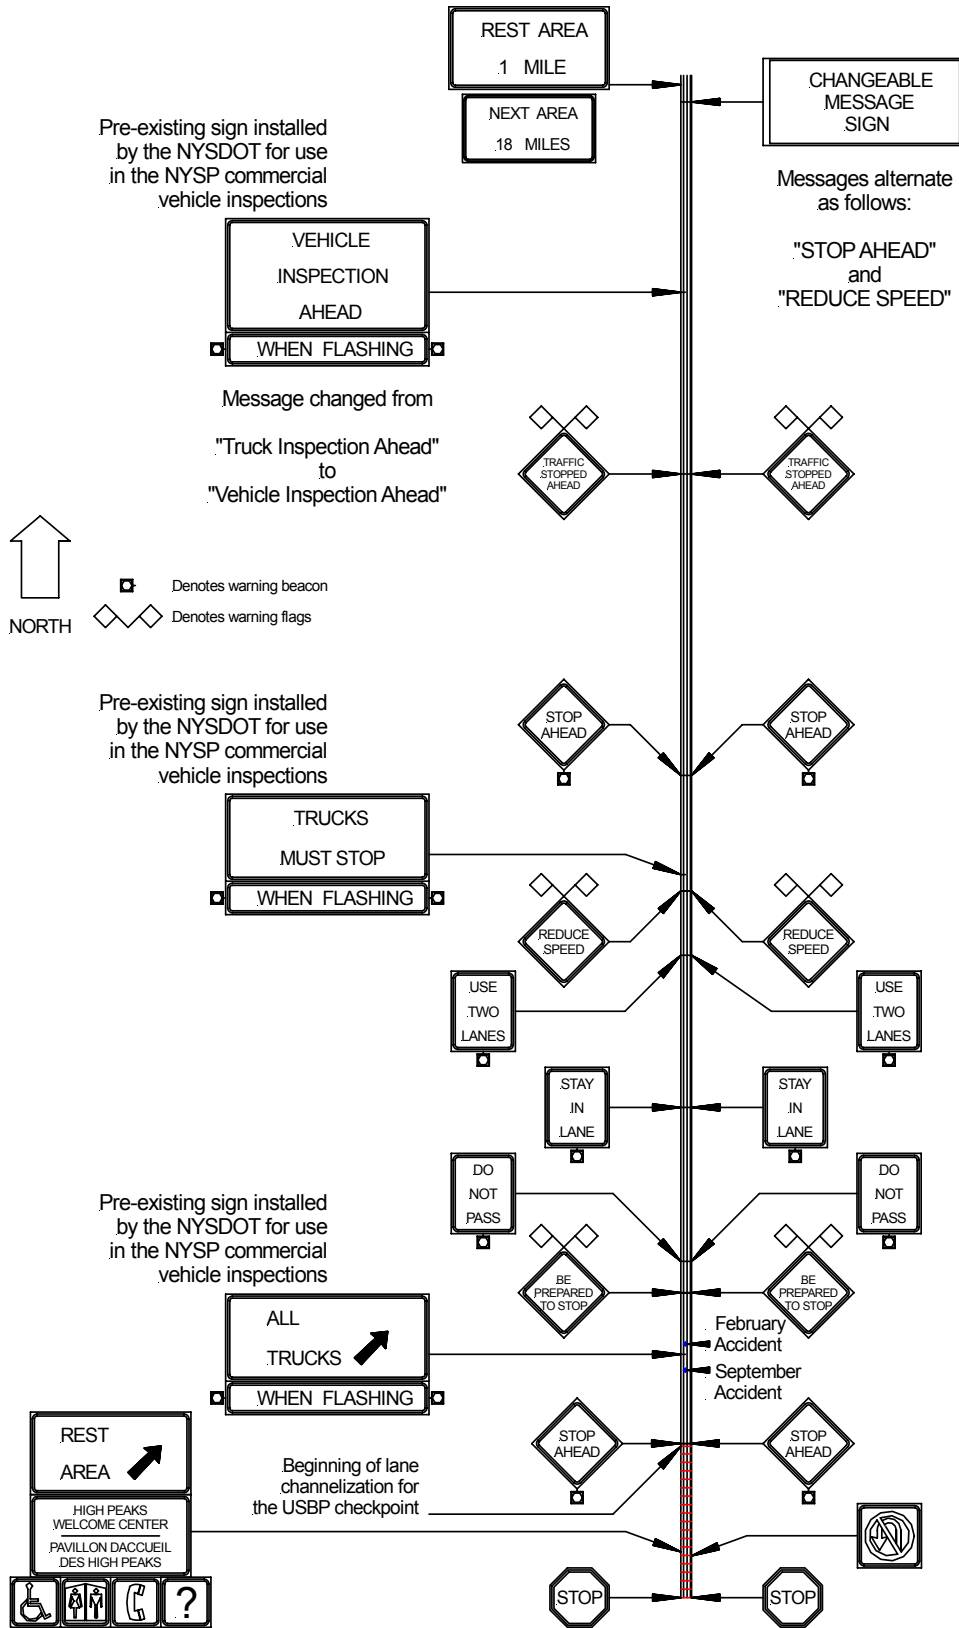
Following the February accident, the USBP and NYSDOT added signage along the approach to the rest area (see figure 2):

- Changeable message sign that alternated between “Reduce Speed” and “Stop Ahead” (in median 4,780 feet prior to checkpoint)
- “Traffic Stopped Ahead” (on right side of road and median 3,770 feet prior to checkpoint)
- “Reduce Speed” (on right side of road and median 2,330 feet prior to checkpoint)
- “Be Prepared to Stop” (on right side of road and median 913 feet prior to checkpoint)

The additional signage notified drivers that traffic might be stopped ahead but did not state where traffic might be stopped on the interstate for the checkpoint. The large number of signs—at least 25—may have been confusing to motorists.

Figure 2. Signage at approach to USBP checkpoint on September 19, 2004.

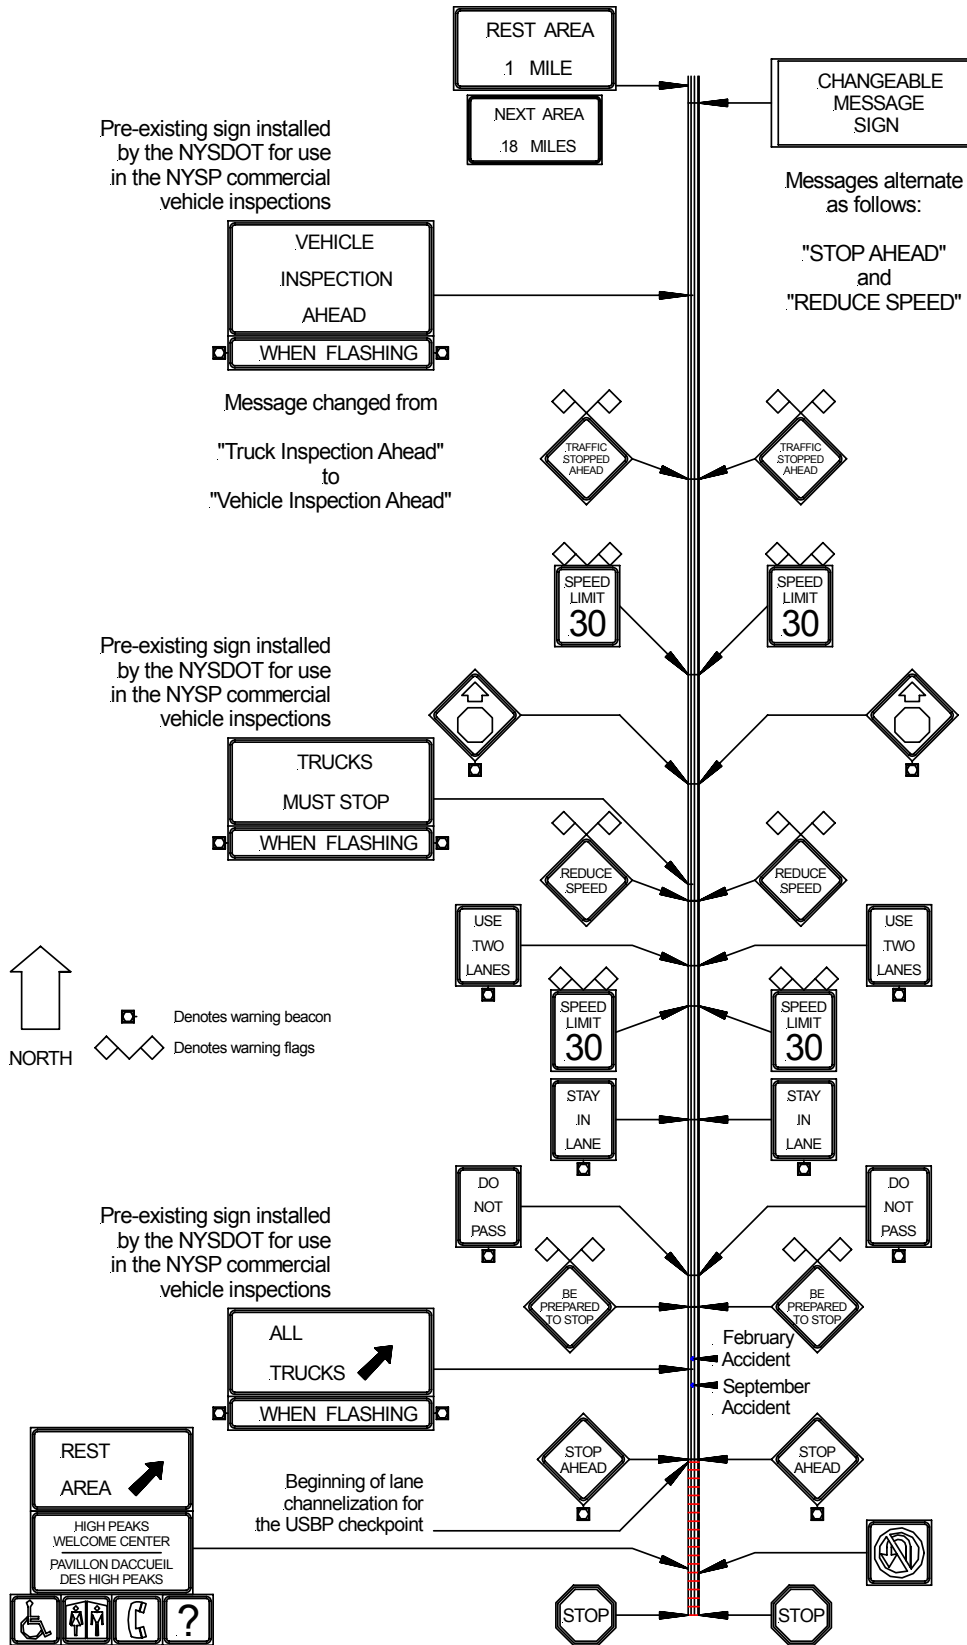
Following the September accident, the USBP and the NYSDOT again added signage (see figure 3; signs more than 5,280 feet from the checkpoint are not shown on the diagram):

- Changeable message sign that alternates between “Be Prepared to Stop” and “Stopped Traffic Ahead” (in median 2.6 miles prior to checkpoint)
- “Speed Zone Ahead” (on right side of road and median 2.2 miles prior to checkpoint)
- “Speed Limit 45” (on right side of road and median 2.0 miles, 1.8 miles, and 1.2 miles prior to checkpoint)
- Changeable message sign that alternates between “Speed Limit 45 MPH” and “Your Speed \_\_\_ MPH” (in median 1.1 miles prior to checkpoint)
- “Speed Limit 30” (on right side of road and median 3,300 feet and 2,138 feet prior to checkpoint)
- Symbol sign for stop ahead (on right side of road and median 3,036 feet prior to checkpoint)

This additional signage created a speed zone in which drivers are to reduce their speed from 65 mph to 45 mph 2 miles prior to the checkpoint and then to 30 mph 0.6 miles before the checkpoint. The NYSDOT also plans to install rumble strips about 1 mile prior to the checkpoint.

Figure 3. Signage at approach to USBP checkpoint after September 22, 2004.

Following the second accident, the number of signs in less than 1 mile preceding the checkpoint increased to 29, resulting in an array of messages that was hardly simple and may have confused motorists. Section 2A.16 of the MUTCD cautions that “overloading road users with too much information is not desirable,” and researchers have found that many safety signs are not noticed in situations of high visual clutter.<sup>4</sup> Although the USBP and the NYSDOT made a commendable effort to improve traffic control at North Hudson after the two accidents, they acted without the benefit of a systematic, comprehensive approach to traffic control in the area. The Safety Board concludes that the signage in place prior to the USBP checkpoint at North Hudson did not clearly convey adequate information to warn motorists that traffic on the interstate would be stopped ahead; the Board further concludes that the numerous signs added to that area following accidents in 2004 may lead to driver confusion due to information overload.
