National Transportation Safety Board

Safety Recommendation

In reply refer to: A-08-22 through -24

On March 22, 2008, a Boeing 757-225, N921UW, operated by US Airways as flight 1250, experienced an in-flight separation of the left upper wing fixed trailing edge panel during cruise flight at 27,000 feet en route from Orlando, Florida, to Philadelphia, Pennsylvania. The panel struck several windows toward the middle of the aircraft, cracking the outer pane of one window. The inner pane of this window was undamaged, and the pressurization of the aircraft was not compromised. No emergency was declared, and the airplane landed at Philadelphia International Airport about 30 minutes after the separation occurred. None of the 174 passengers or 6 crewmembers was injured. The panel has not been recovered. Visual meteorological conditions prevailed at the time of the incident for the 14 *Code of Federal Regulations* Part 121 scheduled passenger flight, which was operating on an instrument flight rules flight plan.

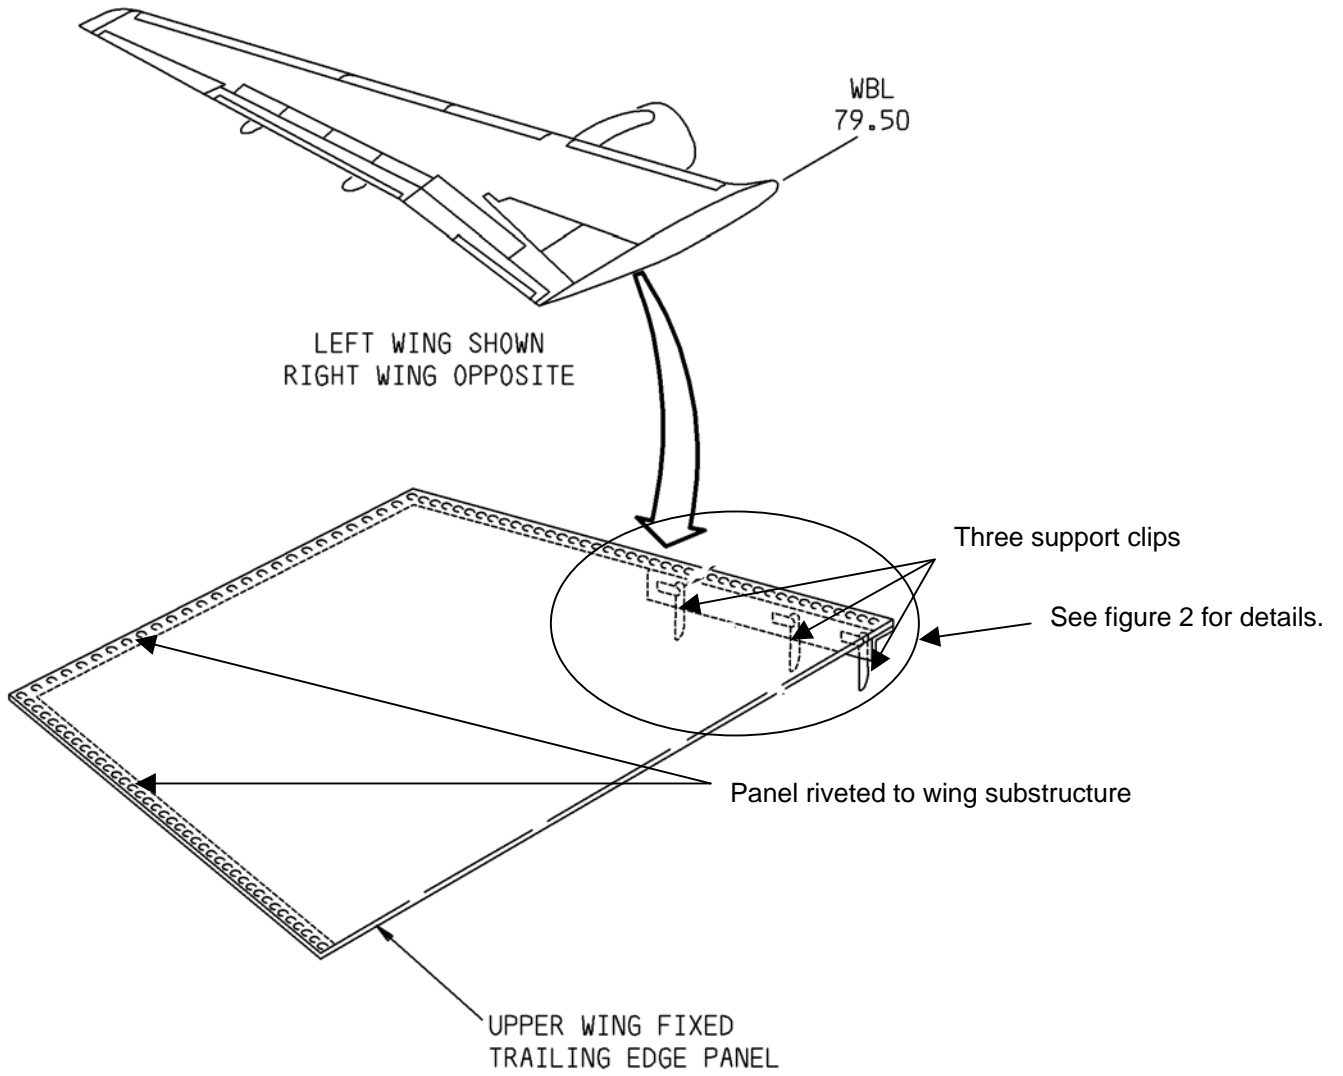
Figure 1. Boeing 757 upper wing fixed trailing edge panel

The B757 upper wing fixed trailing edge panel is a rectangular panel approximately 4 feet by 5 feet. Approximately half of the forward side of the panel is attached to the panel support beam, which is attached to the wing rear spar vertical stiffeners using three support clips and spacers.¹ (See figures 1 and 2.) If these attachment points fail, air can flow under the panel, causing it to lift off the wing and separate. The National Transportation Safety Board's investigation of this incident is ongoing; however, examination of the left wing revealed that the three support clips had fatigue cracks, and the mechanic who removed the clips reported that no spacers had been installed. Additionally, the clips were oriented incorrectly.

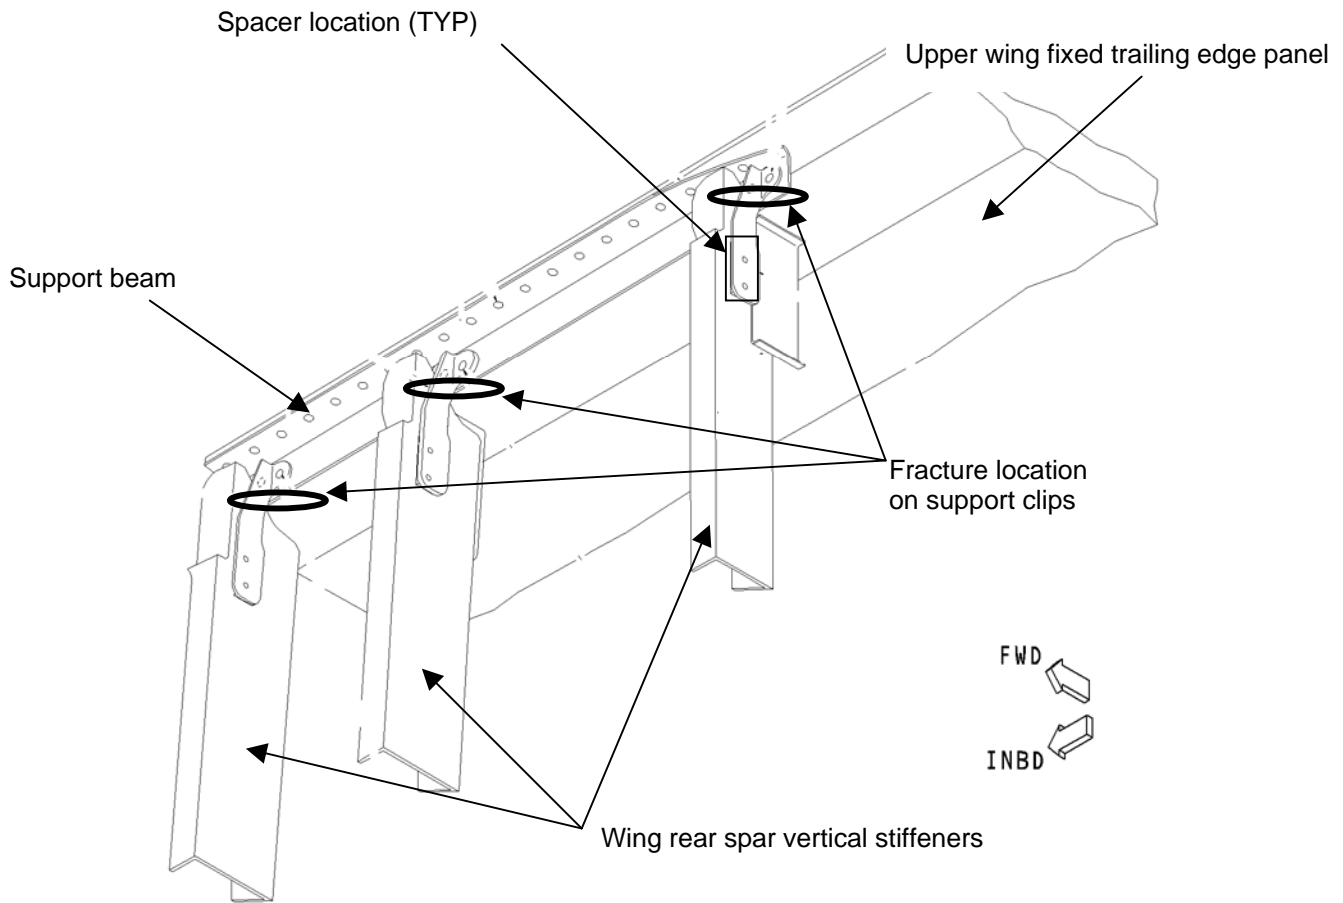
Figure 2. Panel support beam, three support clips, fracture locations & spacer locations

Following the flight 1250 incident, US Airways inspected 18 other B757s that were subject to the AD. A total of 11 cracked clips were found, affecting 7 airplanes. Of the 11 cracked clips, 9 clips (on 5 airplanes) were oriented incorrectly (based on the repair kit used), whereas 2 clips (on 2 airplanes) were oriented correctly. All cracked clips were installed on the aircraft during the early 1990s. US Airways also found one additional airplane with clips installed incorrectly, but the clips were not cracked. US Airways did not record whether spacers were found on any of the 18 airplanes, but, as stated earlier, US Airways reported that no spacers were found on the incident airplane; Boeing stated in its SB that spacers are critical to improved fatigue life of the support clips. The Safety Board concludes that the cracked clips could be the result of incorrect orientation of the clips, aging of the clips, lack of spacers, or a combination of all three.

Require operators of Boeing 757 airplanes to conduct a one-time visual inspection of the upper wing fixed trailing edge panel support beam clips for cracks, proper orientation, and spacers, and to replace cracked clips and reinstall any clips that are improperly oriented or that lack spacers, in accordance with Boeing Service Bulletin 757-57-0027, Revision 2, dated November 14, 1991. (A-08-22)
