National Transportation Safety Board

Safety Recommendation

Date: June 2, 2008

In reply refer to: A-08-30 and -31

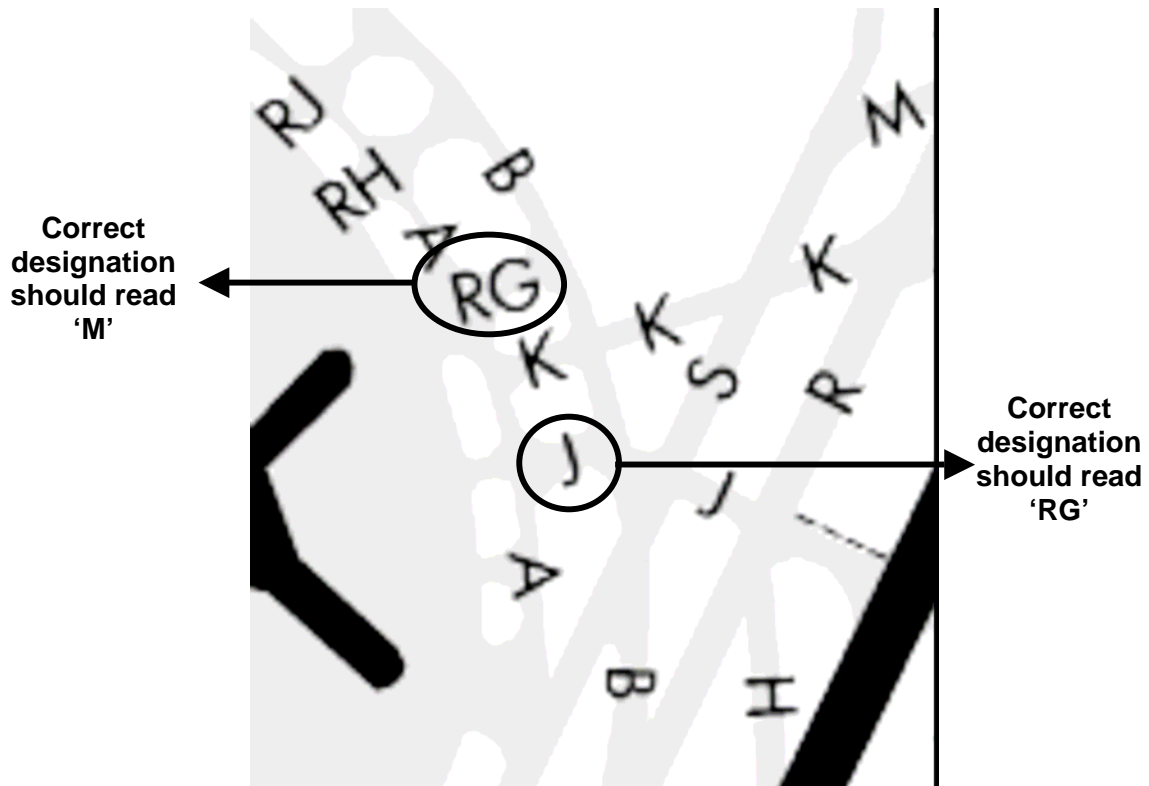
The National Transportation Safety Board's investigation of this event has revealed a safety issue that, though not causal or contributing to the accident, could compromise safety under other circumstances. At the time of the accident, two taxiway designations were incorrectly labeled on the Federal Aviation Administration (FAA) EWR airport diagram.³ As shown in the following figure, taxiway RG should have been labeled as taxiway M, and the ramp-side portion of taxiway J should have been labeled as taxiway RG;⁴ however, all airfield signage and marking plans were accurate at the time of the accident.

Figure. Airport diagram showing incorrect taxiway designations at Newark Liberty International Airport.

The Safety Board's investigation of the details that led to the incorrect EWR airport diagram revealed that the New York Airports District Office (ADO) submitted a marked-up diagram (correctly reflecting multiple changes resulting from a planned taxiway reconstruction) to the Cartographic Standards Branch at FAA headquarters on June 12, 2006. The Cartographic Standards Branch forwarded the revisions to the National Aeronautical Charting Office (NACO) for incorporation and publication in the August 3, 2006, edition of the Airport/Facility Directories (A/FD).⁵ Although some revisions were made correctly, NACO introduced the taxiway labeling errors during the revision process, and the errors were not detected until after the accident.

Develop and document formal guidance for the revision, publication, and review of airport diagrams that contains, at a minimum, a review of draft diagrams before publication, as well as a control to ensure that reviews are performed each publication cycle as required in FAA Order 7910.4C, *Airport Diagrams*. (A-08-30)

Revise FAA Order 7910.4C, *Airport Diagrams*, to ensure airport district offices review revised airport diagrams in their respective regions each publication cycle. (A-08-31)
