# National Transportation Safety Board

## Safety Recommendation

**Date:** July 17, 2008

**In reply refer to:** A-08-51 and -52

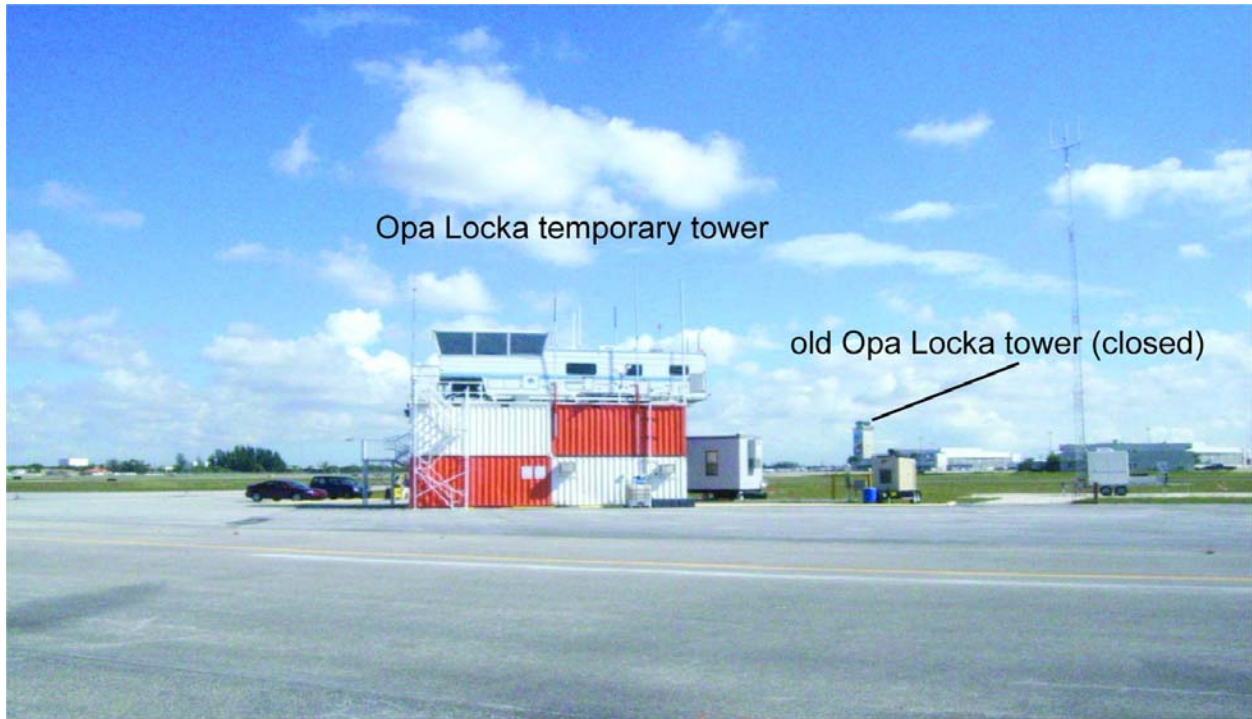
The temporary ATCT was installed after the old, 112-foot ATCT was condemned because of inadequate fire-suppression capability. The temporary ATCT is approximately 29 feet tall and consists of a trailer with a modified ATCT cab fixed to four large metal shipping/storage containers stacked two wide and two tall. (See figure 2 for a photograph showing the temporary ATCT’s design.) The ATCT cab contains a local control position and a ground control position; the ground control position also provides flight data/clearance delivery functions.

**Figure 2.** Photograph of Opa Locka Airport's temporary air traffic control tower (old tower visible in the background).

Tower cab configuration and height should allow the controller to view the airfield from above the horizontal visual plane, which allows the controller to determine spatial relationships between aircraft, vehicles, and other potential hazards. The Safety Board's investigation found that the short height of OPF's temporary ATCT presented an extremely limited line-of-sight view of taxiing aircraft and vehicle movement on many areas of the airport. Because the height and location of numerous buildings blocked visibility from the temporary ATCT, controllers had no visibility of the northeast end of the airport where the majority of aircraft were based and of the final approach course to runway 27R. (See figure 3 for a view of the accident site from the temporary ATCT and figure 3a for a traditional view of the accident site from the old ATCT.) Line-of-sight view was further hindered by the air conditioning unit on the southeast side on the temporary ATCT; the air conditioning unit partially obscured runways 12/30 and 9R/27L.

Until a permanent air traffic control tower (ATCT) is constructed at Opa Locka Airport, ensure a temporary ATCT exists that complies with Federal Aviation Administration Order 6480.4, "Air Traffic Control Tower Siting Process." (A-08-51)

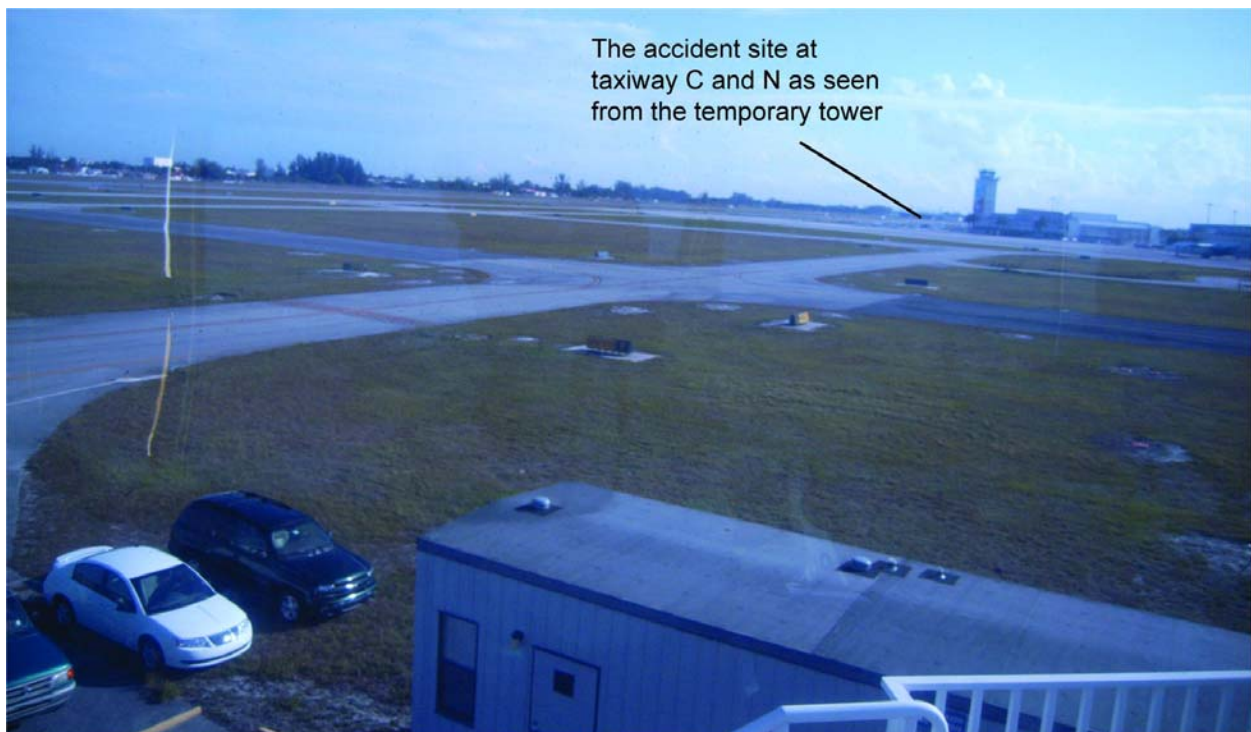
Although, as mentioned earlier, the local controller failed to coordinate with the ground controller in this incident, the visibility restrictions created by the temporary ATCT's short height likely contributed to the November 6, 2007, accident because the controllers could not see N701SE and N18R. This lack of visibility did not allow the controllers to see a developing situation and, therefore, did not allow them to take preemptive action.

**Figure 3.** Northwest view of the accident site from inside Opa Locka Airport's temporary air traffic control tower (ATCT). The current location and height of the temporary ATCT prevent controllers from observing aircraft and vehicle movement on the majority of the airport surface and limit some views of aircraft on approach to the airport.

Require that Opa Locka Airport air traffic controllers provide progressive taxi/ground movement instructions to pilots and airfield vehicle operators that are not visible from the temporary air traffic control tower. (A-08-52)

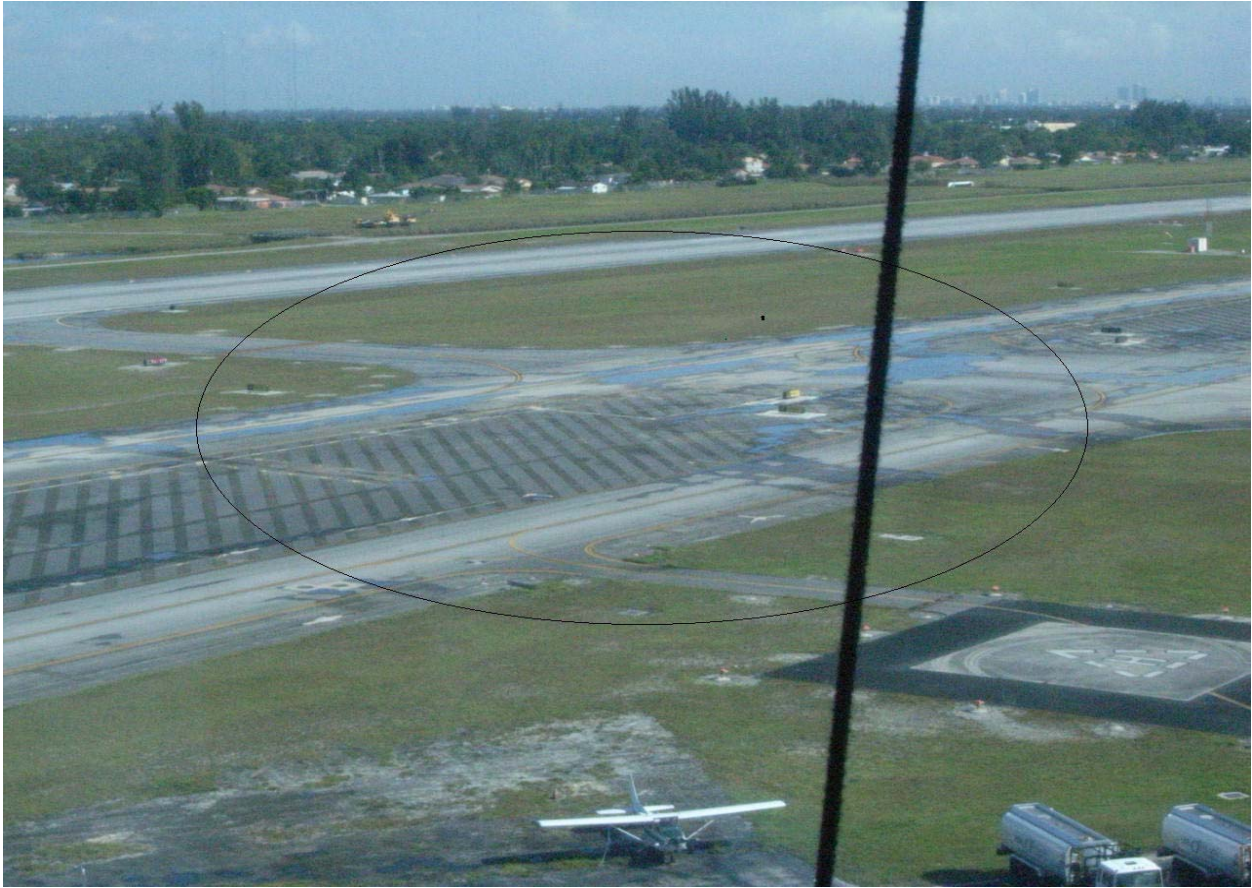
**Figure 3a.** The accident site, as seen from the old Opa Locka Airport's air traffic control tower (ATCT). This photograph provides a traditional view from an ATCT.

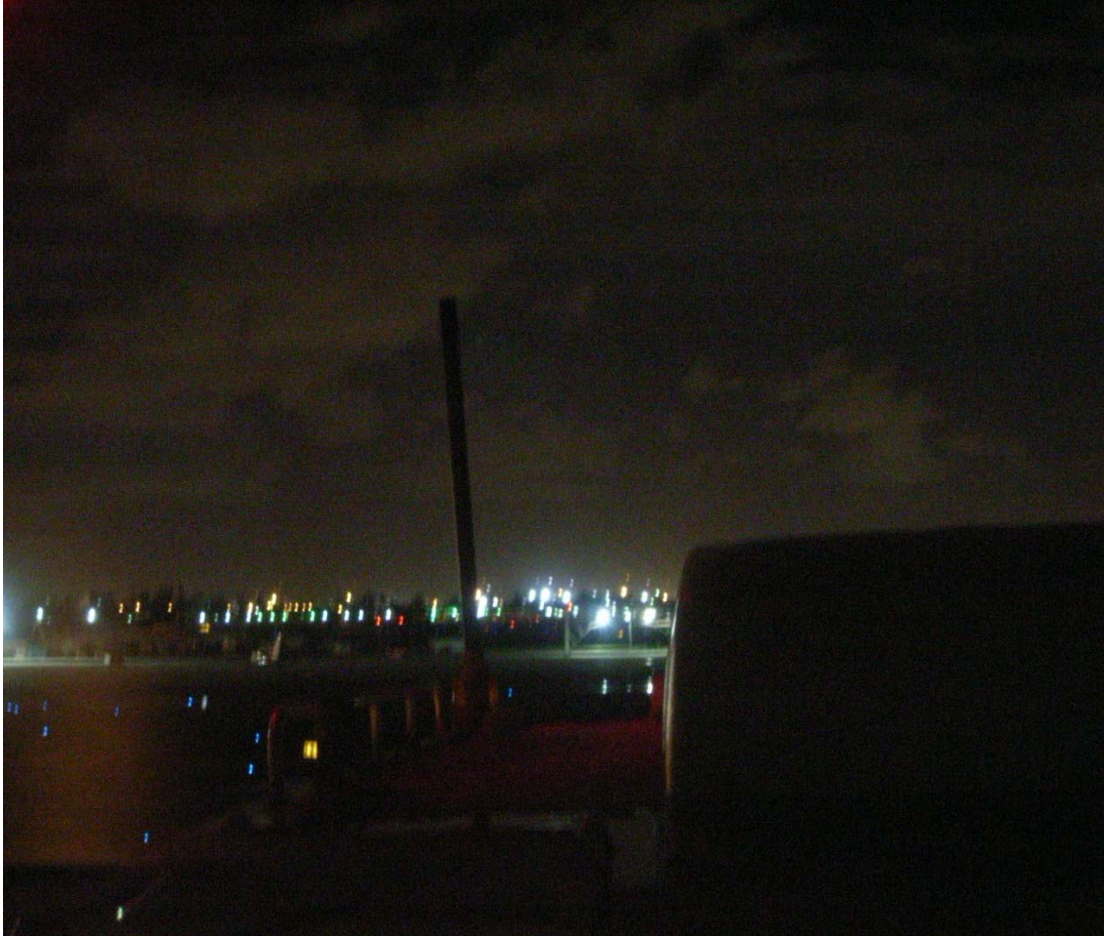
ATCTs usually have windows that slope at an inward angle from the ceiling toward the base of the ATCT to allow any light from inside the ATCT (such as video screens and other equipment) to be reflected onto the ceiling, which is painted black, to allow for clear, unobstructed visibility of the airport environment. Although not a factor in this accident, Safety Board investigators noted that the non-angled ATCT windows in OPF's temporary ATCT reflected interior ATCT cab equipment lighting at night, which made visually discerning aircraft on the airport challenging. Because of the ATCT's height and location, visibility at night was further hampered by vehicular traffic traveling on roadways adjacent to the airport because controllers could confuse vehicular traffic, on and off the airport, with taxiing aircraft (see figure 4).

**Figure 4.** Photograph of runway 12/30 and 9R/27L from Opa Locka Airport's temporary air traffic control tower at night (southeast view). This photograph highlights the difficulties controllers encounter when trying to discern aircraft and vehicles from background clutter, as well as the restricted view created by the air conditioning unit located in the lower right hand corner of this photo. The difficulty discerning aircraft and vehicles is most predominant and dangerous at night.
