National Transportation Safety Board

Safety Recommendation

Date: September 30, 2008

In reply refer to: A-08-75 and -76

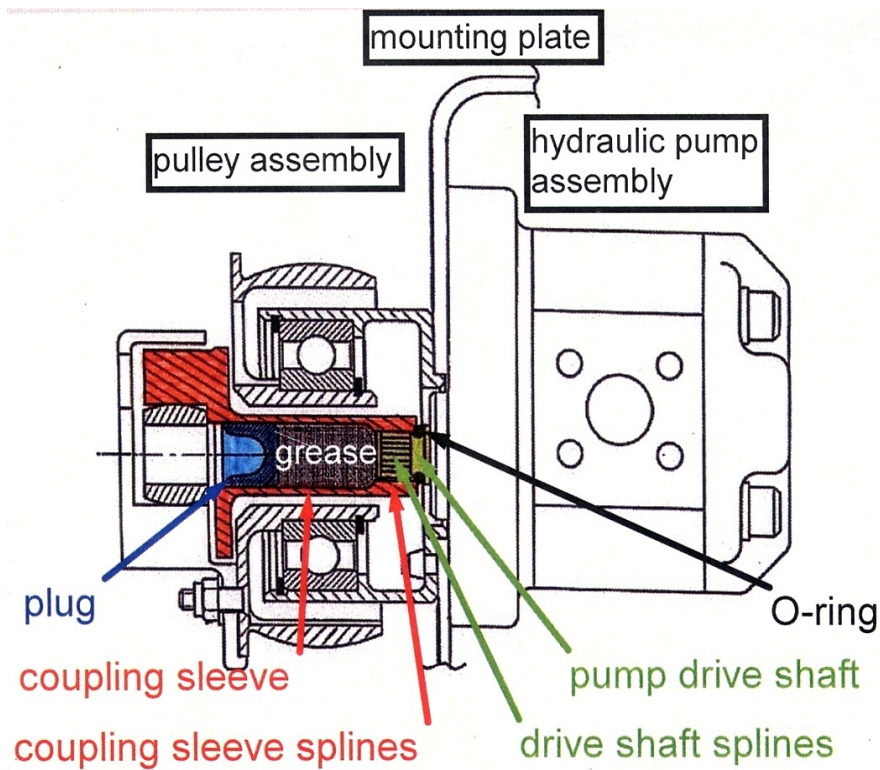
The hydraulic pump assembly is driven by a pulley assembly that contains a coupling sleeve, as shown in the figure. The coupling sleeve, with internal splines at its forward end, extends forward through the center of the pulley assembly to engage with the external splines on the hydraulic pump drive shaft. A lubricant (specified in the maintenance manual as NATO grease G-355) is contained within the coupling sleeve by a plug inserted in the aft end of the sleeve and, at the forward end, by contact with an O-ring located in a groove forward of the drive shaft splines.¹ The pump and the coupling sleeve are replaced “on condition” (that is, when a problem is found during routine maintenance or during operation).

Figure. Diagram of hydraulic pump and pulley assemblies in Eurocopter AS-350 series helicopters.
