National Transportation Safety Board

Safety Recommendation

Date: September 30, 2008

In reply refer to: A-08-77 and -78

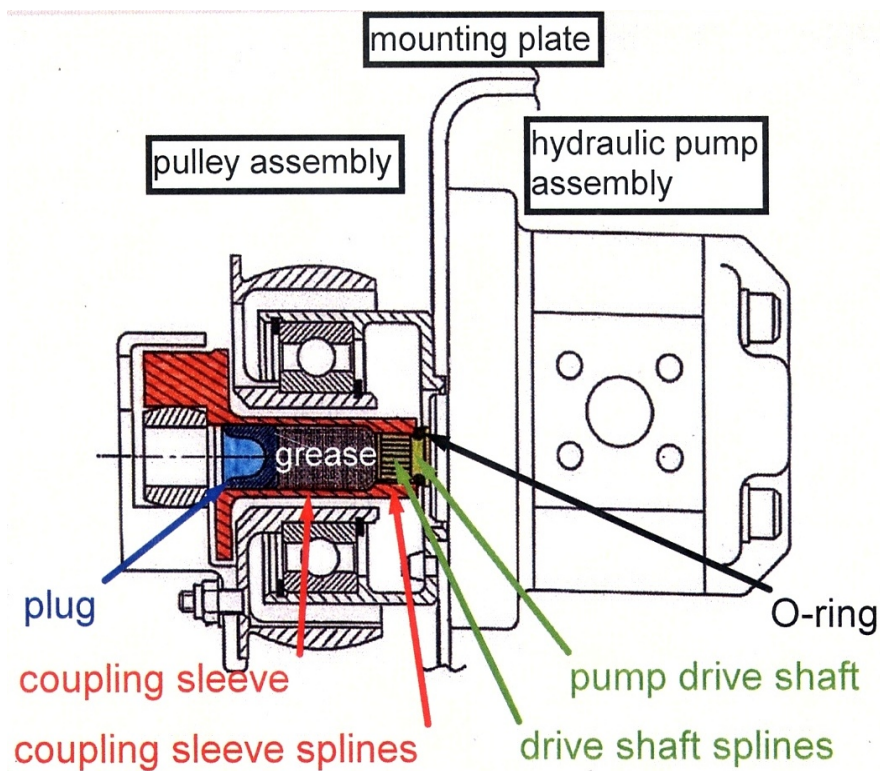
The hydraulic pump assembly is driven by a pulley assembly that contains a coupling sleeve, as shown in the figure. The coupling sleeve, with internal splines at its forward end, extends forward through the center of the pulley assembly to engage with the external splines on the hydraulic pump drive shaft. A lubricant (specified in the maintenance manual as NATO grease G-355) is contained within the coupling sleeve by a plug inserted in the aft end of the sleeve and, at the forward end, by contact with an O-ring located in a groove forward of the drive shaft splines.¹ The pump and the coupling sleeve are replaced “on condition” (that is, when a problem is found during routine maintenance or during operation).

Figure. Diagram of hydraulic pump and pulley assemblies in Eurocopter AS-350 series helicopters.
