National Transportation Safety Board

Safety Recommendation

In reply refer to: A-08-83 and -84

On December 29, 2007, about 1531 central standard time,¹ a Bell 206L1 helicopter, N211EL, operated by Air Logistics, LLC, impacted the water while approaching South Pass Block 38 (SP38), an offshore platform in the Gulf of Mexico, with a commercial pilot and three passengers aboard. All four occupants survived the crash, but one passenger died while awaiting rescue.² The pilot was seriously injured, and the two other passengers received minor injuries. The on-demand air taxi flight was operated under 14 *Code of Federal Regulations* (CFR) Part 135. Instrument meteorological conditions prevailed at the time of the accident.³

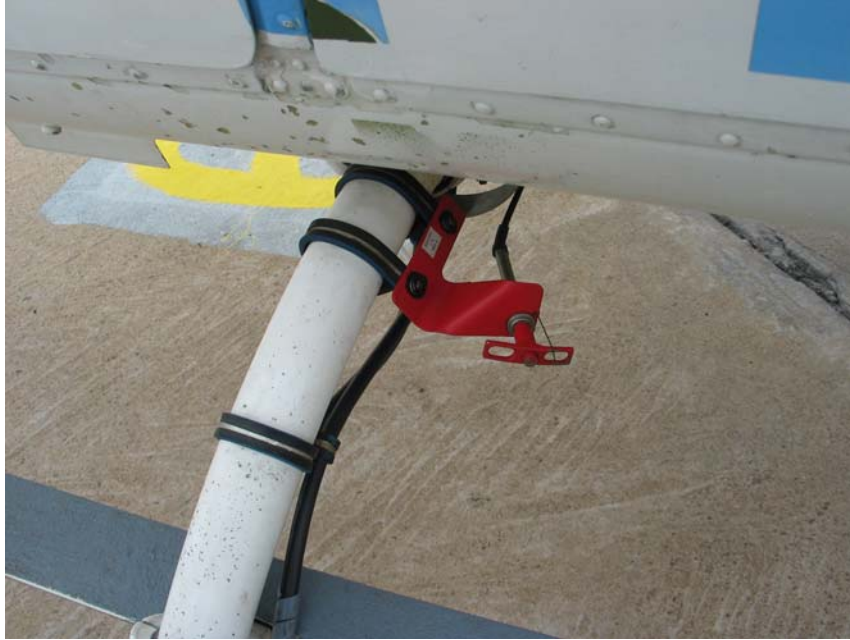
Figure. An external liferaft T-handle on a Bell 206 helicopter forward cross tube

“WARNING” in red letters followed by “to inflate liferafts Pull guard, Push in center detent,^[9] Pull handle on center console RH [right hand] side.” However, there were no external placards on the cross tubes describing the location and operation of the external T-handles.¹⁰

The Safety Board concludes that external placards for the two external liferaft T-handles, similar to the placard for the T-handle in the cockpit, would assist passengers in finding and activating the external T-handles, especially if the pilot were unable to do so. Therefore, the Safety Board believes that the FAA should require operators of turbine-powered helicopters with externally mounted liferafts to install a placard for each external T-handle that clearly identifies the location of and provides activation instructions for the handle.

Require operators of turbine-powered helicopters with externally mounted liferafts to install a placard for each external T-handle that clearly identifies the location of and provides activation instructions for the handle. (A-08-83)
