National Transportation Safety Board

Safety Recommendation

Date: October 16, 2008

In reply refer to: A-08-85 Urgent and -86

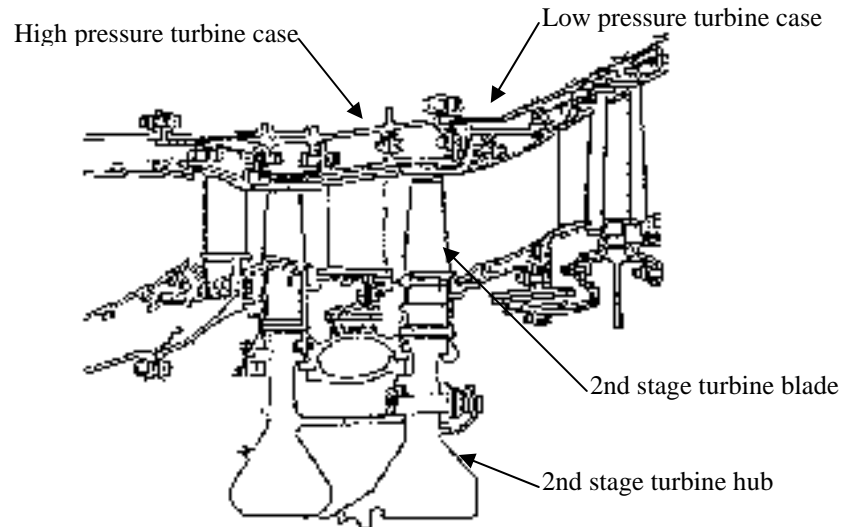
Figure 1. PW2037 HPT and LPT cross-section
Source: Pratt & Whitney

The Safety Board's examination of the right engine revealed a hole in the bottom of the core cowl that was in line with a hole through the engine's HPT and low pressure turbine (LPT) case flanges. (See figure 1.) The disassembly of the engine revealed that portions of

The damage within the HPT module indicated that the four 2nd stage turbine blades separated simultaneously and then, within one-quarter revolution, penetrated the HPT and LPT cases at the flange. According to 14 CFR 33.19, 33.75, and 33.94, turbine blade separations should be contained. However, the regulations require the containment of only a single blade release. Thus, the simultaneous release of four large PW2037 2nd stage turbine blades exceeded the design capability of the cases and resulted in an uncontainment.

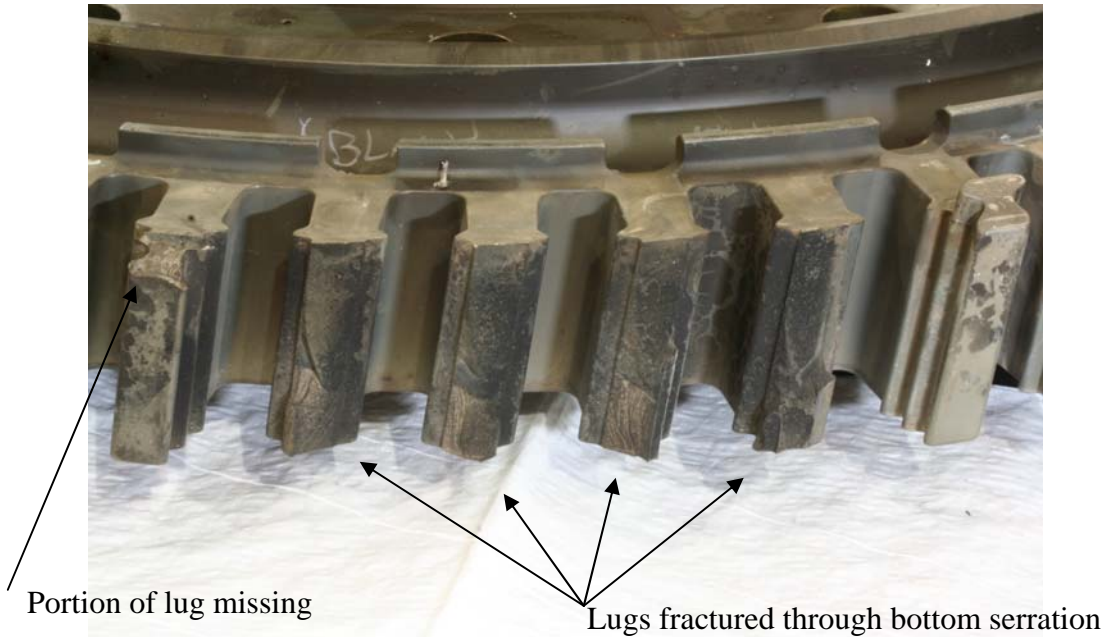
Figure 2. 2nd stage HPT hub showing five consecutive lug fractures

five consecutive 2nd stage turbine hub blade retaining lugs were missing.³ (See figure 2.) In addition, at the location of these lugs, three consecutive 2nd stage turbine blades were fractured through the blade root with only the bottom root serration remaining in the blade slot, and an adjacent 2nd stage turbine blade was missing completely. The examination of the 2nd stage turbine hub also revealed that 11 other randomly located blade retaining lugs had visual cracks. According to Delta Air Lines' maintenance records, the engine had accumulated 10,880 hours and 4,392 cycles⁴ since its last routine overhaul, at which time the 2nd stage turbine hub was inspected.

P&W stated that some of the previous cracks in the PW2037 2nd stage turbine hubs might have been related to the dimensional spacing of the root serrations in the hubs and/or the blade roots, which resulted in the load being transferred to the bottom serrations. P&W accomplished a dimensional inspection of the Delta Air Lines 2nd stage turbine hub blade retaining lugs. P&W reported that at least several of the lugs did not conform to the engineering drawing because the blade retaining serrations appeared to have excess material and the serrations' surfaces were not flat. Because the investigation is ongoing, the effect of this nonconformance on the hub's blade retaining lugs is not yet known.

P&W also stated that the Delta Air Lines 2nd stage turbine hub with the fractured blade retaining lugs appeared to be different from the previous instances of 2nd stage turbine hubs with blade retaining lug cracks. However, in a May 6, 2008, briefing to the FAA on 14 CFR 21.3 events,⁷ P&W stated the American Airlines 2nd stage turbine hub had 2 lug cracks and 26 other crack indications. P&W's briefing to the FAA further indicated that the lugs that were measured were nonconforming.

Because the Delta Air Lines hub had five adjacent fractured blade retaining lugs and the American Airlines hub had two adjacent fractured blade retaining lugs, the Safety Board is concerned that a string of consecutively fractured blade retaining lugs could result in the simultaneous release of multiple blades, which would exceed the design capability of the engine's cases and lead to an uncontainment. In the Delta Air Lines event, the uncontained debris penetrated the engine's cases and cowling at the bottom and did no other damage to the airplane. However, if the debris had come out of the engine from the left side rather than at the bottom, it would have been directed at the fuel tank in the wing, which could have resulted in a fuel leak and fire.

Require that Pratt & Whitney PW2037 engines be removed from service for inspection of the 2nd stage turbine hubs when they have accumulated significantly fewer hours and/or cycles than the incident engine (10,880 hours and/or 4,392 cycles). (A-08-85) Urgent

Require that Pratt & Whitney PW2037 2nd stage turbine hubs undergo recurring inspections when they have accumulated significantly fewer hours and/or cycles than the incident engine (10,880 hours and/or 4,392 cycles) until the cause for the previous instances of cracking is identified and corrective action to prevent future cracking is implemented. (A-08-86)
