Marine Accident Report

**Fire on Board the Small
Passenger Vessel
Seastreak New York
Sandy Hook, New Jersey
September 28, 2001**

**NTSB/MAR-02/04
PB2002-916404
Notation 7494
Adopted September 17, 2002**

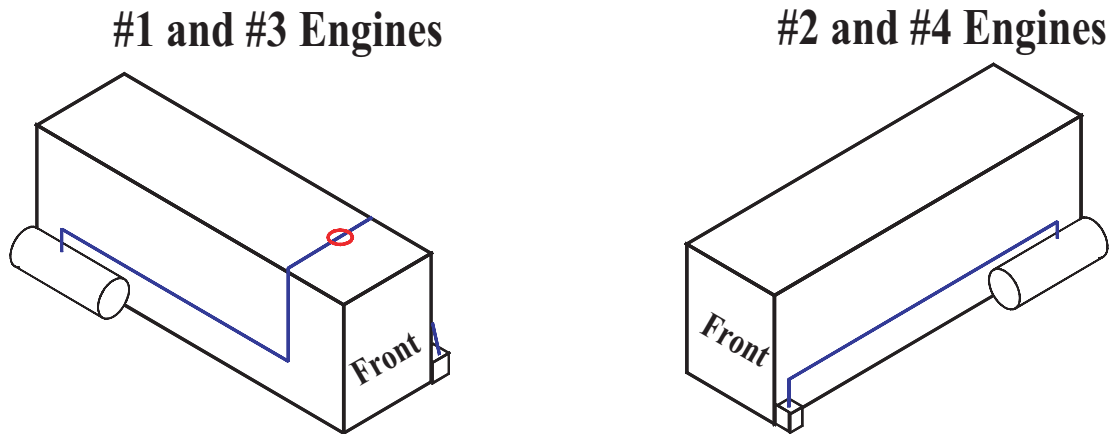
Because the oil filter assembly and the control valves on engines No. 1 and 3 were on opposite sides of the engine, the monitor hose connecting these components was routed forward and across the top of the engine. (See Figure 3.) Product literature provided by the Cummins Engine Company contained no guidance with regard to the routing of the monitor hose. Investigators observed that on the *Seastreak New York*, these hoses came forward on the right side of the engine and then were routed across the top of the forward section of the engine and down to the control valve. The hoses were routed near the forward edge of the exhaust manifold water-cooling shield. The hoses were secured to other hose bundles by tie wraps as they passed along the side of the engine, but they were not secured across the top of the engine.

Figure 3. Sketch of the main engines showing differing routing of the lube oil monitor hoses.

The Safety Board is convinced that the lube oil hose was routed similarly on engine No. 3. When investigators examined engine No. 3 after the fire, they found no evidence that the hose had been secured. They found that one end of the broken lube oil

In the absence of any securing of the lube oil hose in the space underneath the cooling water hoses, the vibrations of engine No. 3 could have provided the mechanism for the migration of the hose from its original position to the hazardous location below the exhaust manifold cooling shield and on or near the forward edge of the exhaust manifold, where the oil hose was subject to heat stress that eventually caused it to fail.

3. The lack of guidance for the proper installation of the lube oil hose resulted in the lube oil hose on engine No. 3 being improperly routed and secured, allowing it to migrate to the forward edge of the exhaust manifold, where it was subject to unintentional heat stress that eventually caused the hose to fail.

The Cummins Engine Company's documentation for the Centinel System does not contain any guidance for routing the lube oil hose from the oil filter assembly around heat sources to the control valve. However, hose installation instructions in the hose manufacturer's catalog state, "When hose lines pass near an exhaust manifold or other heat source, they should be insulated by a heat resistant boot, fire sleeve, or a metal baffle." In this case, the routing of the hose and the failure to secure it as it passed over the engine allowed the hose to come in contact with the exhaust manifold. Had the hose been properly secured as it passed over the engine, it would not have come into contact with the exhaust manifold, and the fire would have been prevented. The Safety Board concludes that the lack of guidance for the proper installation of the lube oil hose resulted in the lube oil hose on engine No. 3 being improperly routed and secured, allowing it to migrate to the forward edge of the exhaust manifold, where it was subject to unintentional heat stress that eventually caused the hose to fail. Consequently, the Safety Board believes that Cummins Engine Company should revise its manufacturing and installation literature for the Centinel System to specify how to safely route and secure the lube oil hose between the oil filter assembly and the control valves on the engines.

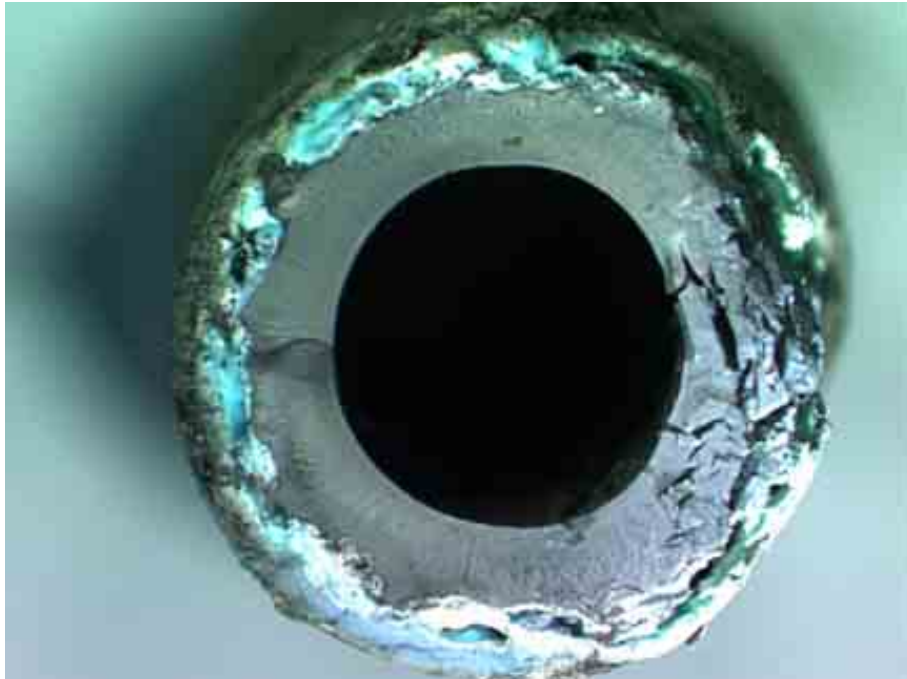
Engine No. 3 Hose Section. The damaged portion of the No. 3 engine hose sleeve was cut circumferentially, allowing the damaged portion to be removed for examination. Portions of the damaged section of the hose were discolored, and the end of the damaged sleeve was flat. Squeezing of the hose revealed that the discolored length had hardened when compared to the nondiscolored area.

The tube retained its black color, but the fracture surface was smooth, with radially oriented lines. Separations were observed within the tube wall consistent with heat differentials between inner and outer surfaces during operation. The surface of the cover was discolored and felt hard to the touch. The underlying material had retained some of its blue coloration, and the visible edges displayed a rounded appearance consistent with re-solidification from a liquid phase. No residual material was observed that would indicate the presence of the braid. The fracture face indicated separations within the tube wall consistent with heat differentials between inner and outer surfaces during operation.

Figure 4. The fracture face of engine No. 3's lube oil monitor hose.

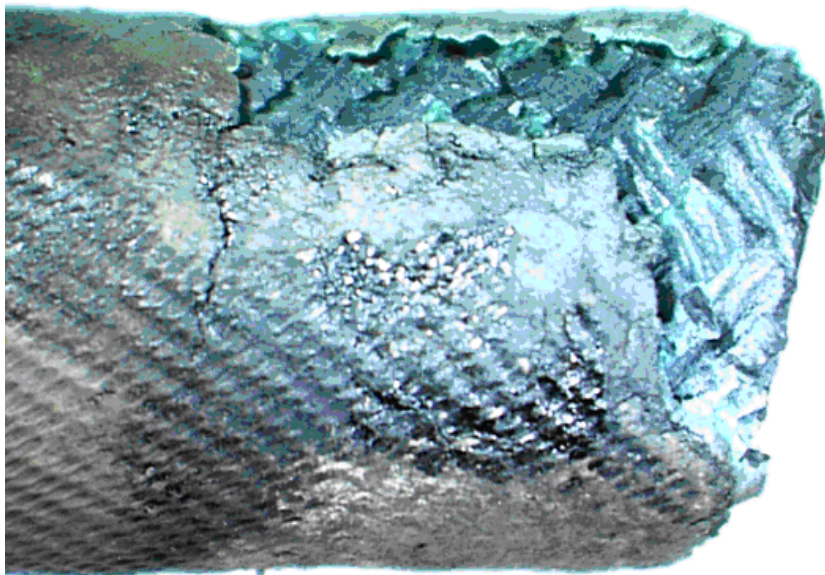
Figure 5. A side view of the fracture face of engine No. 3's lube oil monitor hose.

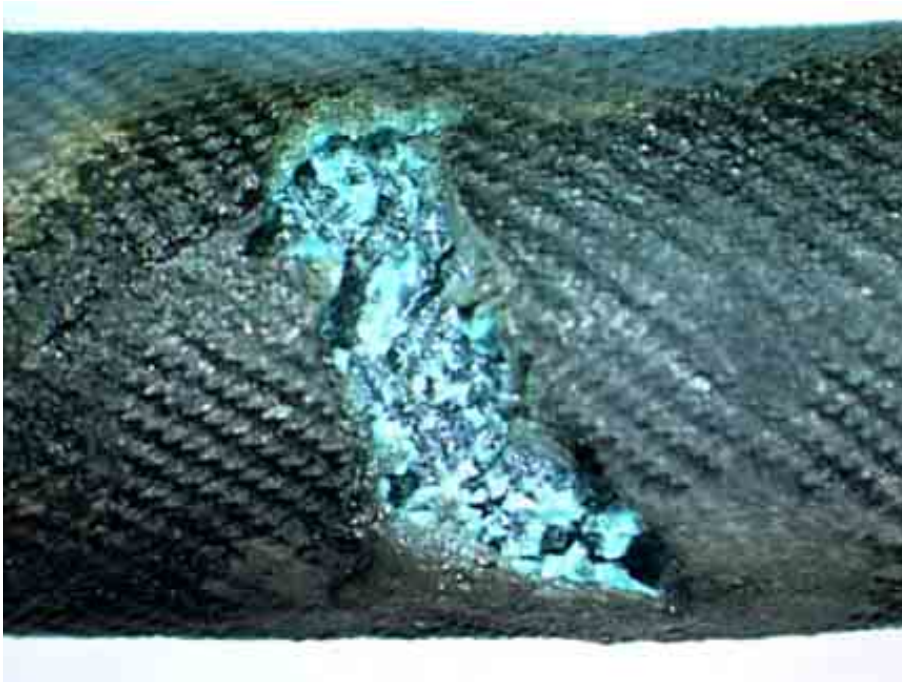
The oil monitor hose identified as being from engine No. 1 was damaged in an area approximately 10 inches long and centered approximately 52 inches from the straight connection end. The oil monitor hose from engine No. 3 was in two pieces—one 98 inches long and the other 49 inches. The loose nylon sleeve on the hoses was intended to protect them from abrasion. An Aeroquip representative indicated that the sleeve had a maximum working temperature rating of 248° F. A plastics encyclopedia indicated that nylon could melt at a temperature of 410° F.⁴

Figure 6. The damaged area on engine No. 3's lube oil monitor hose approximately 2.5 inches from the fracture face.
