NATIONAL TRANSPORTATION SAFETY BOARD

HAZARDOUS MATERIALS ACCIDENT REPORT

FIRE AND EXPLOSION OF
HIGHWAY CARGO TANKS, STOCK ISLAND
KEY WEST, FLORIDA
JUNE 29, 1998

NTSB/HZM-99/01
PB99-917005
Notation 7141A
Adopted September 10, 1999

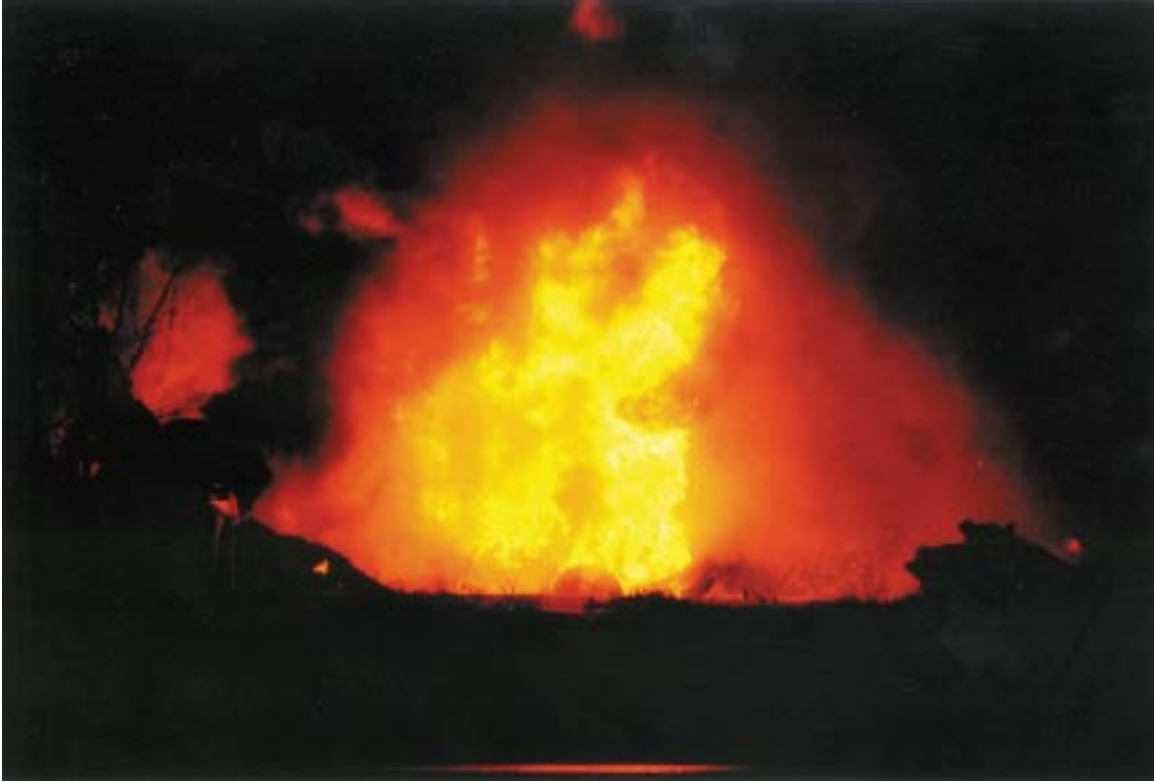
Figure 1. Fire involving the cargo tanks (Photo by Scott Wallace.)

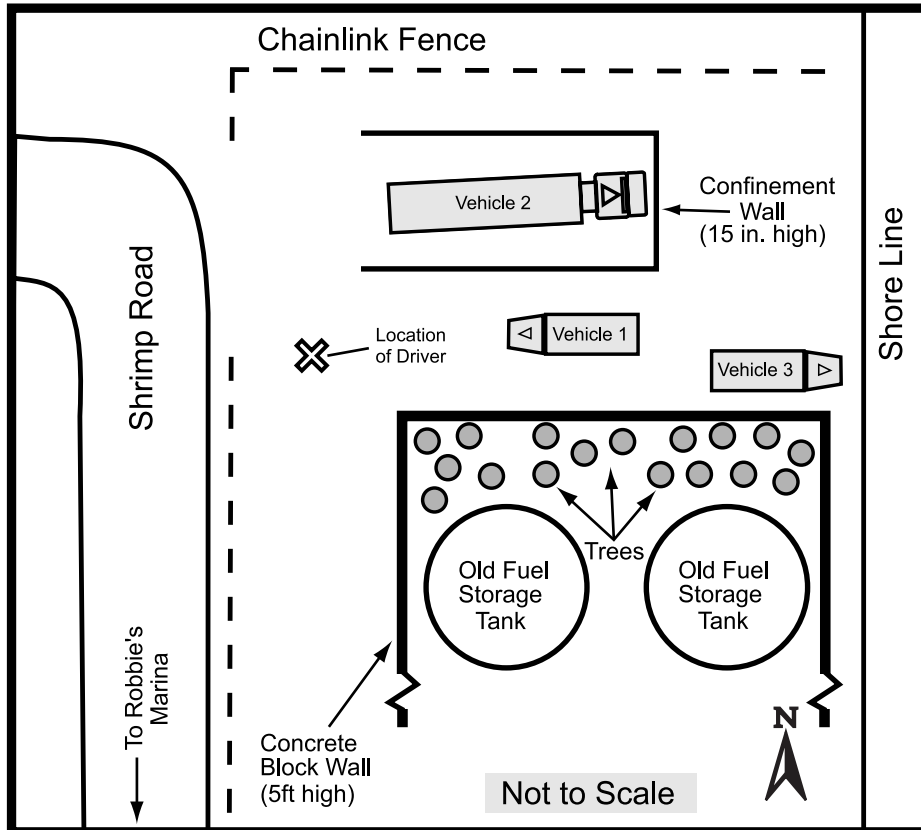
Three vehicles, all owned by Dion, were involved in the accident. Figure 2 shows where the vehicles were when the accident happened.

Figure 2. Accident Site (Vehicle 1 is the straight-truck cargo tank used by the driver. Vehicle 2 is the tractor semi-trailer cargo tank used as a storage tank. Vehicle 3 is the second straight truck.)

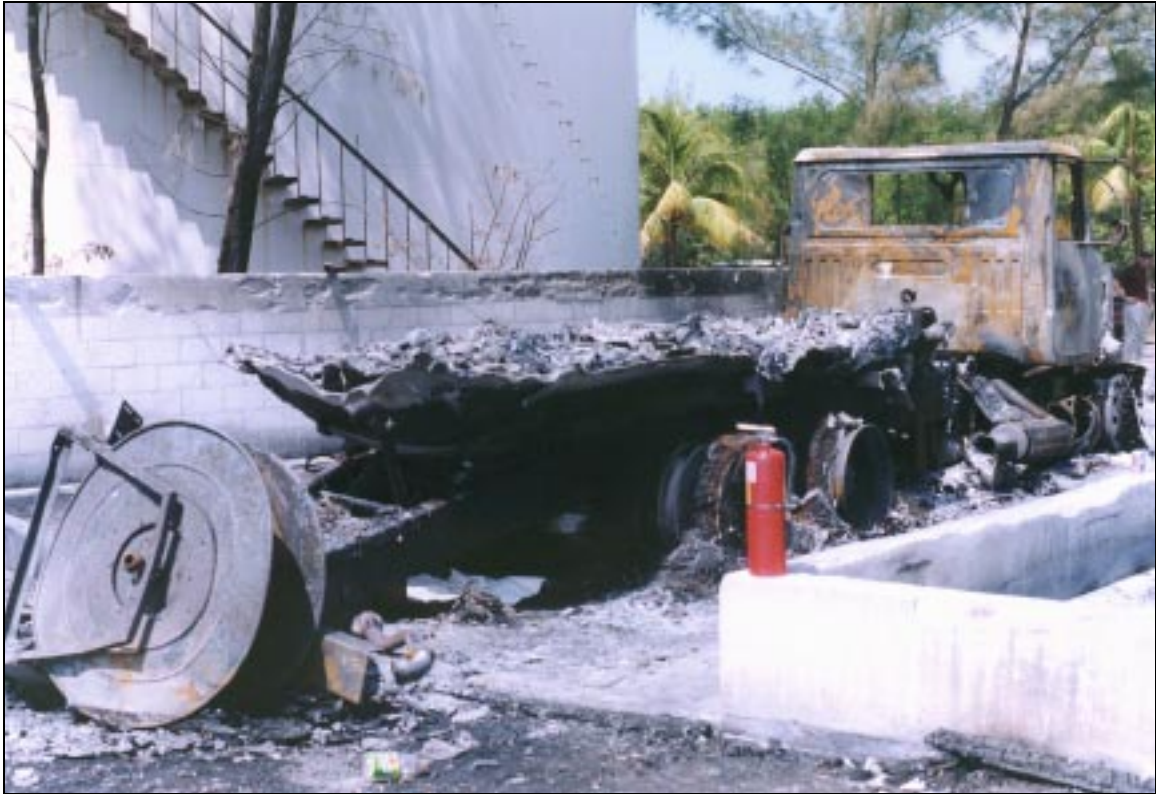
Figure 3. Damage to Vehicle 1

Vehicle 1 sustained extensive fire damage. The upper-shell casing, the baffles, and all four heads were melted down to the chassis level in many areas. The remaining aluminum portions of the tank shell were white, dull, and brittle. Only the aluminum walls between the three compartments and a few inches of the aluminum baffle in the first compartment remained. About a third of the rear tank head remained. (See figure 3.) The remaining aluminum walls at the rear of the tank showed some evidence of tearing and bulging.

Parts of the lids and the integral relief valves (internal steel springs) for the front and middle compartments were within their respective compartments. The lid of the back compartment had been thrown about 25 feet from the vehicle. A postaccident metallurgical examination at the Safety Board's laboratory revealed that the lid had been damaged by the impact but not by heat or fire. The examination also revealed that the weld material on the flange of the lid had failed from overstress and showed no evidence of a preexisting defect.

The damage to the three vehicles and to the concrete pads indicates that Vehicle 1 was the area where the fire started. Vehicle 1 was almost totally destroyed, while the other two vehicles had less severe damage. Also, the spalling of the concrete was most extensive on the pad under Vehicle 1, indicating that it had been exposed to high temperatures for a longer period. Further, the damage to the other two vehicles was greater on the ends that were closer to Vehicle 1. Therefore, the Safety Board concludes that the damage and fires on the other two vehicles resulted from exposure to heat from the fire on Vehicle 1.

The kind of damage that Vehicle 1 sustained indicates that the fire started in the front or middle compartment. The walls of these compartments were melted down to the chassis level, whereas about a third of the rear wall of the tank was still intact. Also, an examination of the lid of the rear compartment, which was found about 25 feet from the truck, indicated that the lid was blown off the tank before the material in the compartment was involved in the fire. The metallurgical examination revealed that the weld material on the lid flange failed from overstress; nothing suggested a preexisting defect. The fact that the lid showed no evidence of fire indicates that it broke away from the compartment before the material within started to burn. Therefore, it is likely that the fire in the front and middle compartments heated the material in the back compartment, causing a rapid overpressurization and explosion in the back compartment, which broke the lid from the tank.

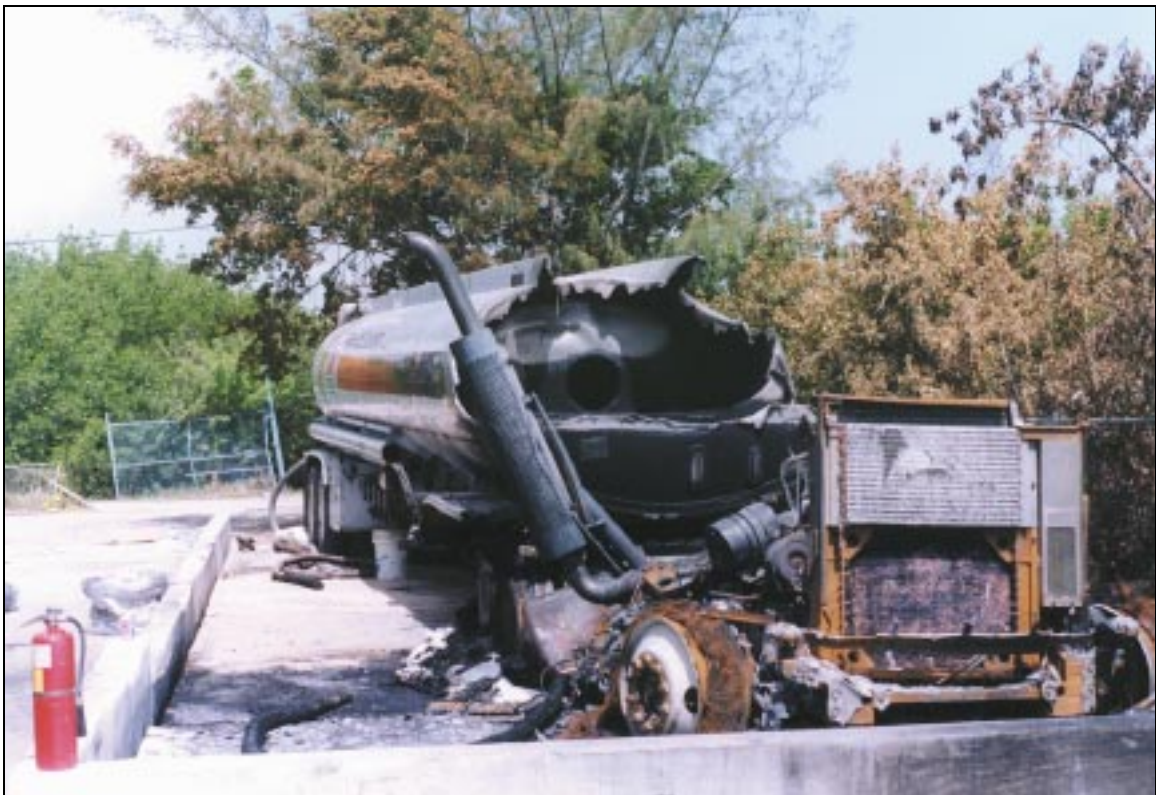
Figure 4. Damage to Vehicle 2

Vehicle 2 sustained extensive damage in the front compartment of the tank and in the tractor. (See figure 4.) The head, wall, and first baffle of the front compartment were melted to about half of their original height. The second baffle was intact but had some bulging in the lower half. The remaining section of the compartment had a heavy layer of soot. The remainder of the cargo tank sustained minimal visible damage; the labels on the side of the tank facing Vehicle 1 showed some signs of soot and burning.

2. The damage and fires on the other two vehicles resulted from exposure to heat from the fire on Vehicle 1.
3. Dion Oil Company did not have written procedures to ensure safe cargo handling, including procedures prohibiting the pouring of flammable liquids into its open cargo-tank compartments and procedures requiring the bonding of cargo tanks when flammable liquids are being switch loaded between them.

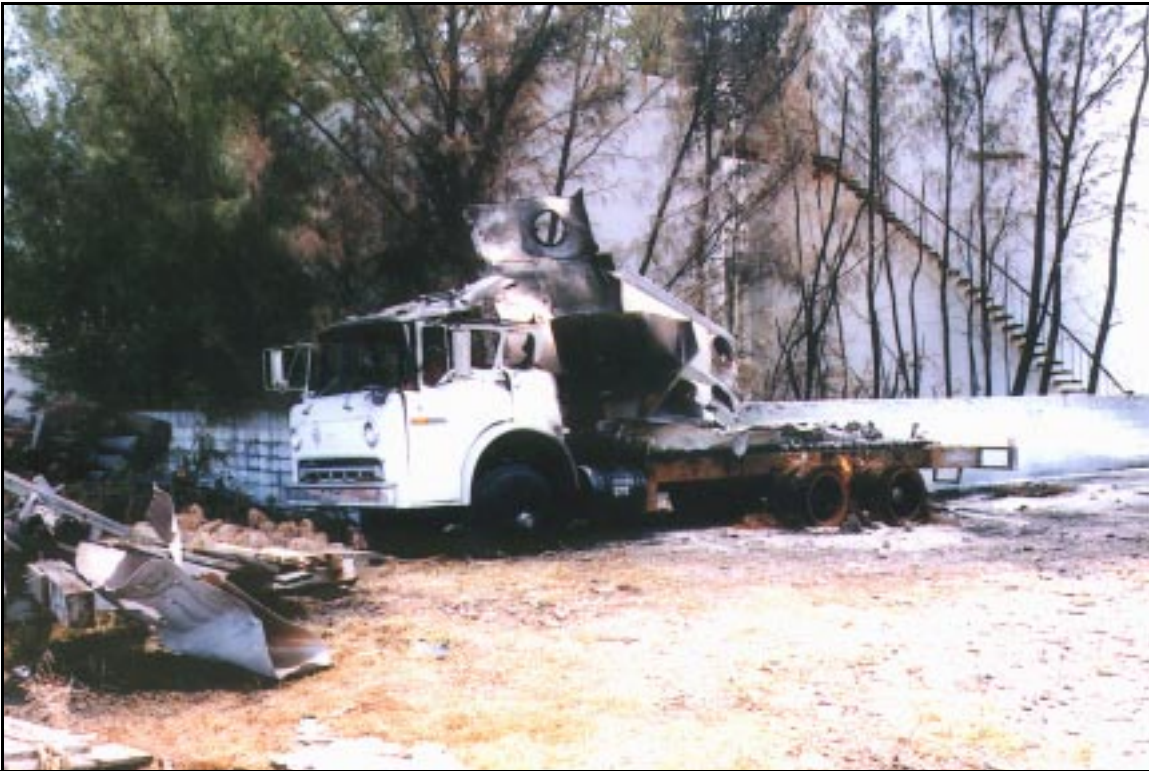
Figure 5. Damage to Vehicle 3

Vehicle 3 had melted extensively at the rear, which was facing Vehicle 1, and showed bulging and tearing in the forward part of the cargo tank. The left side of the front half of the cargo tank had been sheared from the bottom seam and pushed back onto its right side. (See figure 5.) The front baffle remained. Sections of the tank shell had multiple punctures. One of the manhole assemblies from the cargo tank was about 750 feet away, on the opposite side of the empty above-ground storage tanks, which are shown in figure 2. The assembly showed signs of having been damaged by the impact and was broken into several pieces. The left side of the truck cab and the rear supports of the cab frame had been torn, and the cab was bowed forward.

The discovery of a manhole cover from Vehicle 3 about 750 feet away and the sheared metal on the front half of the tank shell indicate that a subsequent explosion occurred when the front compartment on this vehicle failed, which happened because the residue of the materials it contained was overpressured by the radiant heating from the fire on the nearby vehicles.
