UNITED STATES
NUCLEAR REGULATORY COMMISSION
OFFICE OF NUCLEAR REACTOR REGULATION
WASHINGTON, DC 20555-0001

September 20, 2002

NRC INFORMATION NOTICE 2002-27: RECENT FIRES AT COMMERCIAL NUCLEAR
POWER PLANTS IN THE UNITED STATES

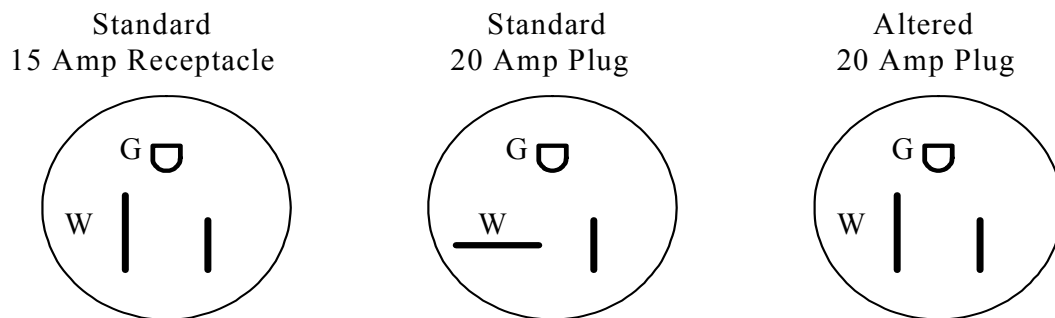
Licensee personnel performed unauthorized modifications to the male connections of two drum heaters, allowing them to be inserted into underrated outlets and extension cords, which ultimately caused the fire. The licensee concluded that the root cause of the fire was the modification of the male connection on a 2,000-watt drum heater. The plug on a second 2,000-watt drum heater was also found to be modified. This unauthorized modification defeated a manufactured safety device (electrical connector standards), thereby allowing the heaters to be energized using undersized extension cords and electrical outlets. On one of the plugs, a prong was twisted 90 degrees to make it similar to a 15-ampere plug. On the other heater, the plug was completely removed and replaced with a 15-ampere plug (see illustrations below).

The fire was a result of modified plugs on two drum heaters, which defeated the intent of the design of electrical outlets. The licensee failed to comply with the procedural requirements for a temporary modification. The heavy smoke from the fire caused a deluge sprinkler system to actuate in a different fire area which sprayed on safety-related electrical equipment. 10 CFR 50.48(a) requires licensees to have a fire protection plan that meets General Design Criterion (GDC) 3 of Appendix A to 10 CFR Part 50. GDC 3 requires that structures, systems, and components that are important to safety shall be designed and located to minimize the probability and effect of fires and explosions, consistent with other safety requirements.
