PIPELINE ACCIDENT REPORT

NATURAL GAS EXPLOSION AND FIRE IN
SOUTH RIDING, VIRGINIA
JULY 7, 1998

NTSB/PAR-01/01

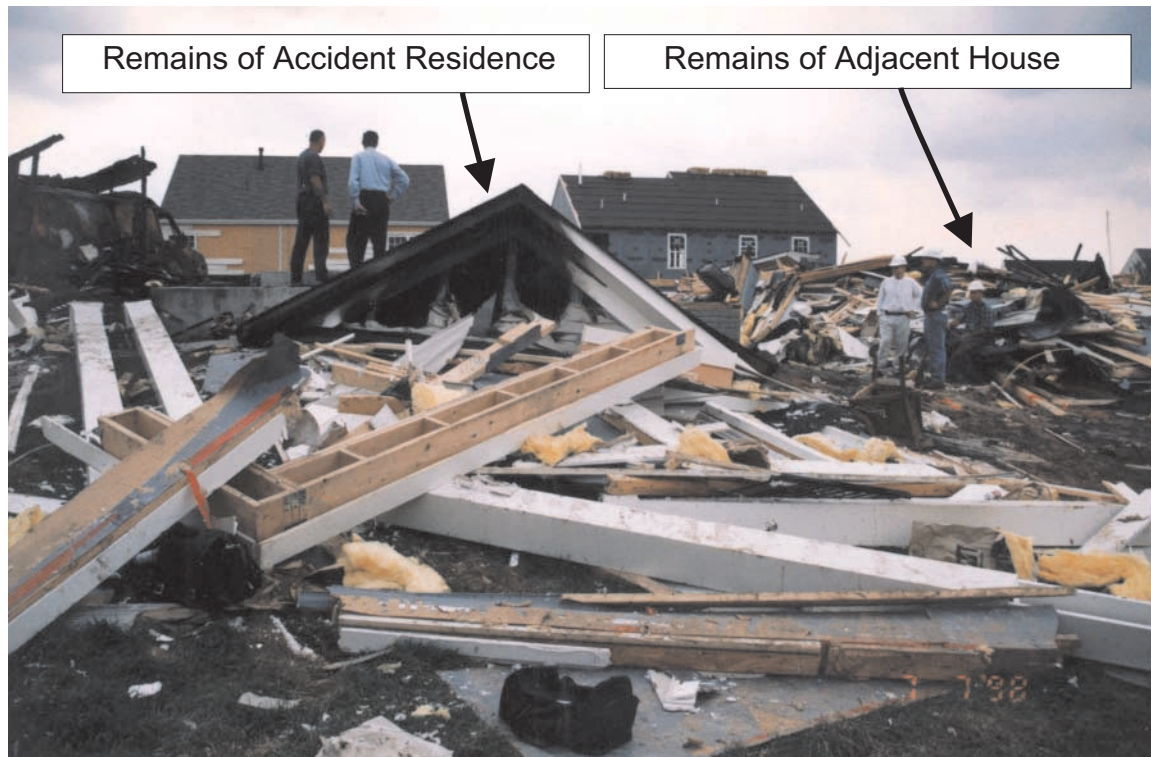
Figure 2. Postaccident debris.

The children were thrown out of the house and onto the lawn, suffering minor injuries. The husband and wife fell into the basement as the first floor collapsed. The husband was able to crawl to safety, but the wife did not escape. The husband was burned severely; the wife died as a result of her injuries. The adjacent, unoccupied house was damaged by the accident and had to be demolished. Four other houses and two vehicles were also damaged.

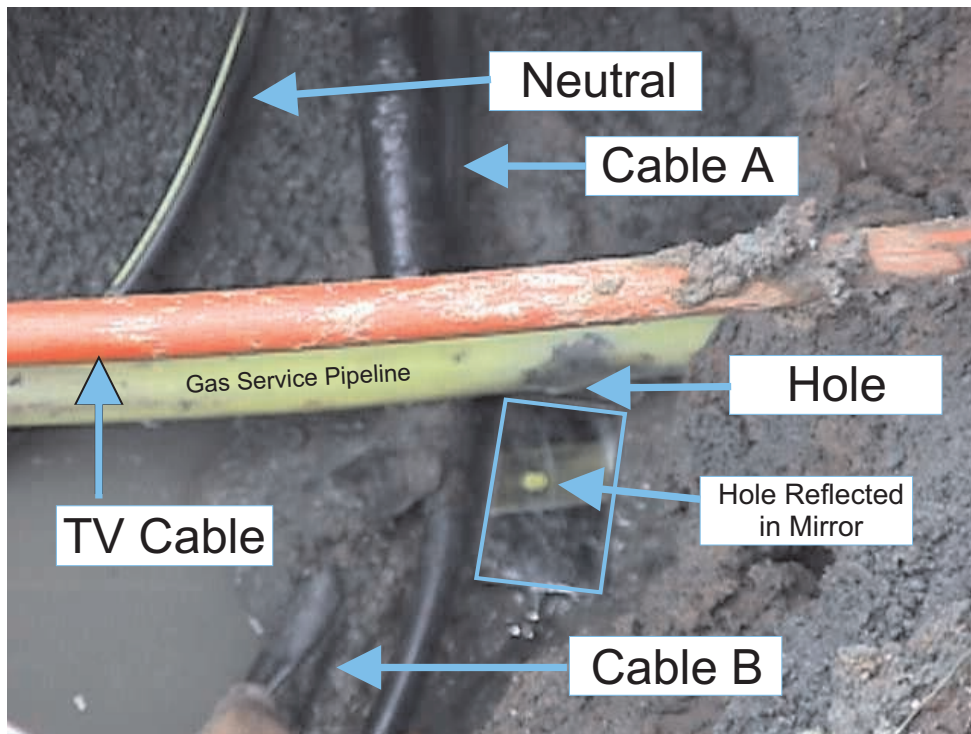
Excavation of the pipeline revealed a TV cable that had been installed at a depth of about 13 inches from the surface sometime after the electrical service line and gas pipeline had been installed. The pipeline was found at a depth of about 45 inches, and just underneath the pipeline was a portion of the electrical service to the house.

Examination of the gas service line revealed a roughly circular 0.38- to 0.44-inch-diameter hole in the pipeline about 7 feet from the north corner of the house. An insulated copper tracer wire ran alongside the gas service line,⁸ and the electrical triplex crossed beneath it. One of the three cables of the triplex was found to be in contact with the gas service line. Because the electrical line was disturbed during the postaccident excavation, the exact preaccident location of the cables in relation to the gas service line and to the hole in the gas service line could not be determined. When excavated, one of the two conductors (current-carrying cables) (designated “cable A” for identification) was found touching the gas service line about 3.75 inches away from the hole along the horizontal axis of the pipe. At this location, the other conductor (designated “cable B”)⁹ was underneath and touching cable A. The neutral cable was several inches away from the other two. (See figure 3.)

Figure 3. Cables and pipeline before removal. Although the TV cable appears to lie near the pipeline in this view, it was found at a depth of about 13 inches and was thus about 32 inches above the pipeline.

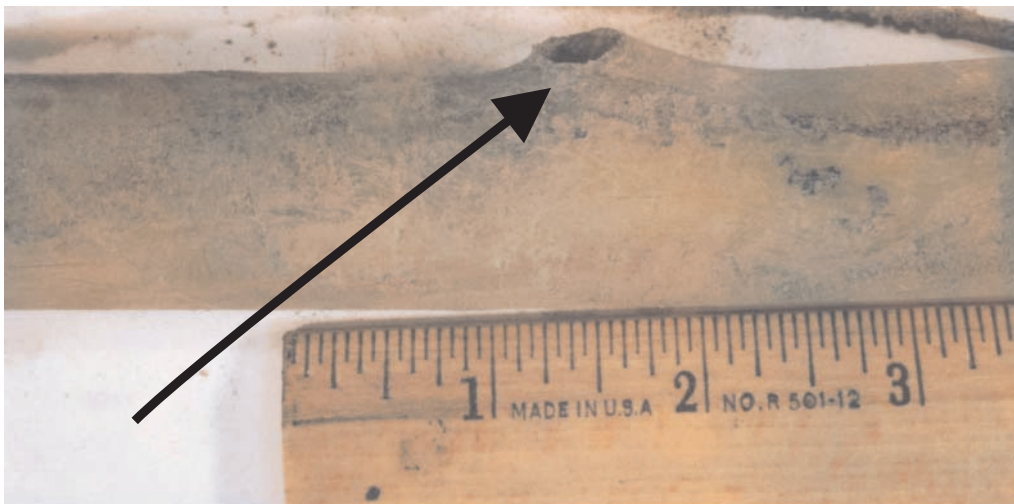
Examination at the Safety Board laboratory revealed that the polyethylene pipe material surrounding the hole in the gas service line was blackened and appeared thinner and cratered, consistent with heat damage.¹⁰ Also, the thinned material formed a conical peak around the hole, consistent with the effect of pressure on a heated and softened pipeline wall. (See figure 4.)

¹⁰ The Vicat softening temperature for the material used in gas pipelines is 247° F (119° C). (The *Vicat softening temperature* is intended to provide a standard for comparing the softening effects of temperature on various thermoplastic resins. It is defined in American Society for Testing Materials standard D1525 as the temperature at which a flat-ended needle of 1-mm² circular cross section will penetrate a thermoplastic specimen to a depth of 1 mm under a specified load using a selected rate of temperature rise.) According to the manufacturer of the material used to construct the gas pipeline in this accident, the material becomes sufficiently molten to fuse with itself at 375 to 400° F (190 to 204° C).

Figure 4. Hole discovered after accident in the 3/4-inch polyethylene natural gas pipeline leading to the residence.

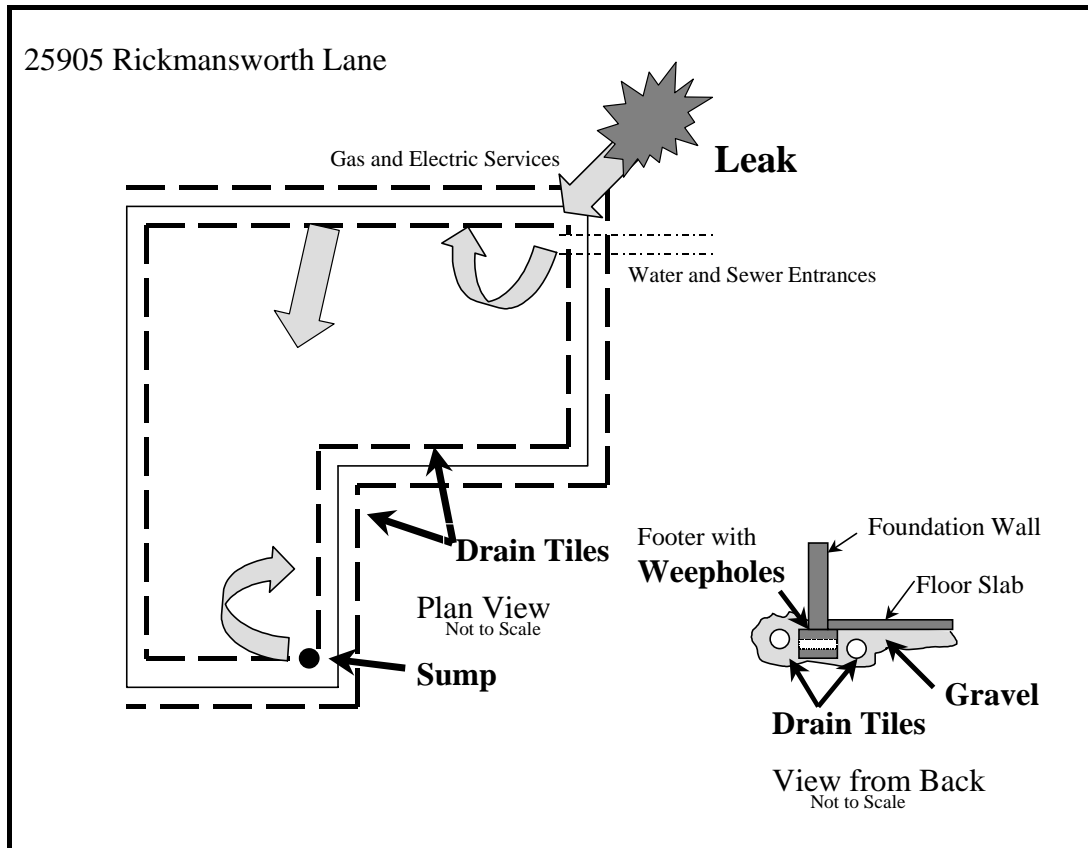
The basement of the house offered several avenues by which gas could have entered and accumulated. (See figure 6.) For example, the sump pit penetrated the concrete floor and provided a possible path. Additionally, the water service line passed under the foundation of the house from a point just outside the northeast wall, near the north corner of the house in proximity to the hole in the gas service line. This line entered the basement through a sleeve penetrating the concrete floor. Also, since the concrete for new foundations is poured during discrete construction steps, cracks may have been present in the foundation where different pours adjoined. The Safety Board concludes that the gas present in the soil around and under the house entered the basement of the residence either through penetrations in the concrete slab or cracks in the foundation, or both.

Figure 6. Paths of possible migration of gas into the basement of the residence.
