**Pipeline Accident Report**

**Rupture of Piney Point Oil Pipeline  
and Release of Fuel Oil  
Near Chalk Point, Maryland  
April 7, 2000**

**National  
Transportation  
Safety Board**  
Washington, D.C.

**NTSB/PAR-02/01  
PB2002-916501  
Notation 7285A  
Adopted July 23, 2002**

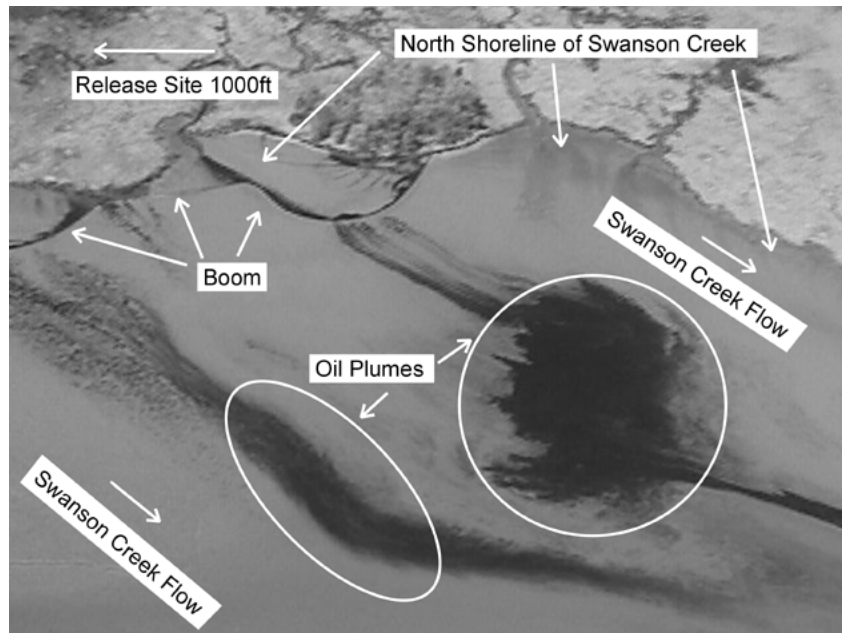
**Figure 7.** Aerial photo of Swanson Creek area taken on April 10, 2000 showing two plumes of oil moving with the creek flow towards the Patuxent River after containment was lost.

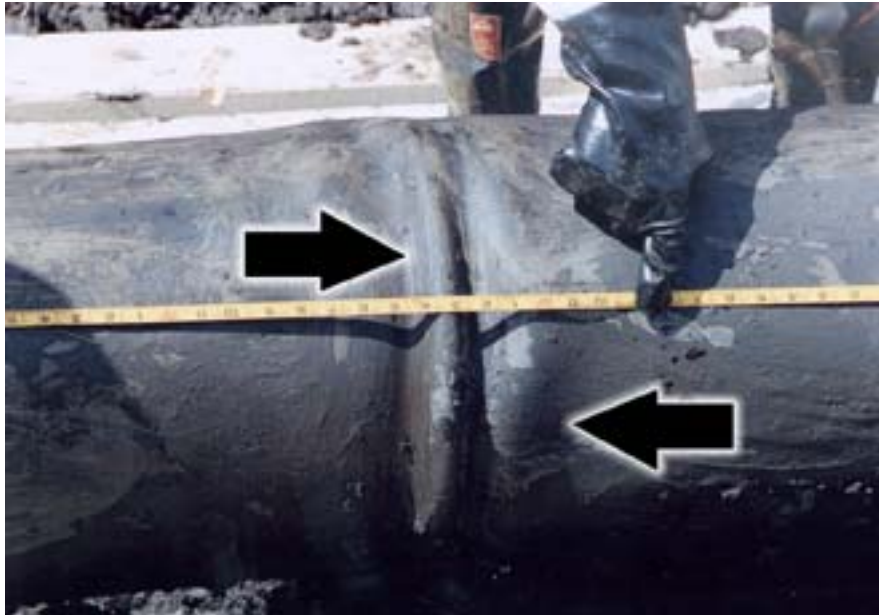
The pipeline was buried about 3 1/2 feet deep at the rupture location. The rupture area was excavated a few days after the failure. When the pipeline was exposed, the profile of a buckle could be seen through the pipe coating. (See figure 9.) When the pipe coating was removed, a crack in the circumferential direction was visible.

**Figure 9.** Indication of the buckle (Arrows show buckle location).

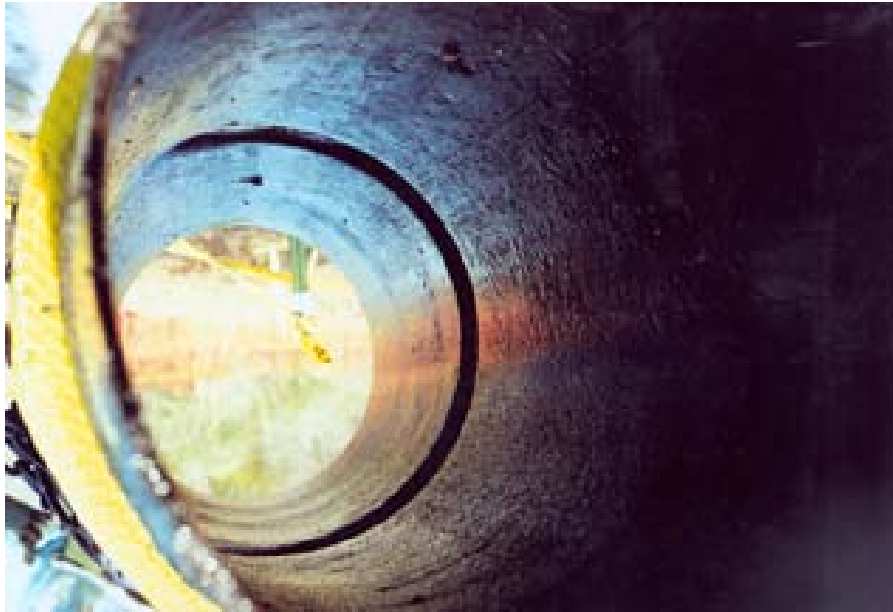
A 53-inch-long section of pipeline taken from the scene was examined at the Safety Board laboratory. The pipe was bent and contained an outward-protruding buckle on the inside radius of the bend. The angle of the bend in which the buckle was formed was determined to be in the 5- to 6-degree range. The buckle extended around 270 degrees of the pipe circumference, from approximately the 10 o'clock to the 7 o'clock position. (See figure 10.) The pipe was deformed into a slightly elliptical shape. The buckle area contained an open crack at the crown of the buckle, which extended from approximately the 2 o'clock to the 4 o'clock position. The maximum height of the buckle was approximately 1 inch at the 3 o'clock position on the inside of the bend. The crack was 6 1/2-inches long by 3/8-inch wide at its widest portion. (See figure 11.) No external corrosion was noted on the pipe section when it was examined under a microscope.

The interior surface of the pipe in the area of the buckle peak contained a number of shallow secondary cracks. All the cracks were circumferentially oriented, confined to the permanently deformed area of the pipe (approximately 1/4 inch from the buckle apex), had blunt tips, and were filled with corrosion products. Some of these cracks exhibited slight branching. The appearance of these cracks was typical of corrosion fatigue cracking in low carbon steels, resulting from exposure to high stress amplitudes.

**Figure 10.** Inside view of the buckle in the removed section of pipe.

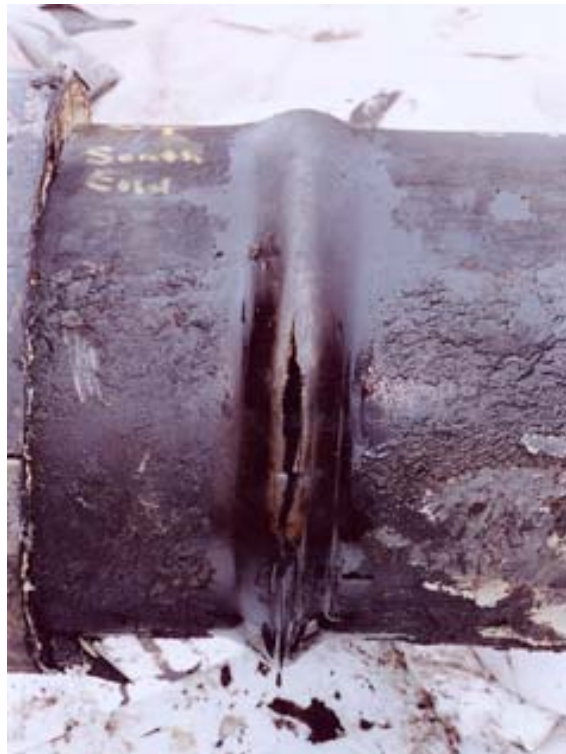
**Figure 11.** 6 1/2-inch-long, 3/8-inch-wide crack, with coating system shown at the left edge of photo.

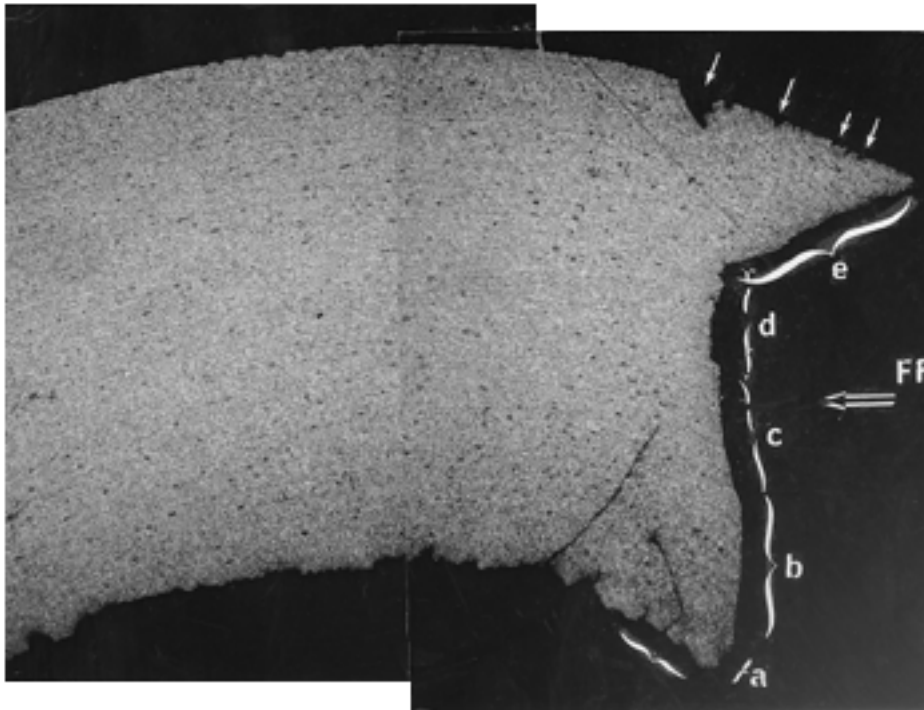
A scanning electron microscope examination revealed five well-defined fracture zones. Figure 12 illustrates the fracture surface profile of the failure. Bracket “a” starts at the interior surface of the pipe, showing a fracture from corrosion fatigue. Brackets “b,” “c,” and “d” show the crack propagation planes changing from 45 degrees from the surface of the pipe to roughly perpendicular, showing both tensile overstress and fatigue propagation, and contain no evidence of corrosion. Bracket “e” shows the crack propagation changing to a 45-degree shear plane. The final separation zone adjacent to the exterior surface of the pipe reveals dimpled features typical of ductile overstress fractures.

**Figure 12.** Fracture surface profile of failure.
