NTSB National Transportation Safety Board

*Office of Railroad, Pipeline &
Hazardous Materials Investigations*

Track, Signal and Engineering

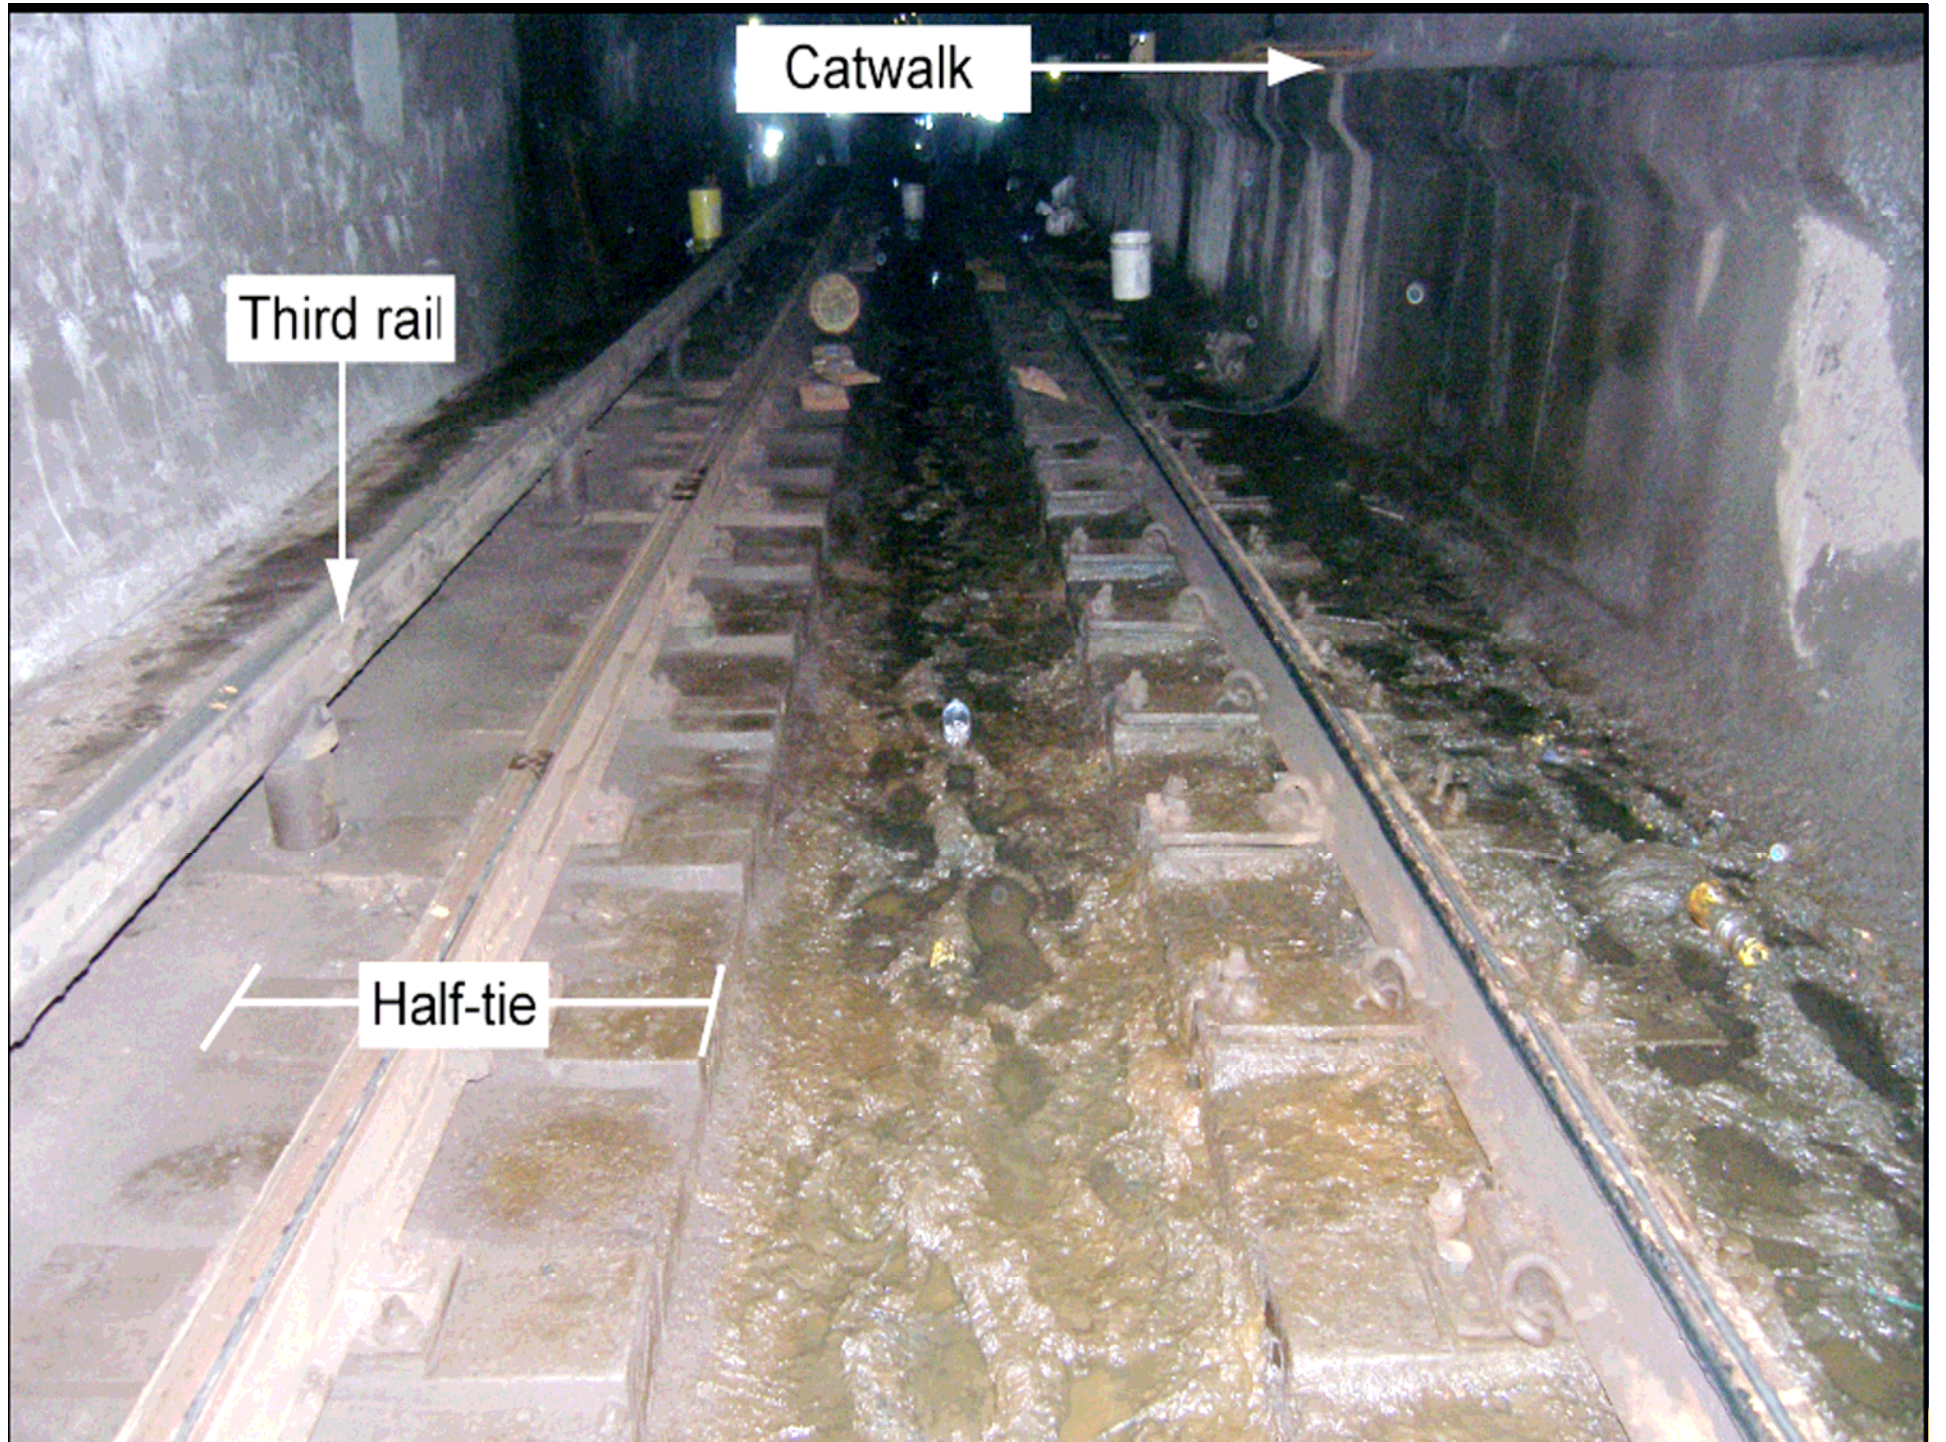
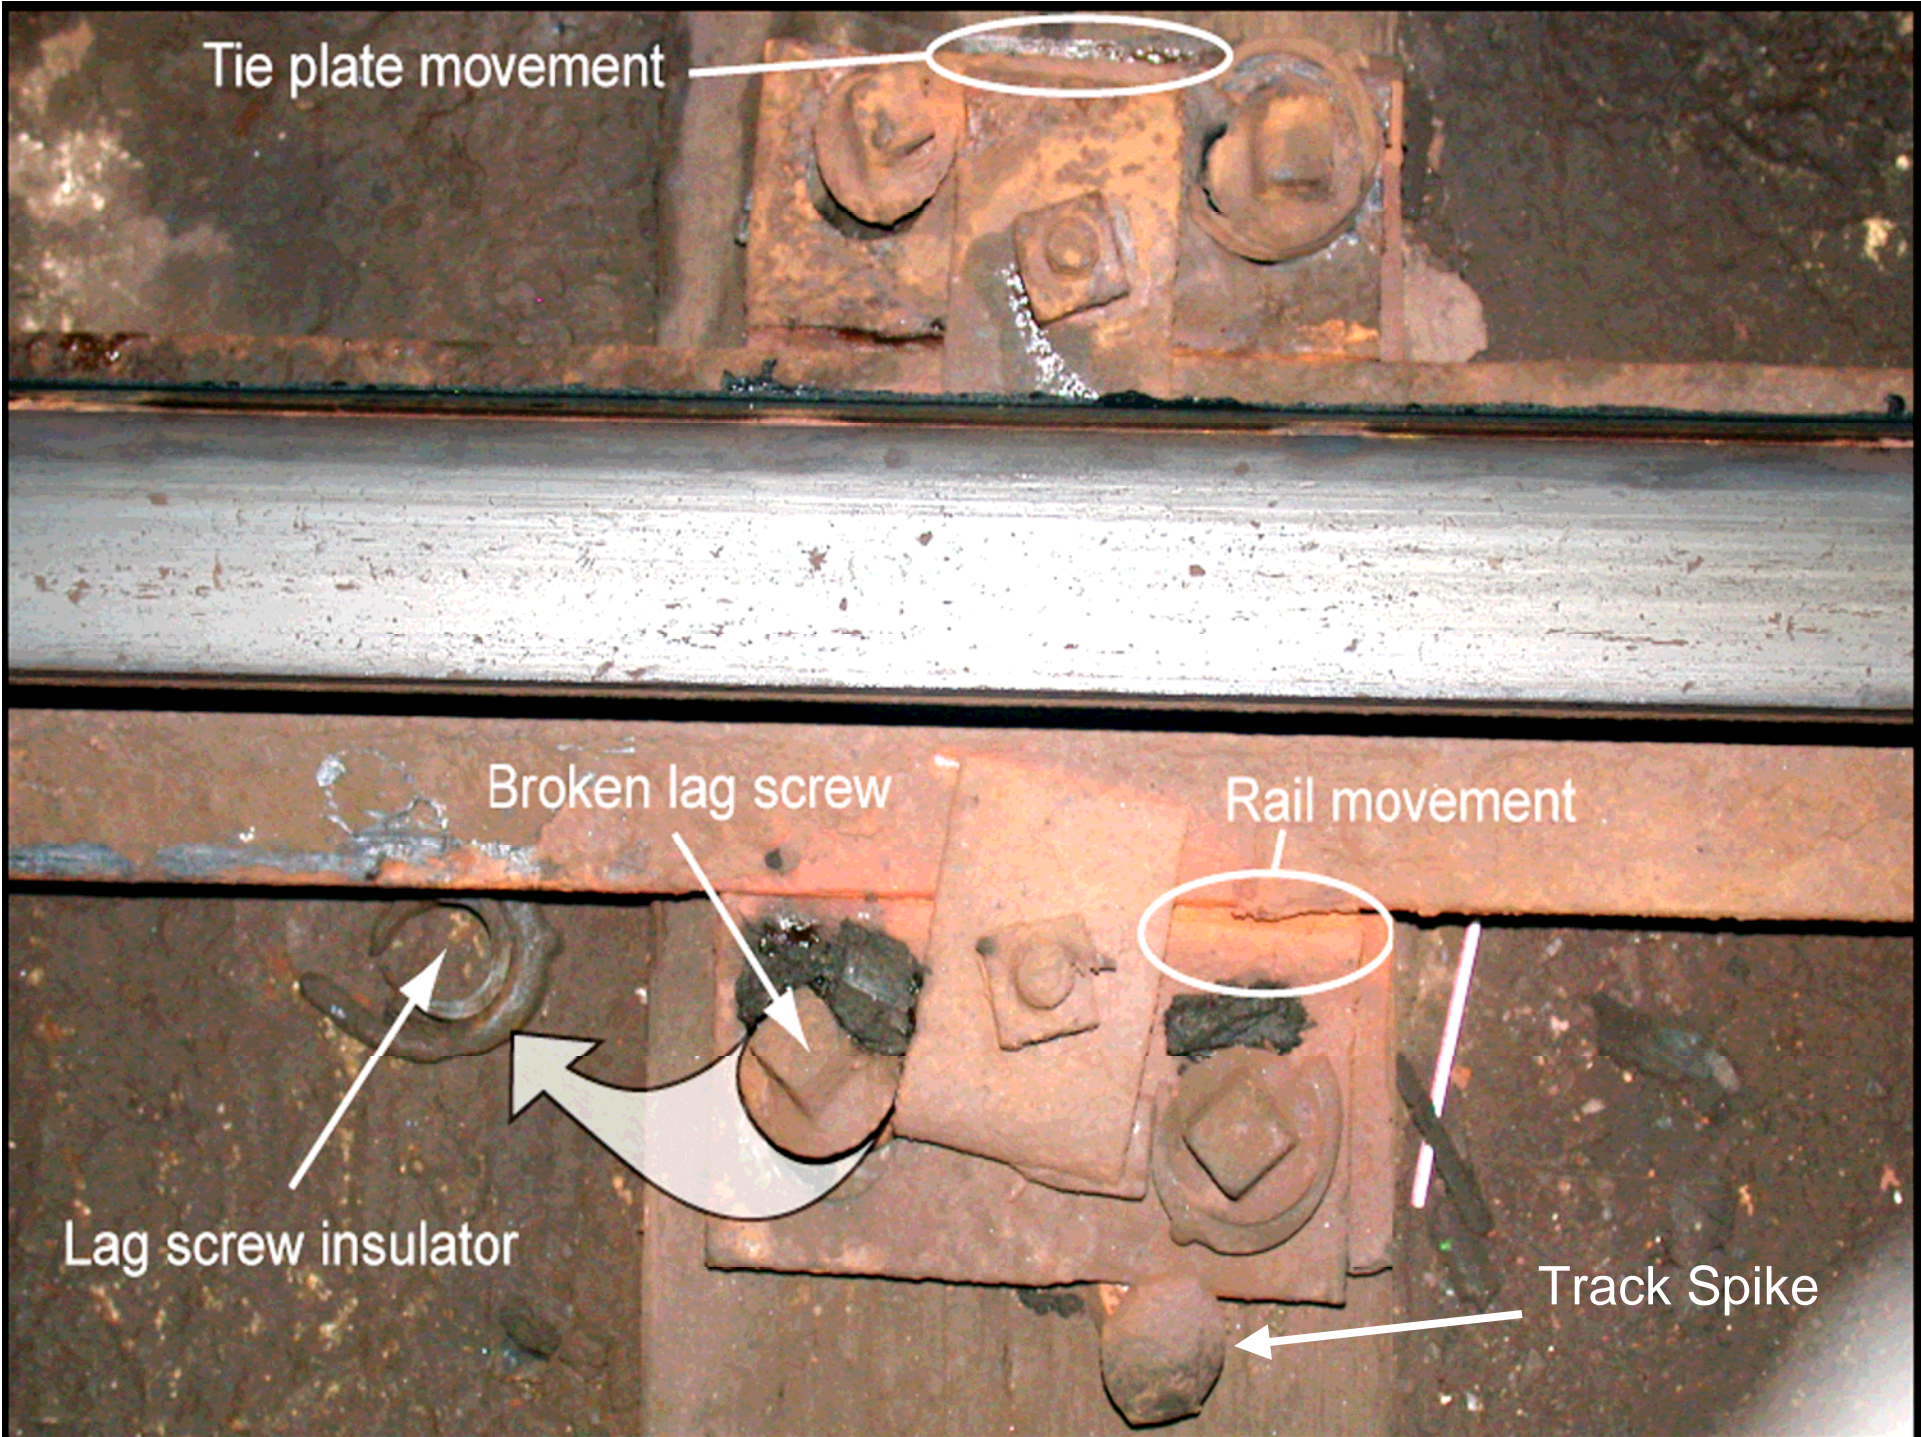
Tie plate movement

Broken lag screw

Rail movement

Lag screw insulator

Track Spike

The dark area on the inner rail of the curve, the abrasion on the tie plates and ties, the broken lag screws, and the tie plates' elongated fastener holes in the area of the derailment were all readily observable and should have been documented during walking inspections.

- Replaced corroded track fasteners and tie plates in the area of the derailment
- Track geometry/strength test completed on all tracks
- Reorganized Engineering and Maintenance Departments
 - Separated maintenance from inspection
 - Thirty-six new positions added to inspection and maintenance

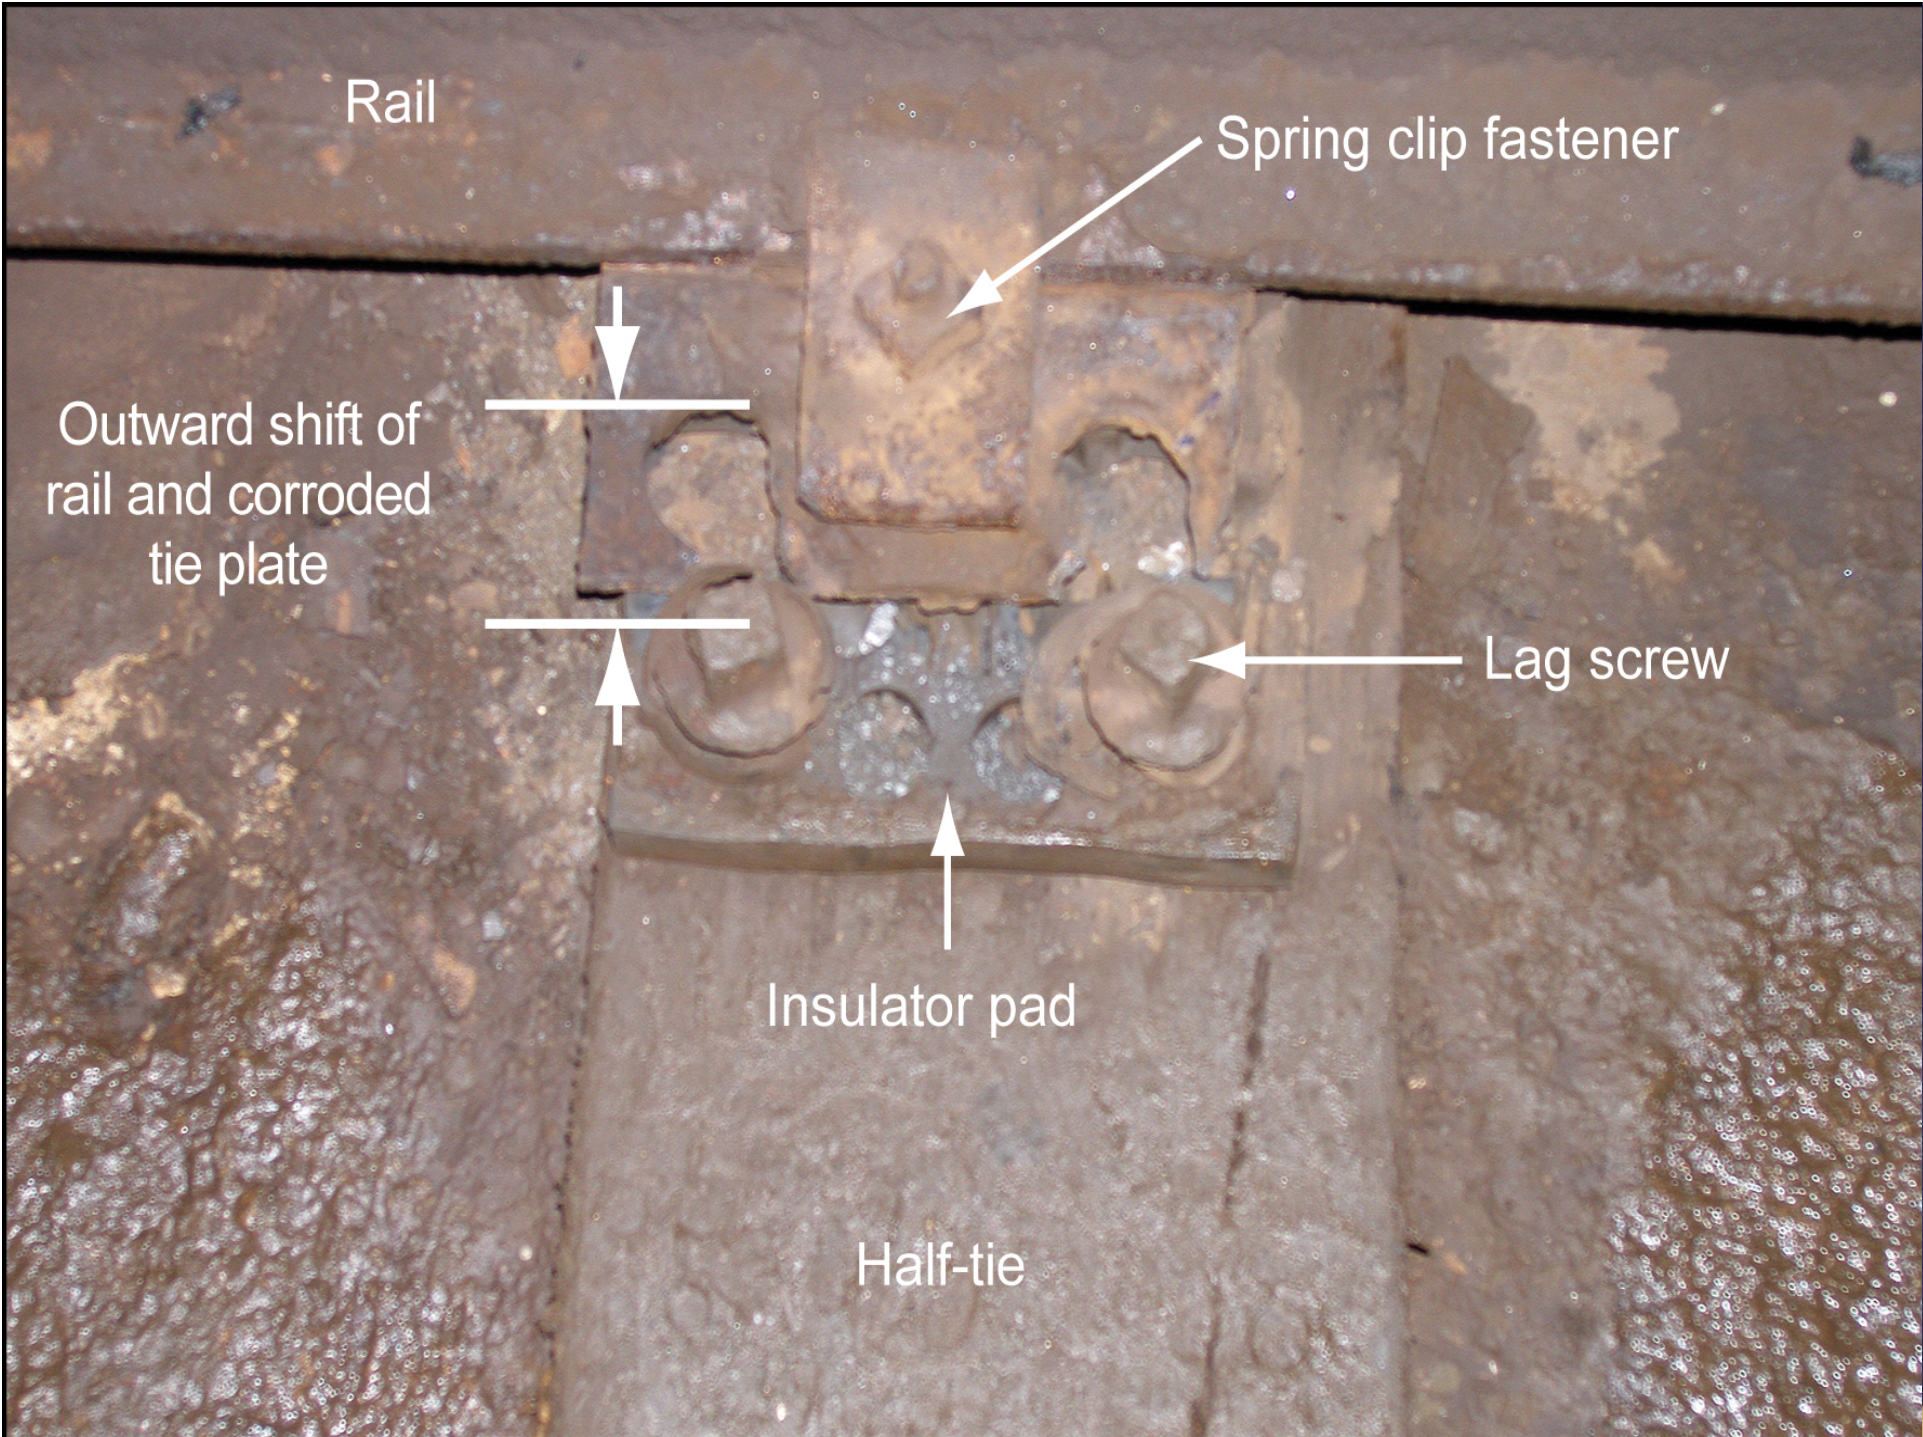
Rail

Spring clip fastener

Outward shift of rail and corroded tie plate

Lag screw

Insulator pad

Half-tie

The tie plates and fastener system failed to maintain the track gage because of the effects of corrosion and/or wear on the rails and rail fastener system, and degraded half-ties.
