NATIONAL TRANSPORTATION SAFETY BOARD
Office of Research and Engineering
Washington, D.C. 20594

Crash Site Factual Report

NTSB Number: DCA03MA022
Location: Charlotte, North Carolina
Date: January 8, 2003
Time: 0848 EST
Aircraft: Raytheon (Beechcraft) 1900D, N233YV
Operator: Air Midwest Inc. (d.b.a. US Airways Express)

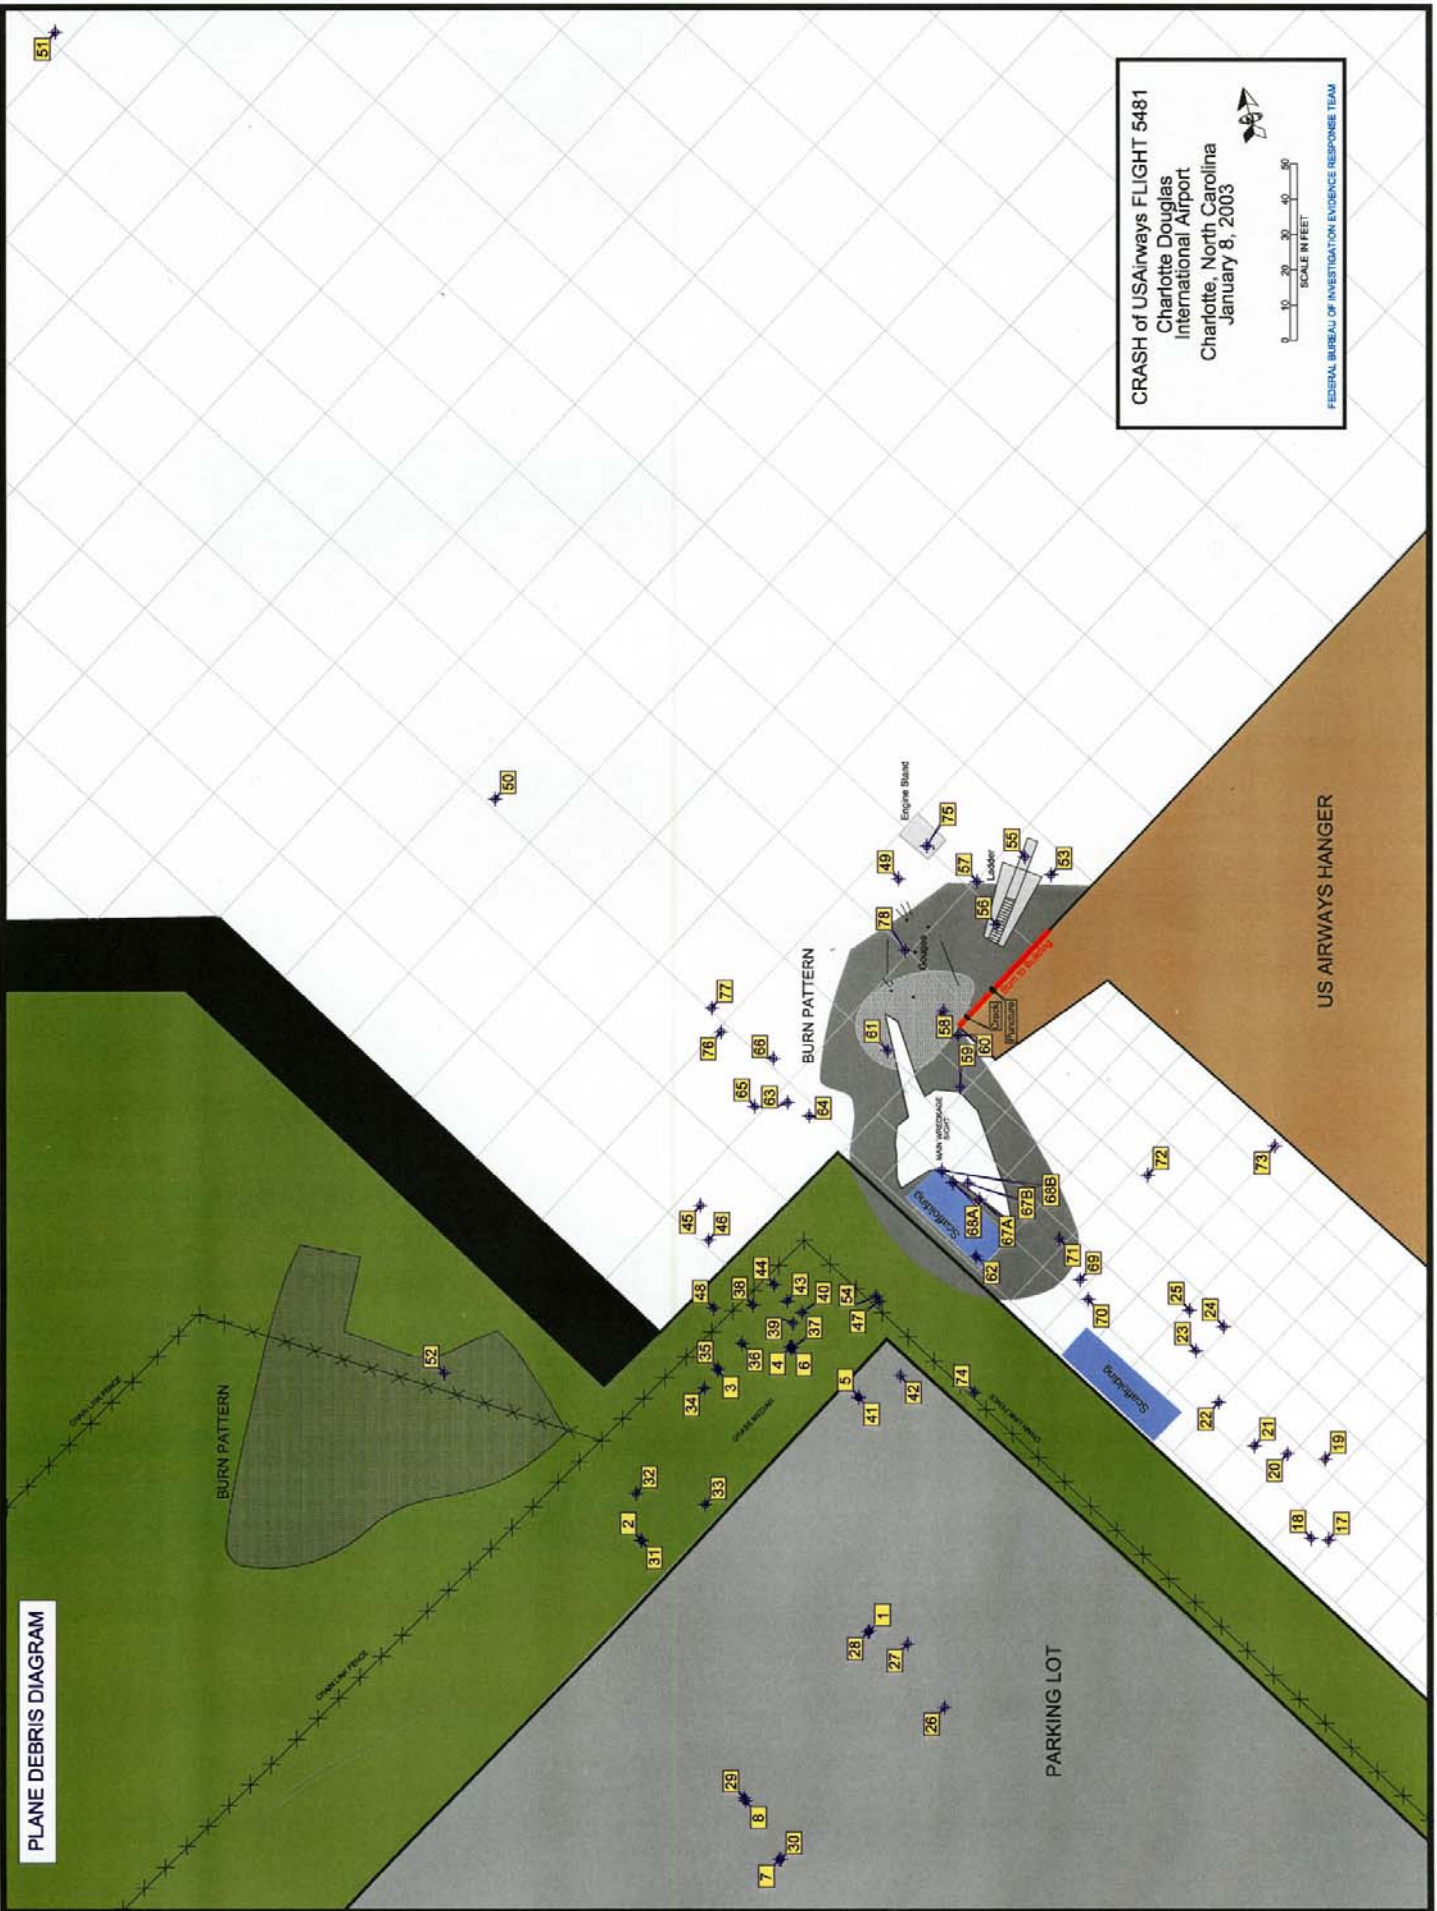
PLANE DEBRIS DIAGRAM

Debris from the Raytheon (Beechcraft) 1900D, N233YV aircraft was found scattered at the northwest corner of the US Airways maintenance hangar main door pocket wall, on the Charlotte-Douglas International Airport (CLT) property. The aircraft main wreckage was located on the concrete tarmac approximately 30 feet southwest of the hangar corner, centered at N35° 12' 23.8" and W80° 56' 47.1" [per Federal Bureau of Investigation (FBI) GPS measurement]. With respect to runway 18R, the accident site was located approximately 7600 feet south of the threshold and approximately 1650 feet east of the centerline.

The impact and fire damaged remains of the aircraft nose, fuselage, left and right wings, two engines, empennage, and landing gear were identified at the main wreckage site. The remains of the empennage were separated from the aft fuselage. The horizontal stabilizer was inverted, resting on its top surface with the taillets attached.

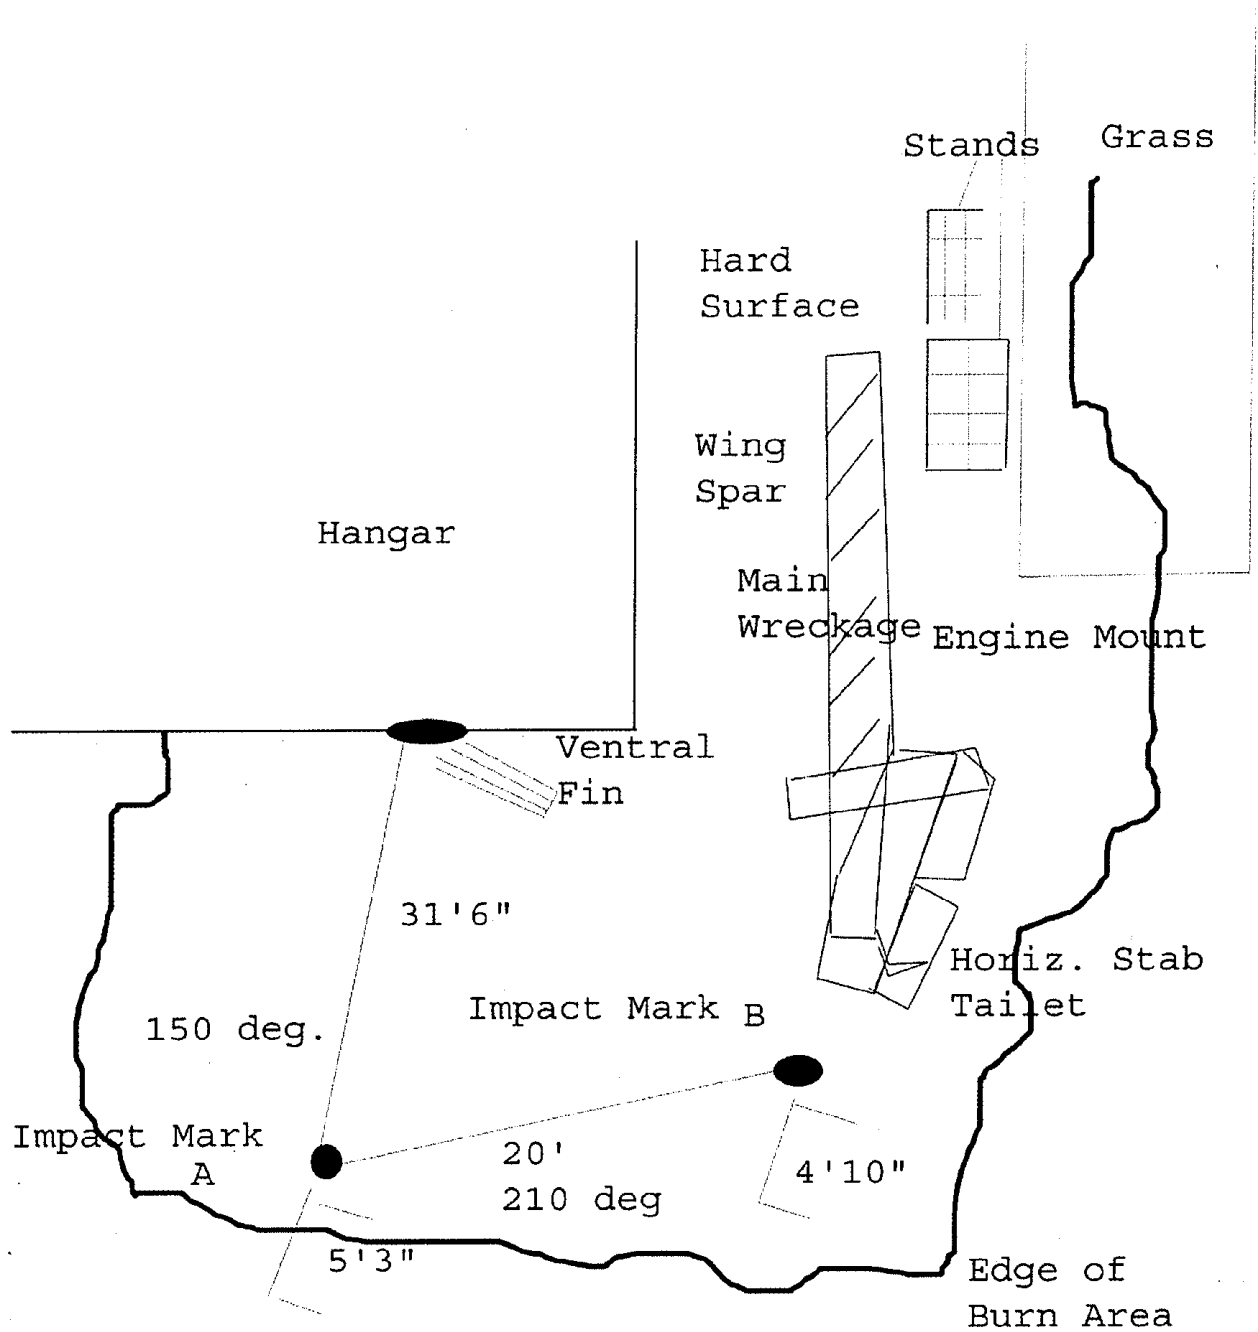
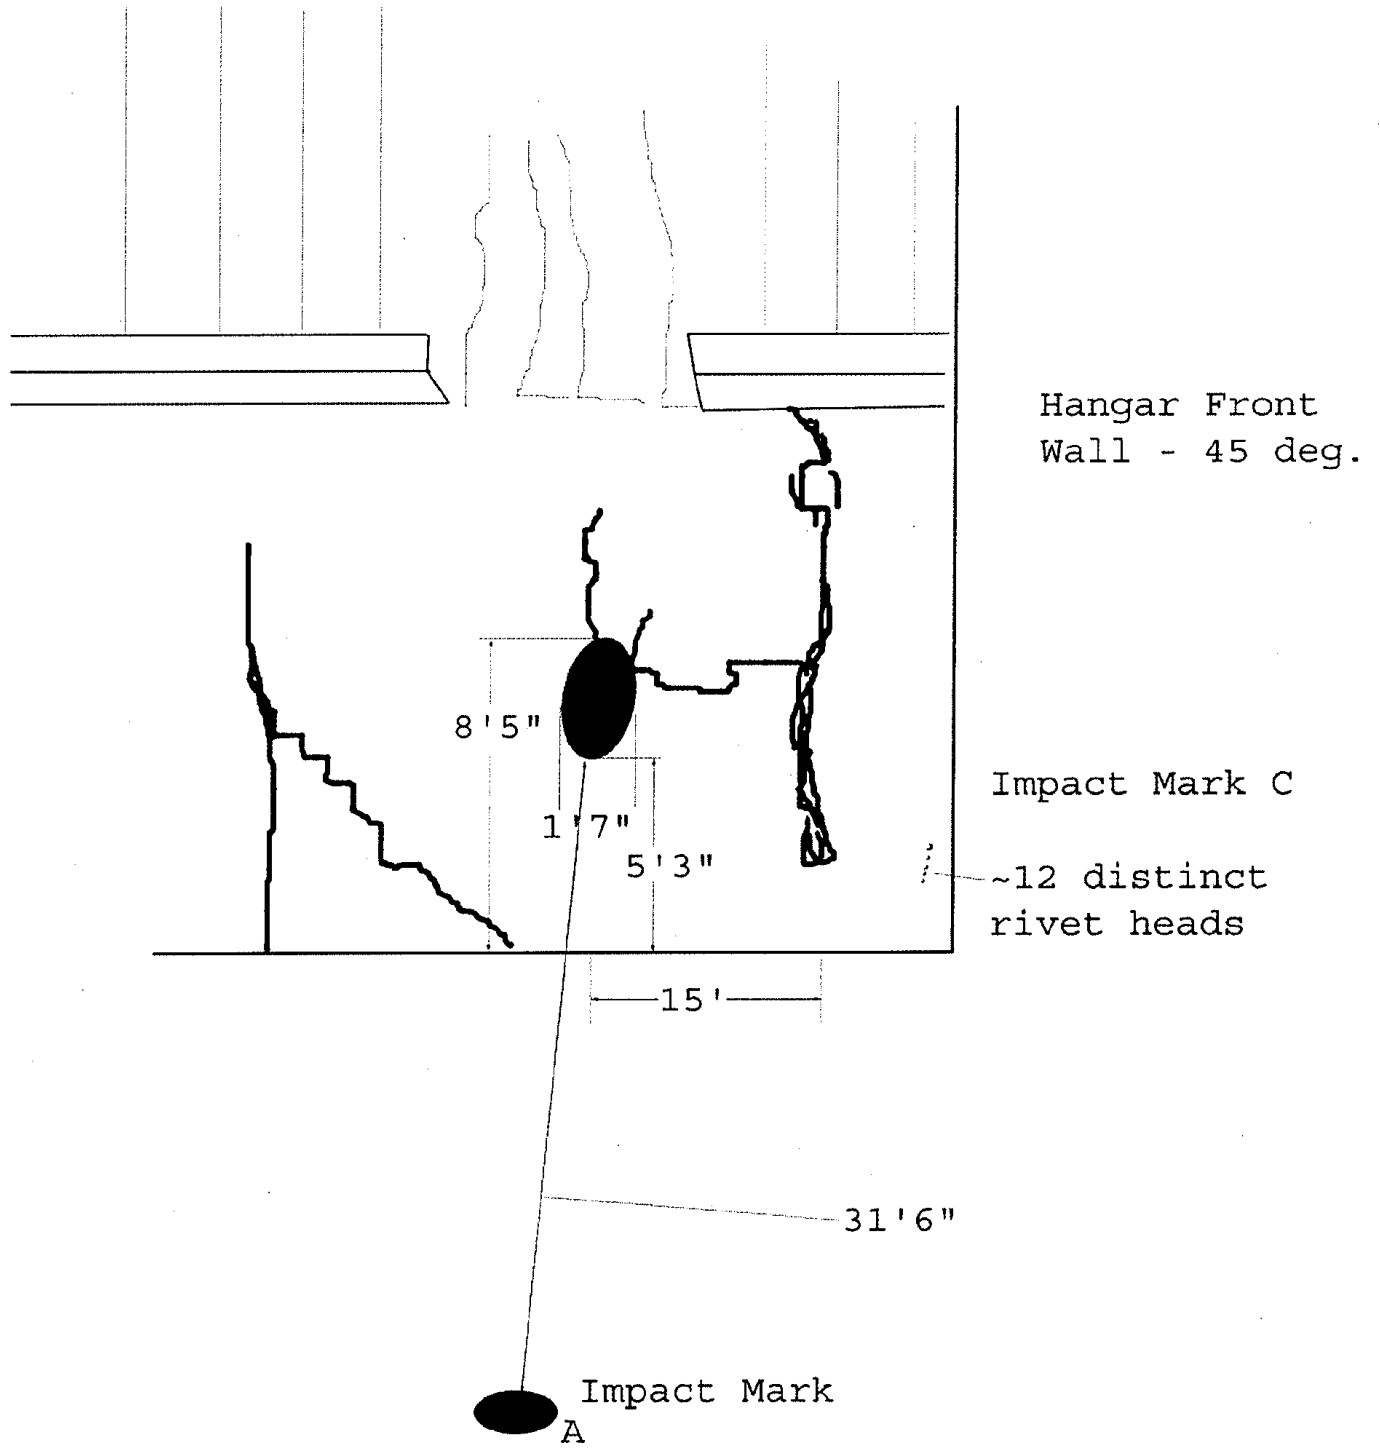
Impact and scrape mark sketches.

Impact and scrape mark damage (see Attachment IV) was present on the concrete tarmac and on the lower corner of the hangar cinder block wall. The initial concrete tarmac impact mark (A) was located approximately 7600 feet south of the runway 18R threshold and approximately 1650 feet east of the runway 18R centerline.

The northern base of the cinder block hangar wall was displaced toward the building interior, punctured in one location, and fractured in several places. The punctured hole in the hangar wall extended from 5'3" above the concrete tarmac to 8'5" above the tarmac. The hole was 1'7" wide at approximately 6'3" above the tarmac. Approximately 20 feet above the cinder block wall puncture, sooting and bubbling of the building exterior metal flashing was observed. Impact mark (C) was located between the fourth and sixth cinder block rows on the north face of the wall corner.

The distance between impact mark (A) on the concrete tarmac and the puncture in the hangar wall was 31'6". A second concrete tarmac impact mark (B) was located 20 feet away from impact mark (A) on a heading of 210 degrees magnetic. Three ground scar marks radiated from impact mark (A), the longest of which was 5'3". Two ground scar marks radiated from impact mark (B), the longest of which was 4'10".
