NATIONAL TRANSPORTATION SAFETY BOARD

SYSTEMS GROUP CHAIRMAN FACTUAL REPORT ADDENDUM, AIRCRAFT CONTROL CABLE TEMPERATURES

A. ACCIDENT: DCA03MA022

AIRCRAFT: Raytheon Model 1900D, N233YV, operated by Air
Midwest Airlines, d.b.a. USAirways Express flight 5481

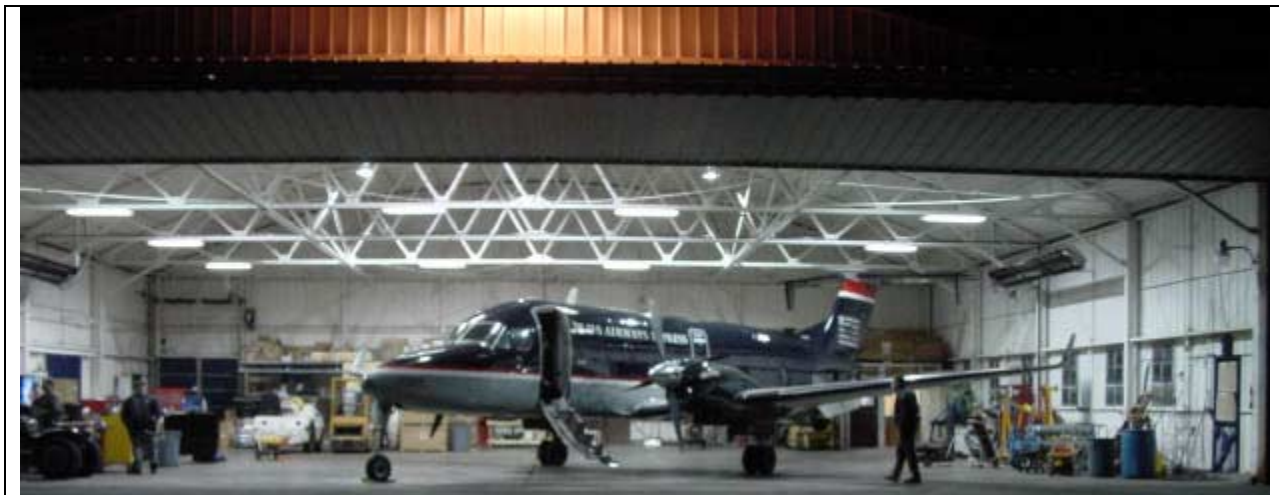
Photograph 1. The photograph shows the hangar before the door was lowered, the airplane parking position, the location of OAT sensor (beneath Captain's side window), and the two heaters between roof trusses of the hangar. The portable heaters had not yet been placed, although one is visible (yellow) to the left of the nose tire and a (black) second portable heater is behind the knee of the person walking. This is not the accident airplane.

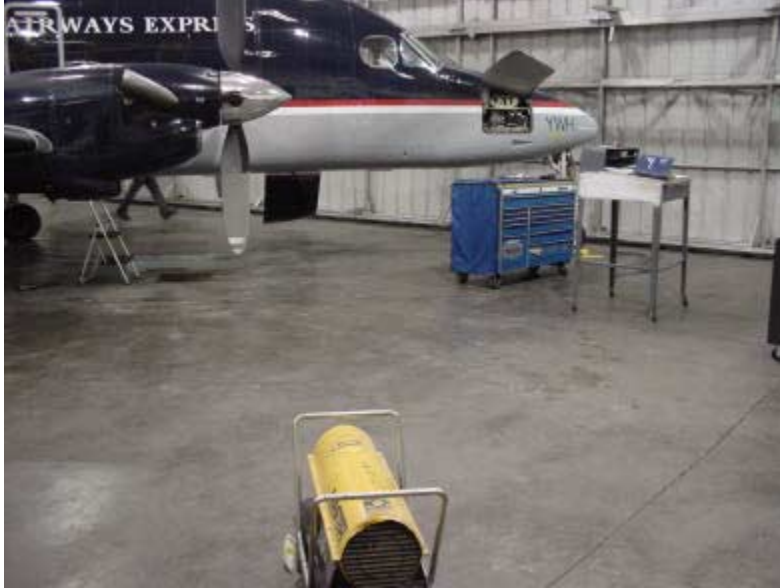
Photograph 2. Kerosene-burning heater pointed toward the right side of the airplane, ahead of wing. Master Model B110BT with placarded output of 110,000 BTU. Note: The location for the OAT probe is on the opposite side of the airplane, beneath the Captain's side window.

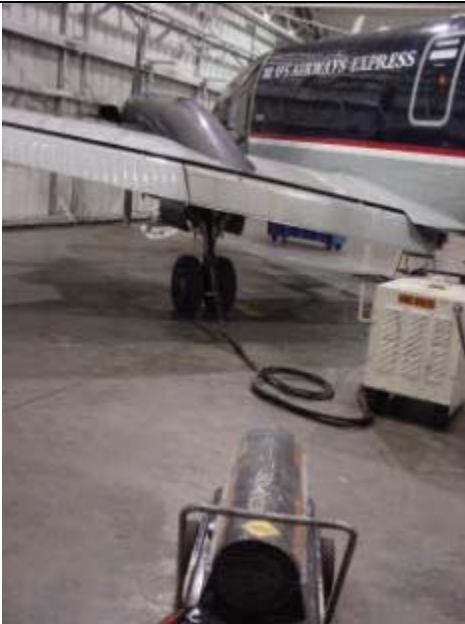
Photograph 3. Kerosene-burning heater pointed toward the right rear of the airplane. DESA Heater Model REM150B with placarded output of 150,000 BTU.

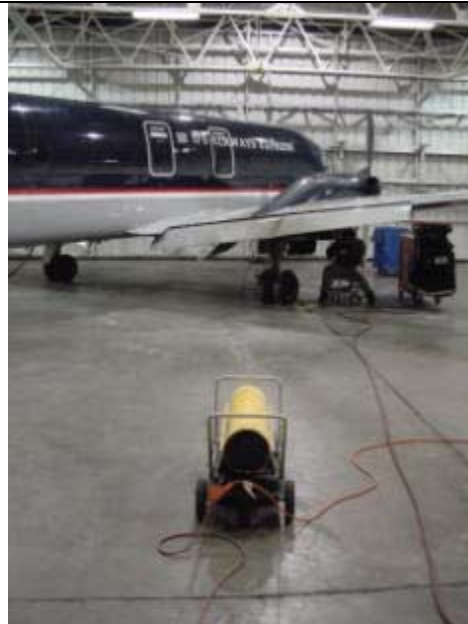
Photograph 4. Kerosene-burning heater pointed toward the left rear of the airplane. Master Model B110BT with placarded output of 110,000 BTU

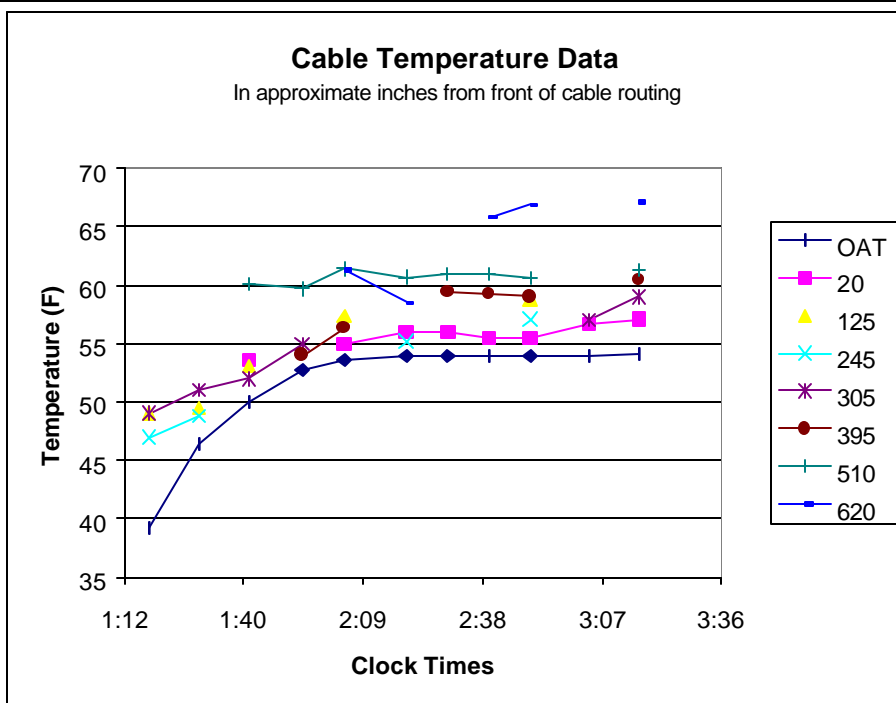
Chart 1. Cable temperature data after hangar door was shut, as collected. Each line/symbol represents an inch-distance from the front of the pitch control system. The weather outside of the un-insulated hangar was measured to be 23.5 to 25 degrees F.

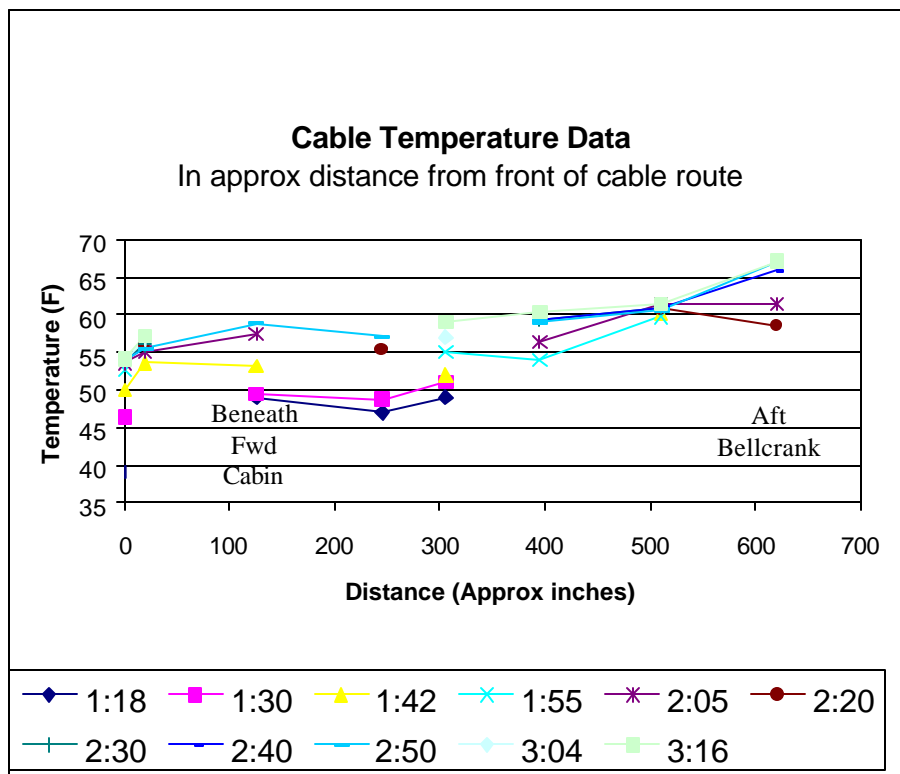
Chart 2. Cable temperature data after hangar door was shut, as collected. Each line/symbol represents a time across the various locations being measured. The "O" on the X-axis (at lower left of chart) represents OAT data.

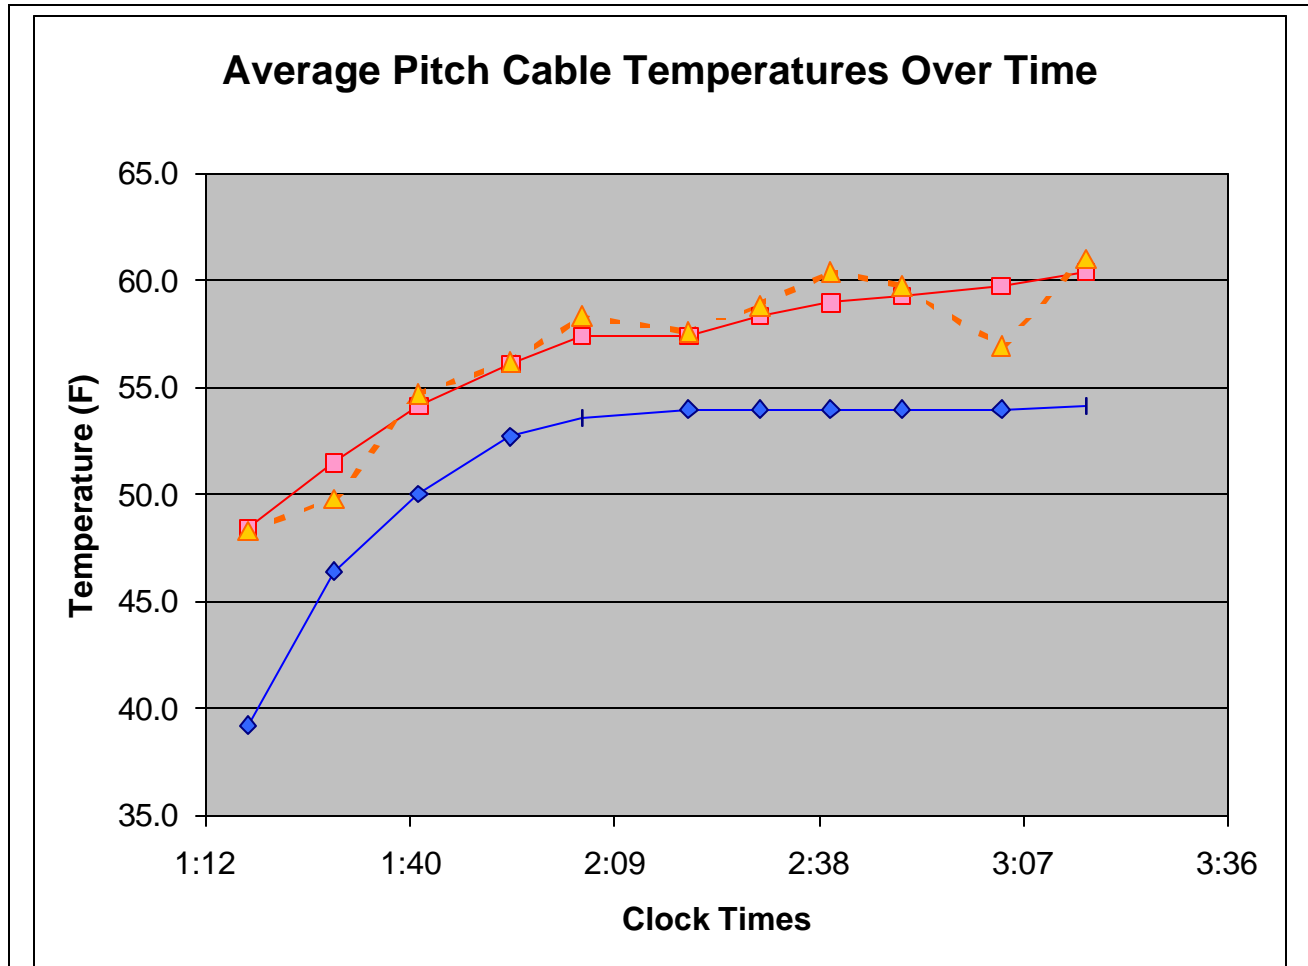
Chart 11. Average cable temperatures for basic data and smoothed data, shown with OAT data. The dashed line and triangles represent averages of collected data. The red solid line with squares represents smoothing of the same data. The lower line with diamonds represents OAT temperatures from the installed gauge.

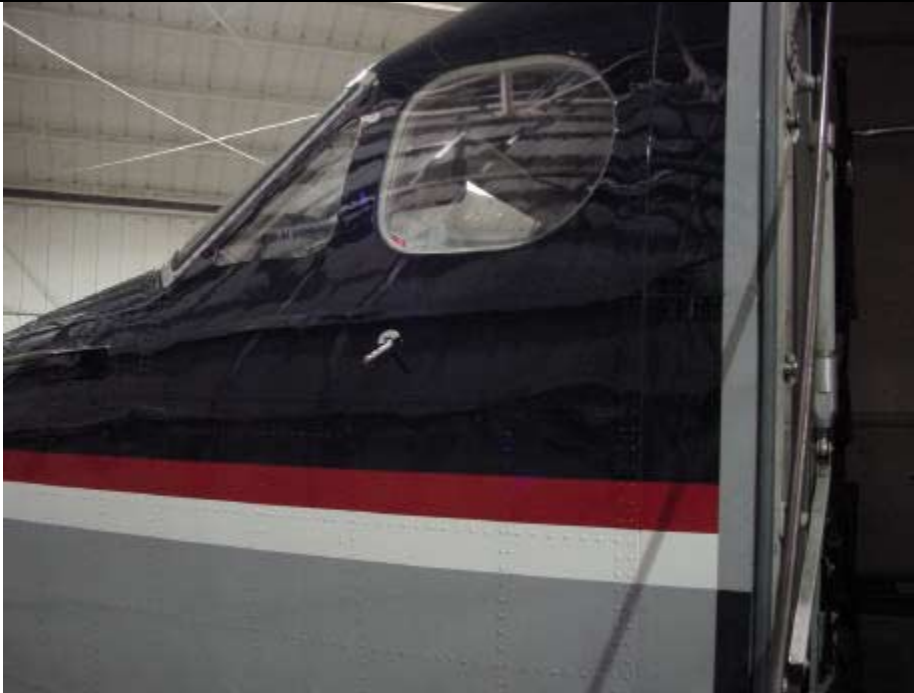
The installed OAT gauge is installed on the left side of the fuselage, near the steel hangar door. (Ref. Photograph 5)

Photograph 5. Installed OAT gauge, beneath Captain's side window. The air-stair is at the right edge of the photograph.

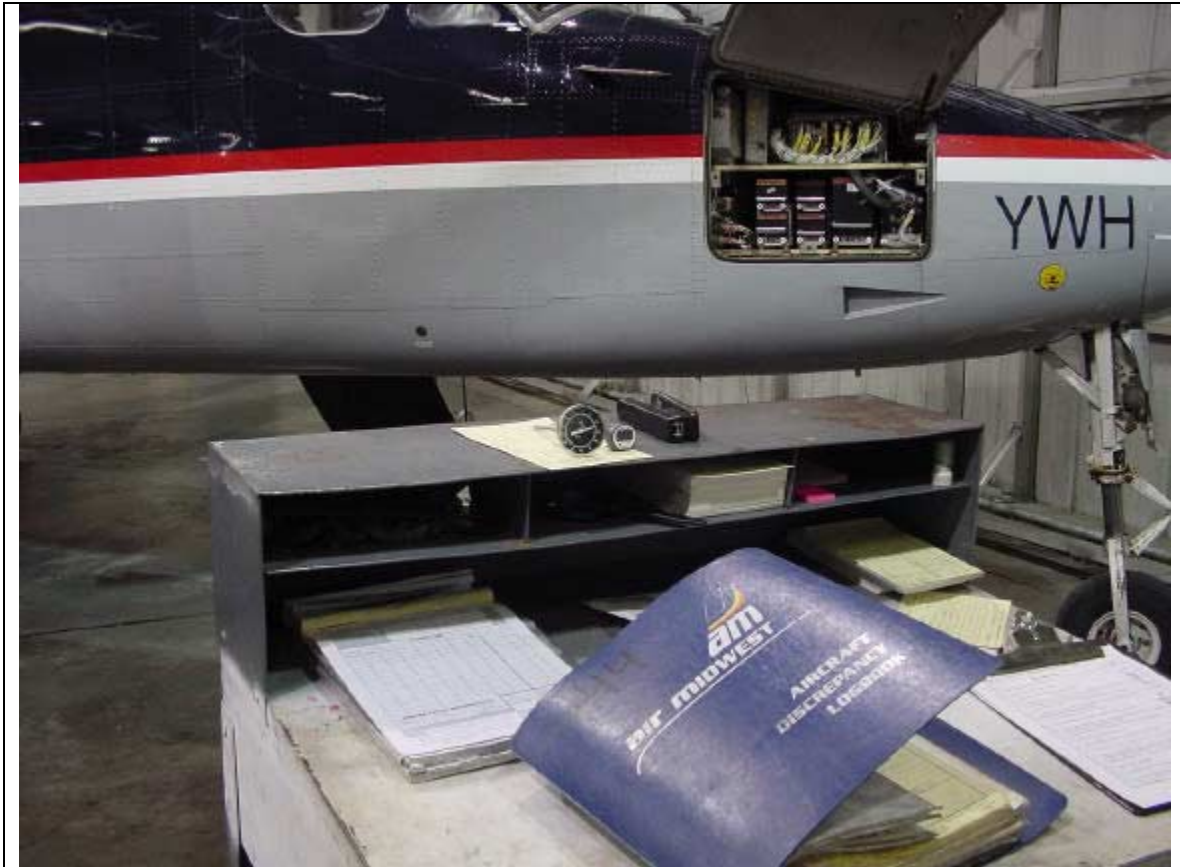
At the time the cable tensions were adjusted on A/C 233 the OAT gage reading was taken while it was laying on the top shelf of the podium. The podium was located at the nose of the A/C approximately 6 ft from the right avionics bay door.

Following receipt of the statement, the podium was placed in the location specified by Mr. States (in his presence) and the spare OAT gauge was laid on top. The NTSB digital thermometer was placed next to the spare OAT gauge and the OAT read about 13.5C (56.3F) while the digital display read 56.8 degrees Fahrenheit. (Ref. Photograph 6) The installed OAT display was 1.8C to 2.0C (3.6F) cooler than the spare OAT at 02:50am and 03:04am.

Photograph 6. Spare OAT and digital thermometer on podium at 04:00am. The proximity of the fuselage and air-stair referenced in previous photo to the steel hangar door is visible in background.
