NATIONAL TRANSPORTATION SAFETY BOARD

SYSTEMS GROUP CHAIRMAN'S FACTUAL REPORT

A. ACCIDENT: DCA03MA022

Location: Charlotte-Douglas International Airport, North Carolina
Date: January 8, 2003
Time: 0848 Eastern Standard Time
Aircraft: Raytheon Model 1900D, N233YV, operated by Air Midwest Airlines,
d.b.a. US-Airways Express flight 5481

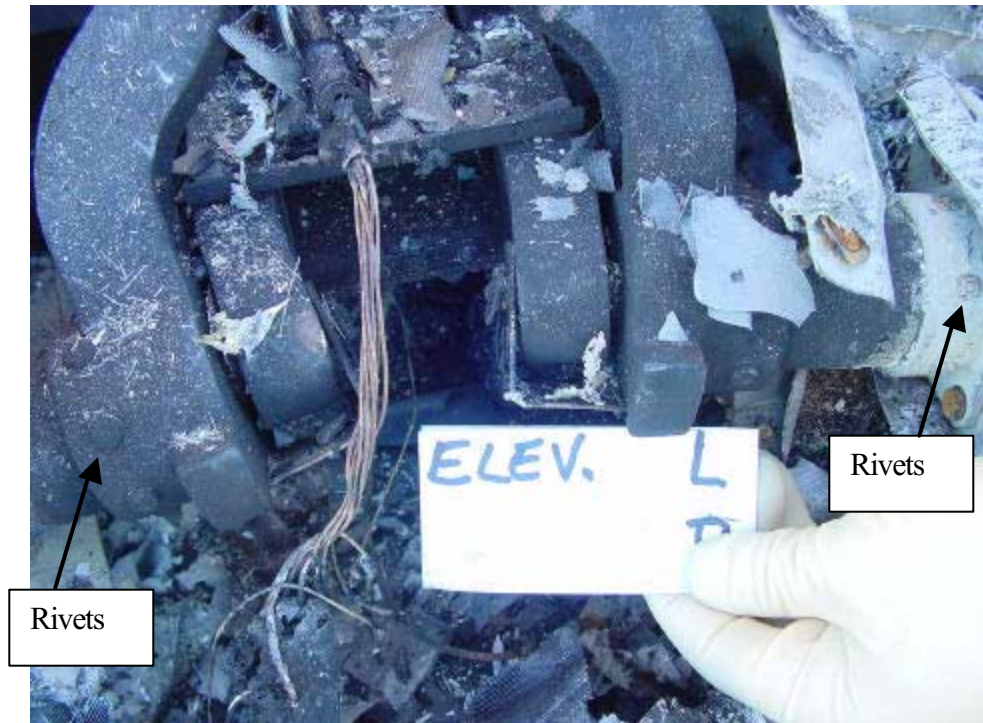
The elevator control horn is located at the root of each elevator; it is connected to the elevator assembly by a shaft. (Ref. Figure 2) At the accident site, the rivets connecting the elevator control horn to the elevator shaft were inspected for security. The rivets were found to be tight and the horns were solidly fixed to the left and right elevator shafts, reference Photograph 1. The horns moved freely in their respective bearings.

Photograph 1. Elevator control horns- left and right elevator

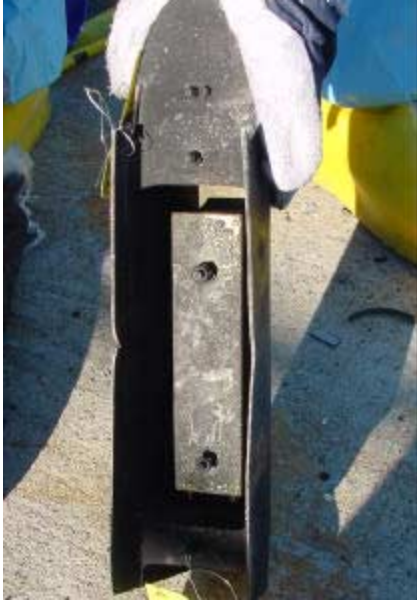
Each blackened elevator weight was found unattached and in an area that had burned; the adjacent aluminum elevator material was missing (Ref. Photograph 2) and splatters of aluminum were found beneath the remains of the tail structure. Each weight had a set of two bolts at one end and each set of bolts was connected by safety wire (Ref. Photograph 3). This arrangement was similar to the configuration described in AD 2002-23-11.

The fire-damaged weight from the right elevator had an internal weight that was loose enough to rattle and the heads of the countersunk mounting screws were found to vary from flush to about 1/8-inch of visible extension from the forward edge of the weight. (Ref. Photograph 4) Examination of the rear side of the threaded ends of the fasteners revealed steel nut-plates that were blackened, and having the edges bent up. The left weight was inspected. Similar nut-plates on the left weight were mounted to aluminum structure. Examination showed that the structural build-up that the countersunk fastener goes through is: weight, aluminum structure, and then into the nut-plate. The aluminum structure that attaches to the right weight was missing. Without the thickness of the aluminum structure, the fasteners were able to move in the screw holes.

Photograph 2. Counter weight - right

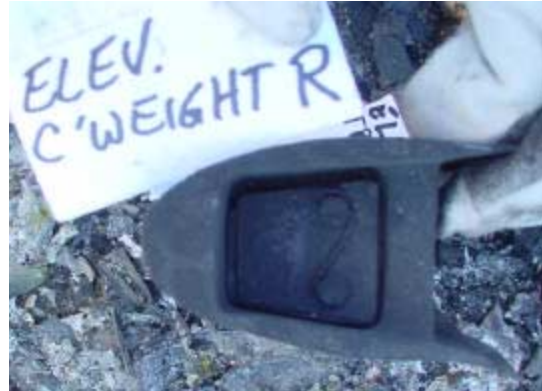
Photograph 3. Safety wire between bolt heads

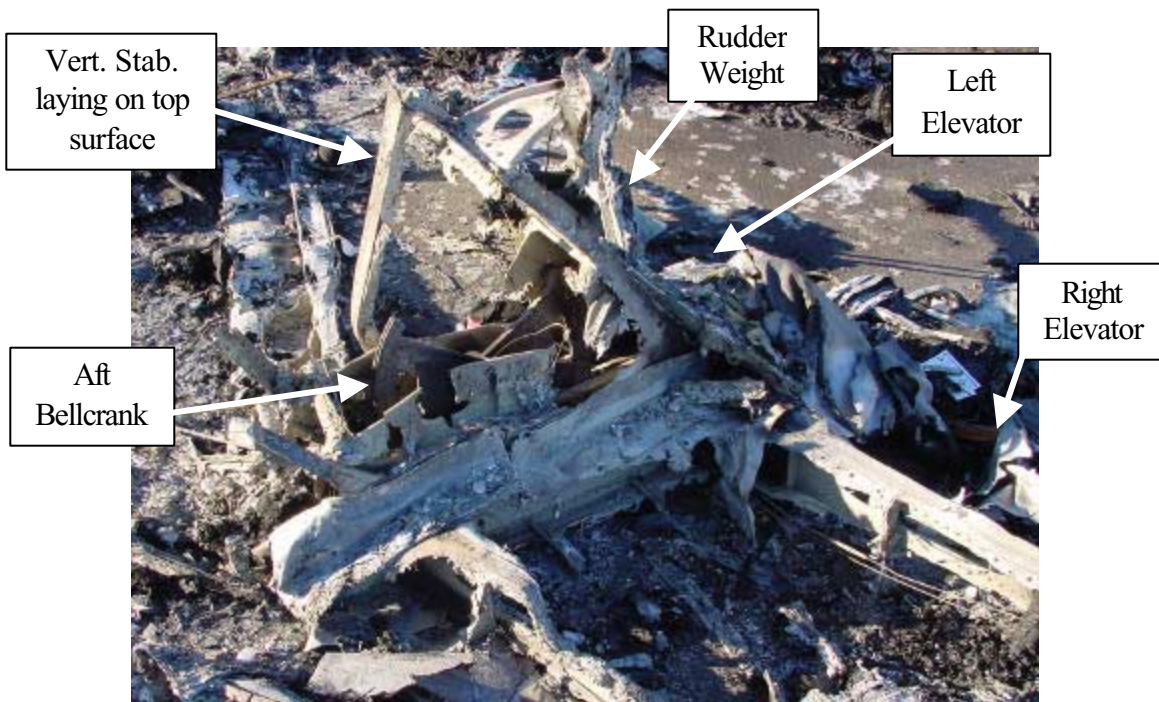
Structure that had contained the aft rig pin⁴ holes for the aft bellcrank was missing and fire damaged; the surrounding area was also fire-damaged (Ref. Photograph 5). Both the bellcrank and pushrod were removed from the aircraft structure (Ref. Photograph 6). Under finger pressure, the bellcrank did not rotate freely and was further examined by the NTSB Materials Laboratory.

Photograph 5. Inverted tail section, with the lower portion of the remaining vertical stabilizer toward the top of the photo. The leading edges are to the left edge of the photo. The right horizontal stabilizer is closest to the viewer. The aft bellcrank is visible at the intersection of the vertical and horizontal stabilizers.

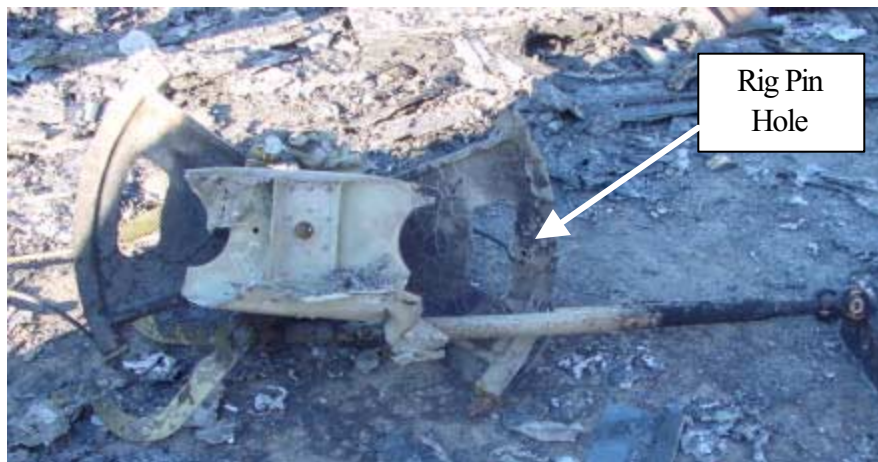
Photograph 6. Aft bellcrank after removal, laying inverted, with right side visible.

The NTSB Materials Laboratory examined the aft bellcrank and the small pieces of structure remaining attached. The remaining structure appeared to have been melted away during exposure to fire. The structural pieces rotated easily (one with little or no resistance and one with small resistance), but it was noted that the attaching bolt and nut did not rotate with the structure. Removal of the nut from the bolt and partial

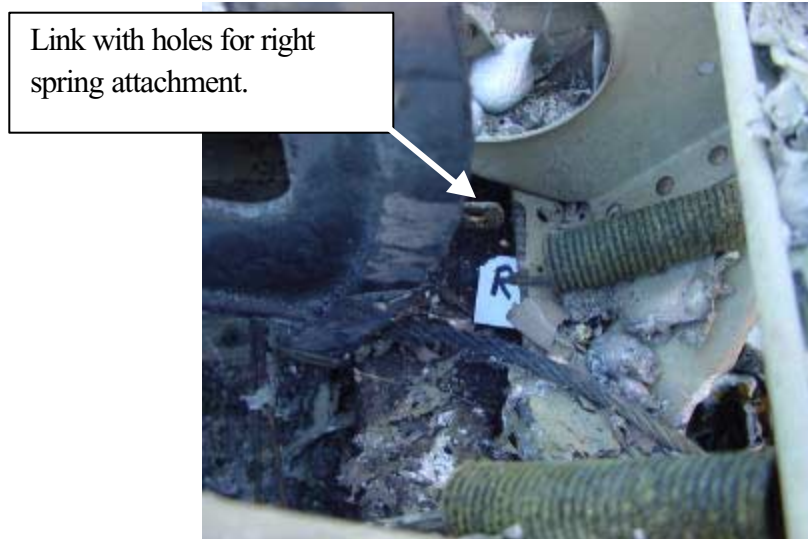
Both left and right down tension springs were located in the area of the aft bellcrank. The right tension spring was found with its upper end not attached to its respective link; its lower end was attached to structure. The structure that forms the lower attach point was fire damaged. The left tension spring was found with its upper end attached to its respective link in the most forward of four holes; its lower end was attached to structure. A visual examination of the spring showed that the spring was not totally relaxed. (Ref. Figure 3 and Photographs 7 and 8).

Photograph 7. Left and right springs shown, right spring is not attached to link. (Right edge of photo is toward nose of airplane.)

Examination of the tension springs at the NTSB Materials Laboratory revealed partial surface melting of the bellcrank, adjacent to the right spring attachment link (upper end of the spring). A globule of re-solidified metal was noted adjacent to the lower end of the spring. Magnified visual examination of the disconnected end of the right spring and the right linkage showed no evidence of unusual wear patterns, scratching, or other damage related to the separation of the spring from the link.

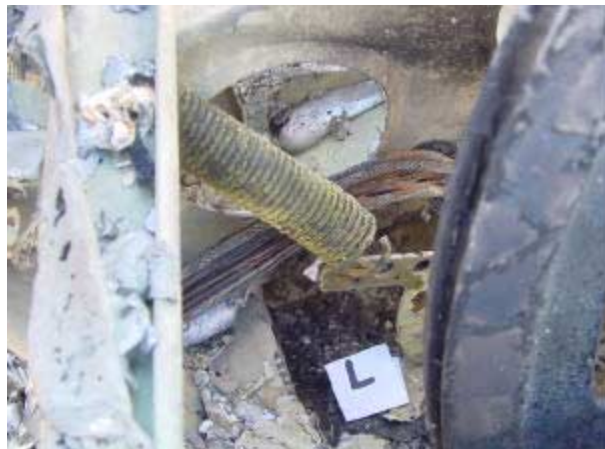
Photograph 8. Left spring as found attached to link. (Left edge of photo is toward nose of airplane.)

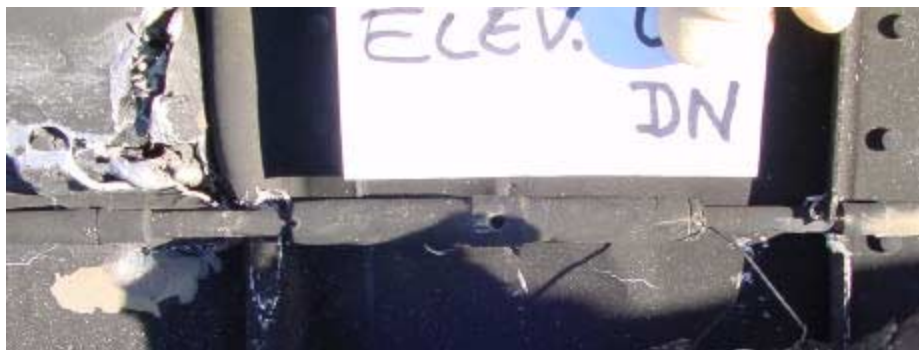
The primary pitch control cables were followed completely from the tail to the nose of the airplane and were found to have one turnbuckle, each. The turnbuckles were located in wreckage from the area of the vertical tail base, about eight feet from the aft bellcrank. The extensions of the turnbuckles were found to be different, with the AND turnbuckle longer than the ANU turnbuckle. (Ref. Table 2) The AND turnbuckle was near full extension, with one thread visible. The ANU turnbuckle extension was found almost fully compressed. (Ref. Photographs 9 and 10)

Photograph 9. Elevator “AND” cable turnbuckle. Note: this turnbuckle was pinched in structure and the safety clip that is visible beneath the “DN” lettering was pulled off during extrication. To mark the rotational position, a stripe of gloss black paint was applied.

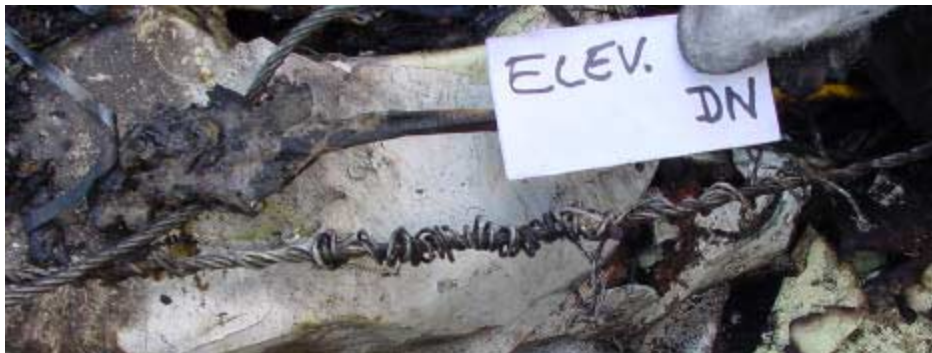
All primary and trim control cables had damage, with numerous bends, kinks, and breaks. At about the location where the fuselage was folded toward the remains of the right wing, the AND pitch control cable was found to have two braided strands (of 7 total) broken and one of the woven strands appeared to have pinch damage and was flattened. The broken strands were spirally unwound and were found in the area between the rear wing spar and the forward edge of the rear cargo compartment. The length from the forward end of the AND cable to the breakage point in strands was 16 feet, 8 inches. The majority of spiral unwrapping was toward the forward end of the cable and was approximately 38 inches long. Forward of the unwound area, the cable remained routed through a pulley/pulley bracket assembly that was sharply gouged on the aft end of the bracket; further inspection found no wear on the bracket. (Ref. Photograph 11).

The portion of the pitch control cable with a spirally unwound section was examined at the NTSB Materials Laboratory. The examination found that the cable was composed of seven strands. Two of the strands were completely severed and a third was partially severed. All of the broken wire ends were located within less than approximately one inch of each other. On one side of the break location, the separated strands had been pushed back from the fracture location, resulting in the unwound spirals. Magnified visual examination of the broken wire ends disclosed that most of the wires were flattened by mechanical damage adjacent to the fracture, and that many of the wires were bent adjacent to the fracture. Bent, flattened, and damaged wires were also noted on the partially separated strand. No evidence of fatigue cracking or preexisting wear was noted in the damaged portion of the cable.

Photograph 11. Elevator down (AND) cable showing spiraled strands.

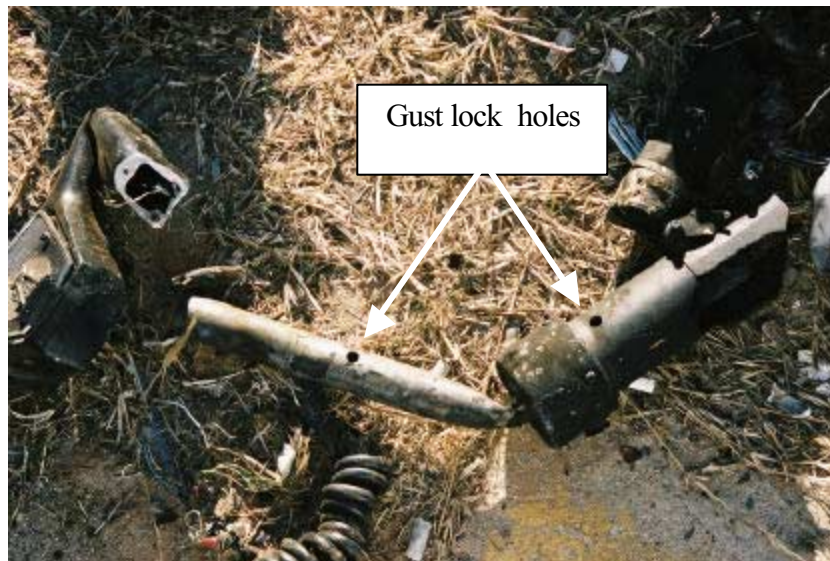
The Captain's control wheel was found approximately 20 feet forward of the cockpit and separate from the tube assembly. The Captain's tube was bent and found mostly extended out of the support assembly. The forward end of the tube was not found connected to the "T" control column; it had separated at the universal joint. (Ref. Photograph 13)

Photograph 13. Captain's control wheel and column assembly. The Captain's control wheel is to the left, the end plate is mounted at the left end of the tube assembly, the gust lock holes in the moveable tube (smaller diameter tube in center-left of photograph) and fixed support assembly (larger diameter tube at right) are visible.

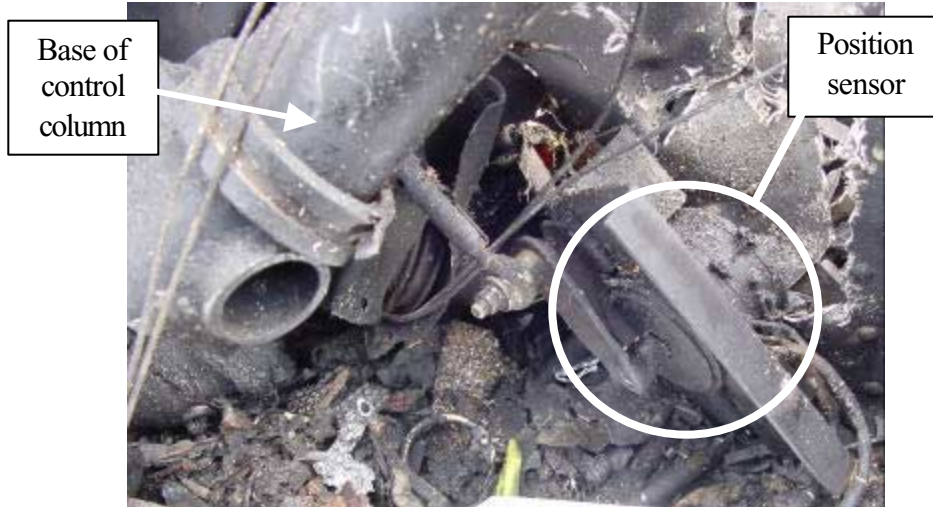
The pitch control column position sensor was found contained within its bracket assembly. (Ref. Photograph 14) Two wires were found attached and extending out of the sensor. The wires were severed about 6 inches away from the sensor. The sensor was firmly attached within the bracket and did not move or rotate. The linkages from the control column to the position sensor appeared to be intact, during an initial examination. After the removal of several other cockpit components, the linkage from the control column to the position sensor was found broken at the control column clamp. The sensor and linkage were removed from the aircraft and the input lever to the sensor was found free to move from the original position. The clamp connecting the linkage to the control column was found attached to the column; however, it was slightly loose due to the rubber contained within the clamp being heat damaged. The sensor rotated freely 360 degrees. A measurement of the broken sensor rod end linkage yielded a center-to-center length of approximately 3.31 inches.

Photograph 14. Column, position sensor, clamp, and linkage.
