# NATIONAL TRANSPORTATION SAFETY BOARD

MATERIALS LABORATORY FACTUAL REPORT

Report No. 02-046

Place : Belle Harbor, New York  
Date : November 12, 2001  
Vehicle : Airbus A300-600  
NTSB No. : DCA02MA001  
Investigator : James Hookey, AS-40

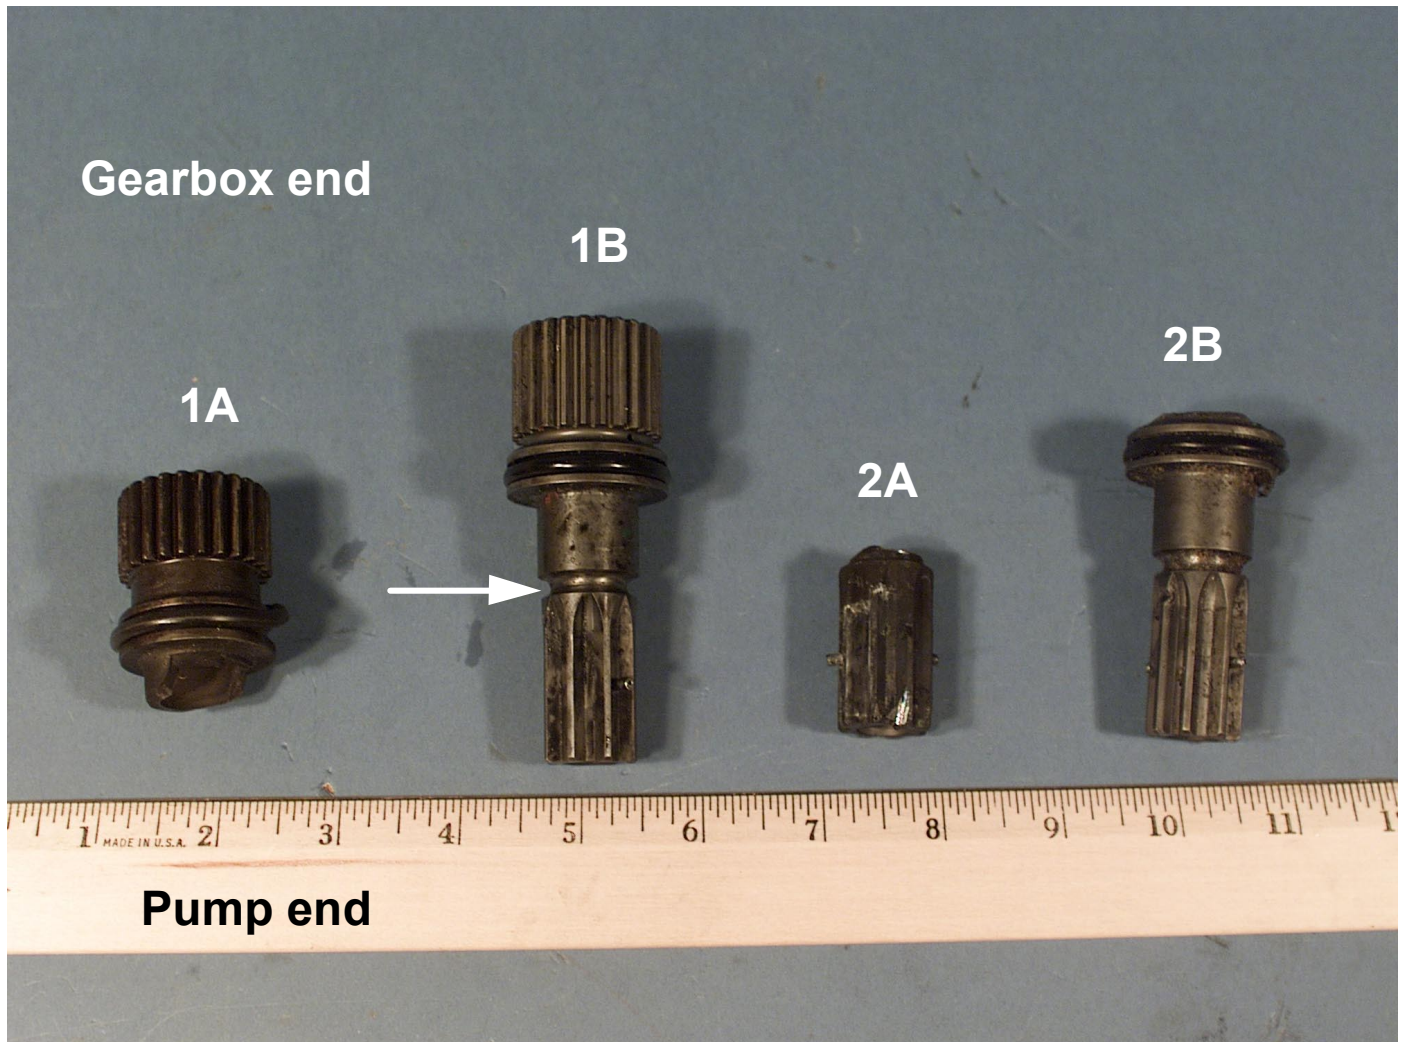
The hydraulic pump drive shaft pieces submitted for examination are shown in an overall view in figure 1. The shaft pieces are oriented in figure 1 with the gearbox end at the top of the photograph and the pump end at the bottom of the photograph. The pieces from the #1 engine are labeled "1A" and "1B", and the pieces from the #2 engine are labeled "2A" and "2B". The 1B shaft from the #1 engine was not fractured, and the unlabeled arrow indicates the reduced section shear point on this shaft. The other three shafts were fractured, each in a different portion of the shaft. Other portions of the shafts were not submitted and are presumed to be lost.

Shaft piece 1A fractured just on the pump side of the "O" ring seal. Various portions of the fracture were angled on flat planes, and all portions of the fracture contained smearing marks on linear fracture features indicating that the fracture occurred primarily under direct shear loading conditions. In addition, the splines on the gearbox end contained an imprint pattern (generated by contact with the internal splines on the mating component) indicating excessive bending loading of this end of the shaft.

This shaft was not fractured, and there was no evidence of torsional damage. One of the protruding ends of the roll pin through the splines on the pump end of the shaft was sheared in the longitudinal direction.

The fracture on this shaft was through the reduced section shear point adjacent to the splines on the pump end of the shaft. Most of the fracture was on a slant 45 degree plane and was typical of an overstress bending fracture. One side of the fracture was deformed slightly outward indicating that some amount of torsional loading may have been present as the fracture occurred. The fracture features were not consistent with an overstress torsional fracture, which typically produces a flat fracture (perpendicular to the axis of the shaft) with circumferential smearing damage.

Shaft piece 2B was fractured adjacent to the splines on the gearbox end. Fracture features were typical of an overstress bending fracture. One of the protruding ends of the roll pin through the splines on the pump end of the shaft was bent toward the end of the splines.

Figure 1. Overall view of the hydraulic pump drive shaft pieces. The unlabeled arrow indicates the reduced section shear point for the 1B shaft.
