# NATIONAL TRANSPORTATION SAFETY BOARD

MATERIALS LABORATORY FACTUAL REPORT

Report No. 02-076

Place : Memphis, Tennessee  
Date : February 4, 2002  
Vehicle : Airbus A300  
NTSB No. : DCA02MA001  
Investigator : Steve Magladry, AS-40

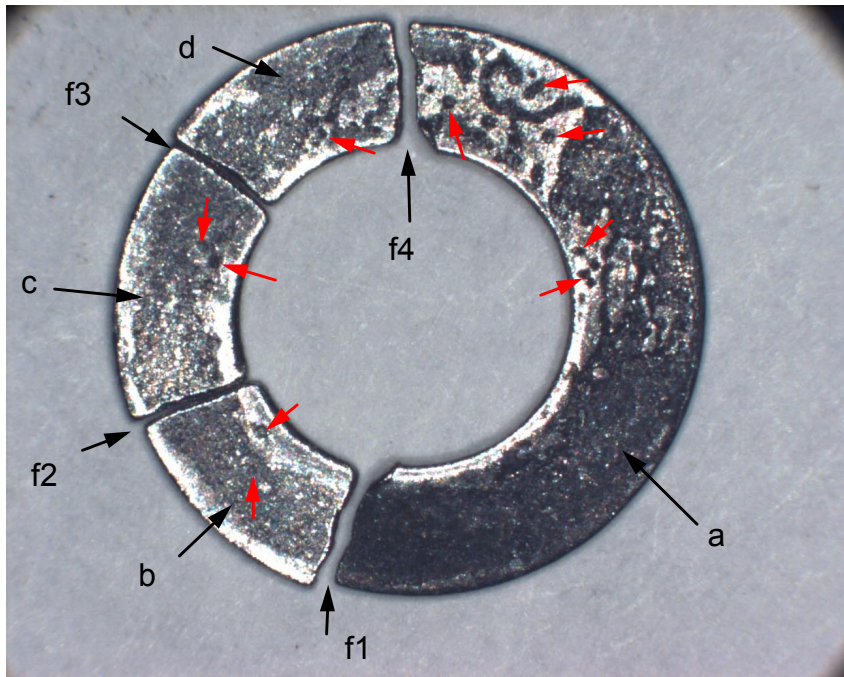
The four intact spring washers were received in bags labeled 1 to 4. The fifth spring washer, fractured into four pieces, was labeled number 5 in the materials laboratory. An overall view of spring washer number 5 is shown in figure 1. The pieces are shown in their relative positions, labeled "a" to "d". The washer was fractured in four locations, labeled "f1" to "f4". As shown in figure 1, the surface of the washer had some areas that appeared optically shiny and bright, consistent with contact and rubbing. Other areas appeared dark. As indicated by red arrows in figure 1, many of the smaller dark areas appeared circular in shape, and the larger dark areas contained circular impressions, features consistent with surface pitting.

smaller peaks of chromium, silicon, and oxygen. The spectra for washer 5 in areas that appeared optically dark also had a major peak of iron and a smaller peak of oxygen, but also had smaller peaks of zinc and phosphorus with no peaks of chromium or silicon.

Hardnesses of washer 1 and washer 5 were measured in the cross-sections using an elongated diamond indenter with a 500-gram load. The average hardness was 49.2 HRC (526 HK) and 54.4 HRC (618 HK) for washer 1 and washer 5, respectively. According to the engineering drawings for the spring washers, the specified material is either 50CV4 or XC75. According to the manufacturer, 50CV4 is a spring steel similar to AMS 6450. The manufacturer did not provide information about XC75 as of the writing of this report. According to the AMS 6450 specifications, the hardness of the finished product should be in the range of 43 to 46 HRC.

Figure 1. Overall view of the convex side of washer 5. The four pieces, labeled "a" to "d", are shown in their relative positions. The four fractures are labeled "f1" to "f4". Unlabeled red arrows indicate some of the circular indentations indicative of surface pitting.

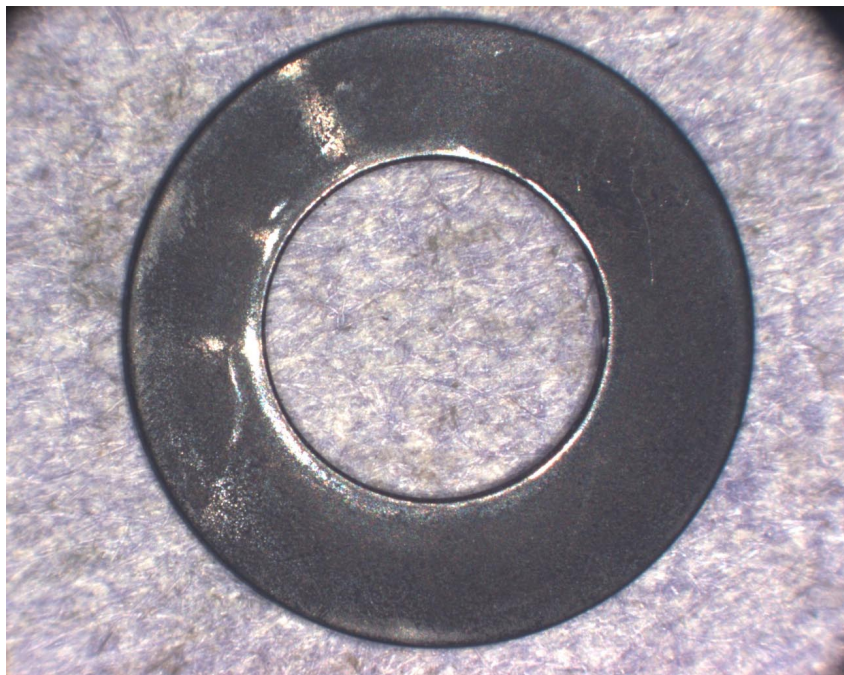
Washer number 1, shown in figure 2, has features typical of the remaining four washers. The majority of the surface did not have rubbing contact and appeared to have a relatively smooth dark surface with no evidence of pitting.

Figure 2. Overall view of the convex side of washer 1 showing features typical of the remaining washers.

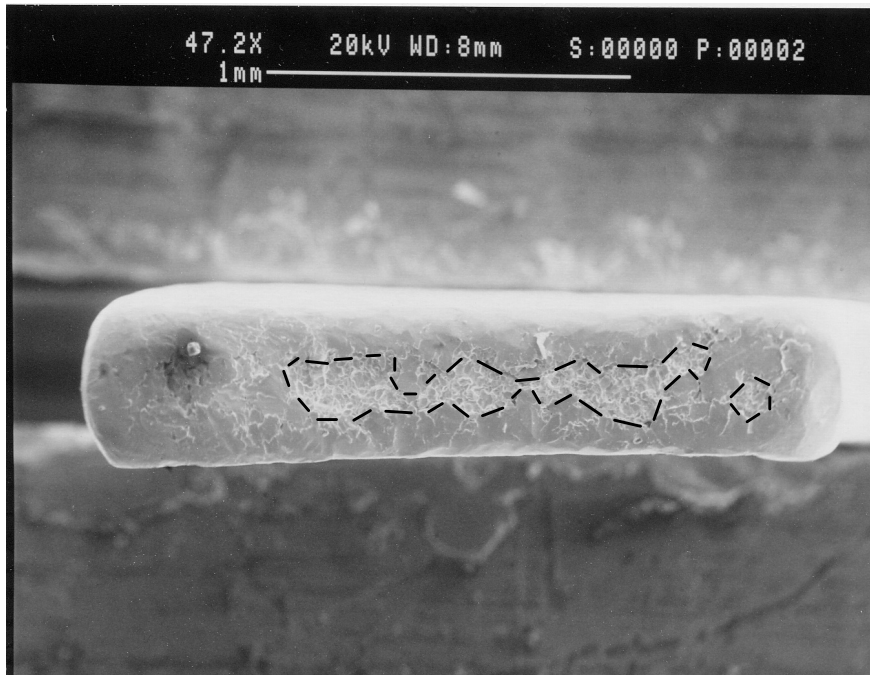
The fracture surfaces for each of the four fractures in washer 5 had similar features, as exemplified by the fracture surface on piece "d" for fracture "f3" shown in figure 3. The edges of each fracture surface were obliterated by post-fracture damage. For each fracture, all of the undamaged areas of the fracture surfaces had a granular appearance consistent with intergranular fracture. A higher magnification view of the typical intergranular features in one of these undamaged areas is shown in figure 4.

Figure 3. View of the fracture surface on piece "d", fracture "f3". Areas bounded by dashed lines indicate relatively undamaged areas with intergranular fracture features.

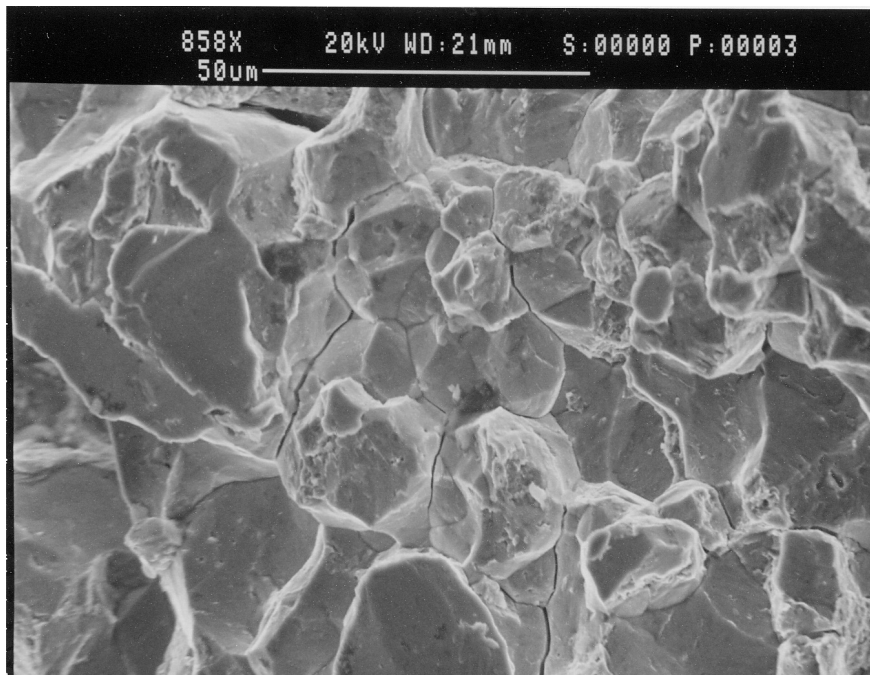
Figure 4. Typical intergranular fracture surface observed on undamaged areas of the fracture surfaces.

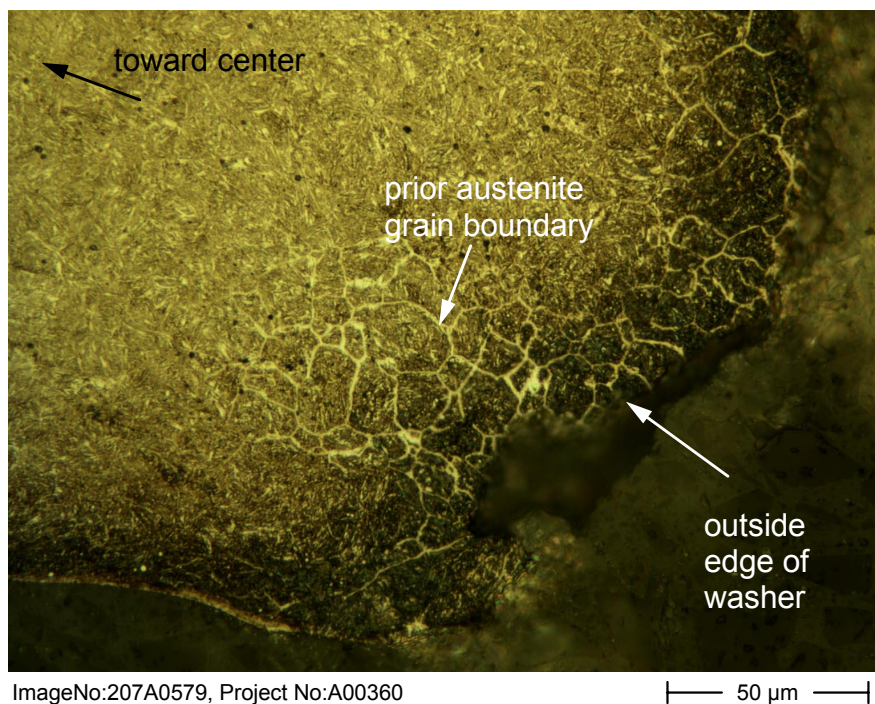
A cross-section of washer 5, piece "c" and of washer 1 was prepared for microstructural examination. The cross-section of piece "c" near the outer edge is shown in figure 5. Prior austenite grain boundaries were observed near the edges, but not toward the center. No prior austenite grain boundaries were observed on the cross section for washer 1.

Figure 5. View of the cross-section of piece "c" showing the microstructure near the edge. Prior austenite grain boundaries (appearing light-colored in the figure) are visible near the edges, but not toward the center. (Nital etch).
