NATIONAL TRANSPORTATION SAFETY BOARD

Group Chairman's Factual Report

Witness Group Factual Report

Location: Belle Harbor, New York
Date: November 12, 2001
Time: 0916 Eastern Standard Time
Aircraft: American Airlines Flight 587, Airbus A300-600
NTSB Number: DCA02MA001

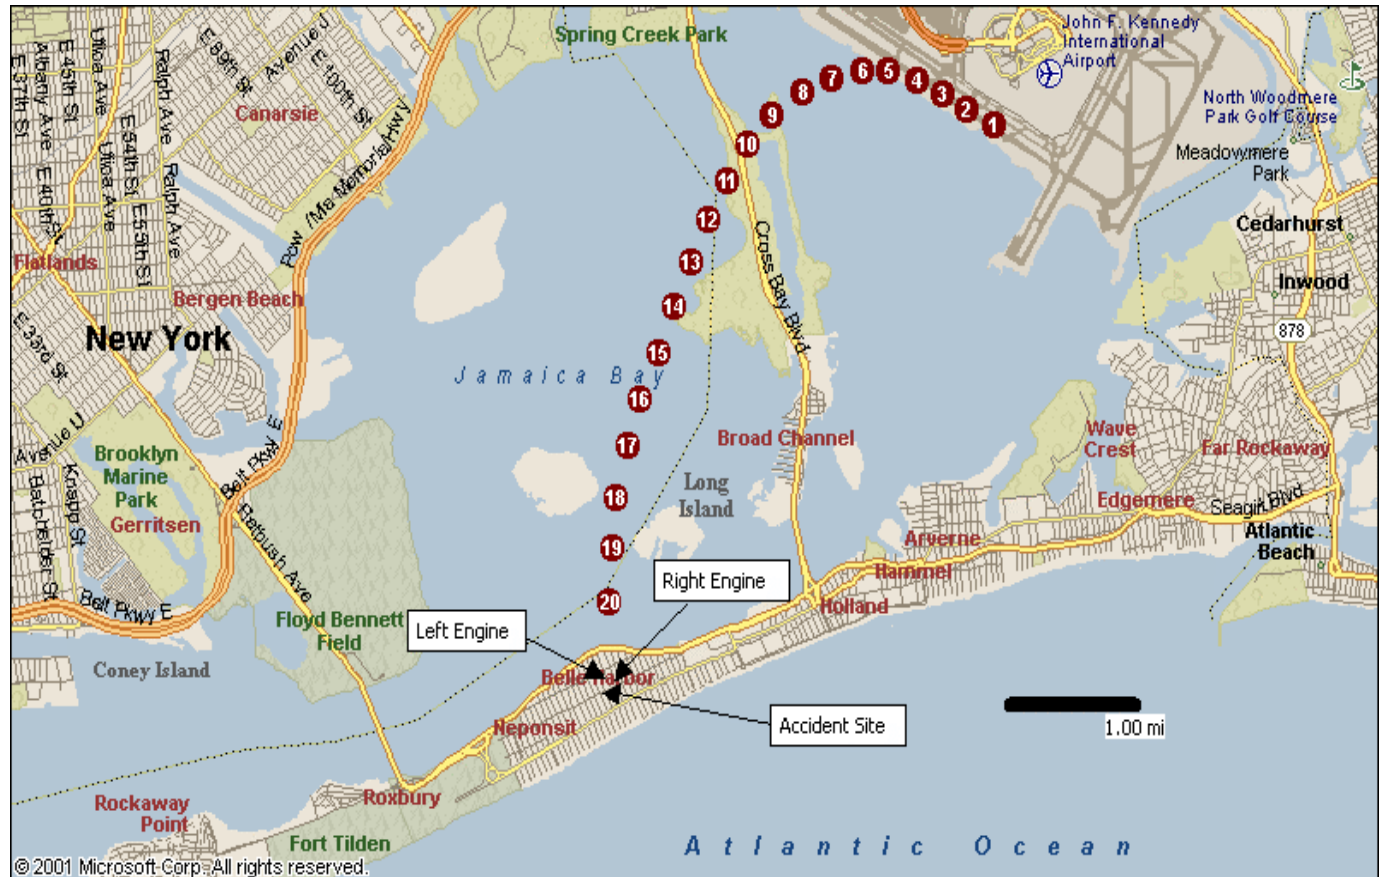
Map 1: Airplane Radar Track Overview

All maps depict the approximate position of the main accident site²⁶. Maps 1, 3 and 4, also depict the approximate positions where the left engine²⁷ and right engine²⁸ came to rest.

Airport Surveillance Radar from JFK for the accident flight was plotted and overlaid on the maps. The radar targets were numbered 1 through 20, and the information associated with the targets is displayed in the table below²⁹.

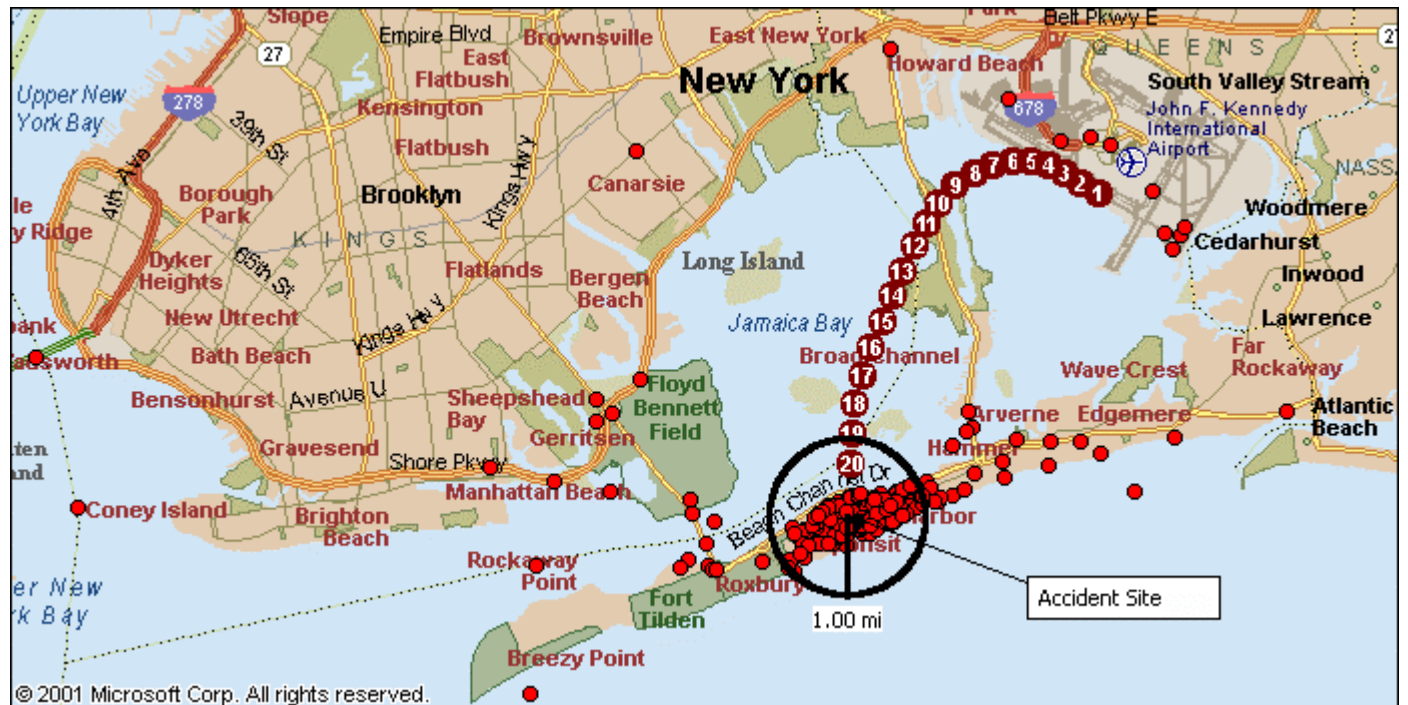
Map 2: Witness Distribution Overview

The witness group plotted the general position of approximately 340 witnesses, using approximately 256 points to depict the distribution of witnesses. Some witness positions were estimated based on available information, while others were grouped together²⁵. Additionally, in some instances it was assumed that the witness observed the airplane
