**GROUP CHAIRMAN'S
REPORT OF INVESTIGATION
SOUND SPECTRUM STUDY**

**American Airlines Flight 587
DCA02MA001**

**Belle Harbor, NY
November 12, 2001**

Group Chairman's Sound Spectrum Study

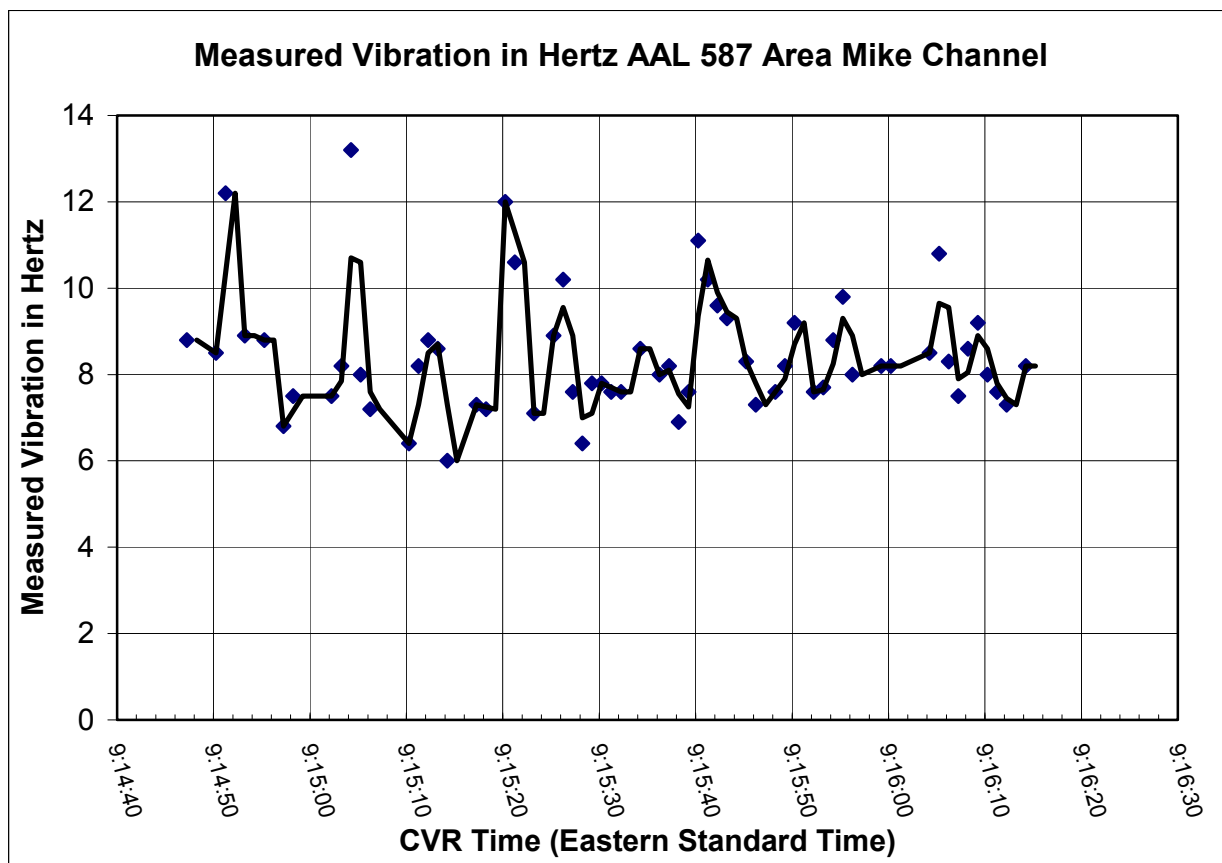
CHART 1

The black trend line shown on the chart is a 2nd order smoothing of the original data points. It can be seen from Chart 1 that there is a general 6-12 hertz vibration measured during the accident flight. This background vibration remains relatively constant throughout the flight from after the landing gear and flaps/slats were retracted to the end of the recording.

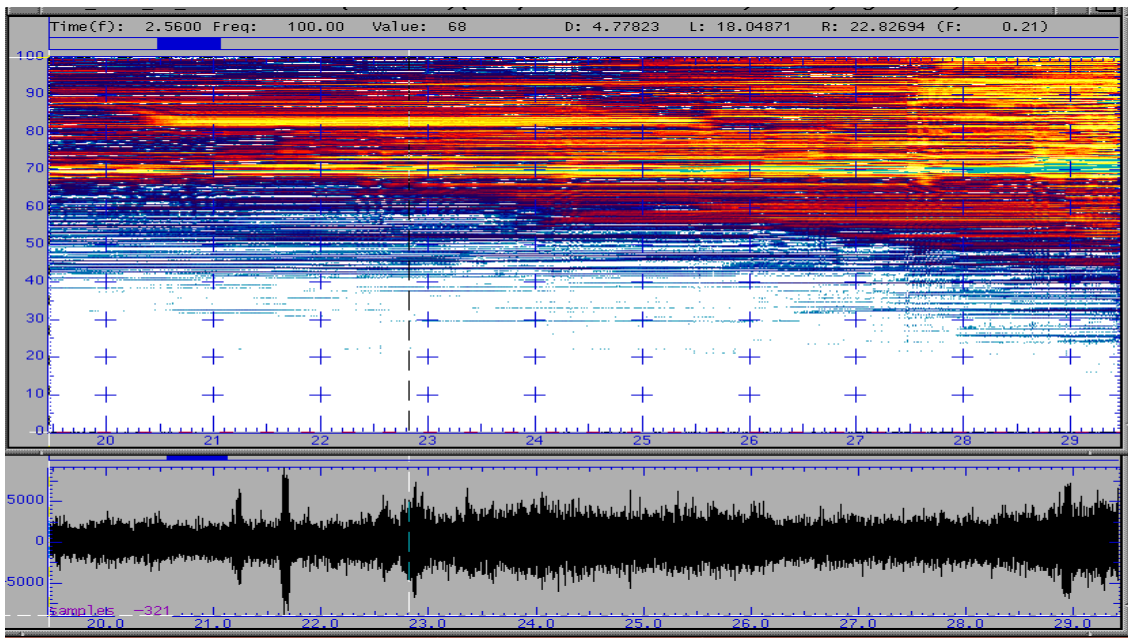
Chart 2 displays time at the start of the takeoff roll. The aircraft starts moving down the runway at about 25 seconds chart time.

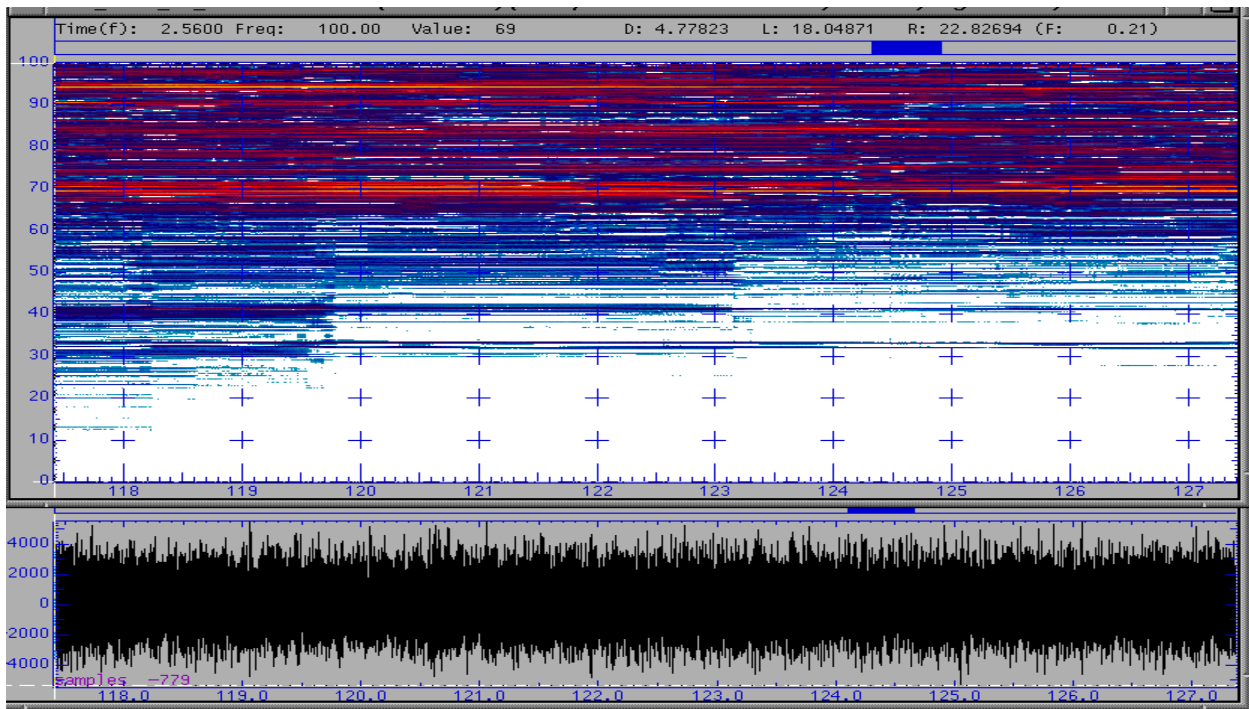
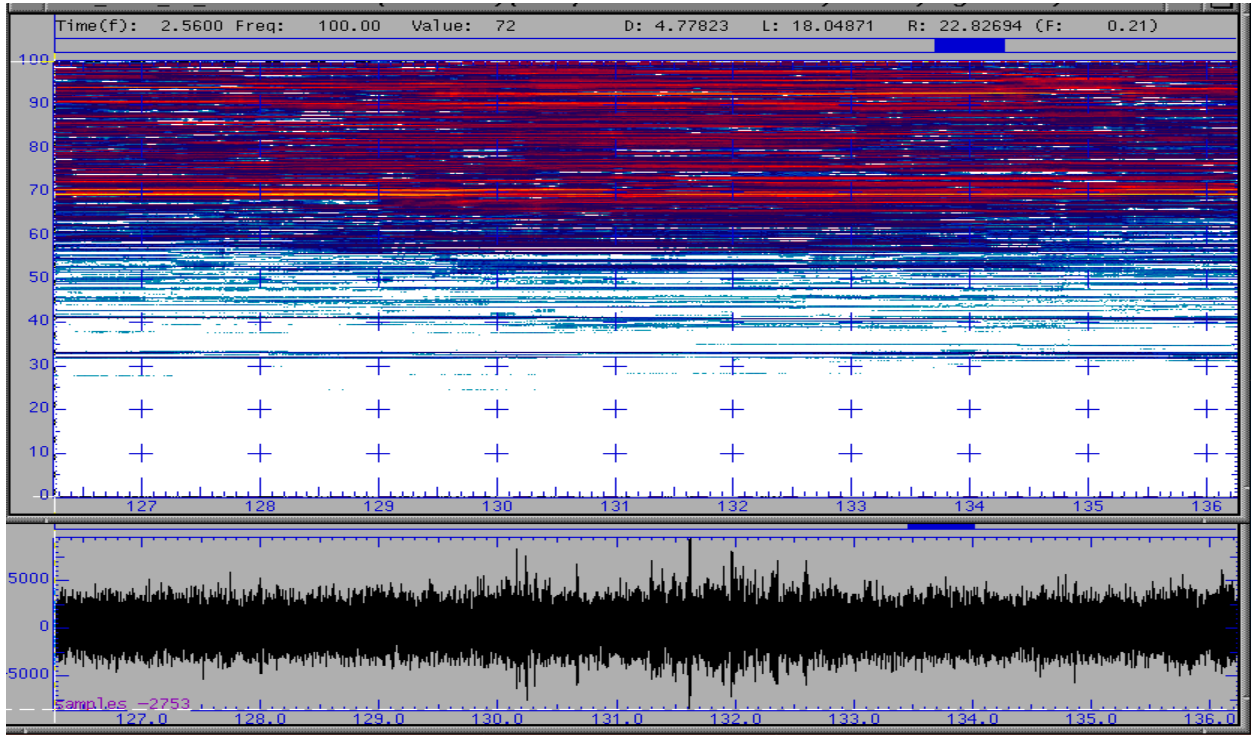
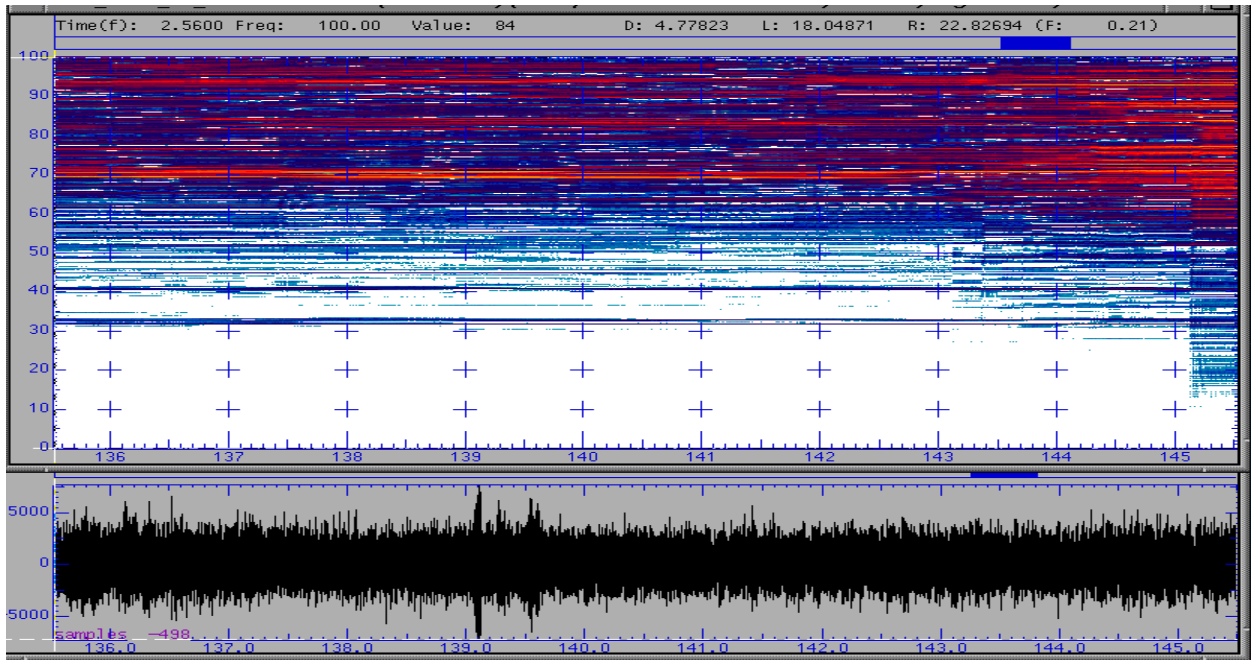
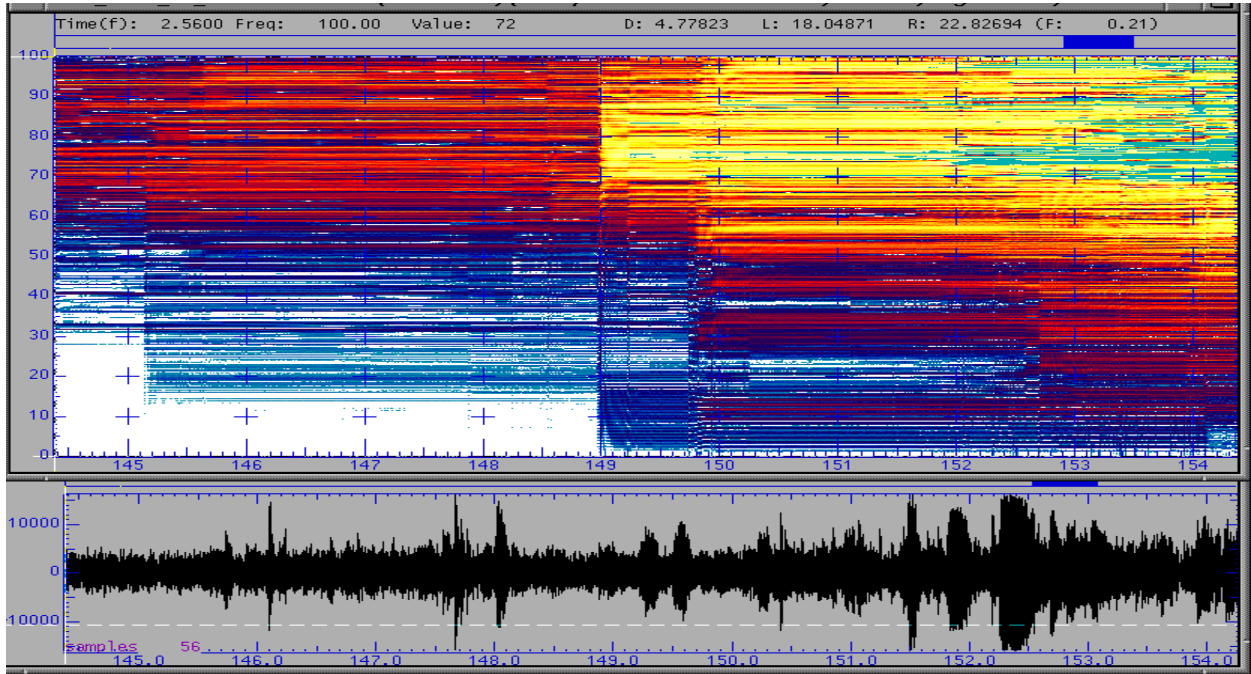
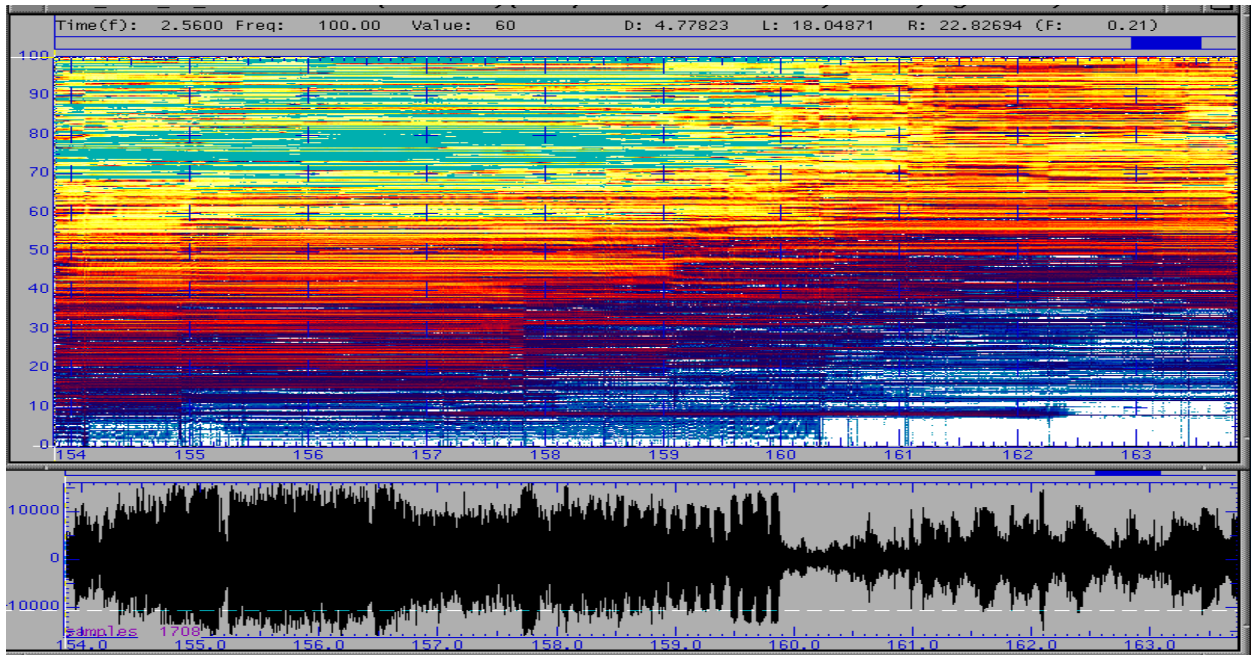
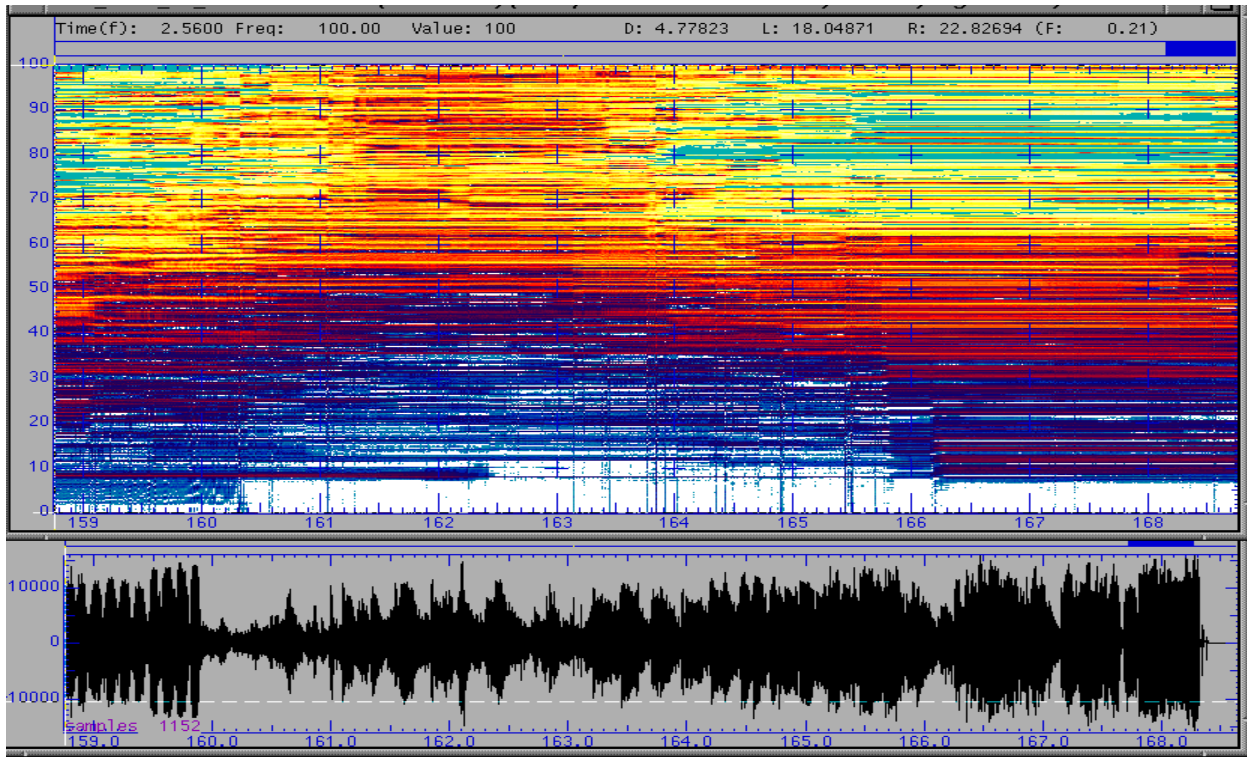
Charts 3-8 depict the last 50 seconds of the cockpit area microphone channel of the accident CVR recording. This is about same time frame as the data presented in Chart 1. It can be seen that there is little if any audio energy below about 30 Hz. From chart time 145 seconds until the end of the recording, this examination technique is not usable because the sound spectrum analysis cannot compensate for the loud noises that are found on the cockpit area microphone channel of the CVR.

Neither examination methods identified any unusual vibration or flutter that preceded the event identified on the CVR transcript at time 0915:52.9 EST
