# NATIONAL TRANSPORTATION SAFETY BOARD

MATERIALS LABORATORY FACTUAL REPORT

Report No. 02-091

Place : Belle Harbor, NY.  
Date : November 12, 2001  
Vehicle : Airbus A300-600, N14053  
NTSB No. : DCA02MA001  
Investigator : Steve Magladry

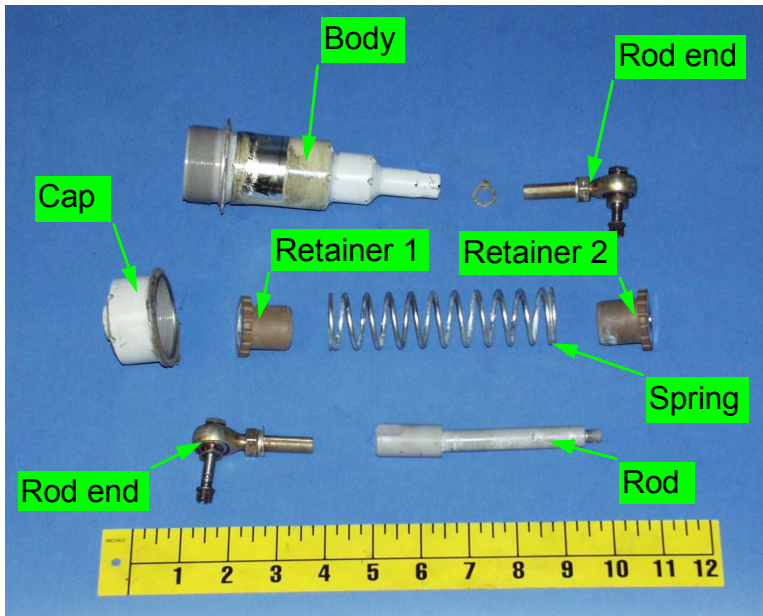
The disassembled spring rod components received for examination are illustrated and identified in figure 1. The spring rod is a device, with a contained spring, that imparts a degree of "feel" to a powered control system. The x-ray illustrated in figure 2 was taken prior to disassembly and reveals the components identified in figure 1 in their assembled locations. The yellow arrow in figure 2 indicates the larger diameter of the rod, protruding from the cap, and its misalignment with the remainder of the spring rod. The amount of misalignment between the two diameters on the rod is also discernible in figure 1.

Figure 1. The spring rod components as received for examination.

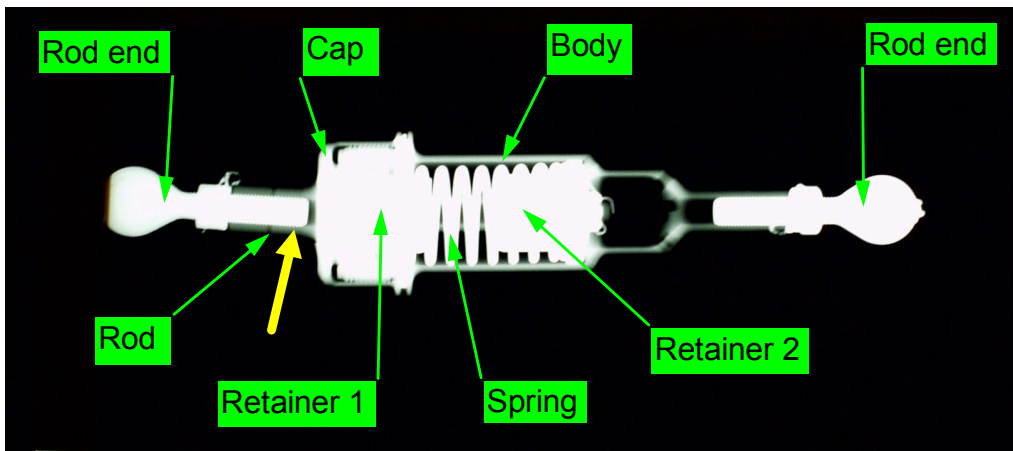
Figure 2. X-ray of the spring rod before disassembly

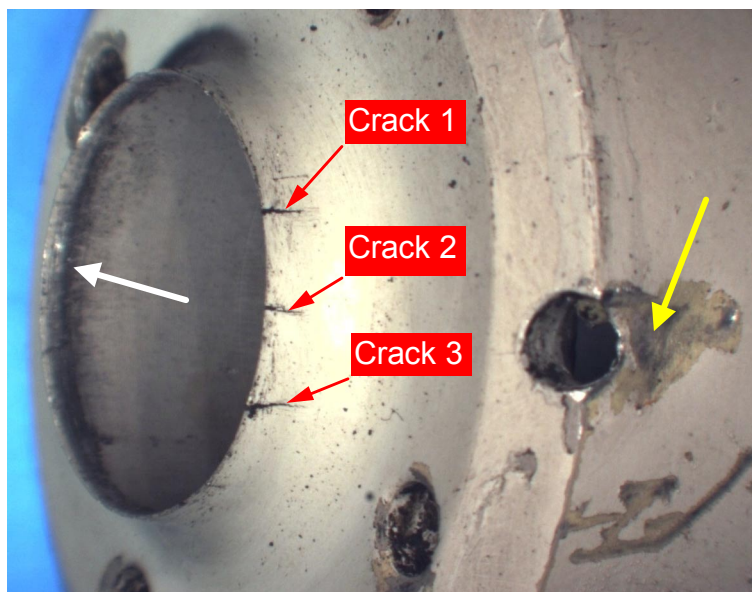
The cap contains 6 vent holes located around the perimeter of the cap. Examination of the cap revealed that it had been impacted on its side, adjacent to one of the vent holes. The yellow arrow in figure 3 indicates the impact mark. The three cracks, numbered and indicated by the red arrows in figure 3, were located on the outer flanged portion of the center hole with the center crack (crack 2) aligned between the impact mark and the cap center. Cracks 1 and 3 were equally spaced on either side of crack 2. The center hole is where the larger diameter of the rod would normally be located. The portion of the inside diameter of the cap that is visible in this illustration contained a circumferential black band, of almost uniform width, indicated by the white arrow. The inside diameter at crack 2 was measured at 0.770 inches and the inside diameter perpendicular to the crack 2 diameter was measured at 0.745 inches.

Figure 3. The impact mark and the cracks observed on the cap.

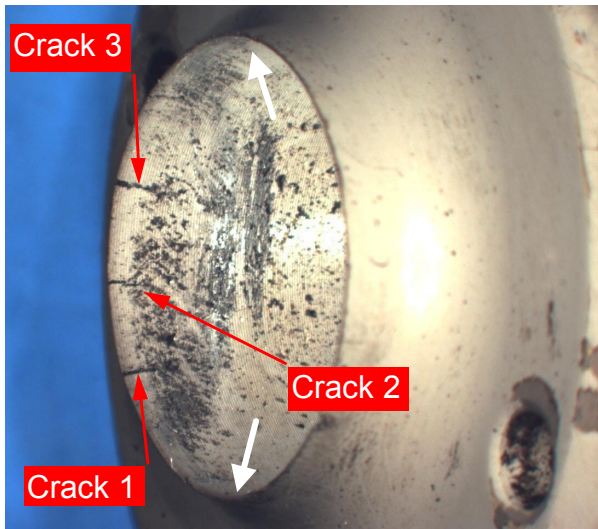
ImageNo:210A0163, Project No:A00329 | 5 mm |

The inside surface of the cap, at the three cracks, is illustrated in figure 4 with the three cracks numbered as in figure 3. The black areas on the surface consist of particles lodged between the circumferential machining marks. The particles were observed on the full depth of the inside diameter, approximately 0.5 inches, but were more abundant for the first 0.3 inches. The white arrows indicate the start of the black band similarly indicated in figure 3.

Figure 4. The inside diameter of the cap adjacent to the three cracks identified as in figure 3.

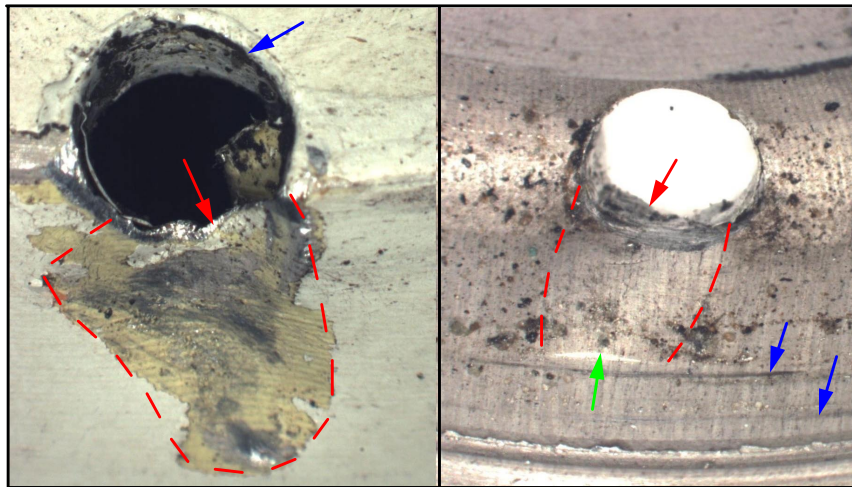
ImageNo: 210A0244, Project No:A00329

A closer view of the impact mark at the vent hole (indicated by the yellow arrow in figure 3) is illustrated in the left view of figure 5. The red dashed line indicates the extent of the deformed surface and the red arrow indicates the edge of the deformed surface at the vent hole. The blue arrow indicates a second slight deformation of the vent hole edge. The right view in figure 5 illustrates the inside surface of the cap, adjacent to the same vent hole. The red dashed line indicates where the inside surface had been deformed inward, and the red arrow indicates the deformed edge of the hole. The green arrow indicates a straight edge to the inward deformation and the blue arrows indicate circumferential score marks that were observed only in the location illustrated.

Figure 5. The exterior (left view) and the interior (right view) of the vent hole with the impact mark.

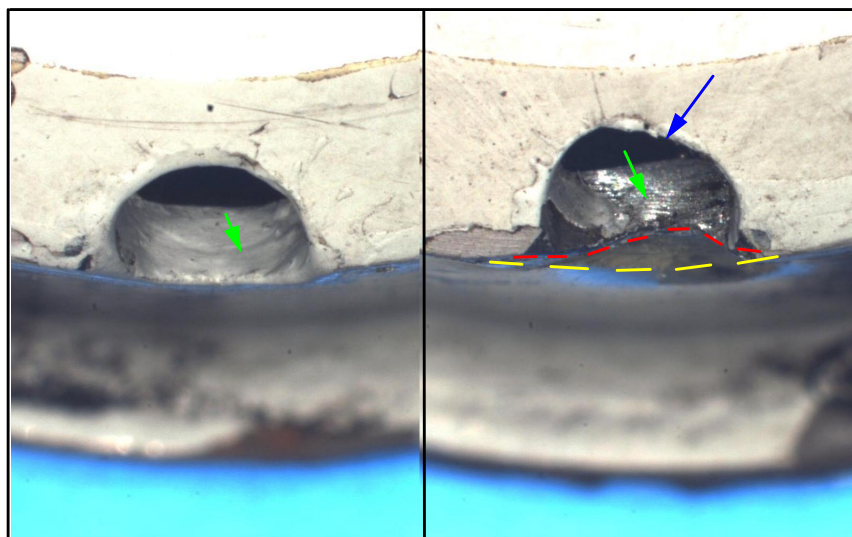
ImageNo: 210A0239, Project No:A00329

The two views in figure 6 are at the same magnification and illustrate two of the vent holes looking from above and parallel to the spring rod axis. The left view illustrates an undamaged vent hole and the right view illustrates the damaged vent hole. The yellow dashed line in the right view indicates what would have been the intact surface and the red dashed line indicates the edge of the impacted hole. The blue arrow, as in the left view of figure 5, indicates deformation to the opposite edge of the hole. In both views, the green arrow indicates circumferential machining marks consistent with the hole being drilled.

Figure 6. Comparison of an undamaged vent hole (left view) and the damaged vent hole (right view) from above.

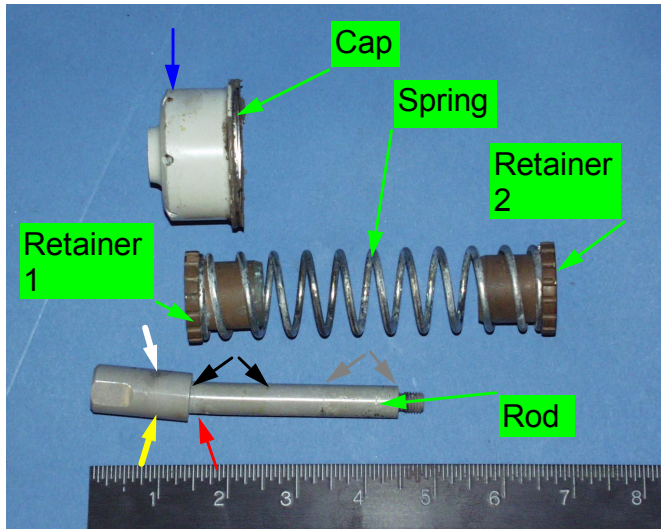
ImageNo:210A0273, Project No:A00329 | 200 mm |

The interacting components, namely the rod, the two retainers, the spring and the cap are illustrated in figure 7, in their relative positions as indicated in figure 2. On the cap, the blue arrow indicates the location of the impact mark, illustrated in figures 3, 5 and 6, and the green arrow indicates location of the cracks, illustrated in figures 3 and 4. The bend in the rod was located at the shoulder between the larger and the smaller diameters and the white, yellow and red arrows indicate the locations of surface features described in the next paragraph. A band of light discoloration was noted around the circumference of the rod at the position indicated by the black arrows in figure 7. A similar band of discoloration, with the addition of corrosion pits, was noted at the position indicated by the gray arrows.

Figure 7. The rod, the spring/retainer assembly and the cap in their relative, assembled, positions.

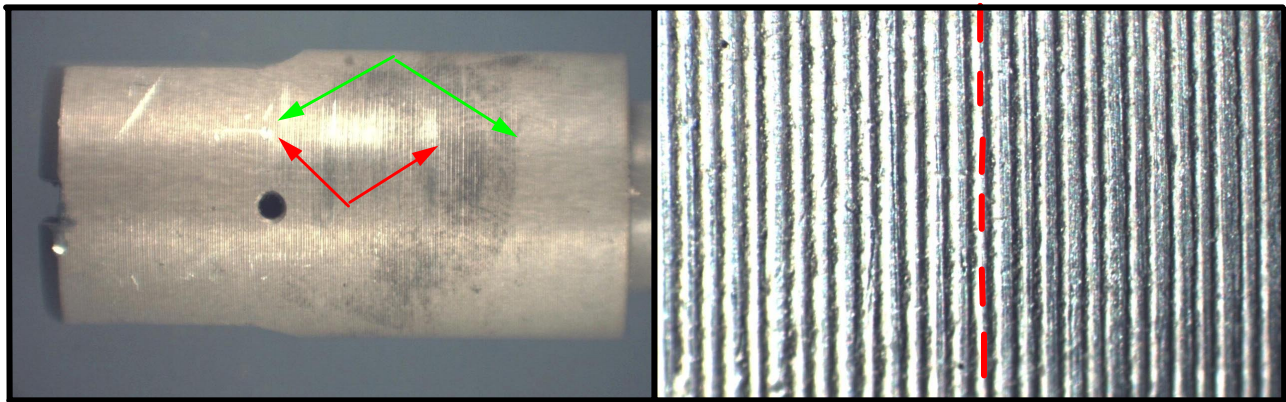
The surface feature on the rod at the location indicated by the white arrow in figure 7 is illustrated in the left view of figure 8. The feature consisted of a black deposit on 3 sides of a shiny surface. The feature was 0.55 inches long, as indicated by the green arrows and the shiny surface was 0.37 inches long, as indicated by the red arrows. The black deposit consisted of particles lodged between the circumferential machining marks and the shiny surface consisted of flattened machining marks. The right view of figure 8 illustrates typical machining marks at this feature. The machining marks to the left of the red dashed line were outside of the shiny surface area and have not been disturbed. The marks to the right

of the red dashed line were located in the shiny surface area and have had their peaks slightly compressed.

Figure 8. The surface feature at the location indicated by the white arrow in figure 7.

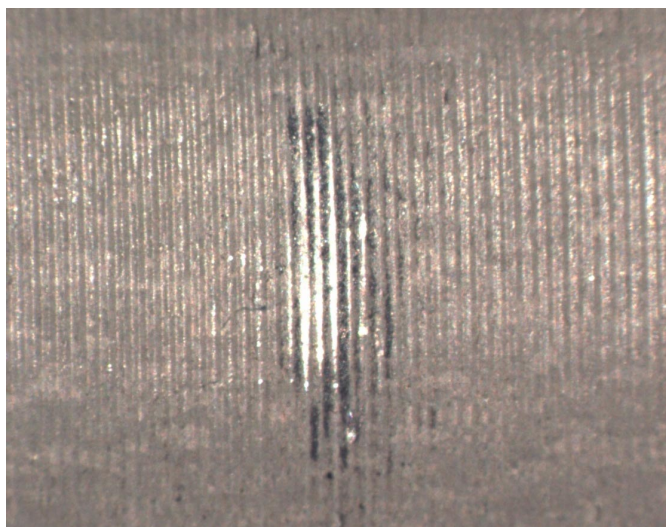
ImageNo: 210A0280, Project No:A00329 | 2 mm |

The surface feature at the location indicated by the yellow arrow in figure 7 is illustrated in figure 9. This feature, located directly opposite to the center of the feature illustrated in the left view of figure 8, displayed a slight compression to the machining marks and more of the black particles lodged between the circumferential machining marks.

Figure 9. The surface feature at the location indicated by the yellow arrow in figure 7.

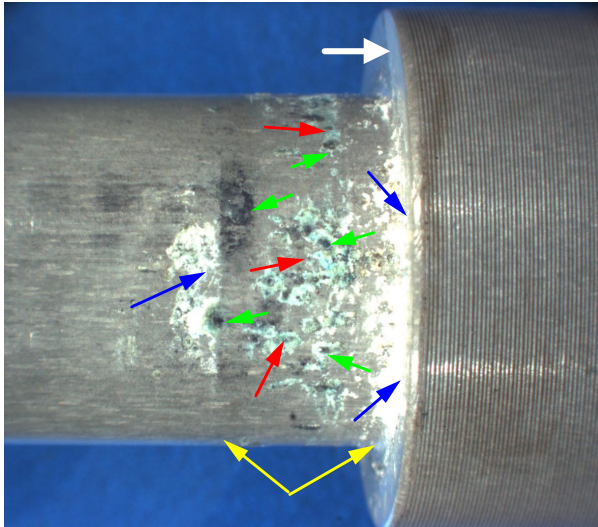
ImageNo:210A0167, Project No:A00329 | 5 mm |

The surface feature at the location indicated by the red arrow in figure 7 is illustrated in figure 10. The yellow arrows in figure 10 indicate a circumferential band containing a black surface deposit, the green arrows indicate black corrosion pits, the red arrows indicate green crystalline deposits, and the blue arrows indicate white crystalline deposits. EDS analysis of the green crystalline deposits revealed elements consistent with an aluminum alloy with distinctive peaks of copper, oxygen and chlorine. Analysis of the white crystalline deposit revealed similar elements with a large chlorine peak.

Figure 10. The surface features at the location indicated by the red arrow in figure 7.

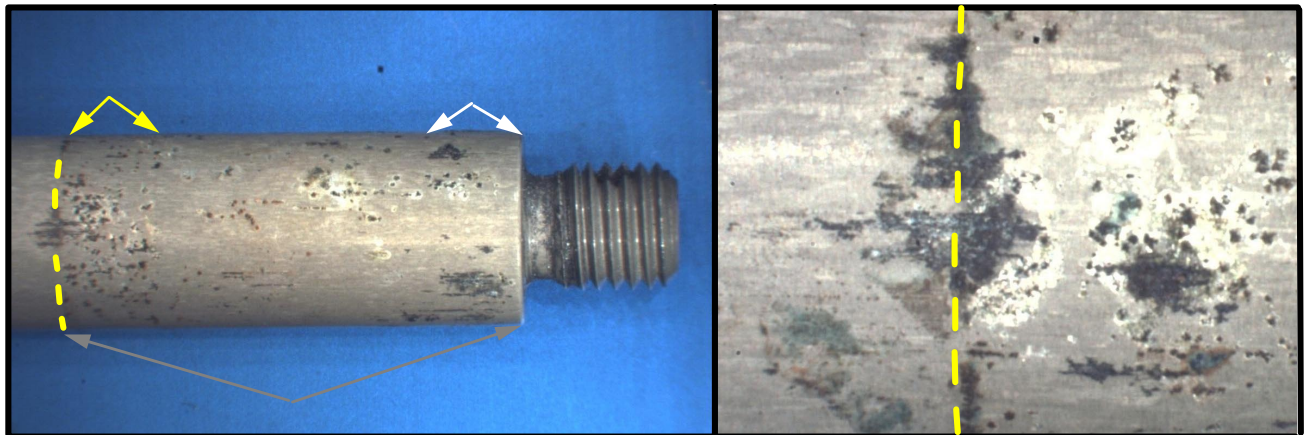
The discolored band with corrosion pits, indicated by the gray arrows in figure 7, is illustrated in the left view in figure 11. The band was approximately 1.06 inches wide from the end adjacent to the thread to the yellow dashed line, with the majority of the corrosion pits located within 0.25 inch-wide bands at each end and indicated by the yellow and white arrows. Visual examination of the surface revealed that the pitting was predominantly black in color and consisted of pits with curved edges and pits that had developed from surface scratches oriented on the longitudinal axis of the rod. The variation in the pits adjacent to the yellow dashed line is illustrated in the right view of figure 11. When the surfaces of some pits were scraped off a majority of them contained white crystals and others contained both white and green crystals, similar in appearance to those illustrated in figure 10.

The surface features at the end of the rod indicated by the gray arrows in figure 7.

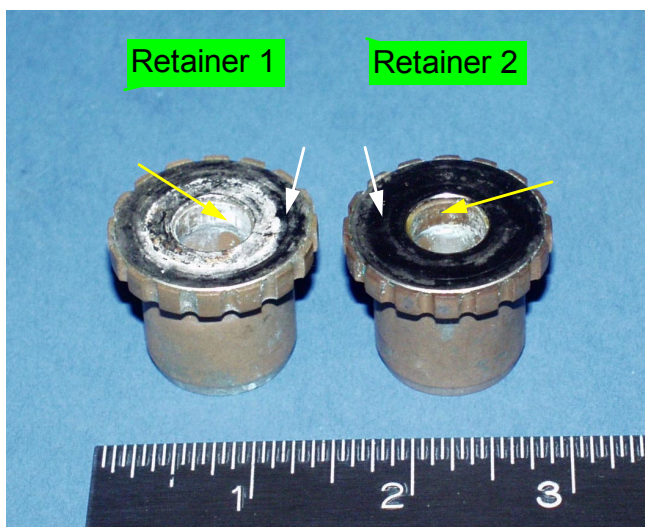
ImageNo:201A0259, Project No:A00329 | 100 mm |

The components identified as retainer 1 and retainer 2 in figures 1 and 7 are illustrated in figure 12. The retainers consist of a brown colored body with a steel washer, identified by the white arrow, located at the outer (as installed) end. The retainers were measured at 1.06 inch long and had an internal shoulder at each end that was 0.25 inch wide. The yellow arrow indicates the outer shoulder on each retainer. The surface of the steel washer on retainer 1, normally in contact with the rod face indicated by the white arrow in figure 10, displayed the same white crystalline deposit. The shoulder, indicated by the yellow arrow, displayed the same white crystalline deposit with light indications of the green crystals. The deposits on retainer 2 appeared similar but were of a much smaller quantity. EDS analysis of the brown colored body revealed that it was a copper alloy.

Figure 12. Retainers 1 and 2 illustrating their outer faces, as assembled and illustrated in figure 7.
