# NATIONAL TRANSPORTATION SAFETY BOARD

MATERIALS LABORATORY FACTUAL REPORT

Report No. 02-083

Place : Belle Harbor, New York  
Date : November 12, 2001  
Vehicle : Airbus A300-600, N14053  
NTSB No. : DCA02MA001  
Investigator : Brian Murphy, AS-40

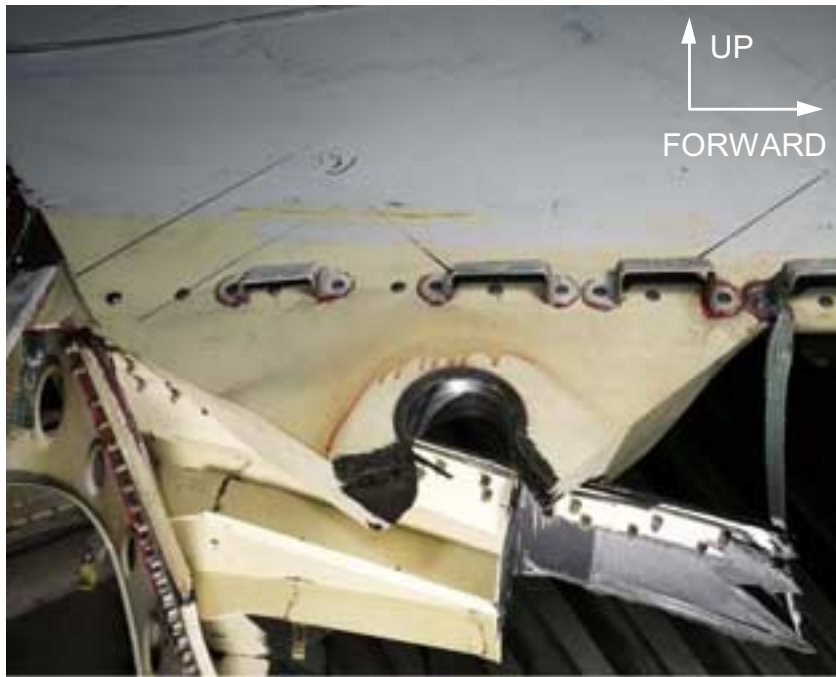
An overall view of the right aft lug upper fracture area on the vertical stabilizer is shown in figure 2. A piece of rib 1 was displaced downward and was covering the inboard side of the fracture surface on the forward leg of the lug. Another view of the right forward lug is shown in figure 3 as viewed from the left after sectioning from the vertical stabilizer. The fracture surfaces intersected the lug attach hole. The lower piece of the lug was not recovered and was missing.

Figure 2. Overall view of the right aft lug viewed from the right showing the upper fracture surfaces. As recovered, a piece of rib 1 was displaced over a portion of the fracture surface.

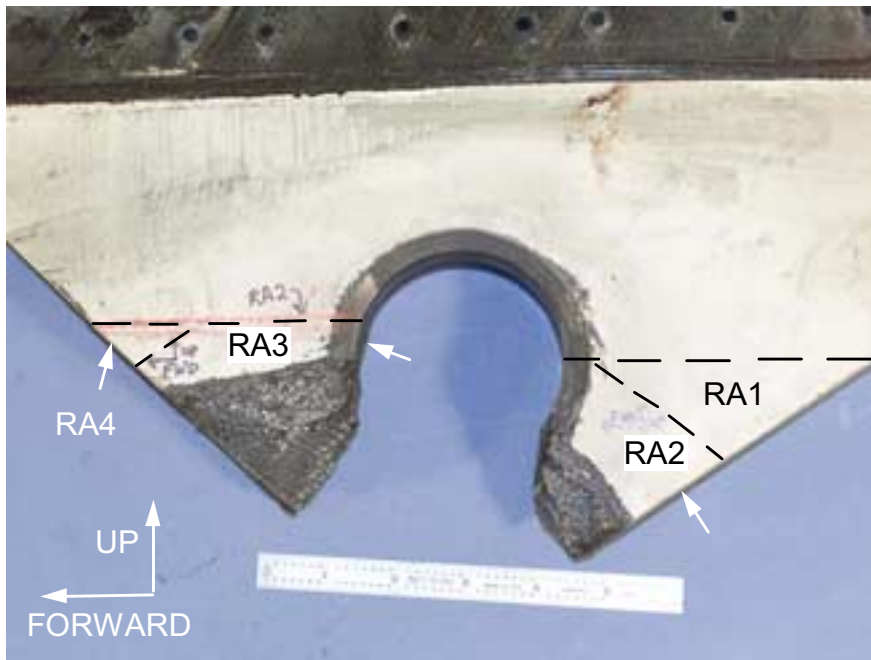
The fracture surfaces were sectioned from the remainder of the lug by cutting at the locations indicated in figure 3. To further facilitate the examination using SEM, specimens RA2 and RA3 were separated along the interlaminar plane that corresponded to the change of plane in the translaminar fracture. This was accomplished by using a screwdriver to pry open the interlaminar cracks indicated in figures 4 and 5. A "-1" and "-2" were added to the specimen labels to indicate the outboard and inboard specimens, respectively. (For example, the inboard portion of specimen RA2 was labeled RA2-2).

Figure 3. View of the right aft lug looking from the left. Dashed lines indicate where cuts were made.

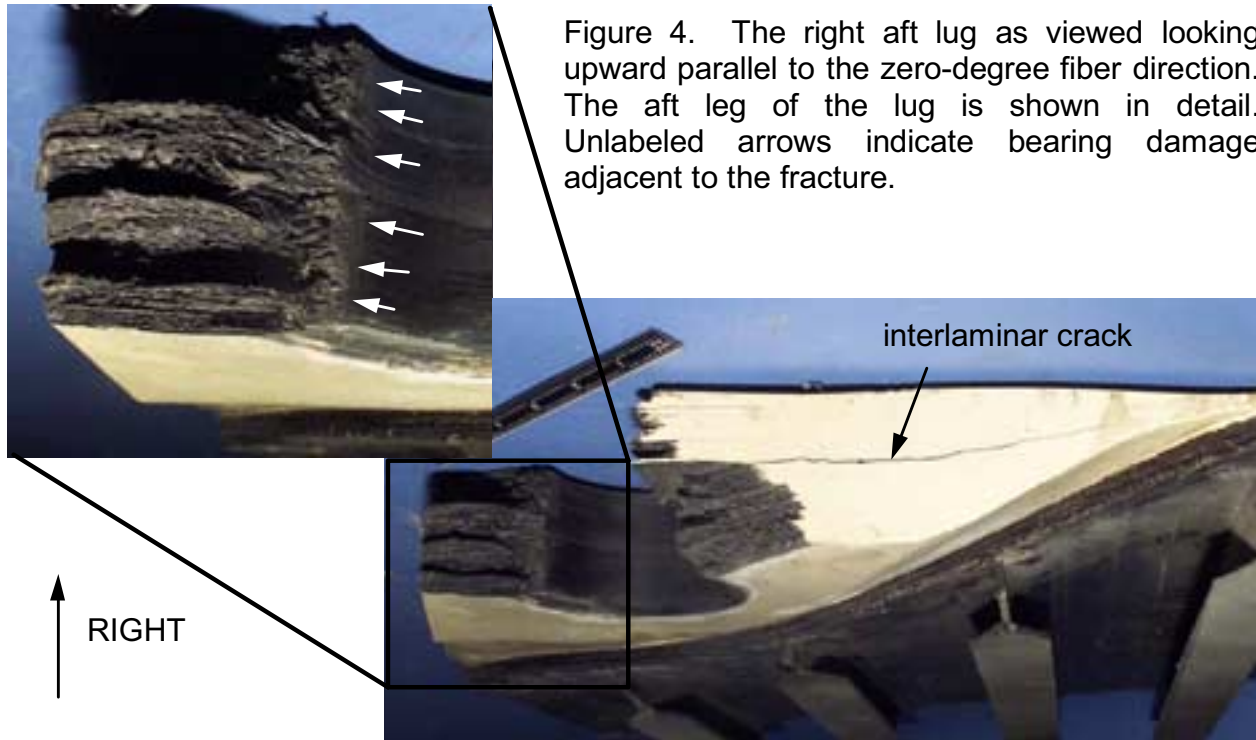
Views of the translaminar fracture surfaces on the aft and forward legs of the right aft lug are shown in figures 4 and 5. The translaminar fracture surfaces had a rough

appearance consistent with fracture primarily under tensile loading. Fractures on each leg of the lug were on different translaminar planes, and the change in planes occurred near the center of the lug thickness. On the aft leg, the outboard side of the fracture was in a plane nearly perpendicular to the zero-degree fiber direction, and the inboard side of the fracture was in a plane approximately parallel to the 45-degree fiber direction. On the forward leg, the outboard side of the fracture was in a plane approximately parallel to the zero-degree fiber direction, and the inboard side of the fracture was in a nearly horizontal plane. Bearing damage was observed at the bore surface near both fracture surfaces, as indicated in figures 4 and 5.

Some interlaminar cracks were observed above the fracture. Black arrows in figures 4 and 5 indicate the largest cracks visible at the outer surface. These cracks intersected the translaminar fracture where the fracture plane changed. The interlaminar cracks visible at the surface were limited to the lug region below rib 1.

Figure 4. The right aft lug as viewed looking upward parallel to the zero-degree fiber direction. The aft leg of the lug is shown in detail. Unlabeled arrows indicate bearing damage adjacent to the fracture.

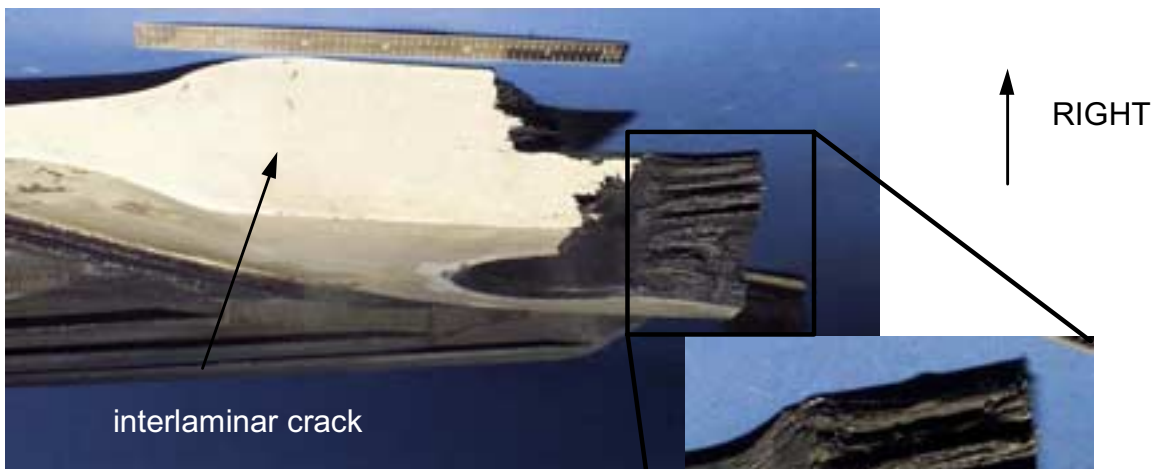
Figure 5. The right aft lug as viewed looking upward and forward. The fracture surface on the forward leg of the lug is shown in detail. Unlabeled arrows indicate bearing damage adjacent to the fracture.

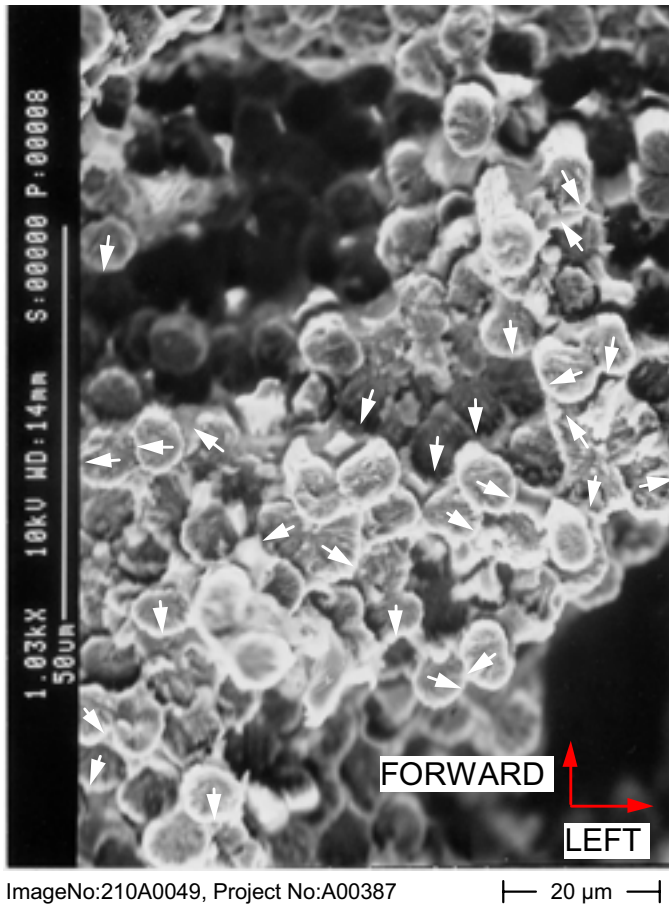
Near the inboard side of specimen RA2-1 (near the center of the lug thickness), the -45-degree fibers were oriented nearly perpendicular to the fracture surface. In this area, these fibers typically showed radial fracture patterns over their fracture surfaces, consistent with overstress fracture under tensile loads. Typical fracture surface features for fibers oriented in the -45-degree orientation in this area are shown in figure 7. Unlabeled arrows in figure 7 indicate the direction of crack propagation within individual fibers. The direction of fracture was sampled from fibers in several locations, and the general direction of fracture was slightly to the right of aft.

Figure 7. Typical appearance of the fractured -45-degree fibers on specimen RA2-1 near the center of the total lug thickness. Arrows on fractured fibers indicate direction of fracture propagation through the fiber.

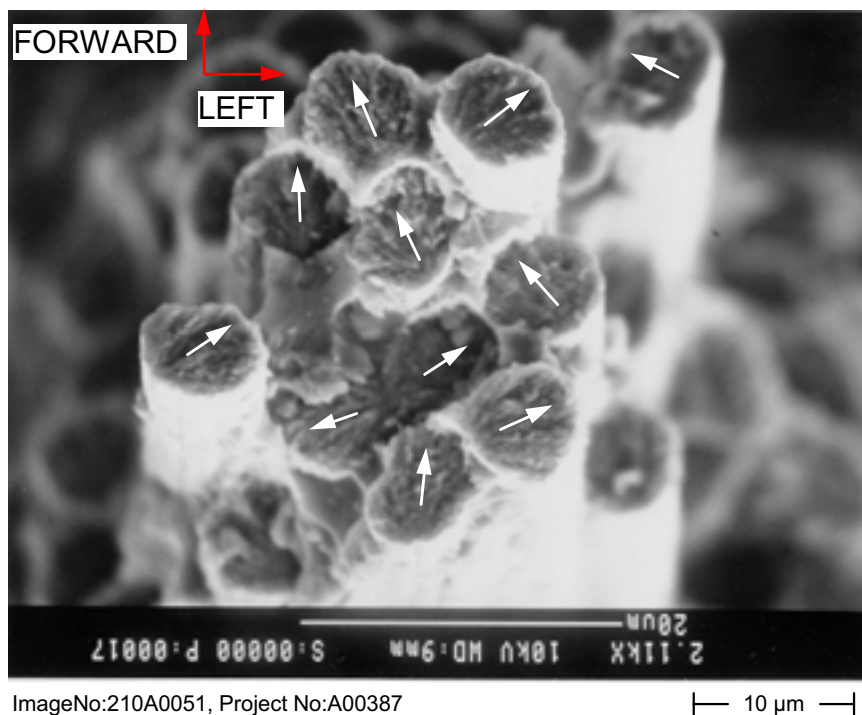
fracture under tensile loads. Similar fracture features were observed throughout the fracture surface. Typical fracture surface features for fibers oriented in the zero-degree orientation are shown in figure 8. Unlabeled arrows in figure 8 indicate the direction of crack propagation within individual fibers. The direction of fracture was sampled from fibers in many locations, and the general direction of fracture was nearly directly forward.

Figure 8. Typical appearance of the fractured zero-degree fibers on specimen RA3-2 near the center of the total lug thickness. Arrows on fractured fibers indicate direction of fracture propagation through the fiber.

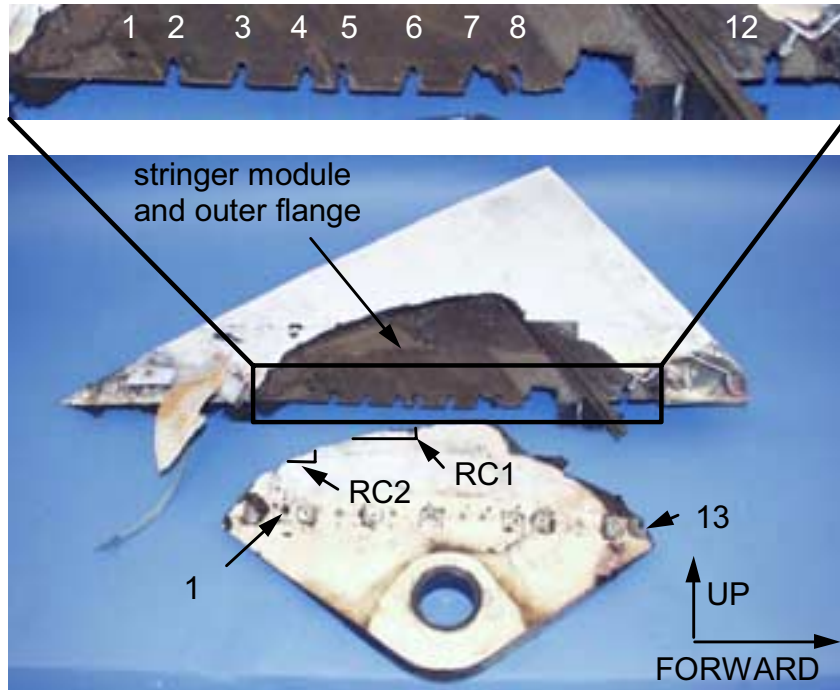
Overall views of the fracture at the right center lug area are shown in figures 9 and 10. The fracture occurred in the vertical stabilizer structure above the lug bore. Translaminar fractures occurred in the skin and the lug build-up layers primarily in a slightly curved plane perpendicular to the zero-degree fiber direction at a location up to approximately 12 inches above the lug attach bolt centerline. As shown in figure 11, the translaminar fracture appeared rough, consistent with fracture from tensile loading. The stringer module structure and stringer outer flange layers, as indicated in figure 9, remained with the upper piece. Rib 1 fastener holes near the lower end of the stringer module and outer flange layers were torn out as shown in the detail in figure 9. The holes are shown numbered aft to forward for reference. The holes for the fasteners that remained with the lower piece were torn out primarily in a downward direction. For holes 2 to 8, the hole was torn out at the lower forward side in a direction parallel to the zero-degree fiber direction, followed by a downward tearout. The material between holes 8 and 9 was torn out and remained attached to the lower piece. A piece of the upper leg of the rib 1 attach angle also remained with the lower piece, as shown in figure 10. Some layers of tape pulled out from the lower piece near the forward side and remained with the upper piece.

The translaminar fracture surface on the lower piece was examined using SEM on two specimens, labeled specimens RC1 and RC2 in figure 9. For fibers oriented in the zero degree direction, the fiber ends generally showed radial fracture patterns over their fracture surfaces, consistent with overstress fracture under tensile loads. Similar fracture features were observed throughout the fracture in areas RC1 and RC2. Typical fracture

Figure 9. Overall view of the right center lug pieces viewed from the right with the upper photograph showing details of the rib 1 fastener hole tearouts in the stringer module and outer flange layers.

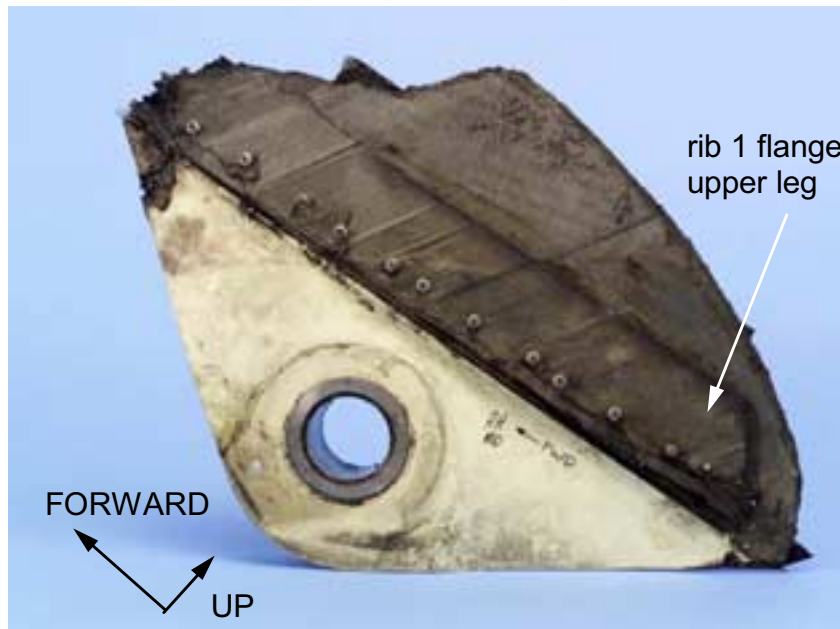
Figure 10. Overall view of the right center lug, lower piece, looking from the left.

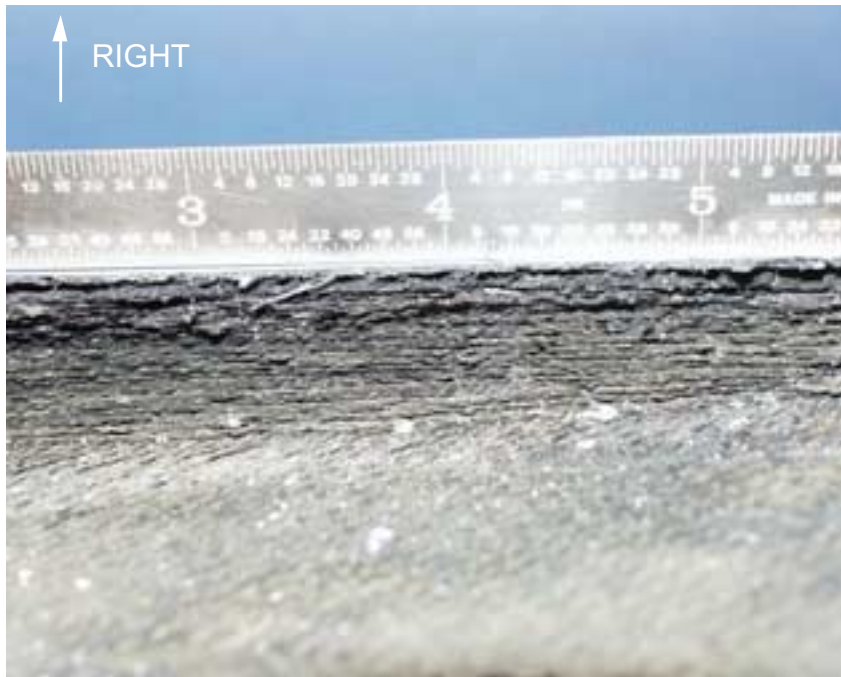
Figure 11. Right center lug upper fracture surface viewed looking upward parallel to the zero-degree fiber direction.

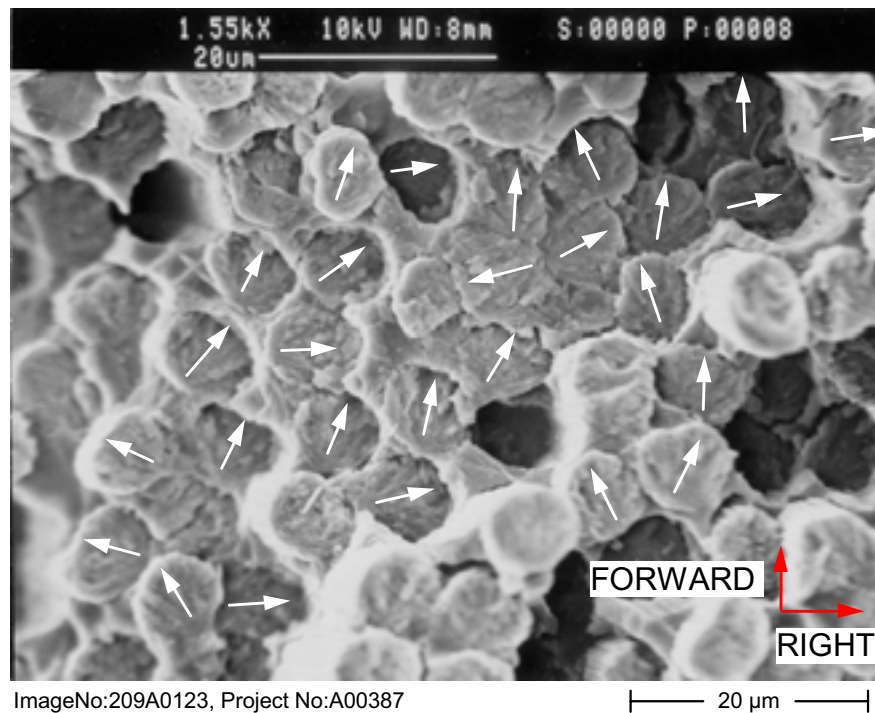
surface features for fibers oriented in the zero-degree orientation are shown in figures 12 and 13 for each area. The area shown in figure 13 was relatively rich in resin compared to other areas on the fracture surface, and the larger areas of resin fracture are indicated in the figure. Unlabeled arrows in figures 12 and 13 indicate the direction of fracture for individual fibers. The direction of fracture was sampled from many locations in the two areas. In specimen RC2, the general direction of fracture was to the right of forward, and in specimen RC1, the direction of fracture was nearly directly forward.

Figure 12. Typical appearance of the fractured zero-degree fibers on specimen RC2 near the exterior surface. Arrows on fractured fibers indicate direction of fracture propagation through the fiber.

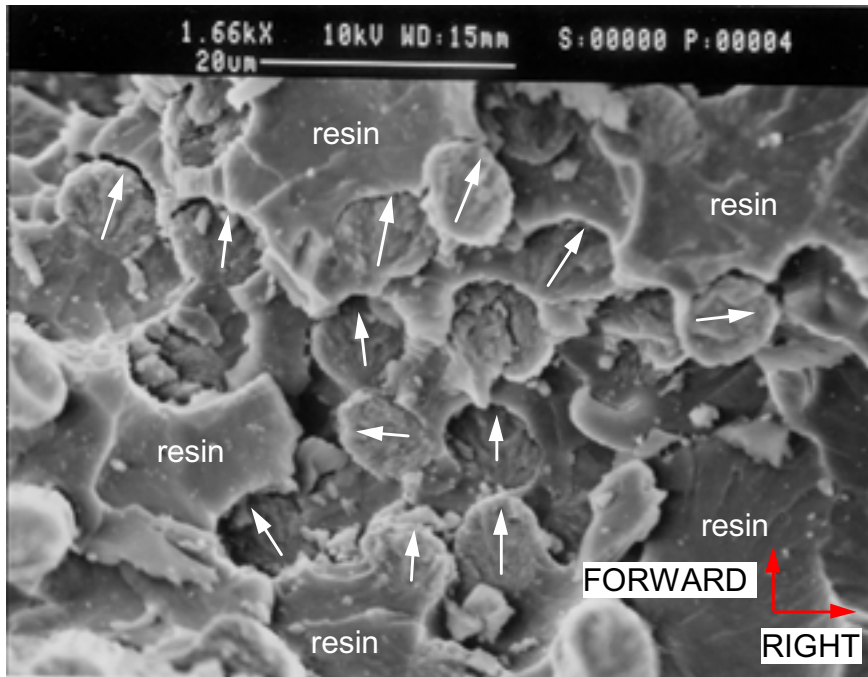
Figure 13. Typical appearance of the fractured zero-degree fibers on sample RC1 near the exterior surface. Arrows on fractured fibers indicate direction of fracture propagation through the fiber.

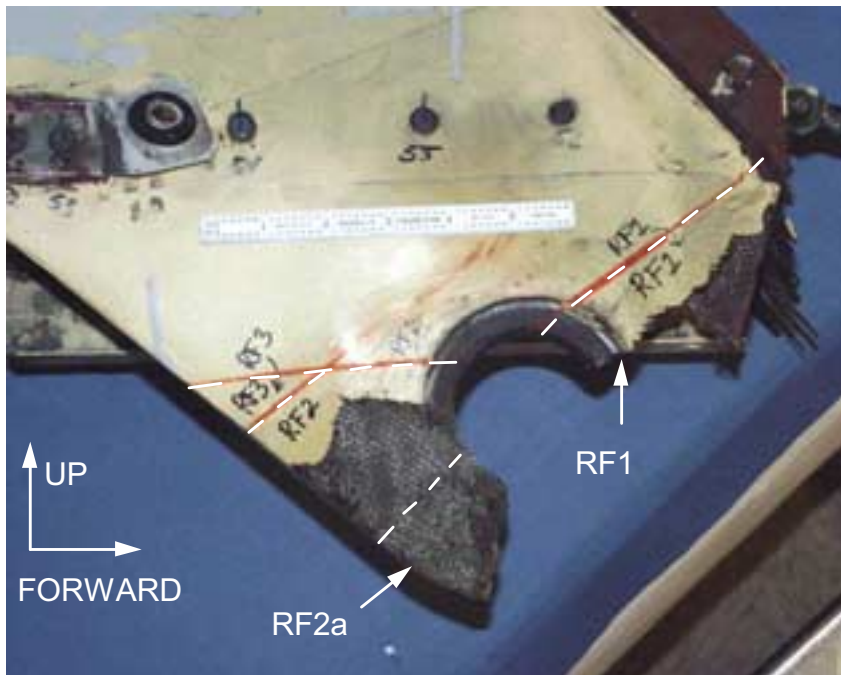
An overall view of the right forward lug upper fracture area is shown in figure 14. Additional views of the right forward lug are shown in figures 15 to 24. The fracture surfaces intersected the lug attach hole. Most of the lower portion of the lug was missing and was not recovered, but a small amount of composite material was left in the circumferential groove between the two hat bushings that remained attached to the fuselage. The translaminar fracture surfaces had a rough appearance consistent with fracture primarily under tensile loading. A few layers near the inboard and outboard surface had translaminar fractures approximately three inches above the remaining translaminar fractures with interlaminar fractures between the translaminar fracture locations.

The translamina fracture surface on the aft leg of the lug, specimen RF2a in figure 14, was examined using SEM. For fibers oriented in the zero degree direction, the fiber fractures typically showed radial fracture patterns over their fracture surfaces as shown in figure 21 and the upper portion of figure 22, features consistent with overstress fracture under tensile loads. In some areas near the center of the lug thickness, some of the zero-degree fibers had relatively smooth fracture features with changes in the fracture plane within the fibers (called chop marks), features consistent with local fiber bending under compressive load. These areas were relatively isolated and appeared to coincide with areas where the fractured ends of layers appeared bent or damaged from the optical examination. Other zero-degree fibers in the same areas had radial fracture patterns, consistent with overstress fracture under tensile load. Figure 22 shows a view from the center of the thickness showing fibers with the different fracture features in the same view. Unlabeled arrows in figures 21 and 22 indicate the direction of fracture for individual fibers. The direction of fracture was sampled from many locations throughout specimen RF2a. For most of the fracture area, the general direction of fracture was slightly to the right of downward and aft. In the center of the thickness near the lug bore, the direction of fracture was approximately midway between the left and the downward and aft directions.

The translamina fracture surface on the forward leg of the lug, specimen RF1 in figure 14, was examined using SEM. For fibers oriented in the zero degree direction, the fibers typically showed radial fracture patterns over their fracture surfaces, consistent with overstress fracture under tensile loads. Similar fracture features were observed throughout the fracture surface. Typical fracture surface features for fibers oriented in the zero-degree orientation are shown in figure 24. Unlabeled arrows in figure 24 indicate the direction of fracture for individual fibers. The direction of fracture was sampled from many locations, and the general direction of fracture was slightly to the left of forward.

Figure 14. Overall view of the right forward lug upper fracture area. Dashed lines indicate locations where cuts were made.

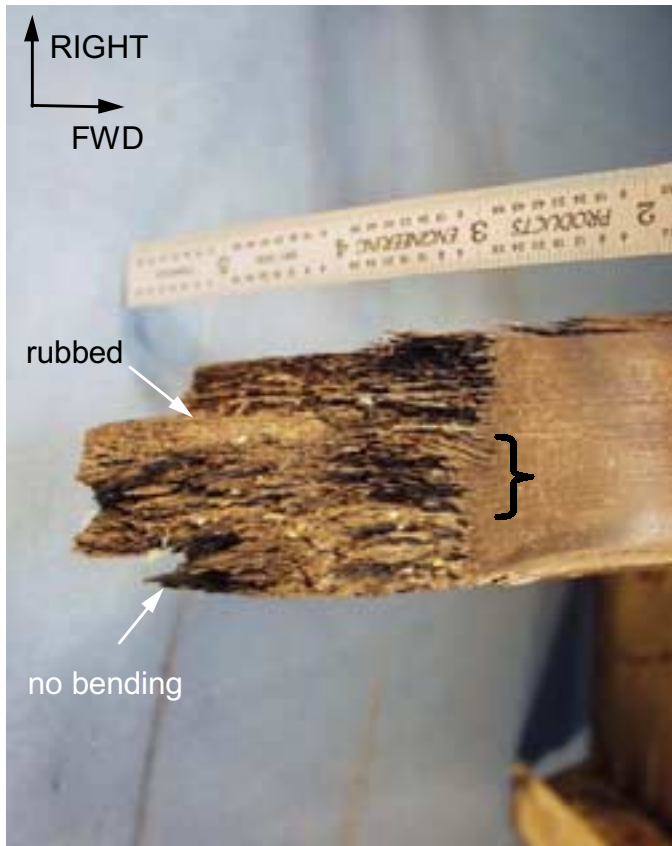
The aft leg of the lug is shown in figures 15 to 20. Fracture on the aft leg of the lug occurred on different planes. On the inboard and outboard sides of the aft leg, the fracture was on planes perpendicular to the zero-degree fibers along the length of the spar, and near the center of the aft leg, the fracture was on a plane approximately parallel to the 45-degree fiber direction. Near the bore surface, some fractured ends of the layers were bent to the right as shown by the black bracket in figure 15. At the aft end, some fractured ends of the layers near the center of the lug thickness were bent to the left, as shown by the white bracket in figure 16. On the right of these center layers, the fracture surface had a smooth appearance consistent with post-fracture contact damage (see arrow labeled "rubbed" in figure 15). A few layers near the inboard interlaminar fracture were not bent, as indicated in figure 15, although many adjacent layers to the right were fractured above the translaminar fracture for the indicated layer. At the aft end as indicated in figure 16, some of the fractured ends of the layers near the outboard surface were bent to the right, and some of the fractured ends of the layers near the inboard surface were bent to the left consistent with a local compressive loading.

Figure 15. Direct view of the right forward lug, aft leg looking upward and aft. The bracket indicates fiber ends bent to the right.

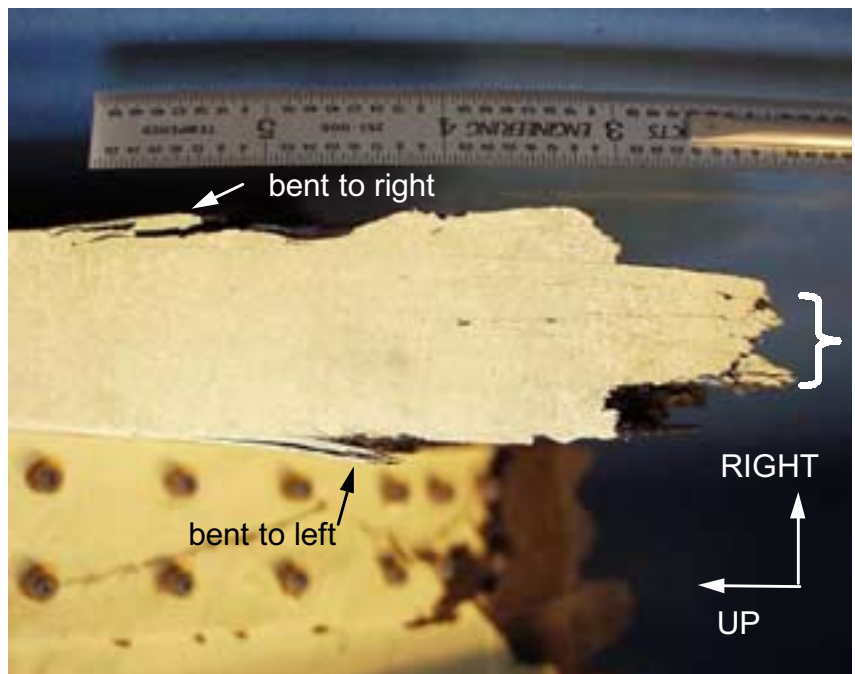
Figure 16. The aft surface of the right forward lug above the fracture through the aft leg, showing delaminations. View is looking upward and forward. The bracket indicates fiber ends bent to the left.

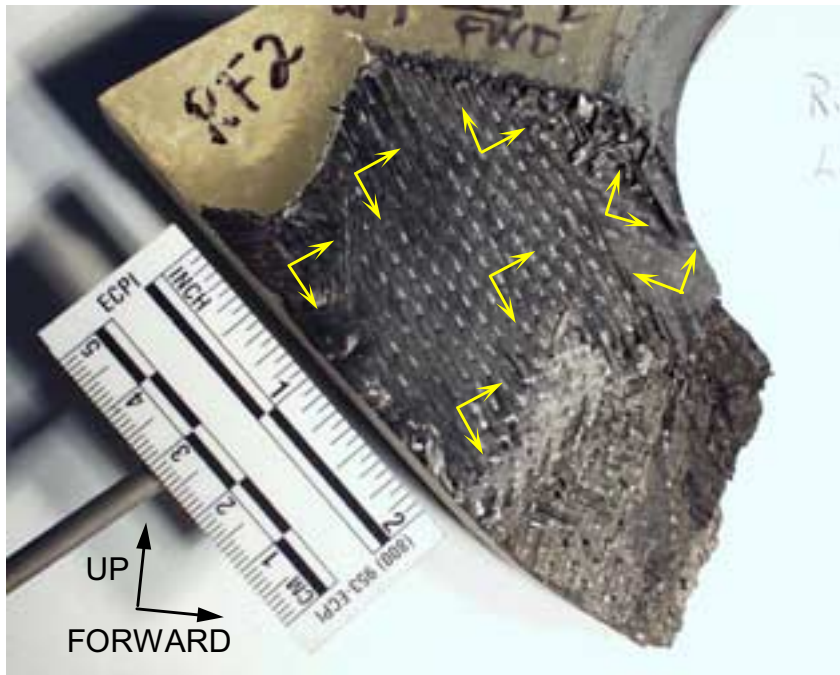
The interlaminar fractures near the inboard and outboard sides of the aft leg were examined using SEM. Relative motions of the mating fractures were determined from the hackle directions in the epoxy matrix, and the general crack propagation direction was determined from river markings<sup>4</sup>, also in the epoxy matrix. The results are shown in figures 17 to 20. Relative to the center layers at the time of fracture, the outer and inner layers

Figure 17. Aft leg of the right forward lug showing the outer delamination surface. Arrows indicate directions of hackles observed. Shear tractions on the surface acted opposite to the direction of the hackles.

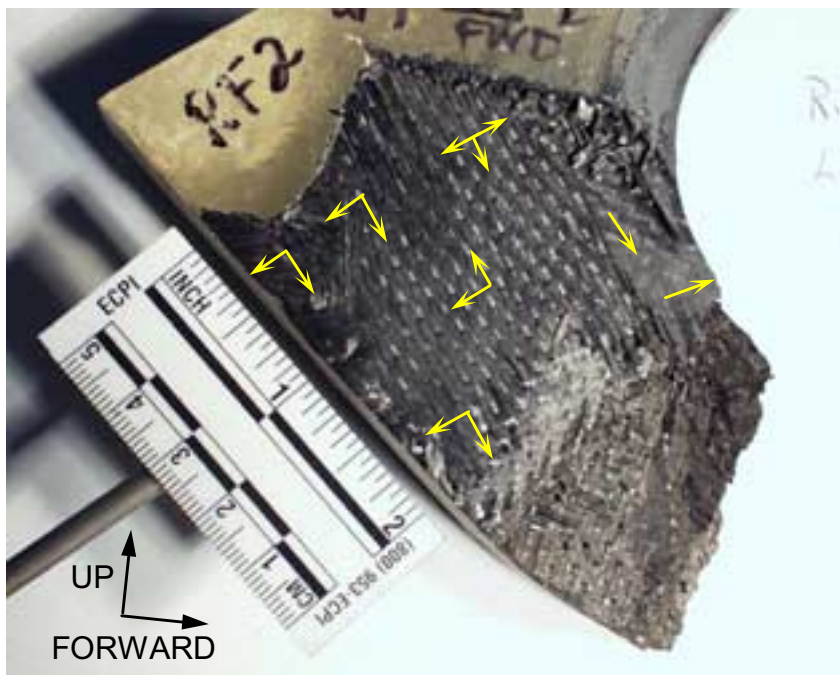
Figure 18. Aft leg of the right forward lug showing the outer delamination surface. Arrows indicate the direction of the river markings at the bases of the hackles.

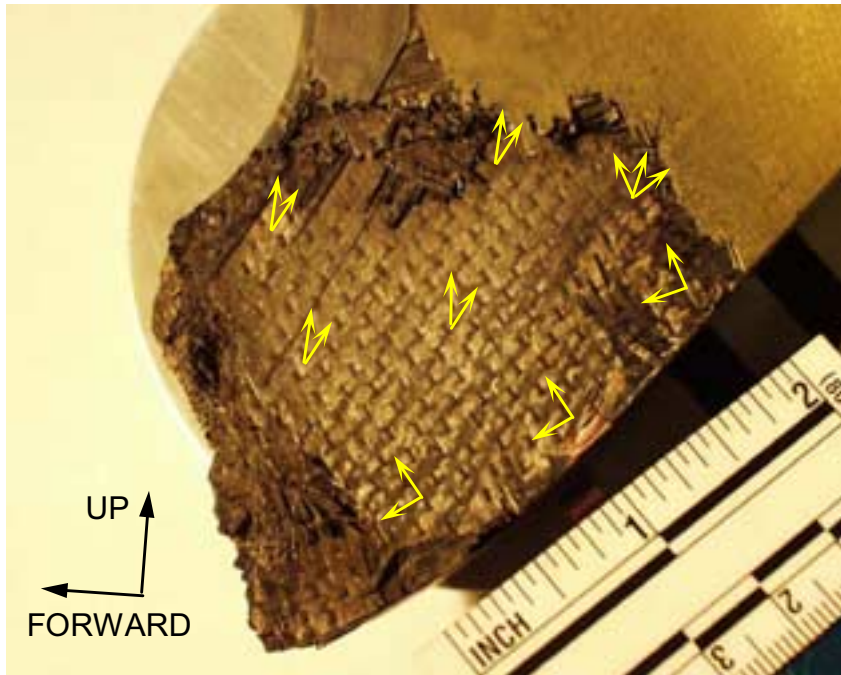
Figure 19. Aft leg of the right forward lug showing the inner delamination surface. Arrows indicate directions of hackles observed. Shear tractions on the surface acted opposite to the direction of the hackles.

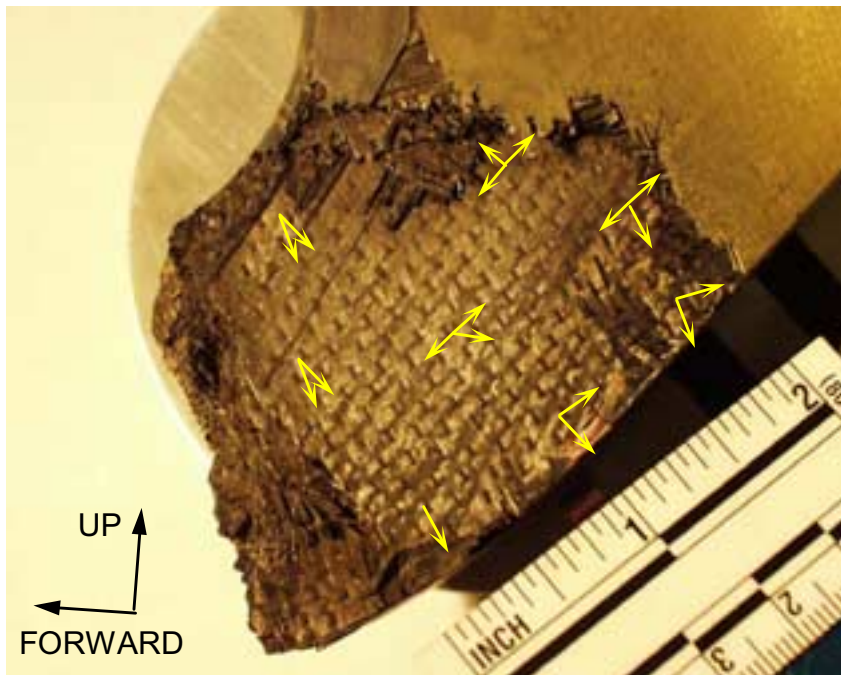
Figure 20. Aft leg of the right forward lug showing the inner delamination surface. Arrows indicate the direction of the river markings at the bases of the hackles.

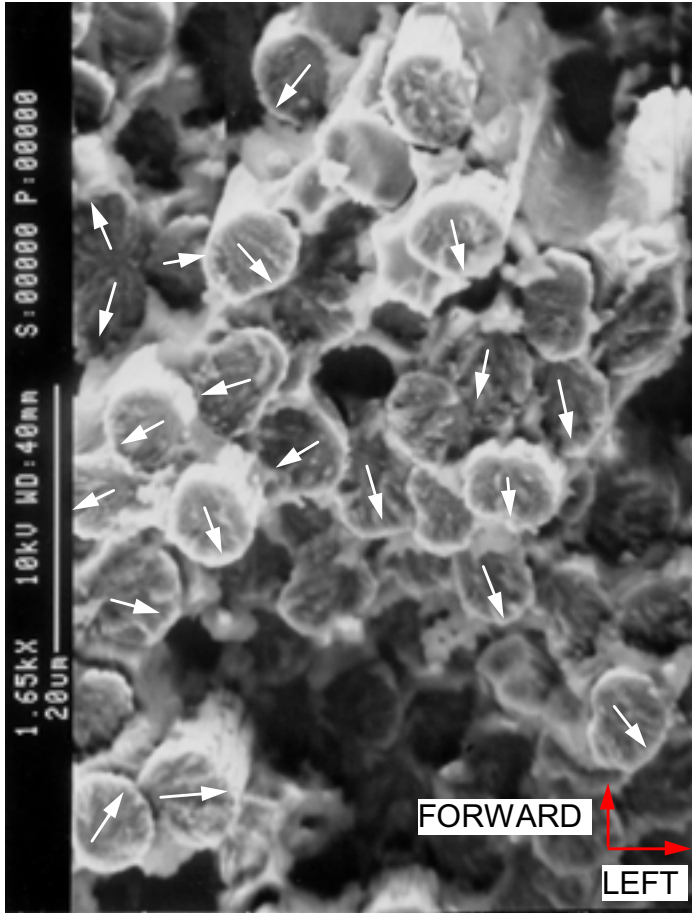
Figure 22. Typical appearance of the fractured zero-degree fibers on sample RF2a near the forward and center portions of the fracture. Arrows on fractured fibers indicate direction of fracture propagation through the fiber. Arrows "c" indicate fiber ends having chop marks.

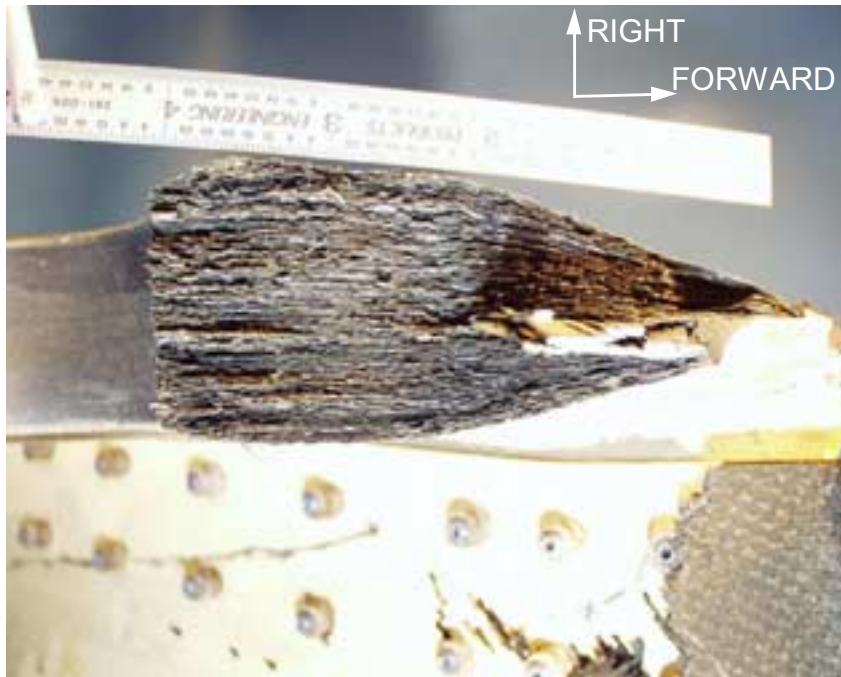
On the forward leg of the lug, the fracture surface was almost entirely on a plane that was perpendicular to the length direction of the front spar as shown in figure 23. Near the forward end, some center layers did not have transverse fractures and extended below the fracture surface to the original lug forward lower surface. The lower ends of these center layers were bent to the left and had a rubbed appearance on the right side. Red-colored deposits were observed on the fracture surface in the adjacent area.

Figure 23. Fracture surface on the forward leg of the right forward lug, View is looking upward parallel to the zero-degree fiber direction.

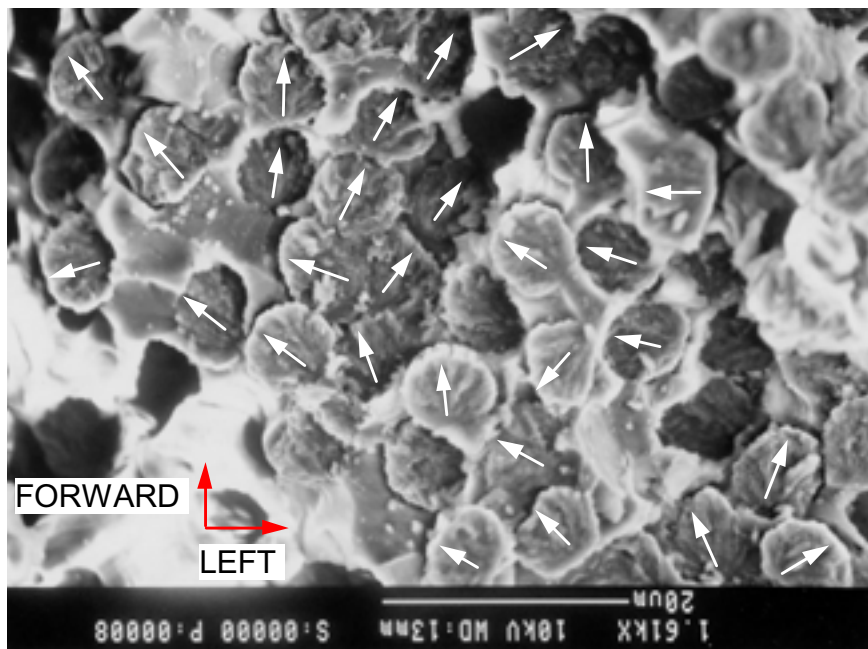
Figure 24. Typical appearance of the fractured zero-degree fibers on sample RF1 near the outer and aft portions of the fracture. Arrows on fractured fibers indicate direction of fracture propagation through the fiber.

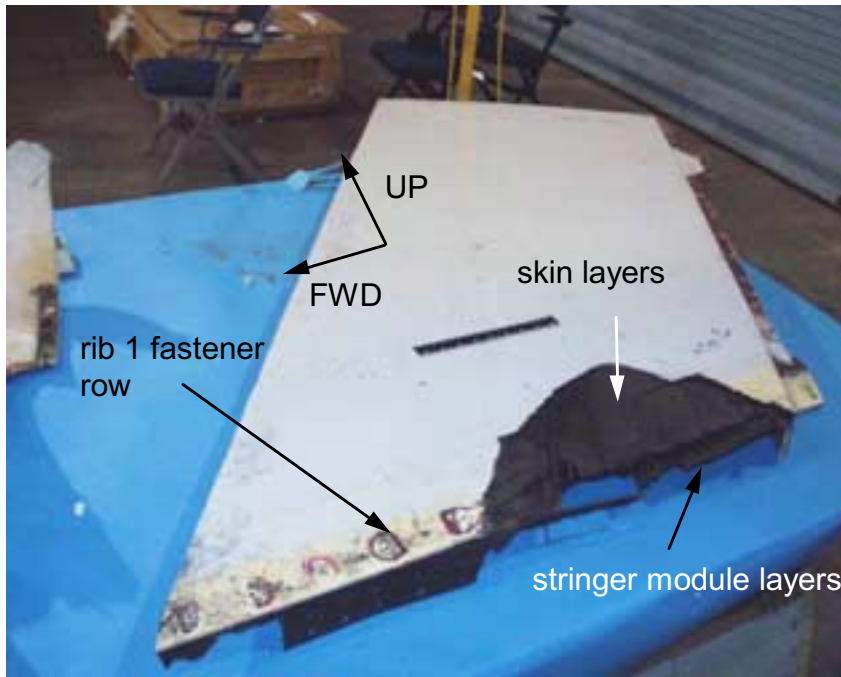
Overall views of the left aft lug area are shown in figures 25 and 26. A combination of fractures listed below allowed the lug structure to separate from the vertical stabilizer and remain attached to the fuselage after the accident, leaving a gap between the skin layers and the stringer module structures at the aft lower end of the vertical stabilizer. Ultrasonic C scans performed by NASA and by Airbus indicated that this gap was part of a continuous interlaminar fracture extending at least 2 inches forward of stringer 4 and 8 inches above rib 4. For more details of the nondestructive examination, see Materials Laboratory Factual

Figure 25. Overall view of the upper piece containing the upper portion of the fracture at the left aft lug, viewed looking up and to the right.

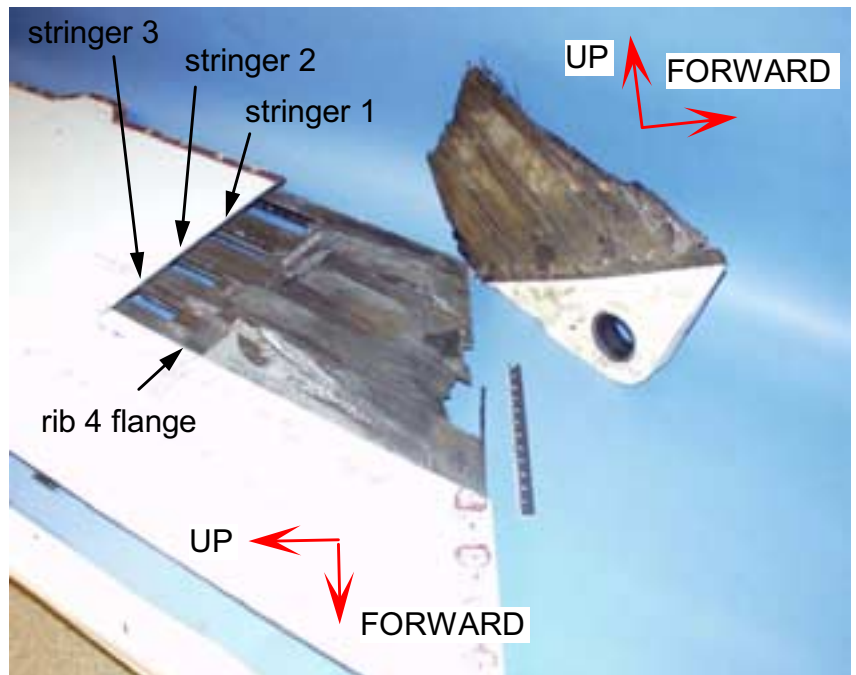
Figure 27. Mating fracture surfaces at the left aft lug area between the lower piece and the stringer module structure of the upper piece after cutting through the skin.

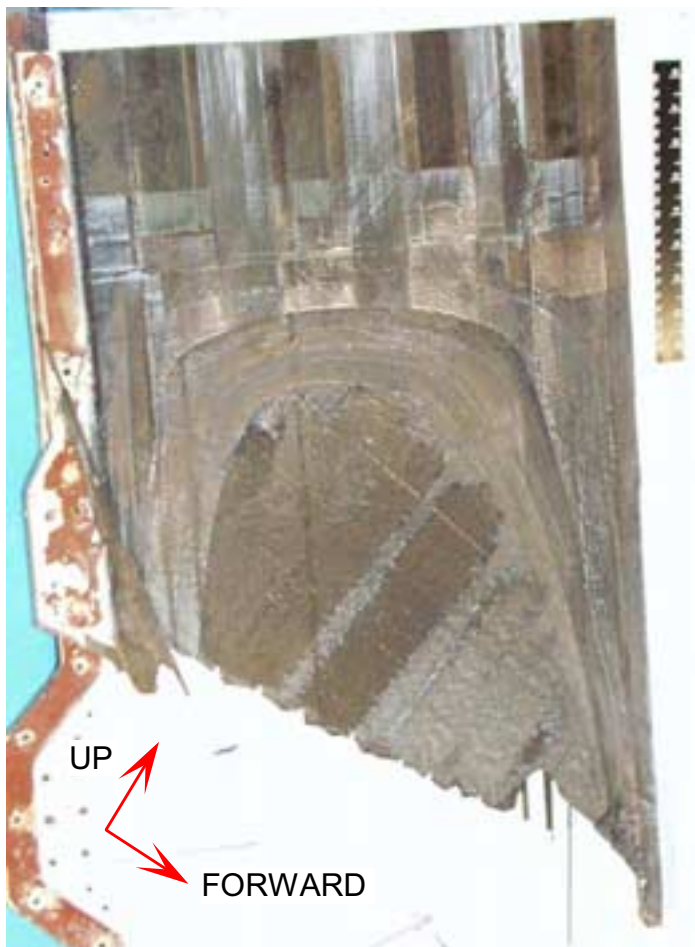
Figure 28. Inner surface of the vertical stabilizer skin section at the left aft lug after cutting from the upper piece. The lower portion of this interlaminar surface mates to the outer surface of the inner precured lug half.

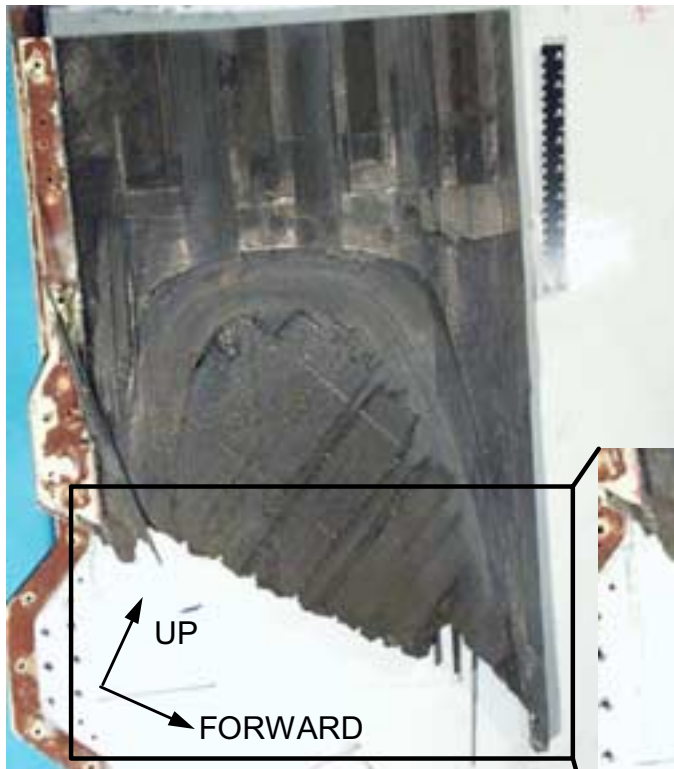
Figure 31 shows the interior surface of the skin section after cutting from the upper piece. The row of rib 1 fastener holes in the skin section is indicated in the inset photograph in this figure. The translaminar fracture in the skin intersected most of these fastener holes except for an area near the forward end, where the fracture was above holes 9 to 11.

Figure 31. The interior surface of the skin section at the left aft lug fracture area after cutting from the upper piece. Inset photograph shows the numbered rib 1 fastener holes.

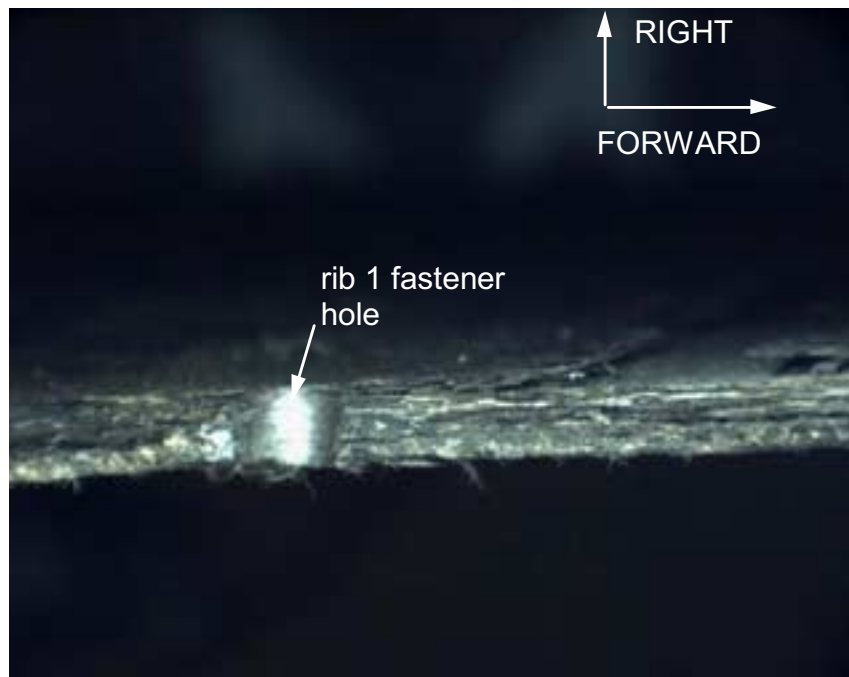
Figure 32. Vertical stabilizer skin fracture at a rib 1 fastener hole in the vicinity of the left aft lug, viewed looking upward.

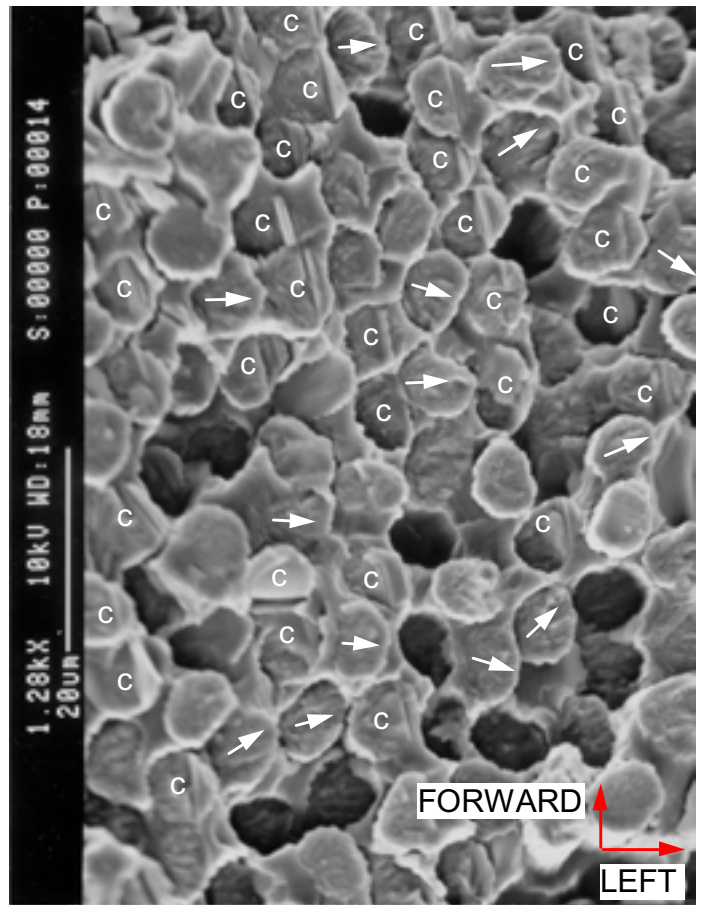
Figure 34. SEM photograph from the center of specimen LA5a. Arrows indicate the direction of tensile crack propagation and labels "c" indicate compressive failure on the ends of zero-degree fibers.

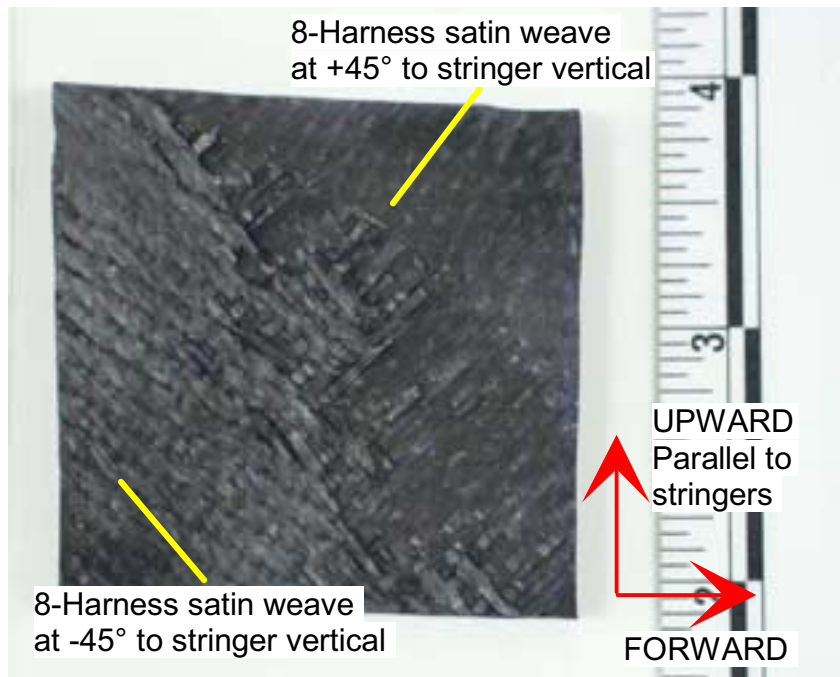
Figure 35. Fracture surface of specimen LA1a.

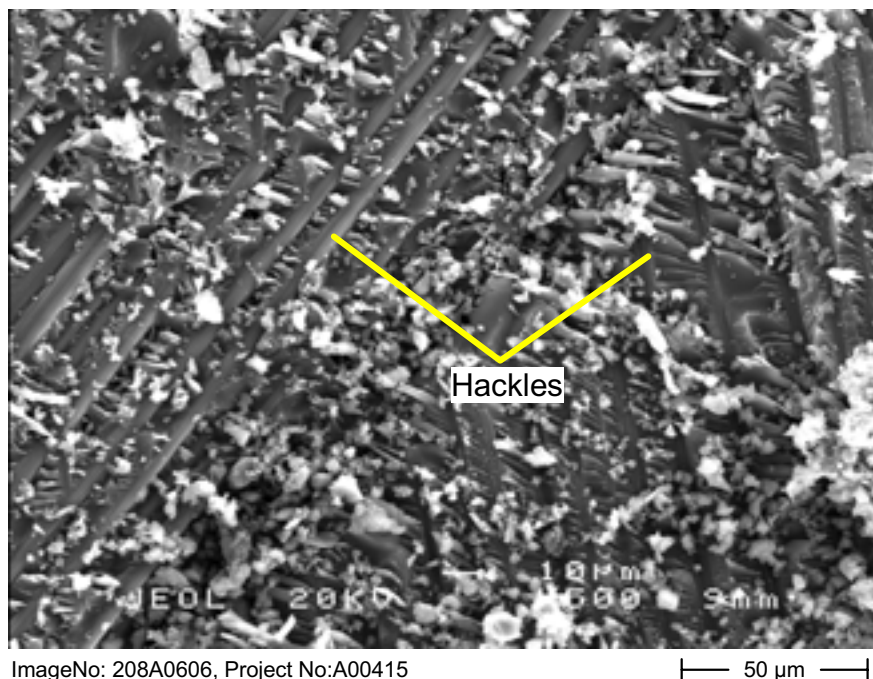
Figure 36. Example SEM photograph from the top forward area of specimen LA1a. Hackles are indicated between +45-degree fibers (left) and zero-degree imprints (right), pointing up and forward. Orientation as in figure 35.

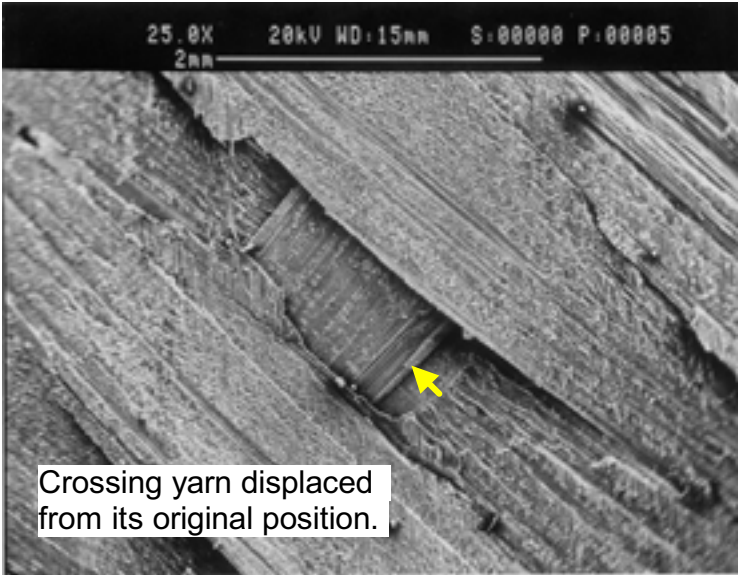
Figure 37. Specimen LA5 inner surface. An unlabeled arrow indicates a crossing bundle that was displaced from its original position. Orientation as in figure 35.
