# NATIONAL TRANSPORTATION SAFETY BOARD

MATERIALS LABORATORY FACTUAL REPORT

Report No. 02-083

Place : Belle Harbor, New York  
Date : November 12, 2001  
Vehicle : Airbus A300-600, N14053  
NTSB No. : DCA02MA001  
Investigator : Brian Murphy, AS-40

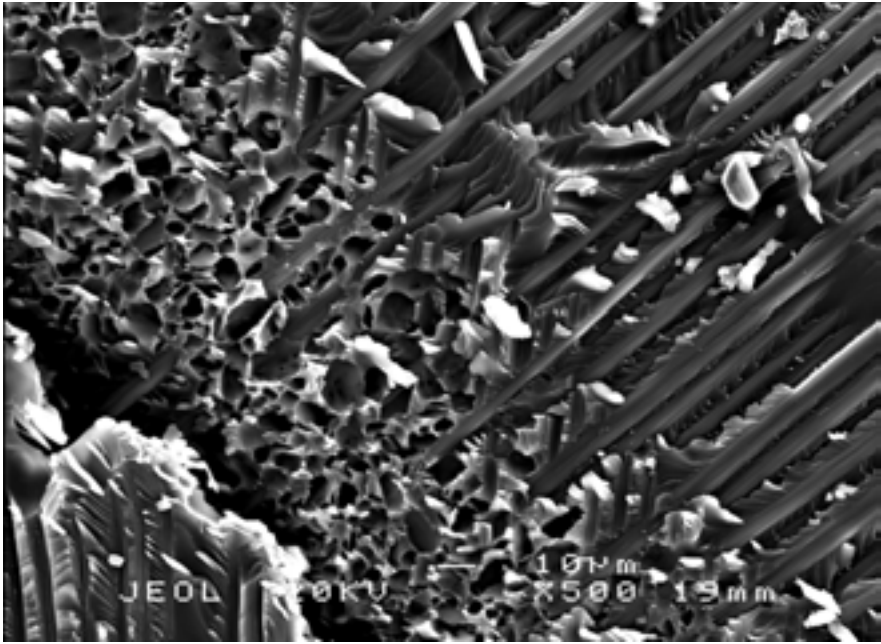
Figure 38. Microscopic matrix porosity in a region where bundles cross on specimen LA1b. The main bundle is at the upper right, and vertical imprints are at the lower left. Orientation as in figure 35.

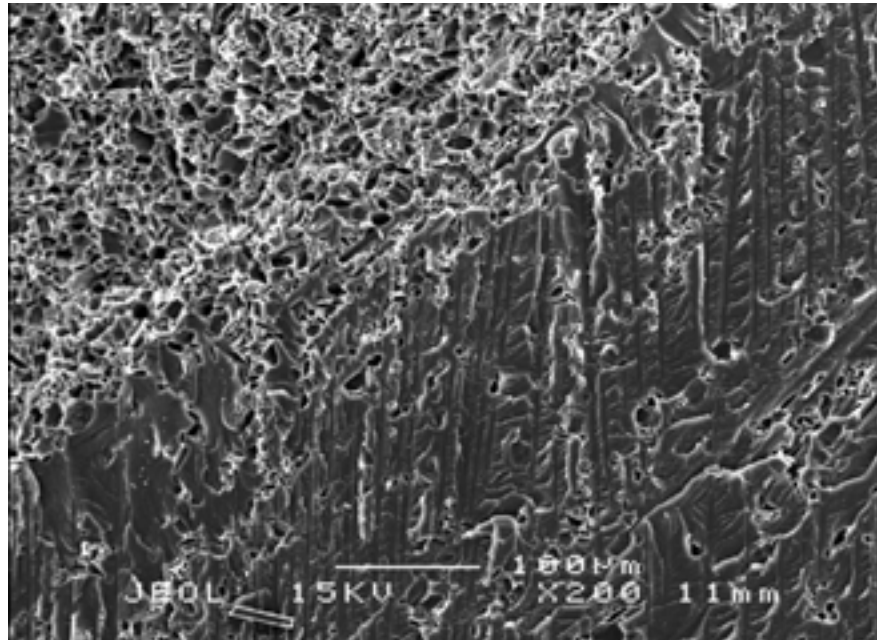
Figure 39. Microscopic matrix porosity on the outboard piece of LA1c. This porosity is shown at the upper left, with ill-defined hackles shown at the lower right. Orientation as in figure 35.

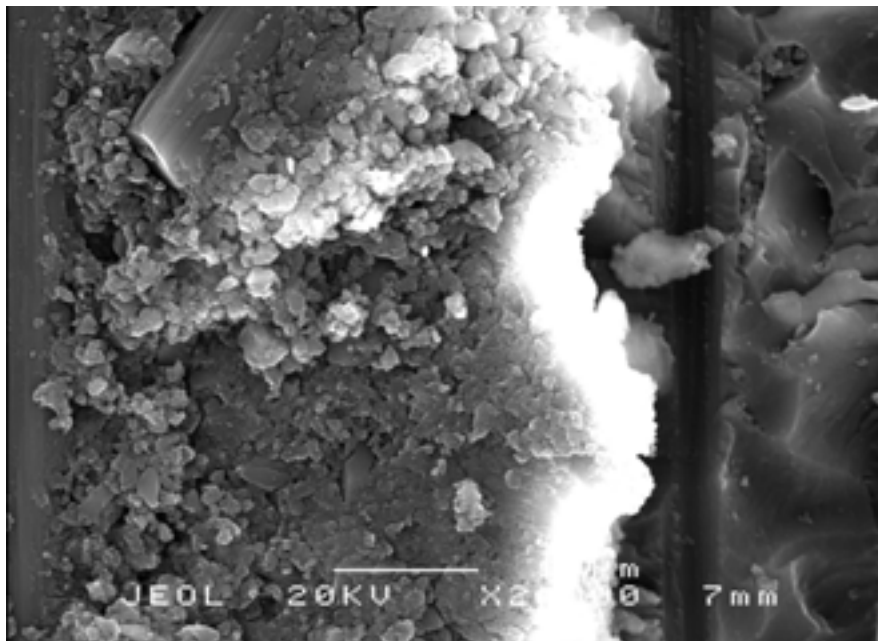
Figure 40. Microscopic matrix granularity on the outboard piece of LA1c. A fiber fragment is shown at the upper left. Orientation as in figure 35.

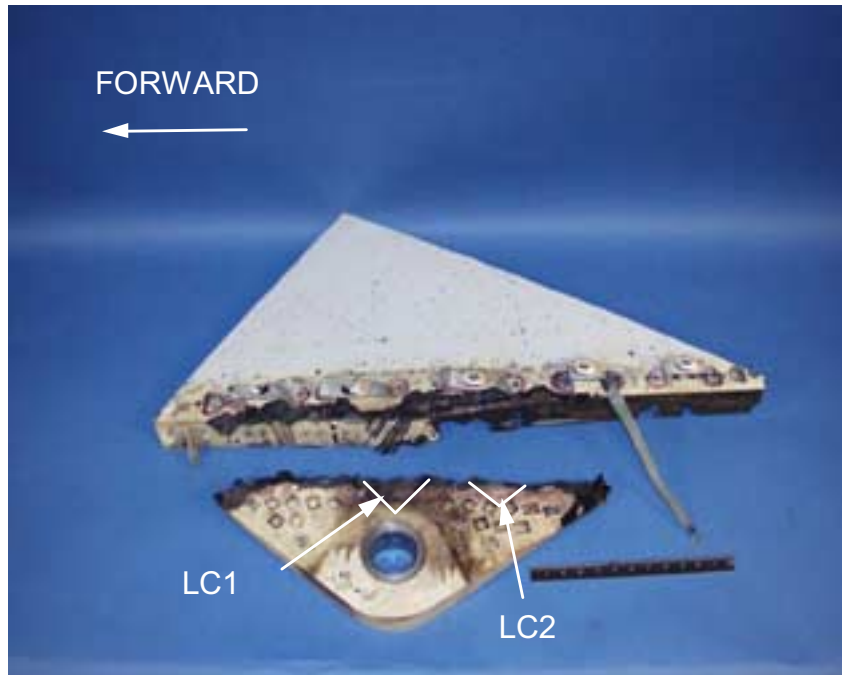
Figure 41. Overall view of the two portions of the fractured structure at the left center lug viewed looking from the left.

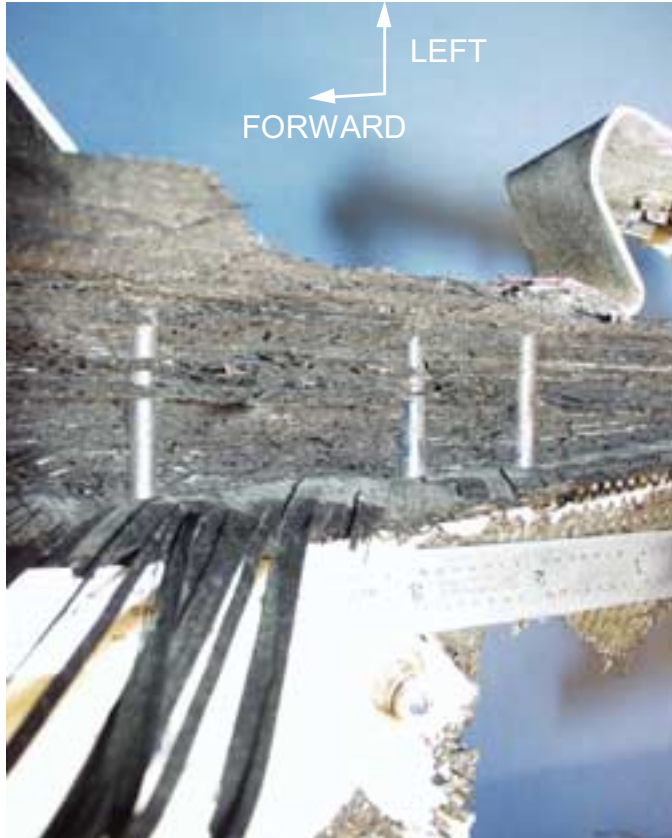
Figure 42. Upper fracture surface at the left center lug, viewed looking upward parallel to zero-degree fibers.

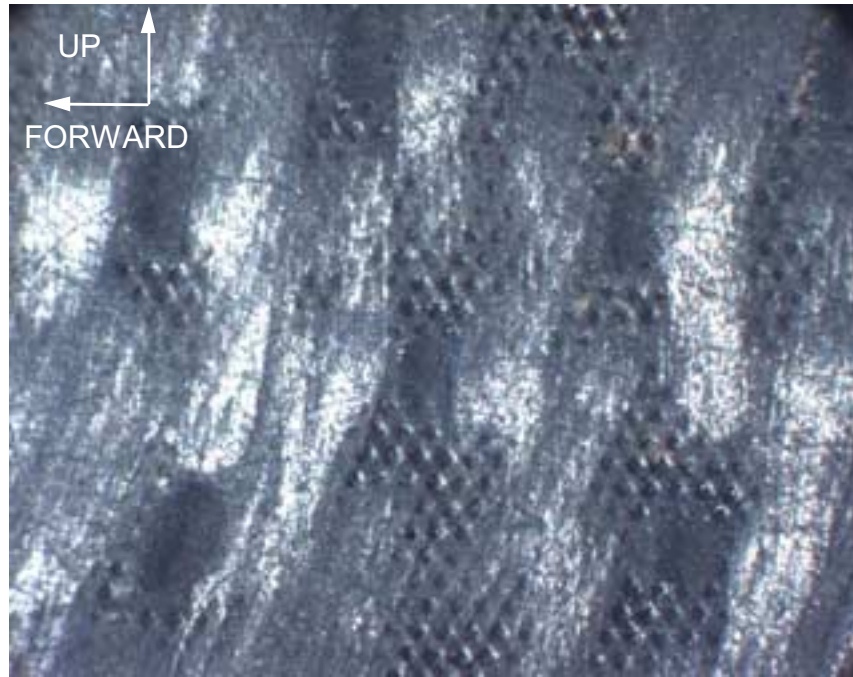
Figure 43. Interlaminar fracture surface on the inboard piece of specimen LC2.

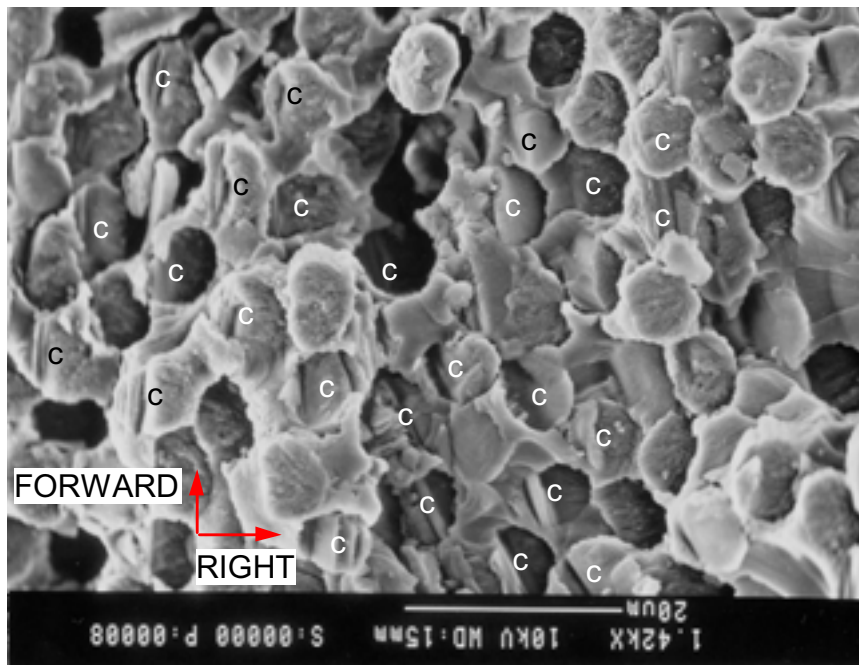
Figure 44. Translaminal fracture surface on the outboard piece from specimen LC2, with the fibers indicated by "c" containing chop marks typical of compressive failure.

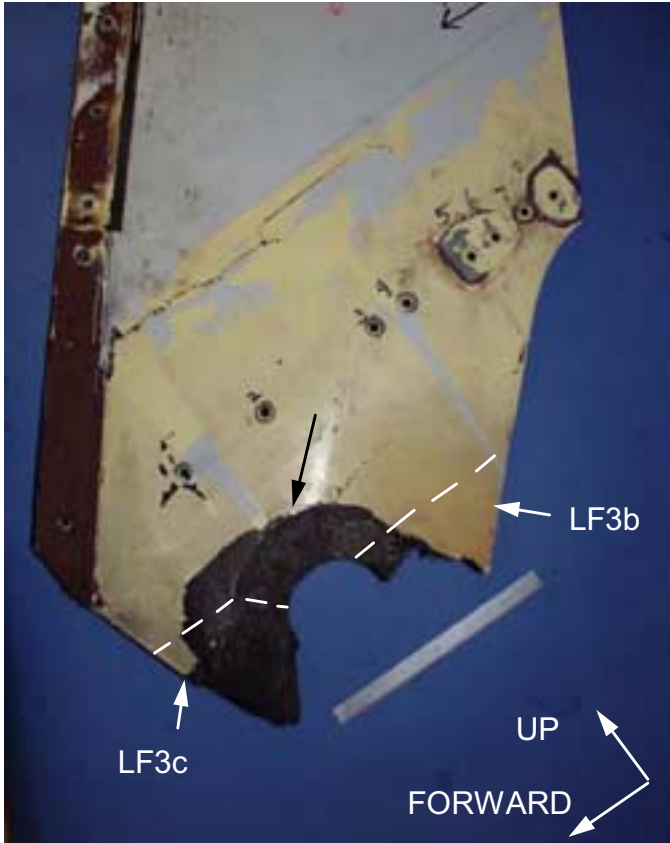
Figure 45. Overall view of the left forward lug translaminar fracture. An unlabeled arrow indicates the upper end of the bearing indentation.

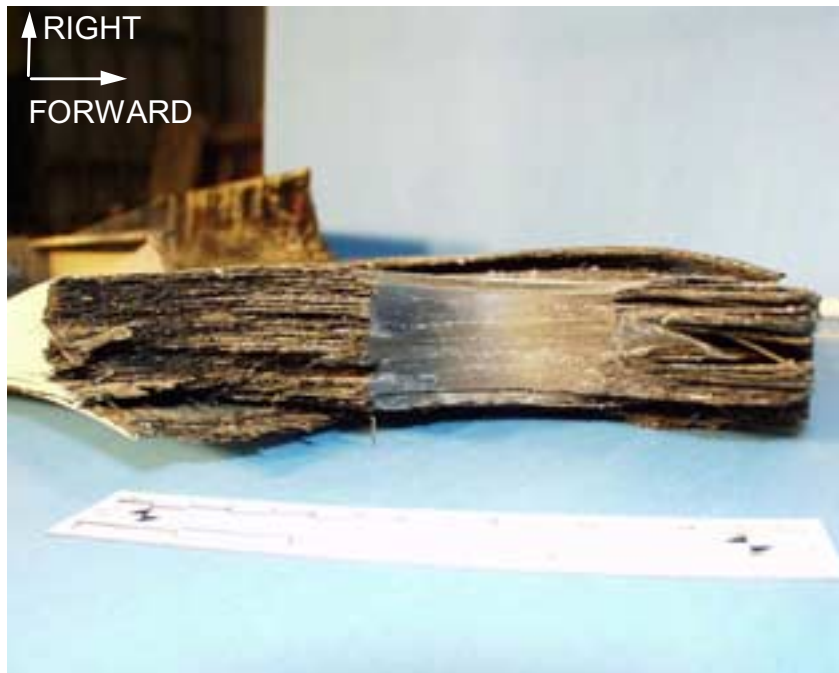
Figure 46. Upper fracture surface of the left forward lug, viewed looking up.

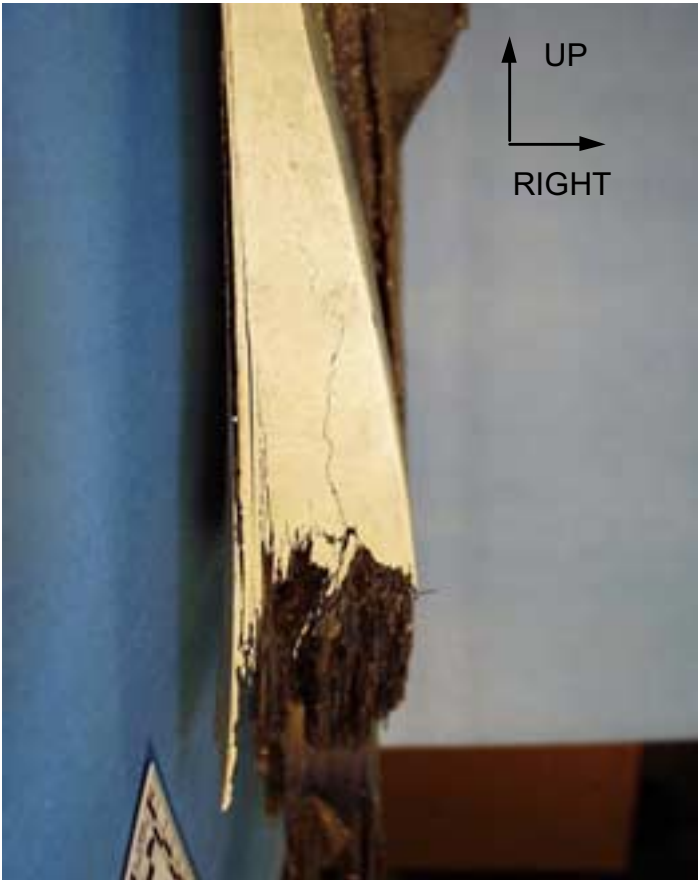
Figure 47. View of the aft surface of the left forward lug.

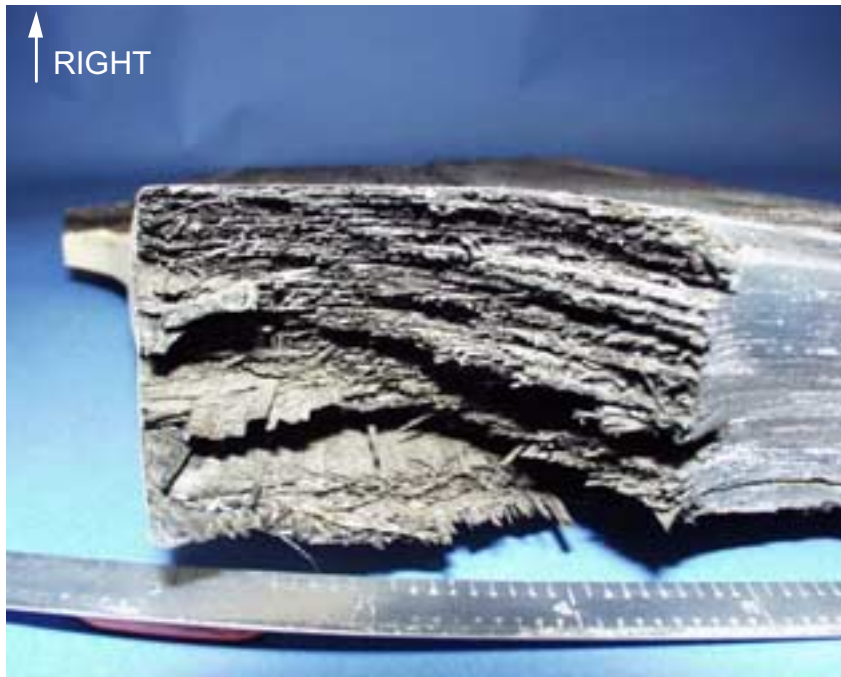
Figure 49. Closer view of the left forward lug upper fracture surface, aft leg, as viewed looking upward parallel to the zero-degree fiber direction.

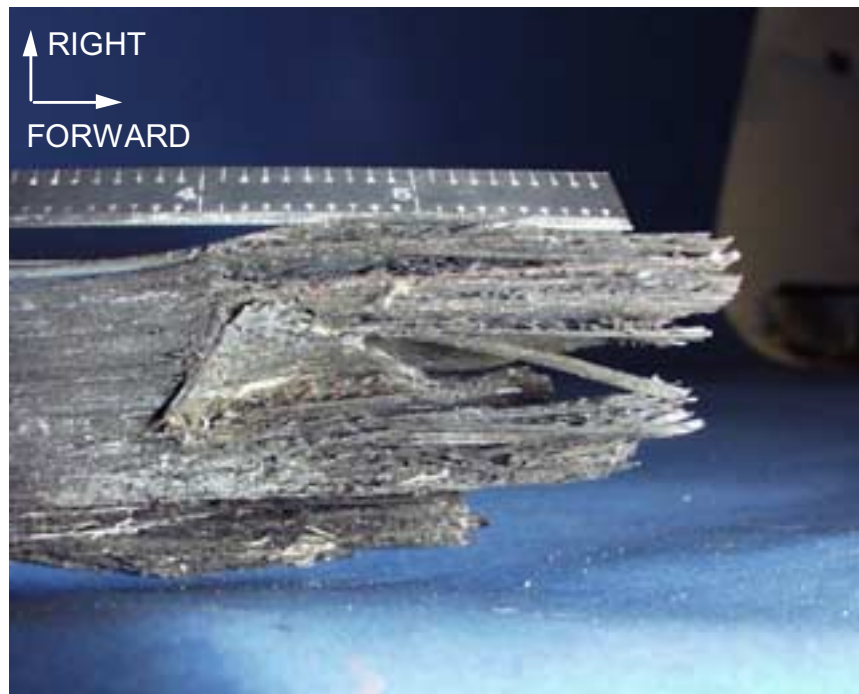
Figure 50. Closer view of the left forward lug upper fracture surface, forward leg, as viewed looking up.

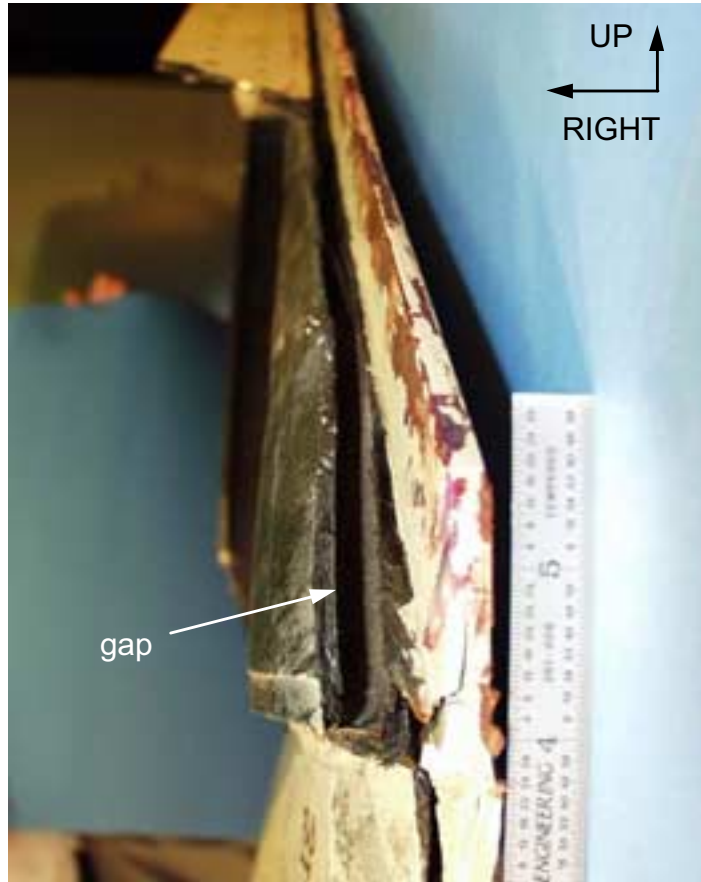
Figure 51. The visible gap at the forward lower end between the inner precured lug structure and the stringer outer flange structure as viewed looking aft.

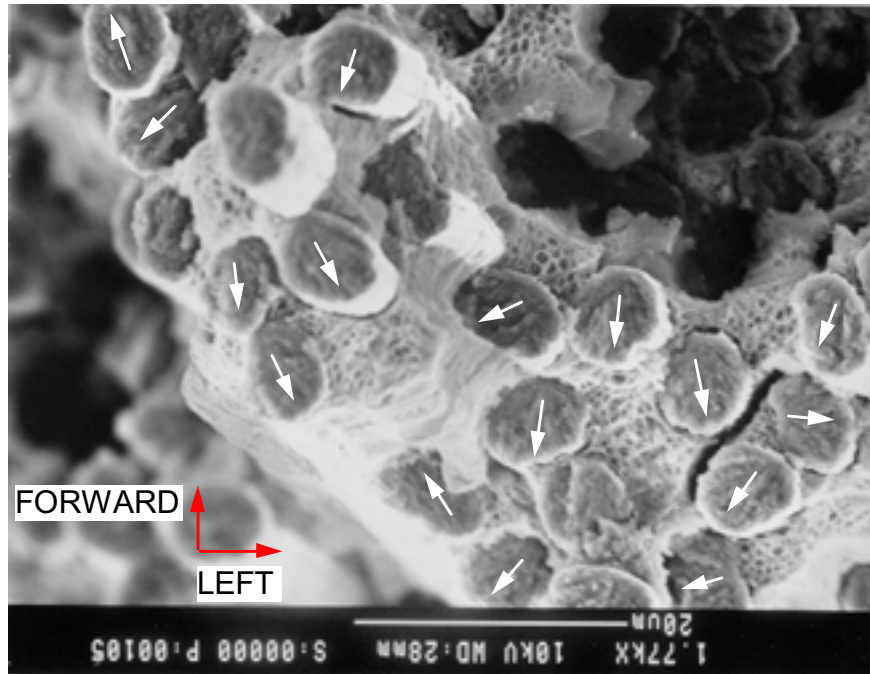
Figure 52. SEM photograph of the ends of zero-degree fibers from specimen LF3b. Arrows indicate fracture propagation direction in fibers with radial marks.

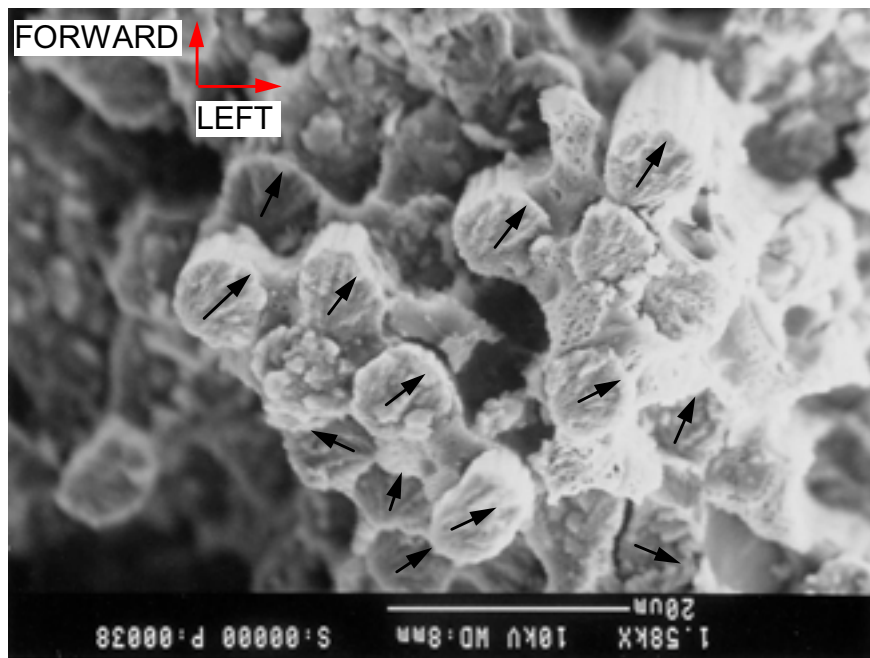
Figure 53. SEM photograph with arrows indicating the direction of tensile crack propagation on the ends of zero-degree fibers from the inboard center piece of specimen LF3c.

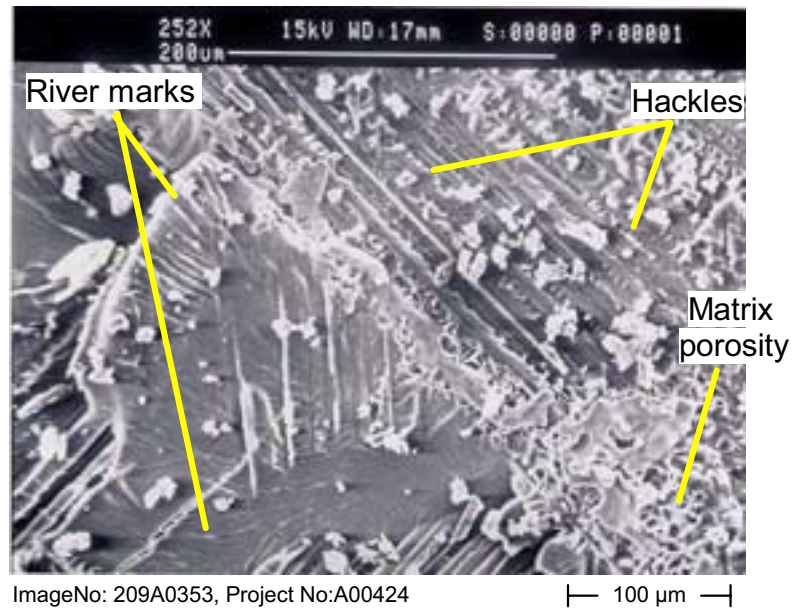
Figure 57. Example SEM photograph from the top forward corner of specimen LF3a-5b. Hackles indicated point up and forward, and river marks also point generally up and forward. Orientation as in figure 56.

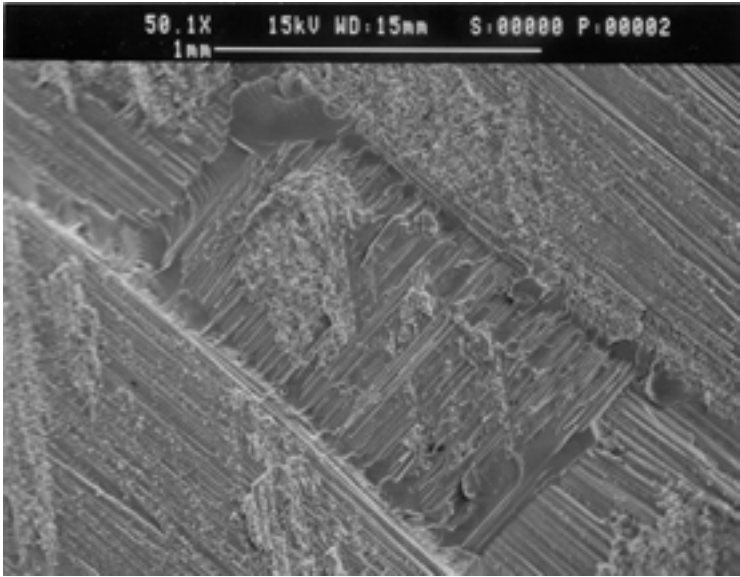
Figure 58. A view of the center of specimen LF3a-5c showing a bundle crossing in the woven fabric. Orientation as in figure 56.

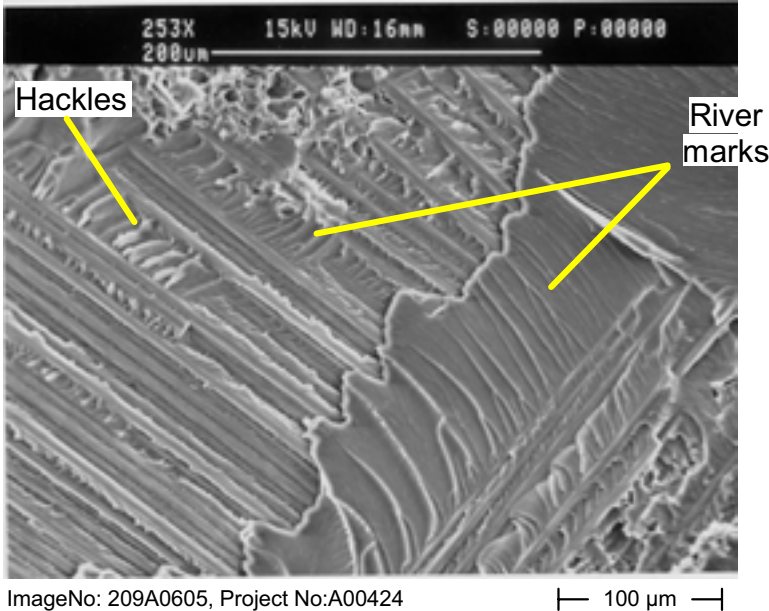
Figure 59. Higher magnification view of the upper left corner of the bundle crossing shown in figure 58. Orientation as in figure 56.

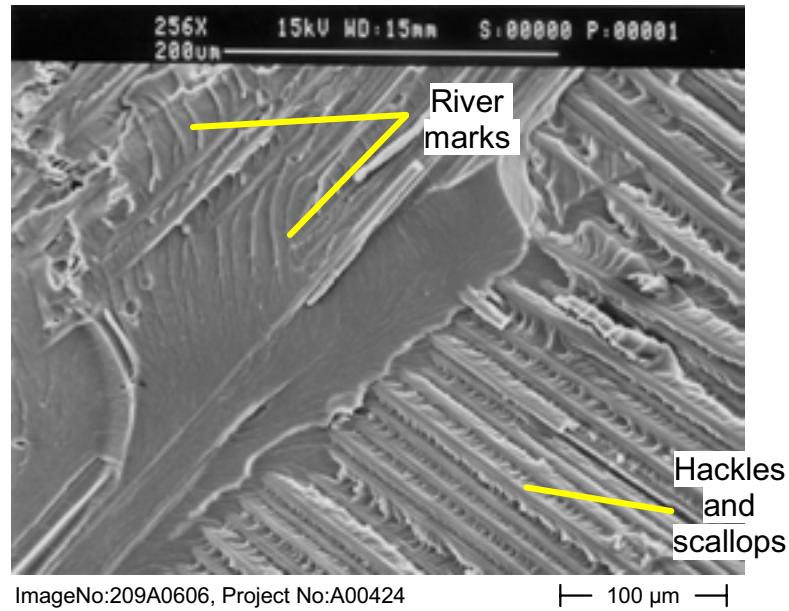
Figure 60. Higher magnification view of the lower right corner of the bundle crossing shown in figure 58. Orientation as in figure 56.

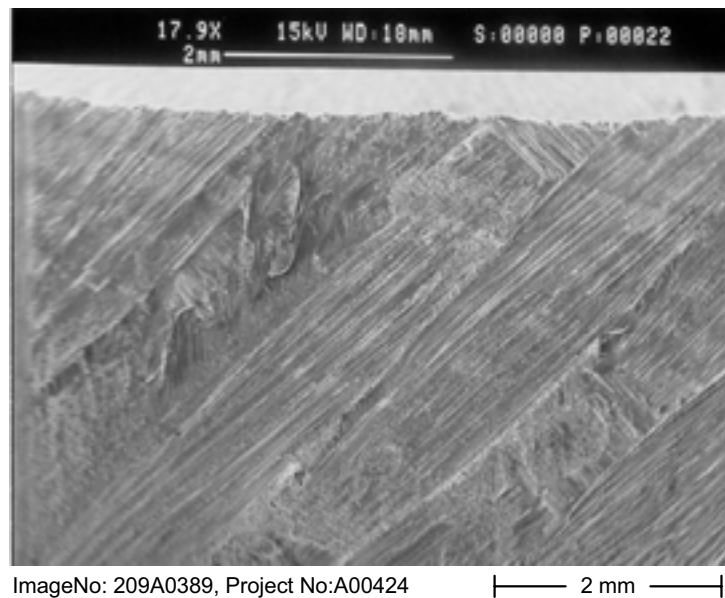
Figure 61. Faint bands at the top forward edge of section LF2b-1 indicate the direction of crack propagation upward and aft. Orientation as in figure 56.
