# NATIONAL TRANSPORTATION SAFETY BOARD

MATERIALS LABORATORY FACTUAL REPORT

Report No. 02-078

Place : Belle Harbor, New York  
Date : November 12, 2001  
Vehicle : Airbus A300-600, N14053  
NTSB No. : DCA02MA001  
Investigator : Brian Murphy, AS-40

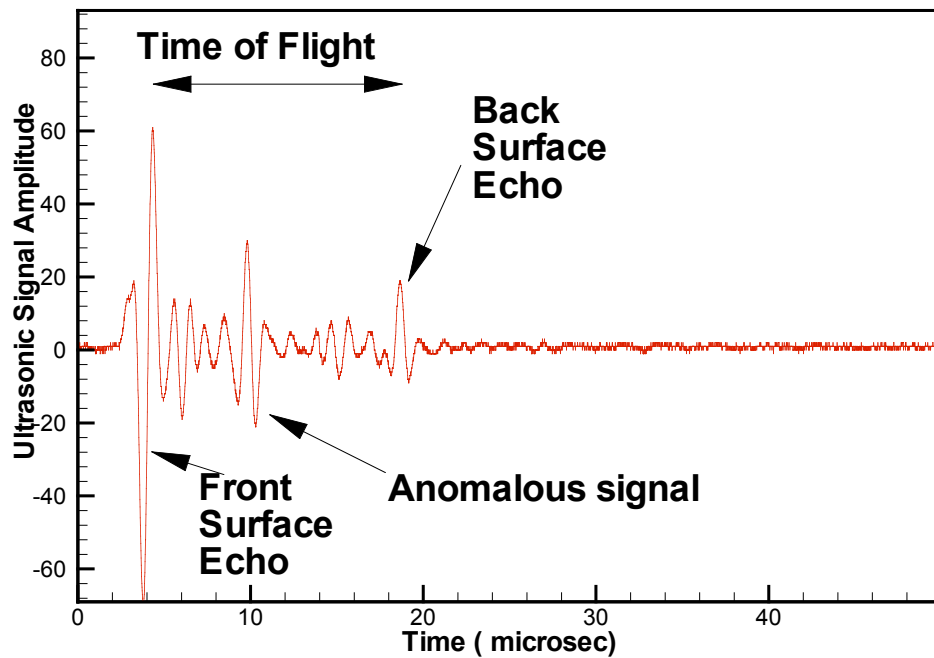
Figure 1.02 Typical ultrasonic signal from region of specimen with anomalous signal.

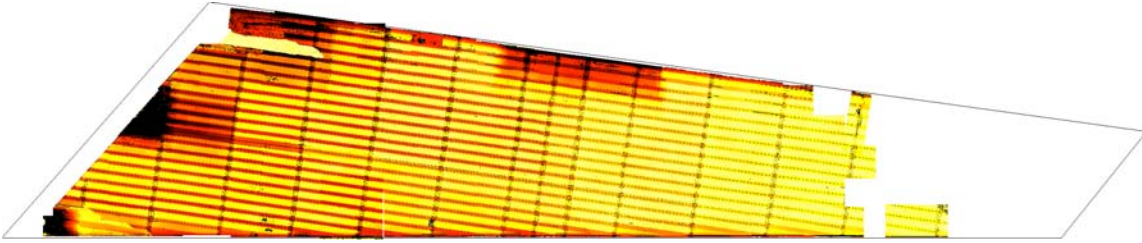
Figures 1.03-1.23 are the results obtained from measurements on the left side of the tail. Figure 1.03 is the compilation of all the time of flight measurements performed on the left side. Two notable delaminations were detected at the lower end near the forward and aft spars. Enlarged images of the data with a designation of the extents of these two delaminations are shown in figure 1.04. Figure 1.05 designates the regions shown in figures 1.06 to 1.23. These are the images of regions with anomalies in the relative attenuation, with responses typical of those found in figure 1.02.

Figure 1.03 Ultrasonic time of flight measurements performed on the left side of the composite tail.

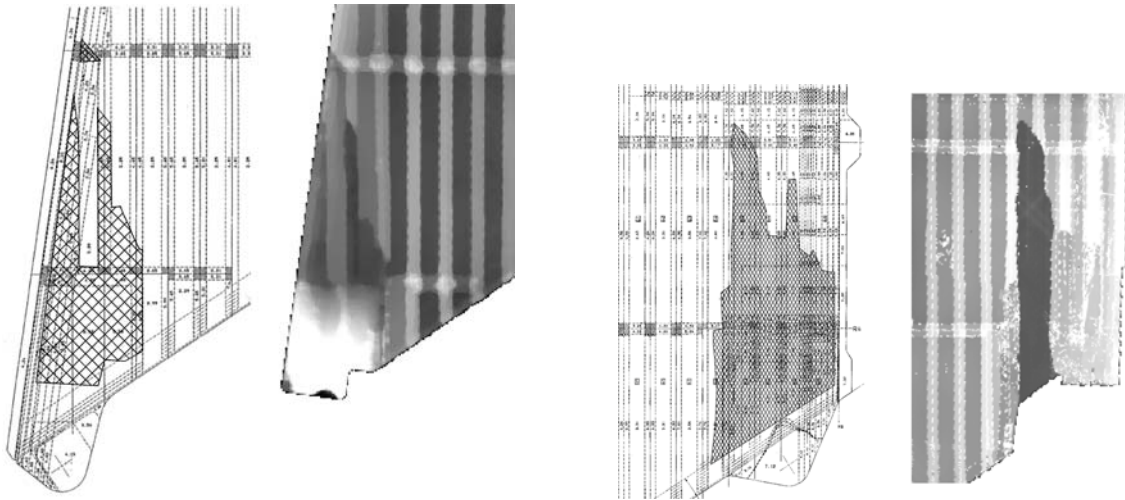
Figure 1.04 Expanded view showing delaminations at the lower end near the forward and aft spars.

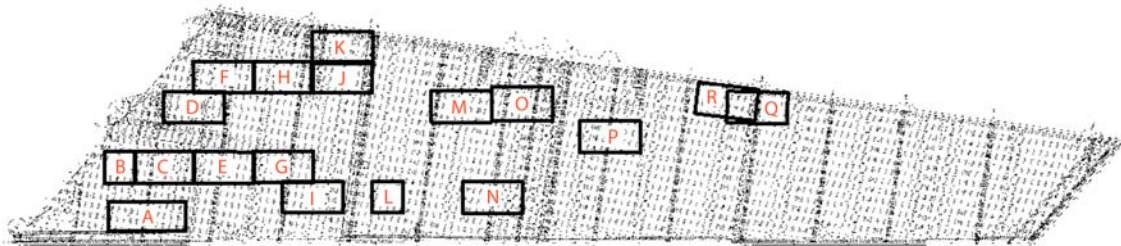
Figure 1.05 Region definitions used in subsequent images for the left side of tail. These are the regions with significant anomalies in ultrasonic attenuation responses.

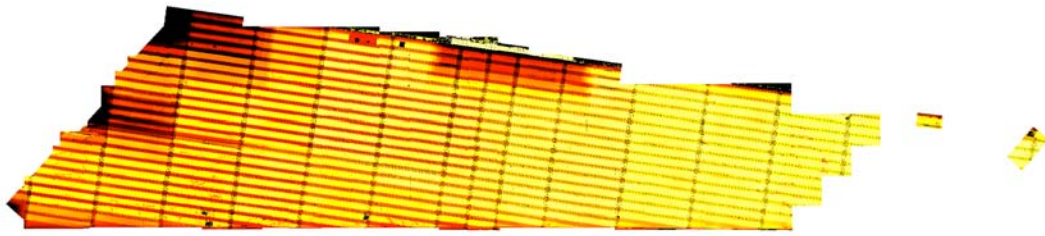
Figures 1.24-1.38 are the results obtain from measurements on the right side of the tail. Figure 1.24 is the compilation of all the time of flight measurements performed on the left side. No notable delaminations were detected on the right side of the tail. Figure 1.25 designates the regions shown in figures 1.26 to 1.38. These are the images of regions with anomalies in the relative attenuation, with responses typical of those found in figure 1.02.

Figure 1.24 Ultrasonic time of flight measurements performed on the right side of the composite tail.

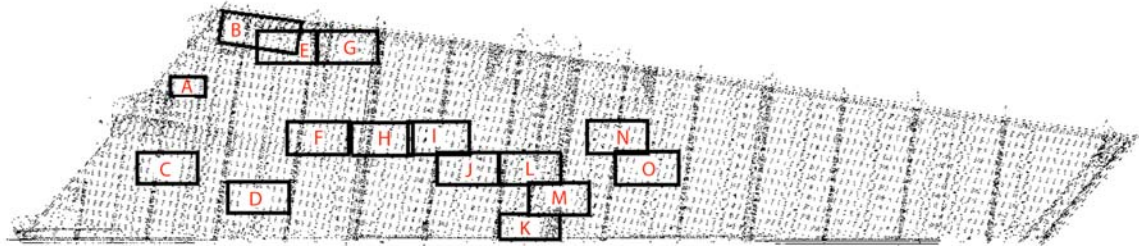
Figure 1.25 Region definitions used in subsequent images for the right side of tail. These are the regions with significant anomalies in ultrasonic attenuation responses.

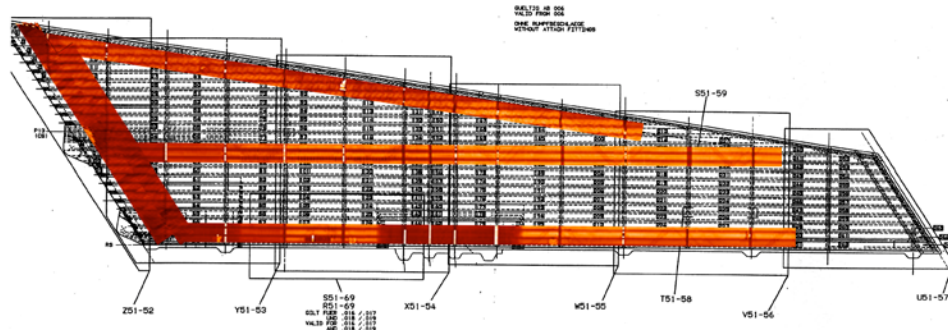
A compilation of all the data from the right side superimposed on a schematic of the tail is shown in figure 2.01. The data from the left side is shown in figure 2.02. Regions of higher stiffness appear red, and lower stiffness regions appear orange in the figures. The most significant characteristics in the images are the variations in thickness of the composites tail. Aside from stiffness changes associated with thickness variations, there is no apparent evidence of any change in stiffness in the data.

Figure 2.01 Lamb wave results for the right side of the composite tail.

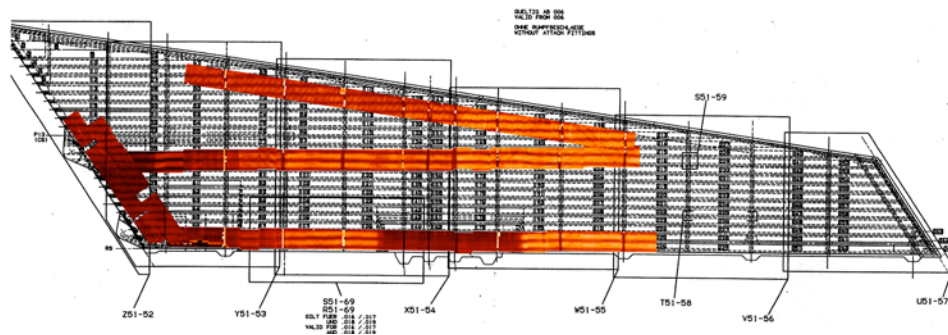
Figure 2.02 Lamb wave results for the left side of the composite tail.

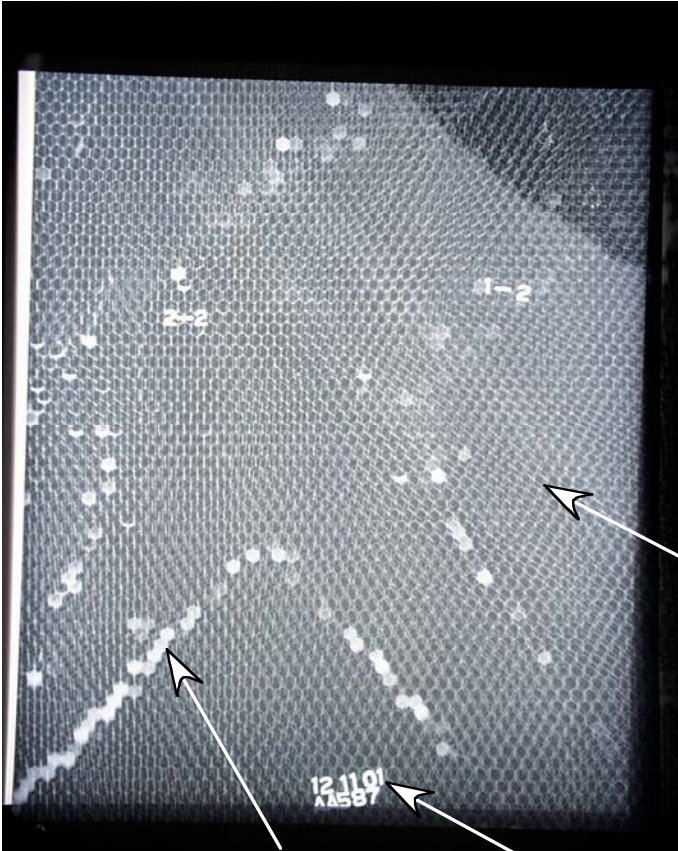
A typical image is shown in figure 3.01. In the image, the entrapped water is clearly visible. Also visible in the image are the lead markers and the walls of the honeycomb. A compilation of all the photos is shown in figure 3.02. In the figure it is clear that the entrapped water is at the lower half of the rudder section.

Figure 3.01 Radiographic image of water in honeycomb of rudder.

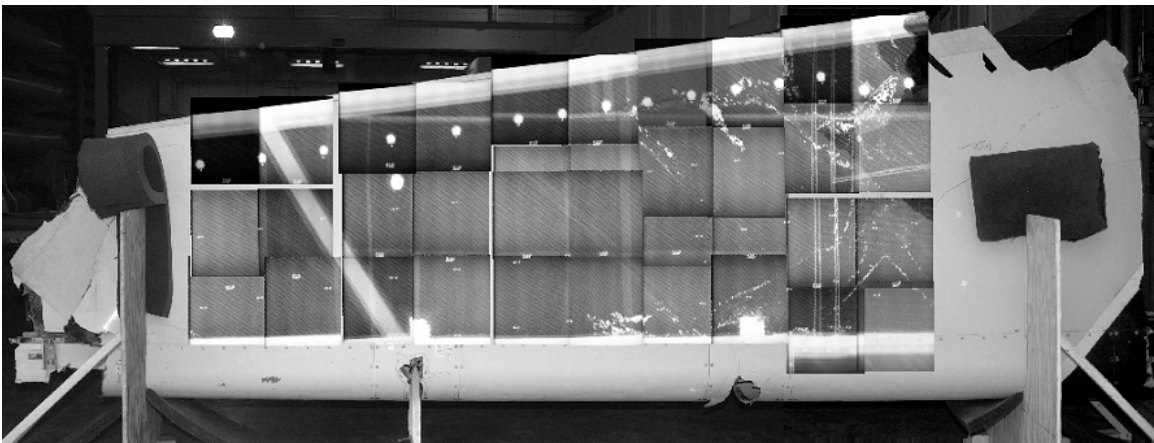
Figure 3.02 Compilation of radiography results superimposed on picture of the section of rudder examined.

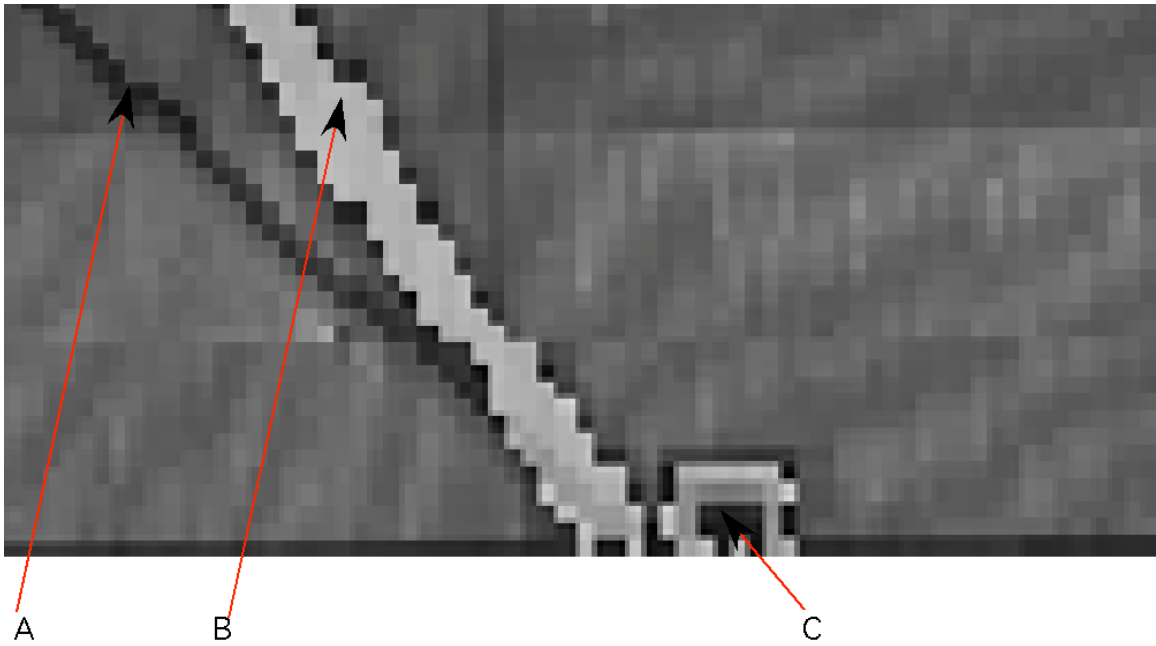
Measurements were performed with a transducer separation of approximately 2 inches. Measurements were only performed on portions of the rudder with enough residual strength to easily support the weight of the scan frame. A compilation of all the data from the right side of the rudder superimposed on a picture of the right side of the rudder is shown in figure 4.01. The data from the left side superimposed on the same picture is shown in figure 4.02. In regions with consist face sheet thickness, the areas with lower stiffness appear as lighter regions. Where there is an increase in ply thickness due to ply overlaps, these regions appear darker in the image. The system has difficulty tracking the delay time in the ultrasonic pulse in regions with significant addition subsurface support such as the lightning strip and rudder hinge attach blocks. For these regions, the stiffness maps are not meaningful. Figure 4.03 indicates typical responses in these regions.

Figure 4.03 Identification of typical structural features in the Lamb wave image. A) Ply overlap, B) lightning strip and C) rudder hinge attach block.

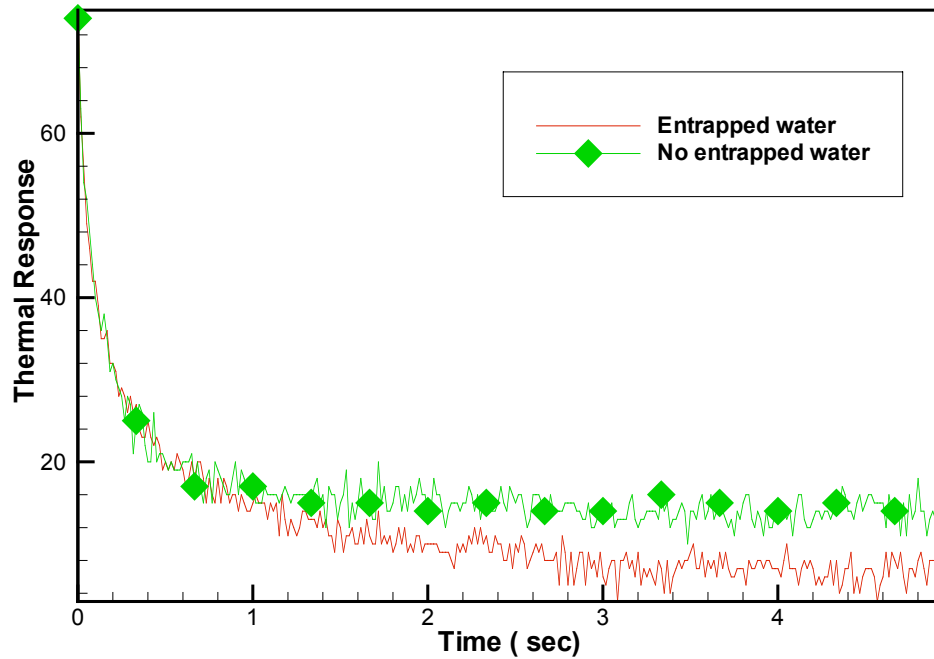
The thermal time response for a region of the rudder with and without entrapped water in the honeycomb is shown in figure 5.01. It is clear from the figure that there is significantly more cooling occurring in the region with entrapped water. The regions that appear darker in the data are indications of water. Other substructures, such as potting in the honeycomb also caused significant additional cooling relative to the unbacked face sheet. A compilation of all the data from the right side of the rudder superimposed on a picture of the right side of the rudder is shown in figure 5.02. The data from the left side superimposed on the same picture is shown in figure 5.03. Figures 5.04 and 5.05 show the same data with the locations of water highlighted in red.

Figure 5.01 The thermal time response for a region of the rudder with and without entrapped water in the honeycomb

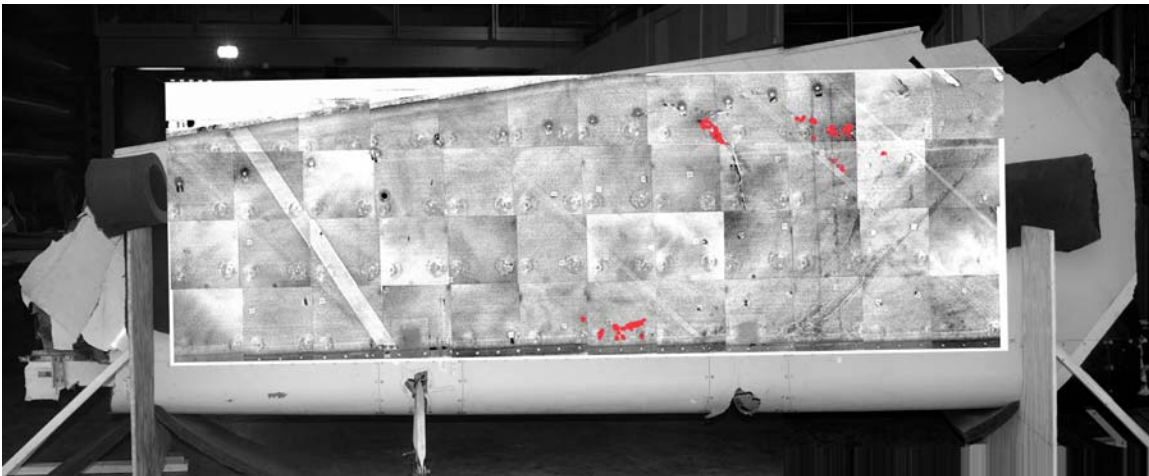
Figure 5.04 A compilation of all the data from the right side of the rudder superimposed on a picture of the right side of the rudder with water highlighted in red

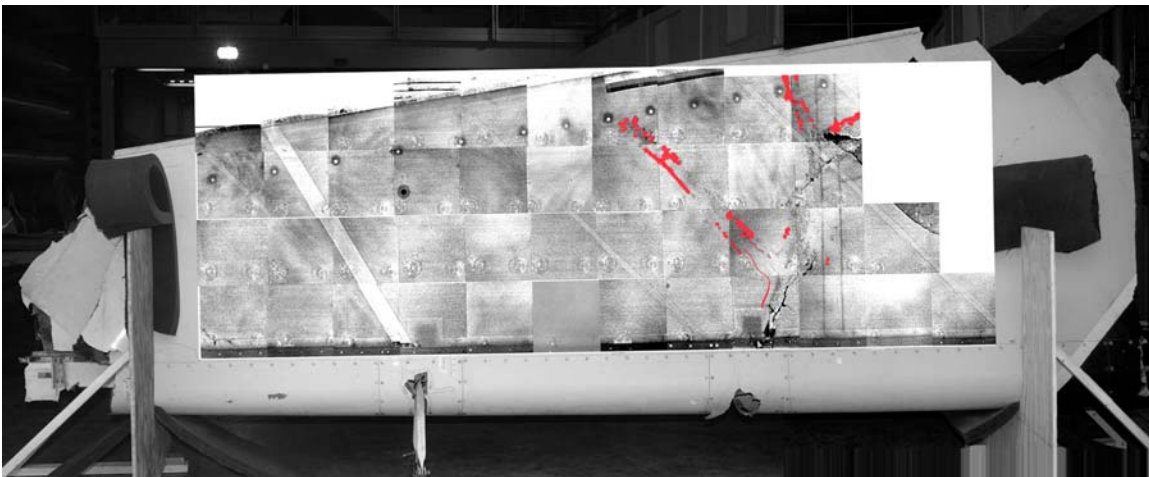
Figure 5.05 a compilation of all the data from the left side of the rudder superimposed on a picture of the right side of the rudder with water highlighted in red
