# NATIONAL TRANSPORTATION SAFETY BOARD

MATERIALS LABORATORY FACTUAL REPORT

Report No. 02-077

Place : Belle Harbor, New York  
Date : November 12, 2001  
Vehicle : Airbus A300-600, N14053  
NTSB No. : DCA02MA001  
Investigator : Brian Murphy, AS-40

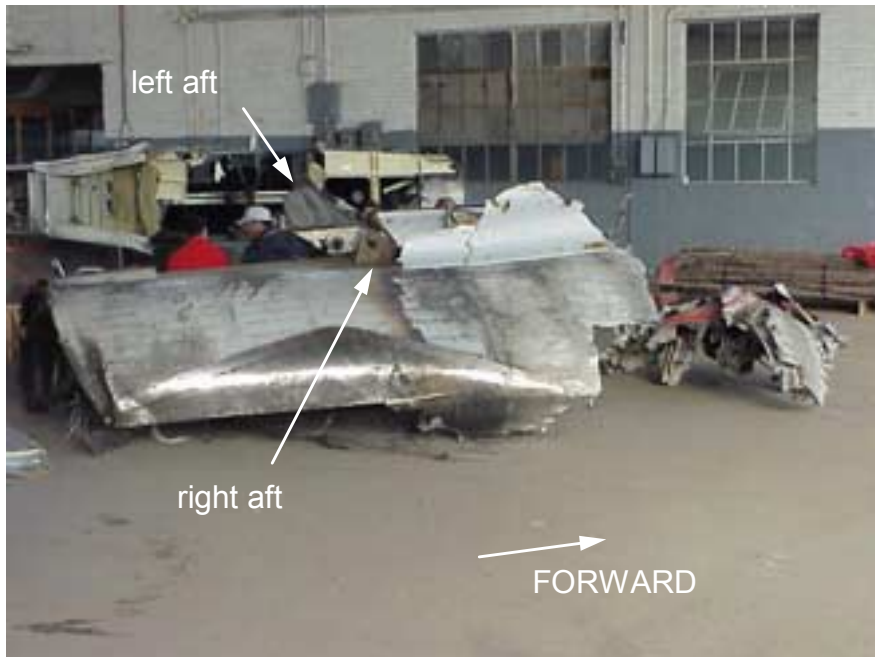
ImageNo:208A0115, Project No:A00386

Figure 1. Overall view of the fuselage pieces as examined at Floyd Bennett Field. The vertical stabilizer is shown in the background.

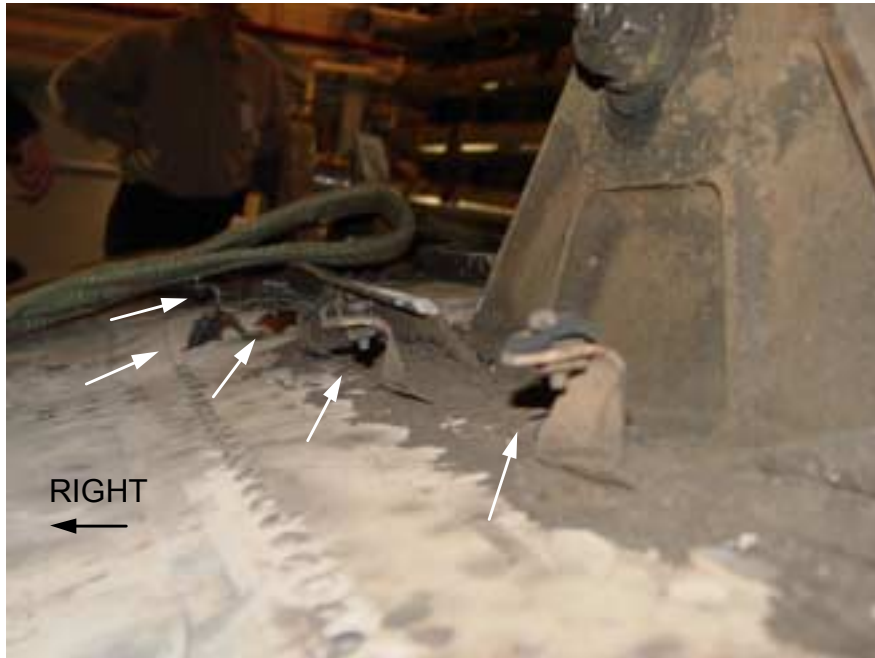
ImageNo:208A0124, Project No:A00386

in figure 7. The tenth clip from the rear was broken. On the left side, the nine aft-most clips from the rear were approximately in their normal position. The tenth clip from the aft was bent upward and aft. Figure 8 shows the first through seventh clips as viewed looking aft.

Figure 7. Closer view of the right side fairing clips, indicated by unlabeled arrows, on the aft fuselage piece viewed looking aft.

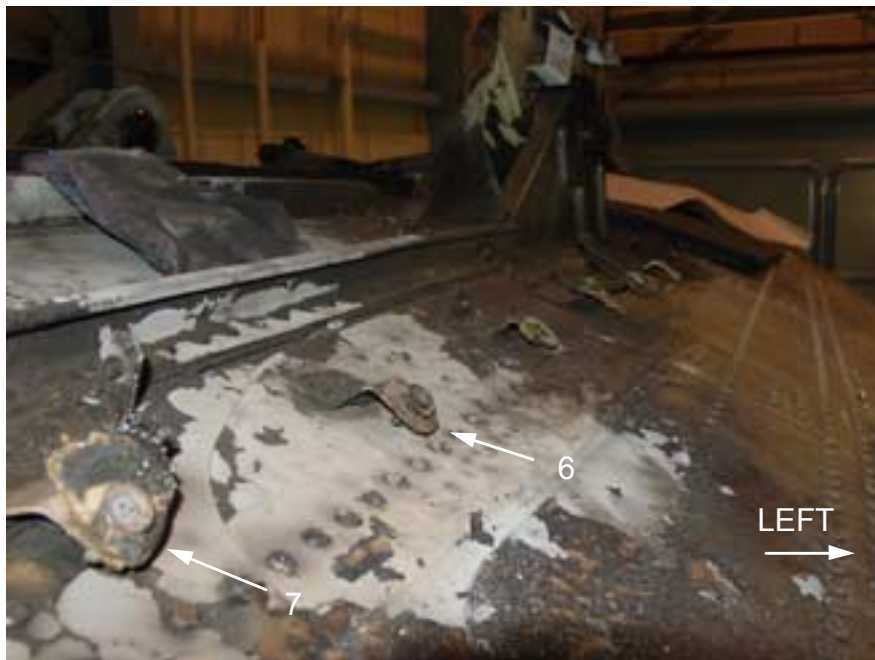
ImageNo: 208A0123, Project No:A00386

Figure 8. Closer view of the left side fairing clips on the aft fuselage piece viewed looking aft. Arrows indicate the sixth and seventh fairing clips from the aft.

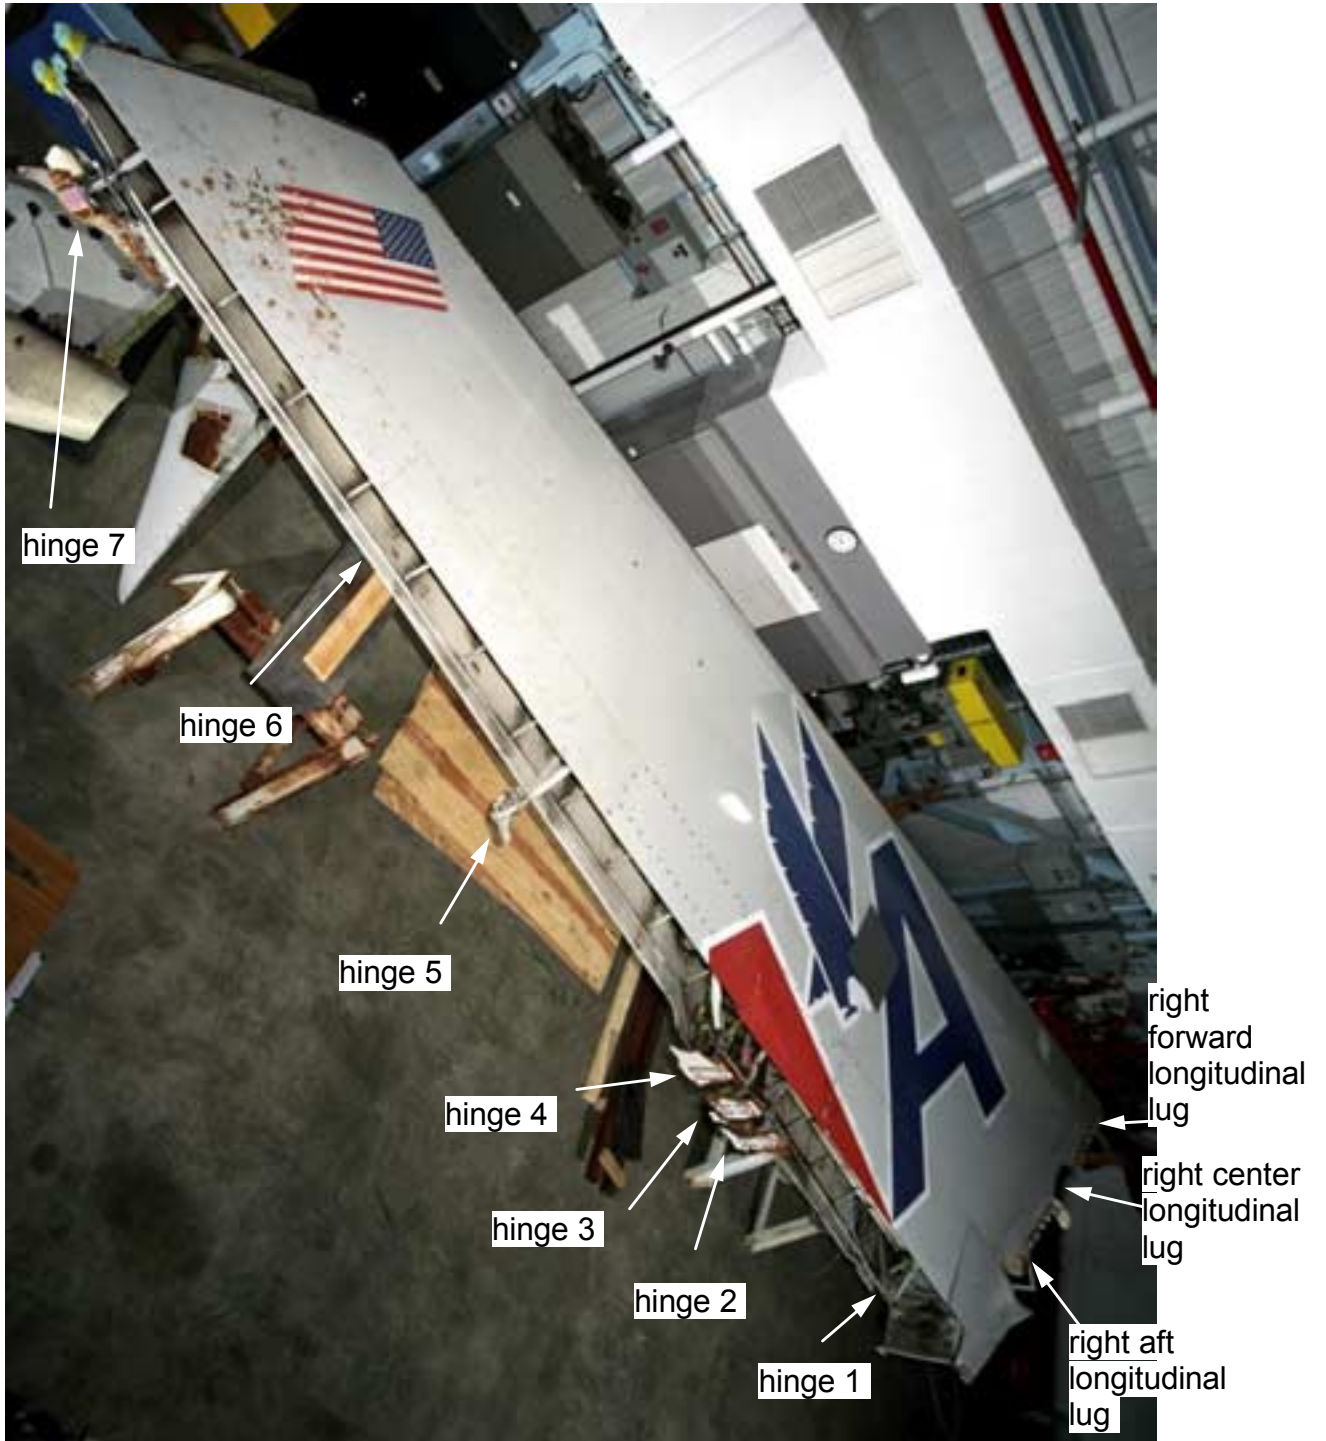
The vertical stabilizer was largely intact with no significant areas of skin buckling. An overall view of the right side of the vertical stabilizer is shown in figure 9 as it was examined at NASA Langley Research Center. The LE fairings were removed for shipping from Floyd Bennett Field. There were some localized areas of damage on the vertical stabilizer, which will be described below. At the lower end, shown in figures 10 and 11, each of the six attachment locations were separated either by fractures that intersected the lug attach hole or by fractures through the structure above the hole. Portions of rib 1, the rib 1 rib-to-skin attach angle, and the lower end of the forward spar also were fractured. Along the trailing edge, the TE panels were damaged in several locations.

Figure 9. Overall view of the vertical stabilizer as it was examined at NASA Langley.

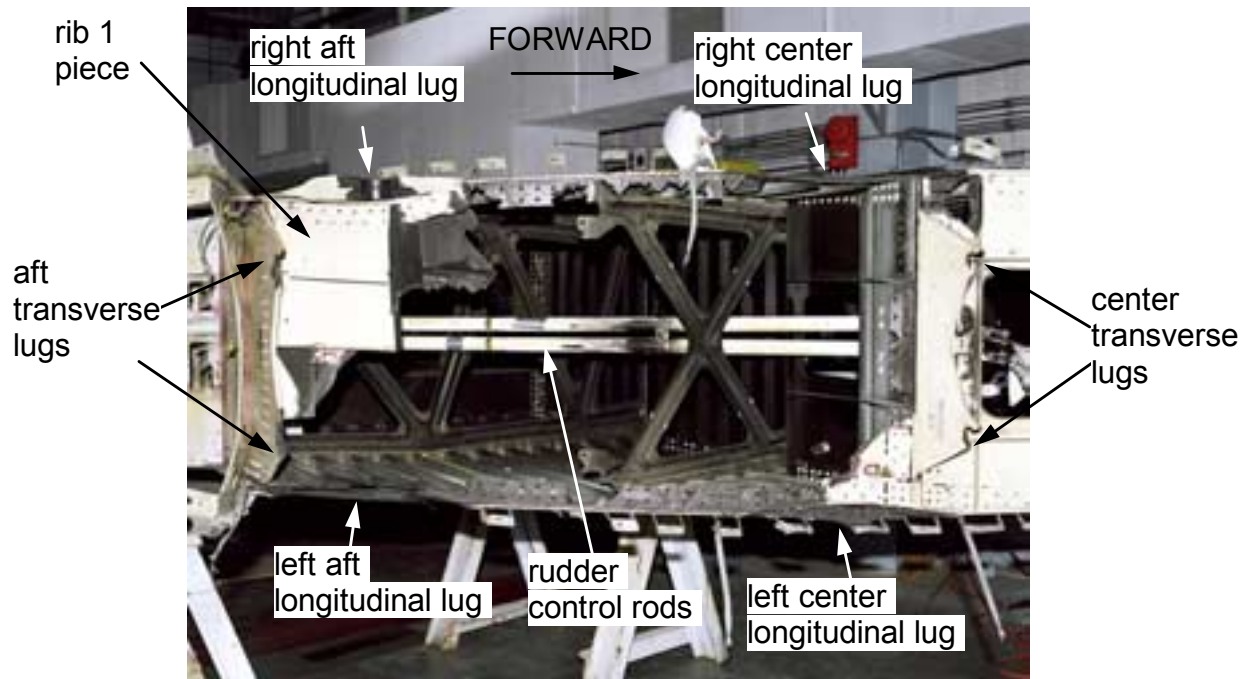
ImageNo:208A0214, Project No:A00386

Overall views of the lower end as shown in figures 10 and 11 show the rib 1 damage. The portion of rib 1 between the aft spar and center spar was missing except for two areas: (1) An area adjacent to the right side of the aft spar (about 21 inches by 14 inches). The forward end of this area was deflected downward and was held in position by the fracture surface on the right aft lug. (2) A triangular area at the left center fitting (about 9 inches by 8 inches). Portions of the lower leg of the rib 1-to-skin attach angle remained, and fasteners were pulled downward through those remaining areas. At the forward end, the center portion of rib 1 was missing from the front spar back to the forward end of an access hole, and the left side of rib 1 was missing from the front spar back to the aft end of that access hole.

Figure 10. View of the aft portion of the lower end of the vertical stabilizer.

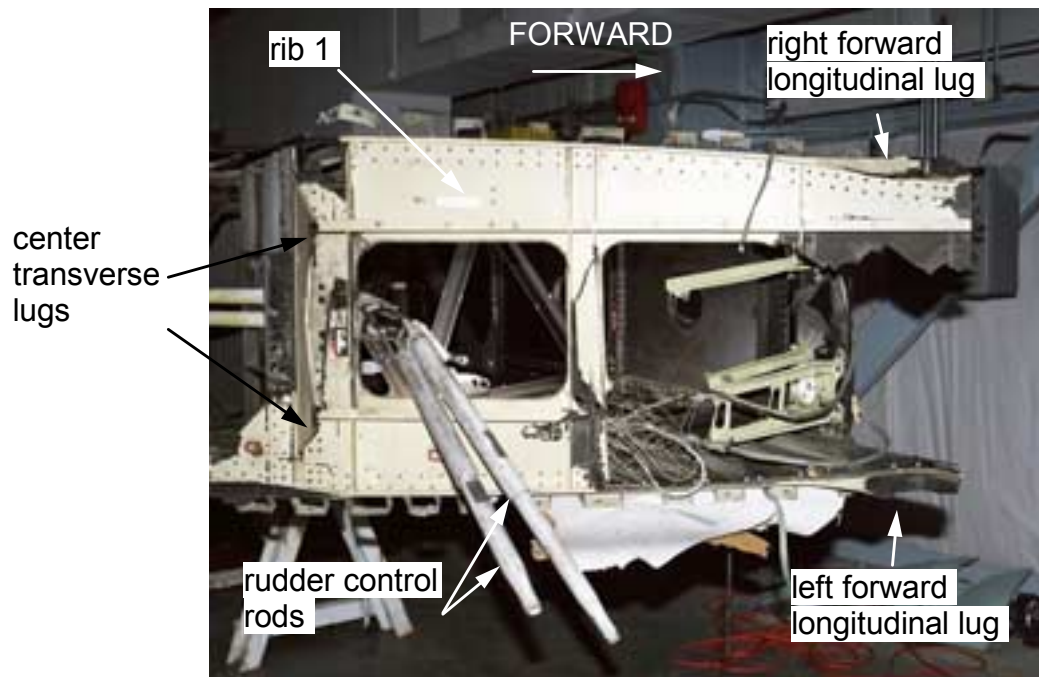
ImageNo: 208A0215, Project No:A00386

As shown in figure 11, the forward spar was fractured above the forward transverse lug attachment area at a position approximately 14 inches above rib 1, just below two racks for electronic equipment. A piece of the spar remained attached to the fuselage left transverse yoke, as shown in figure 27. This remnant piece had an edge of an access hole at the upper end. The lower piece of the right attach lug also remained in the right transverse yoke. The pieces that remained with the attach yokes had heavy fire damage.

Figure 11. View of the forward portion of the lower end of the vertical stabilizer.

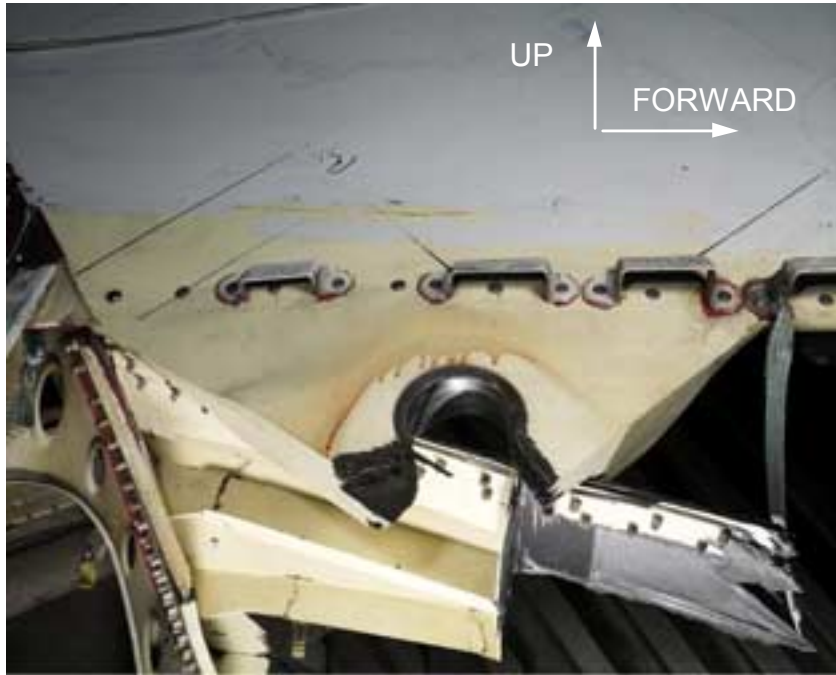
ImageNo:208A0259, Project No:A00386

Two views of the right aft longitudinal lug are shown in figures 12 and 13. Figure 13 shows the lug fracture after a piece of rib 1 was removed. As shown in figure 10, the piece of rib 1 covered the inboard side of the translaminar fracture in the forward leg of the lug. The fracture surfaces intersected the lug attach hole. The lower portion of the lug was missing and was not recovered. The translaminar fracture surfaces appeared to have a rough appearance consistent with fracture under primarily tensile loads. Fractures on each leg of the lug were on different translaminar planes, and the change in planes occurred near the center of the lug thickness. On the aft leg, the outboard side of the fracture was in a plane nearly perpendicular to the zero-degree fiber direction, and the inboard side of the fracture was in a plane approximately 45 degrees from the zero-degree fiber direction. On the forward leg, the outboard side of the fracture was in a plane approximately parallel to the zero-degree fiber direction, and the inboard side of the fracture was in a nearly horizontal plane. Some ply separation was observed above the fracture, with the largest separations intersecting the translaminar fracture where the fracture plane changed. The ply separations visible as cracks on the surface were limited to the lug region below rib 1.

The bore of the right rear lug was in good condition, showing bearing contact over a large portion of the bore surface. A few lines of partially circumferential white powdery deposits were noted on the bore surface.

Figure 12. View of the right aft longitudinal lug on the vertical stabilizer.

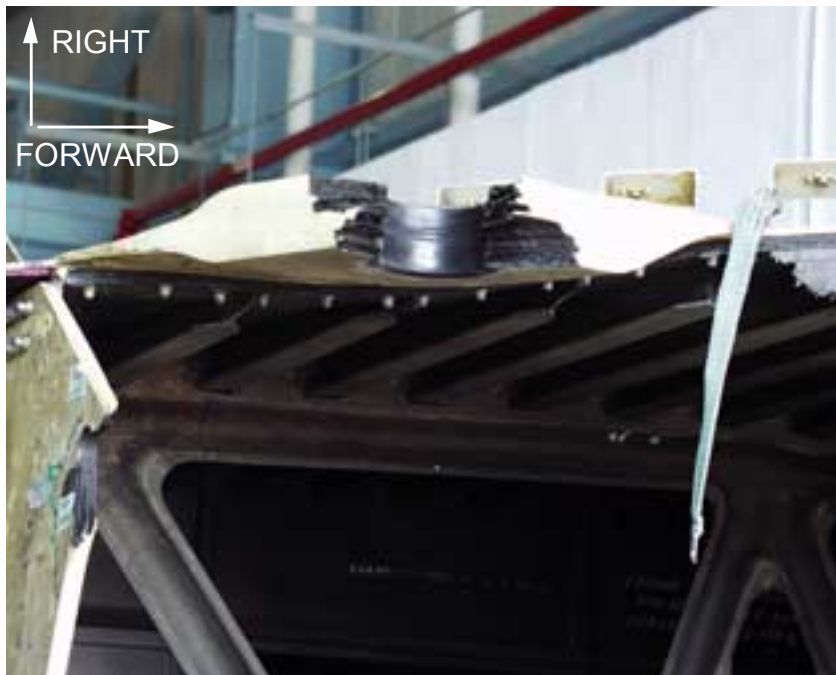
ImageNo: 208A0230, Project No:A00386

Figure 13. Another view of the right aft longitudinal lug on the vertical stabilizer shown after the piece of rib 1 that covered part of the fracture was removed.

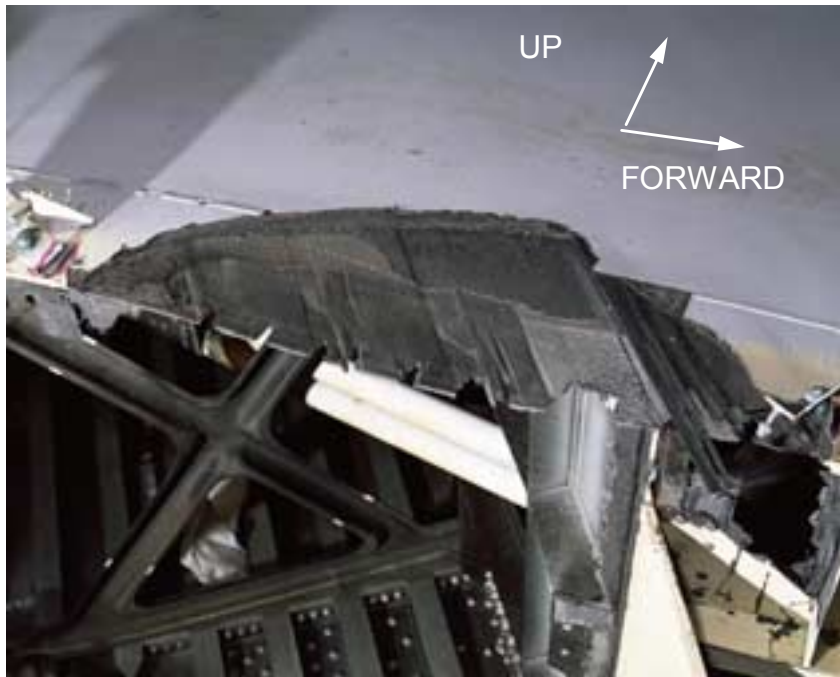
ImageNo:208A0221, Project No:A00386

Views of the right center lug area fracture are shown in figures 14 and 15. The fracture occurred in the vertical stabilizer structure above the lug bore, and the lower piece remained attached to the fuselage as shown in figure 15. Translaminar fractures occurred in the skin and the lug build-up layers (pre-cured halves) primarily in a slightly curved plane perpendicular to the zero-degree fiber direction at a location up to approximately 12 inches above the lug attach bolt centerline. The translaminar fracture appeared rough, consistent with fracture from tensile loading. The stringer module layers<sup>3</sup>, as can be seen in figure 14, remained with the main portion of the vertical stabilizer, and tape layers (stringer outer flange layers) between the stringer module layers and the lug build-up layers (pre-cured halves) also remained with the vertical stabilizer. Rib 1 fastener holes near the lower end of the stringer module layers were torn out in a downward direction for the fasteners that remained with the lower piece. A piece of the upper leg of the rib 1 attach angle also remained with the lower piece. Some layers of tape pulled out from the lower piece near the forward side and remained with the upper piece. There was a ply separation on the forward edge of the lower piece in a fire-damaged area.

Figure 14. View of the right center longitudinal lug area on the vertical stabilizer.

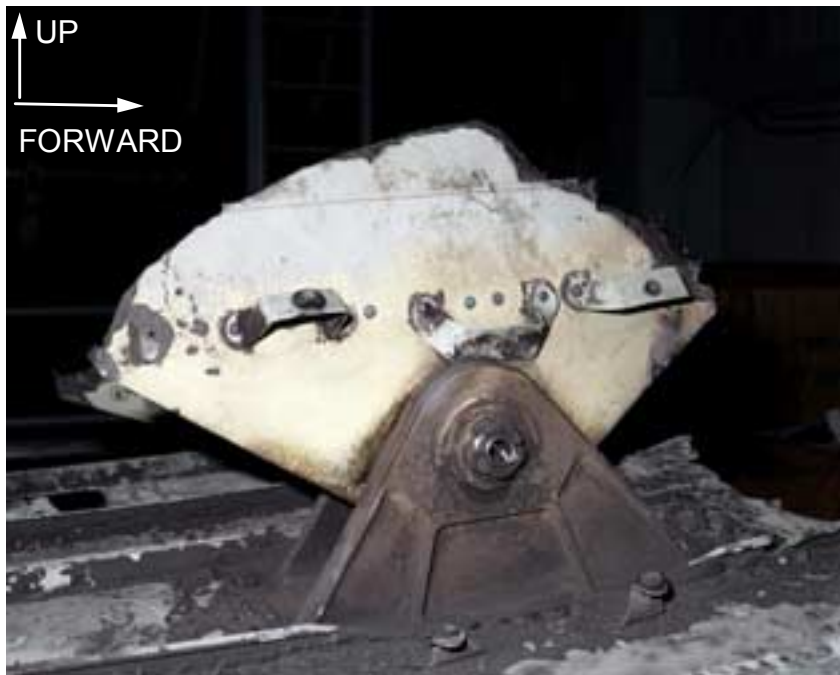
ImageNo: 208A0254, Project No:A00386

Figure 15. View of the mating piece of the right center longitudinal lug that remained attached to the fuselage.

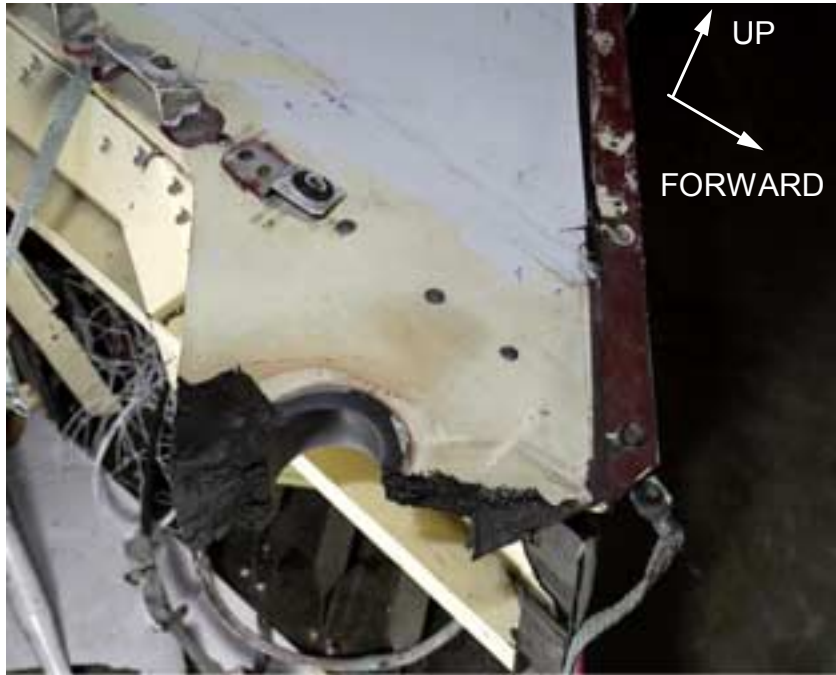
ImageNo:208A0260, Project No:A00386

Views of the right forward lug are shown in figures 16 and 17. The fracture surfaces intersected the lug attach hole. Most of the lower portion of the lug was missing and was not recovered, but a small amount of composite material was left in the circumferential groove between the two hat bushings that remained attached to the fuselage. The translaminar fracture surfaces appeared to have a rough appearance consistent with fracture primarily under tensile loading. On the aft leg of the lug, fracture occurred on different planes. On the inboard and outboard sides of the aft leg, the fracture was on planes perpendicular to the length of the front spar, and near the center of the aft leg (with a width of approximately 50 percent of the thickness), the fracture was on a plane at a 45-degree angle to the zero-degree fiber direction. On the forward leg of the lug, the fracture surface was almost entirely on a plane that was perpendicular to the length direction of the front spar.

The bore of the right forward lug was in good condition, showing bearing contact over a large portion of the bore surface. A few lines of partially circumferential white powdery deposits were noted on the bore surface.

Figure 16. View of the right forward longitudinal lug on the vertical stabilizer.

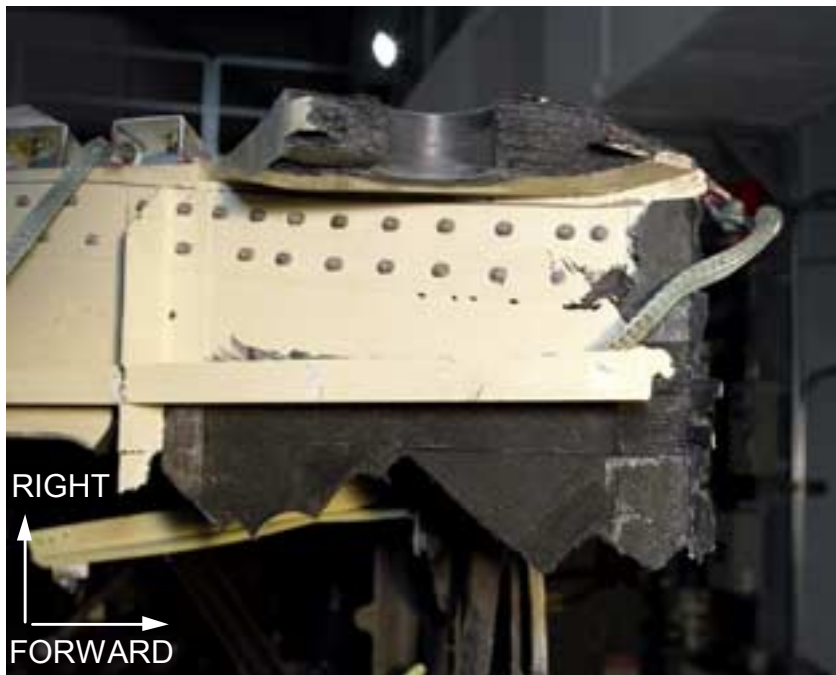
ImageNo: 208A0218, Project No:A00386

Figure 17. Another view of the right forward longitudinal lug on the vertical stabilizer.

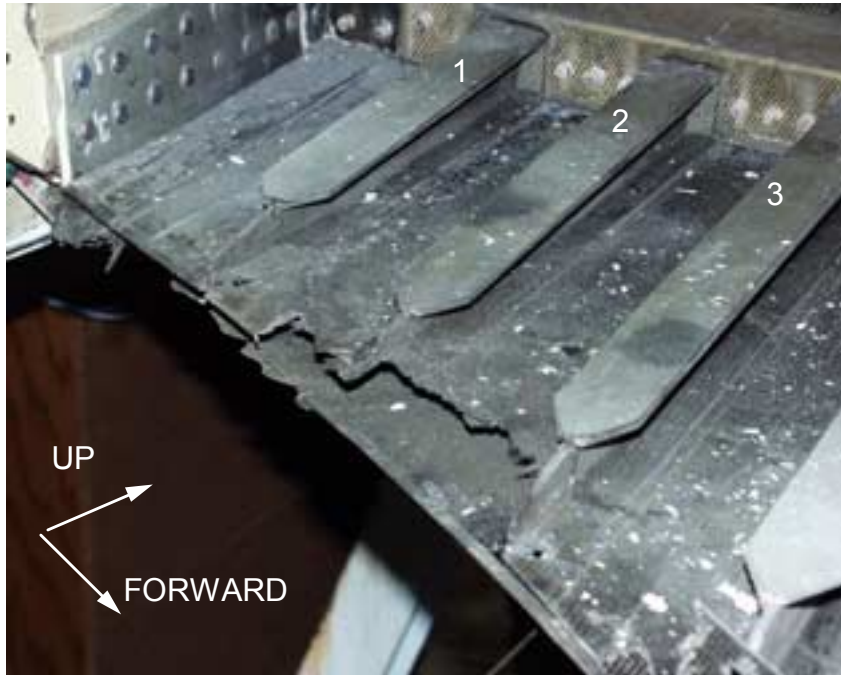
ImageNo:208A0226, Project No:A00386

remained attached to the fuselage as shown in figure 19. A translaminar fracture occurred near the center of the lug (about four inches above the lug bore), fracturing primarily at the rib 1 fastener row as shown in figure 18. The fracture intersected most of the fastener holes except for an area near the forward end, where the fracture was above the holes. The fracture surfaces were generally rough on the inboard side of the fracture, but appeared smoother on the outboard side of the fracture, consistent with either a bending fracture or a tensile fracture with post-fracture damage. Interlaminar fractures occurred at either side of the middle piece that fractured from the middle of the lug and between the stringer module layers and the lug build-up layers. Some of the tape layers between the stringer module layers and the lug build-up layers also remained with the upper piece and some remained with the lower piece. Fractures at the upper end of the lower piece generally appeared to correspond with the upper ends of the lug build-up layers.

The left stringers 1, 2, and 3 were cracked or fractured at the stringer runout area near the bottom end of the stringers. A small part at the runout of stringers 1, 2, and 3 had web and flange damage consistent with outboard bending. Rib 1 fasteners were pulled out of the stringer module layers and the fasteners remained attached to the lower piece of the lug.

Figure 18. View of the left aft longitudinal lug area on the vertical stabilizer. Stringers 1, 2, and 3 are labeled.

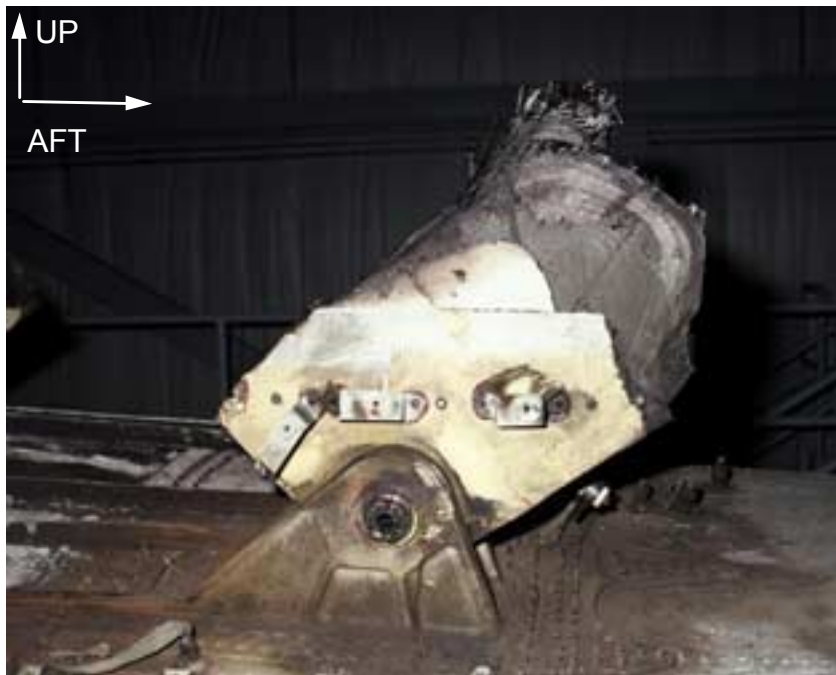
ImageNo: 208A0256, Project No:A00386

Figure 19. View of the mating left aft longitudinal lug piece that remained attached to the fuselage.

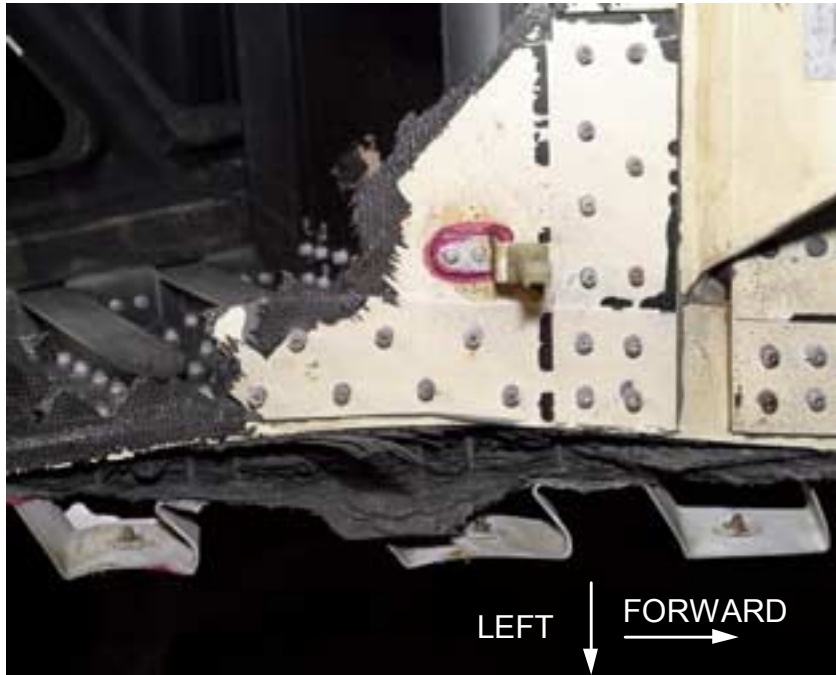
ImageNo:208A0253, Project No:A00386

Views of the left center lug area fracture are shown in figures 20 and 21. The translaminar fracture occurred in the vertical stabilizer structure above the lug bore, and the lower piece remained attached to the fuselage as shown in figure 21. There were multiple fasteners through the lug and adjacent structure both above and below the fracture associated with a factory repair (concession number TH-9802). There was no visible sign of distress or fracture associated with the repair fasteners. None of the other fittings had similar fasteners. The translaminar fracture occurred primarily at the rib 1 fastener row as shown in figure 20, intersecting most of the rib 1 fastener holes. The fracture was horizontal and perpendicular to the skin surface. The fracture surfaces were generally rough, consistent with fracture under primarily tensile loading.

Figure 20. View of the translamellar fracture for the left center longitudinal lug.

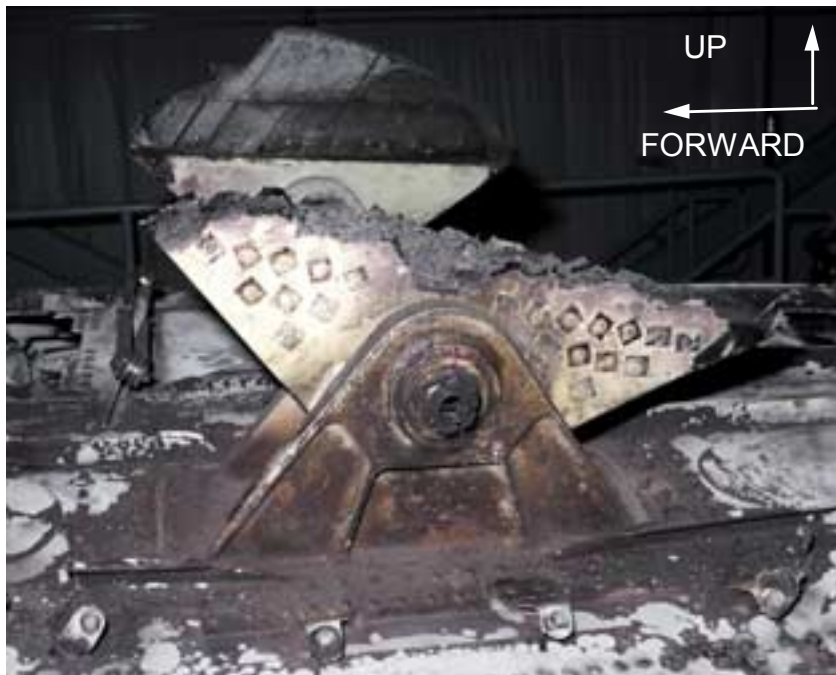
ImageNo: 208A0255, Project No:A00386

Figure 21. View of the left center longitudinal lug that remained attached to the fuselage. Repair rivets with square angle shims are visible on the surface.

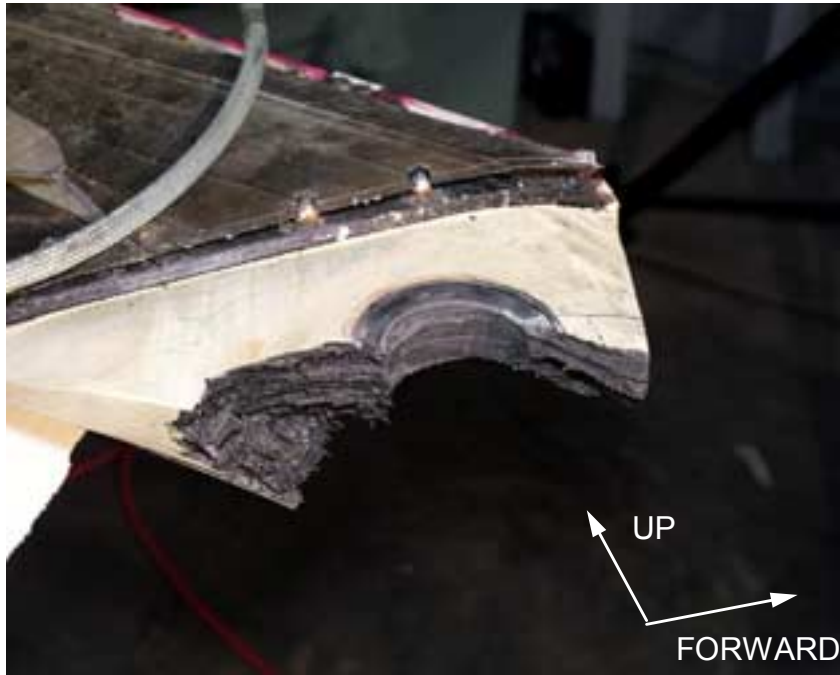
ImageNo:208A0219, Project No:A00386

Views of the left forward lug are shown in figures 22 to 24. The fracture surfaces intersected the lug attach hole. The lower portion of the lug remained with the fuselage and had a darkened appearance consistent with severe exposure to heat and fire as shown in figure 24. The upper side of the fracture is shown in figures 22 and 23. On the aft leg of the lug, the translaminar fracture was primarily on a horizontal plane and appeared rough, consistent with fracture under tensile loading. On the forward leg of the lug, the translaminar fracture intersected the bore nearly tangentially and was primarily on a plane parallel to the zero-degree fiber direction. The fracture surfaces on the forward leg of the lug were rough with multiple ply separations in the leg above the fracture surface, consistent with tensile fracture with transverse shear. On the outboard side of the hole above the bore, a bearing indentation was observed as shown in figure 23. The indentation was approximately 1/8 inch deep and the shape corresponded to the profile of the upper

Figure 22. View of the left forward longitudinal lug on the vertical stabilizer.

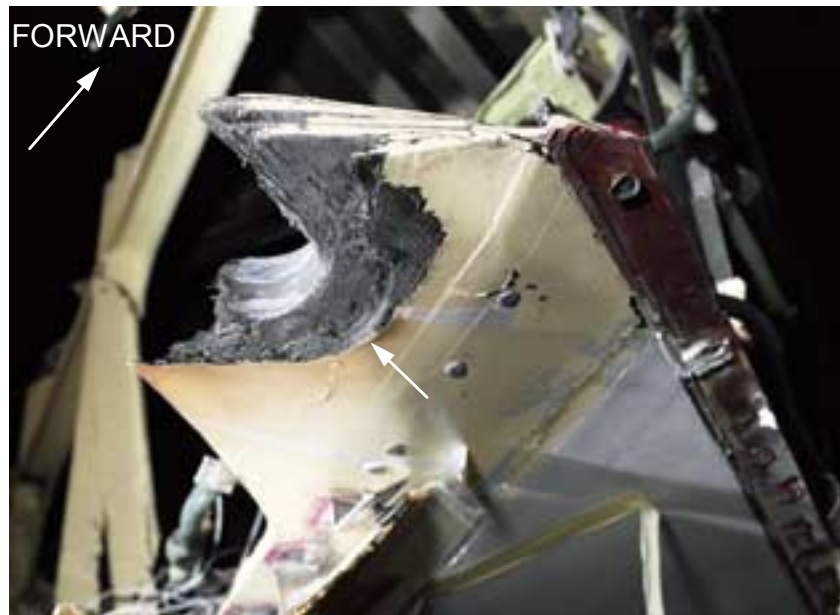
ImageNo: 208A0252, Project No:A00386

end of the outboard lug on the fuselage clevis attach fitting. Ply separation also was observed in the fire damaged lower portion of the lug that remained with the fuselage.

Figure 23. Another view of the left forward longitudinal lug on the vertical stabilizer showing the left side. An unlabeled arrow indicates an area of crushing damage corresponding contact with the upper end of the metal fuselage attach fitting lug.

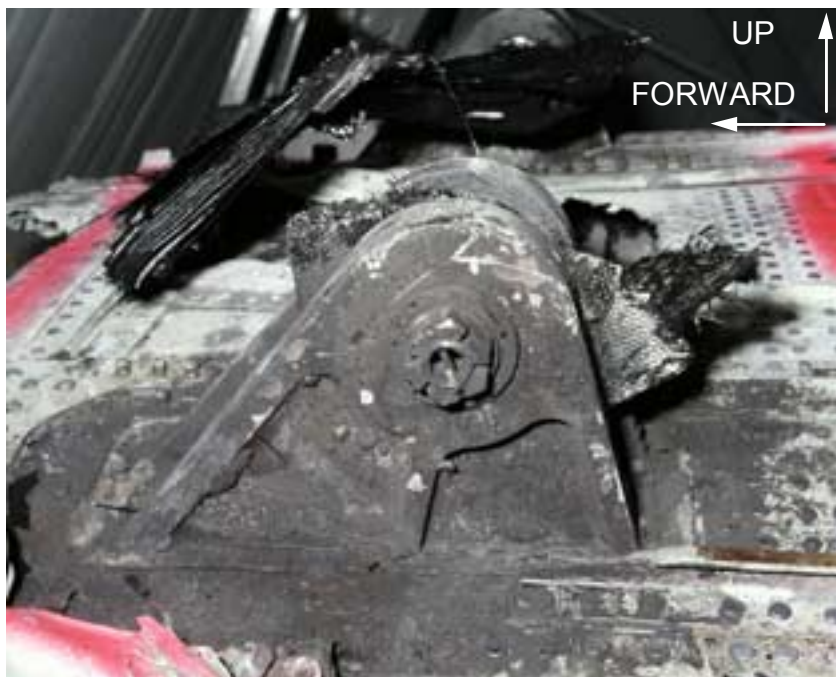
ImageNo:208A0257, Project No:A00386

Figure 24. View of the lower piece of the left forward longitudinal lug that remained attached to the fuselage.

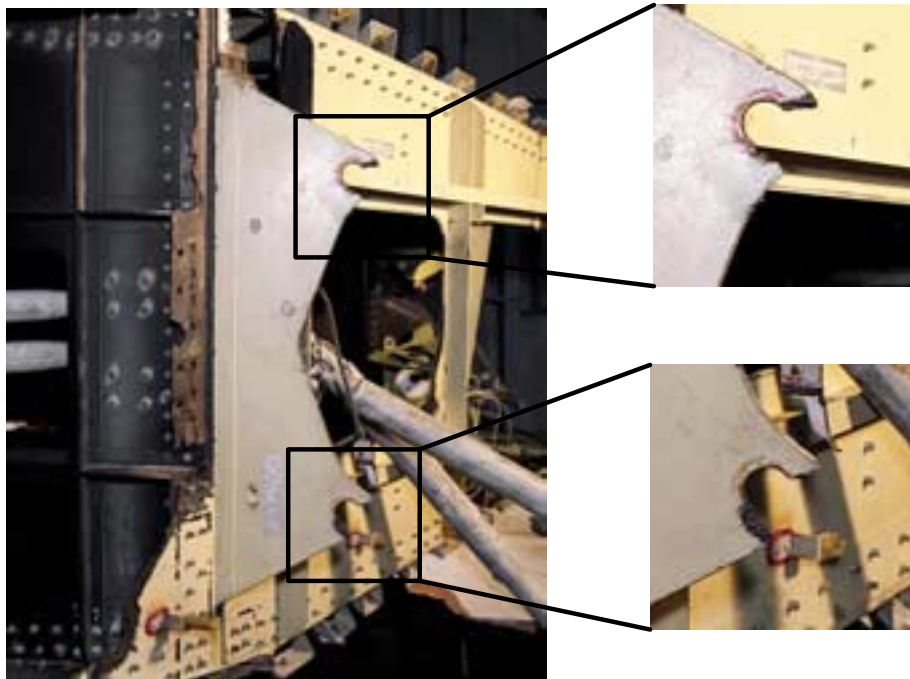
ImageNo: 208A0222, Project No:A00386

A view of the upper portion of the center transverse lugs is shown in figure 26. The translamina fractures of the lugs intersected the lug attach holes. On the right lug, the outboard leg was fractured in a vertical plane, intersecting the bore approximately at a 90-degree angle. The inboard leg was fractured at an approximately 45-degree angle to the vertical direction, intersecting the bore approximately tangentially. On the left lug, the inboard leg was fractured in a near vertical plane, intersecting the bore approximately at a 90-degree angle. The outboard leg was fractured at an approximately 45-degree angle to the vertical direction, intersecting the bore approximately tangentially. All fracture surfaces were rough, consistent with fracture under tensile loading. The lower pieces of the lugs were not recovered.

Figure 26. The center transverse lugs on the vertical stabilizer as viewed looking upward and forward.

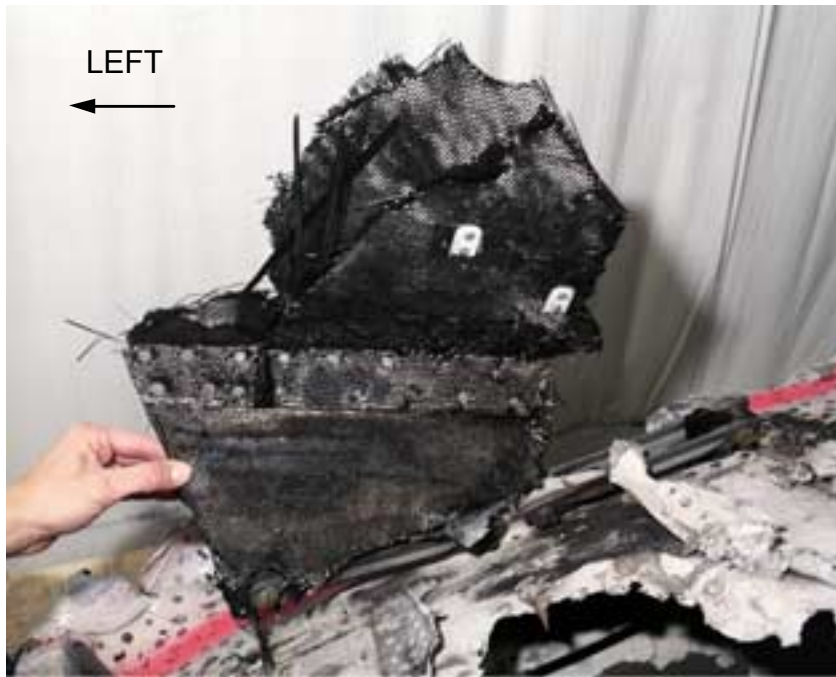
ImageNo:208A0258, Project No:A00386

Figure 27. A piece of the forward spar that remained attached to the fuselage as viewed looking forward. The piece is heavily damaged by heat and fire.

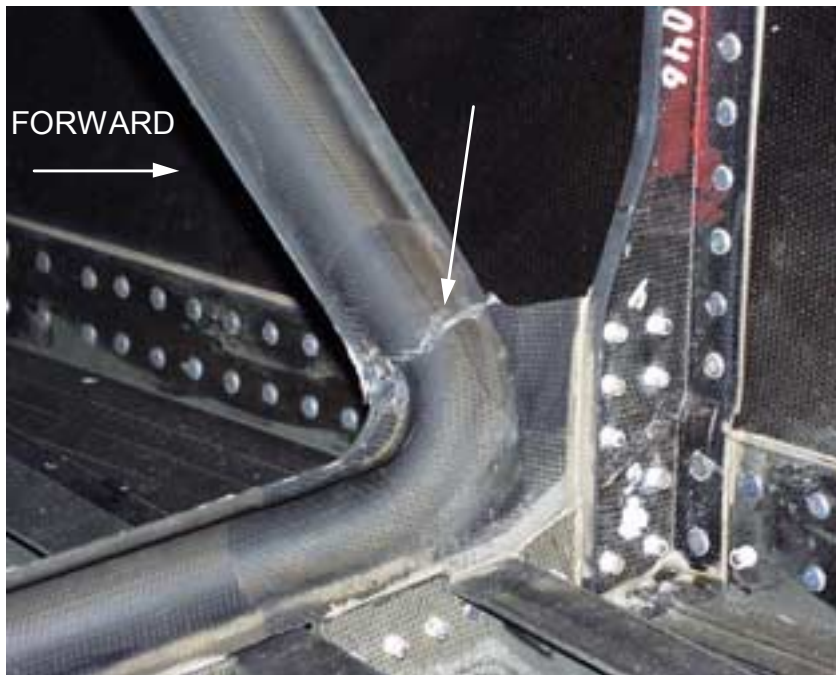
ImageNo: 208A0231, Project No:A00386

Figure 28. An unlabeled arrow indicates the fracture in the rib 3 diagonal channel as viewed from below.

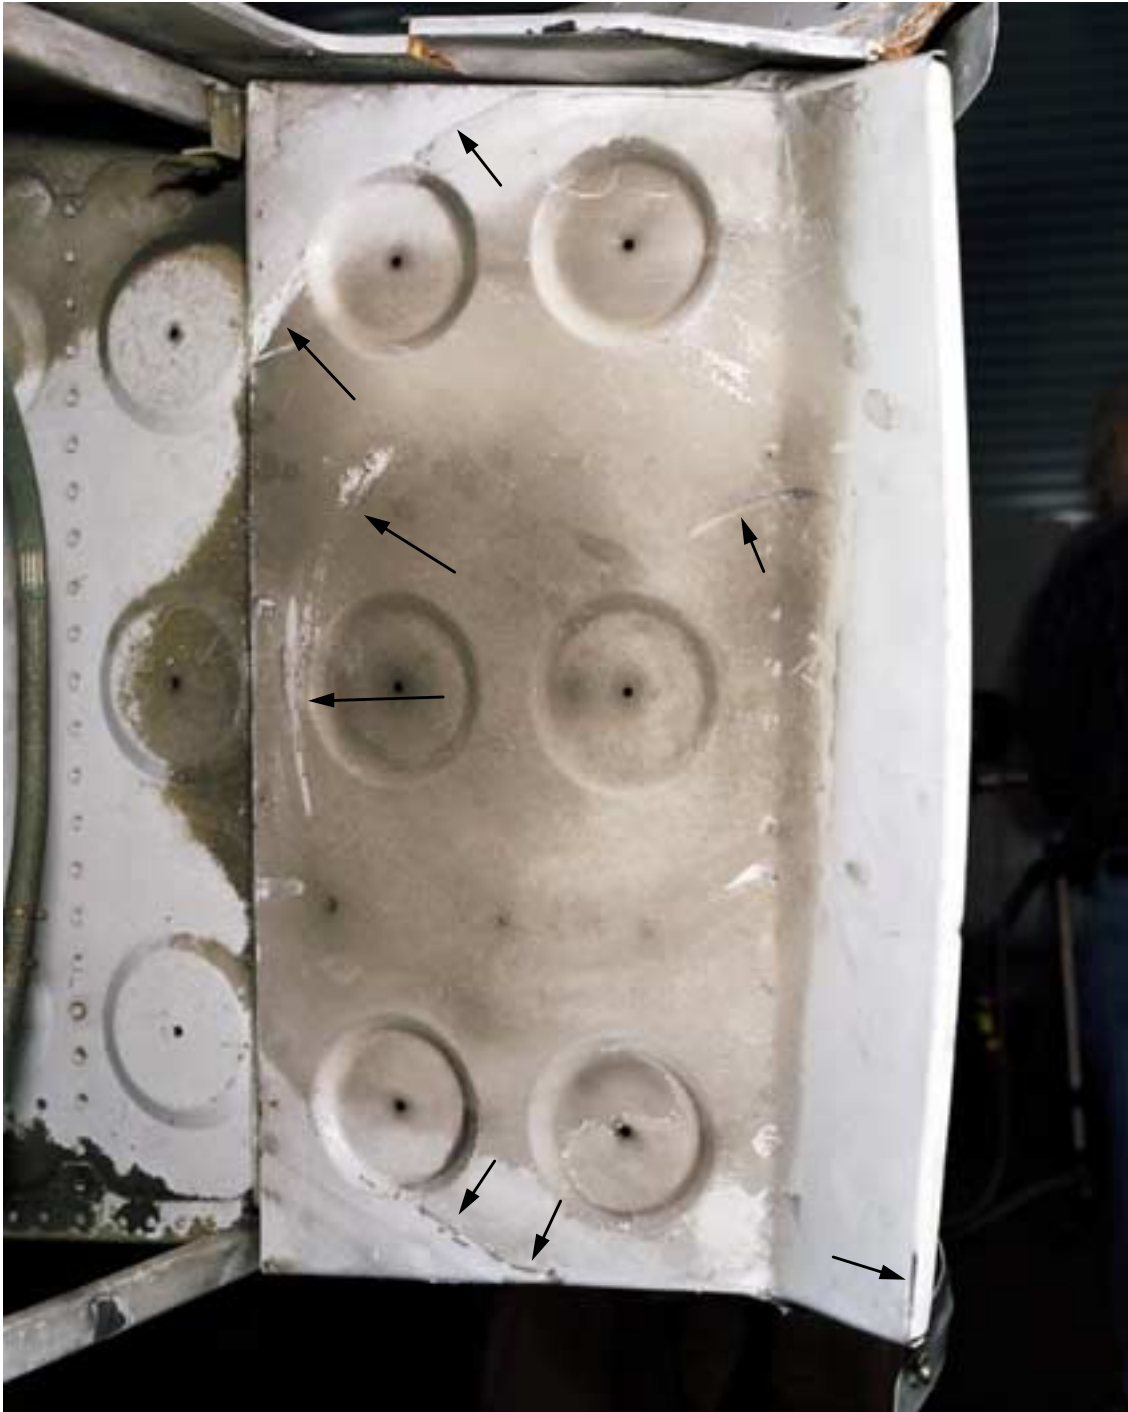
ImageNo:208A0441, Project No:A00386

Figure 30. View of the damaged metal cover plate at the lower end of the hingeline on the vertical stabilizer. Unlabeled arrows indicate witness marks that correspond to contact with the lower end of the LE fairing and the fairing lower metal closure.

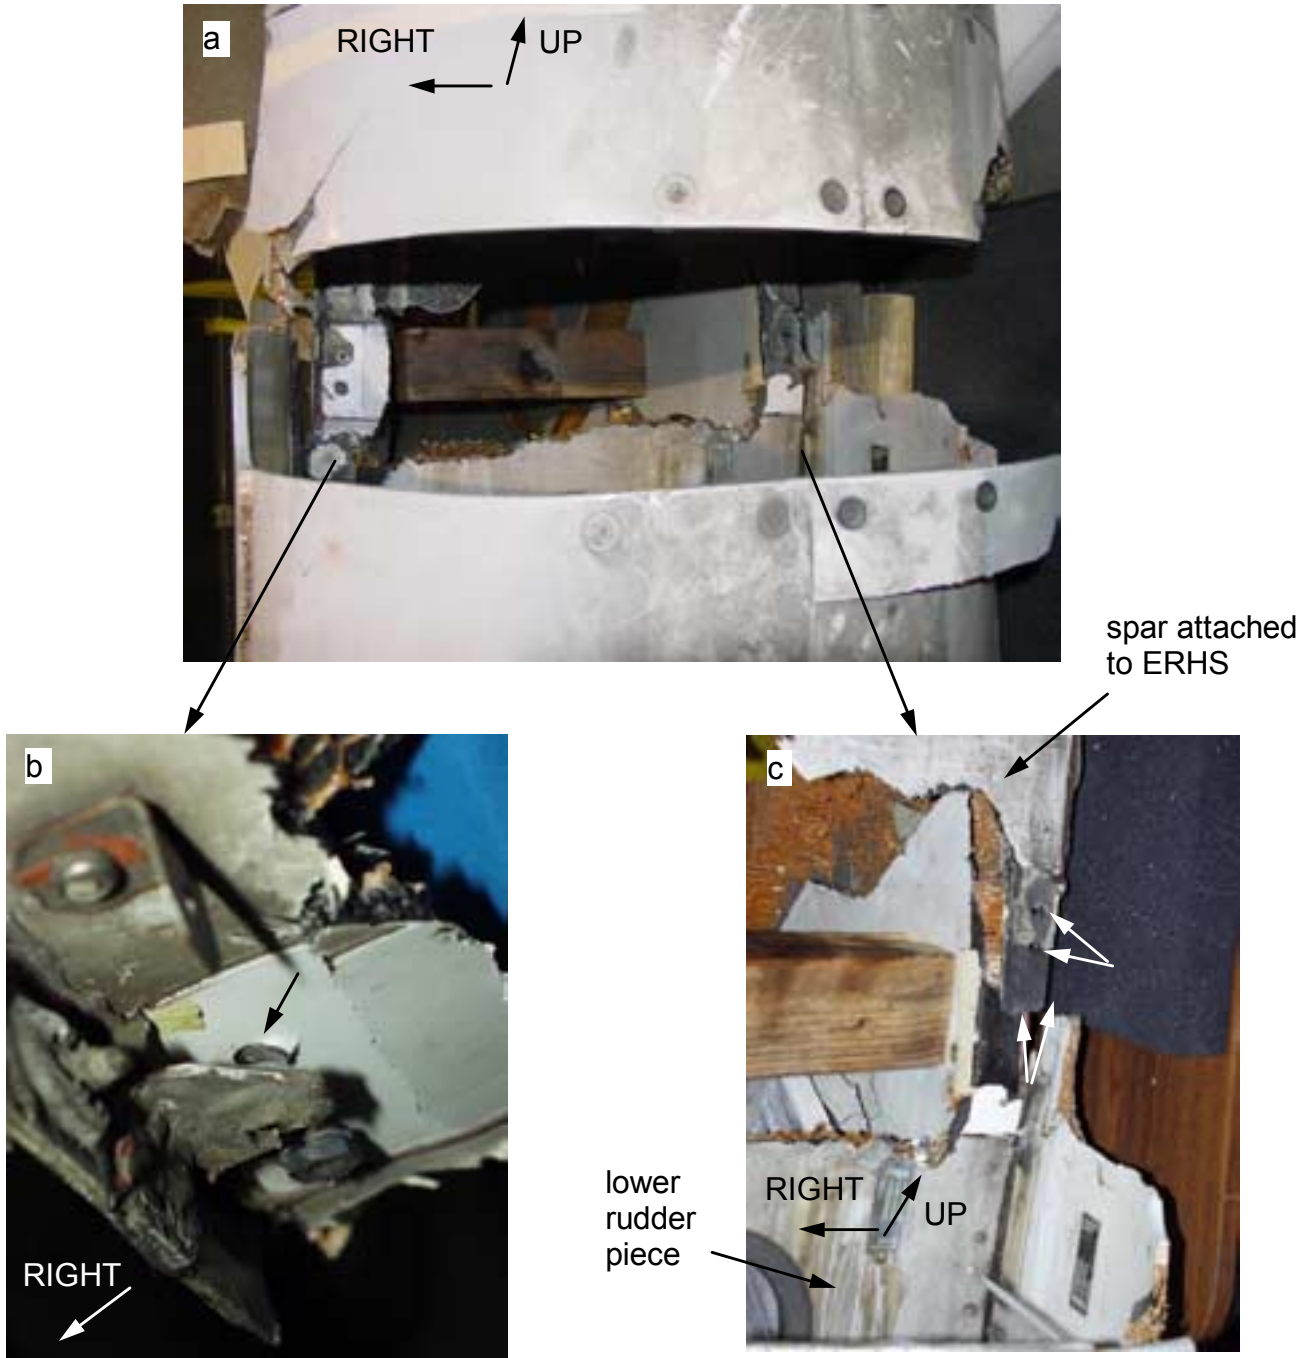
Figure 31. (a) View of hinge 1 aft fitting attach area at the rudder leading edge. (b) Right and (c) left attach bolt areas are shown in detail. The unlabeled arrow in (b) indicates the sheared aft fitting attach bolt. The unlabeled arrows in (c) indicate portions of the left attachment bolt holes in the spar that remained attached to panel ERHS and to the lower piece of the rudder.

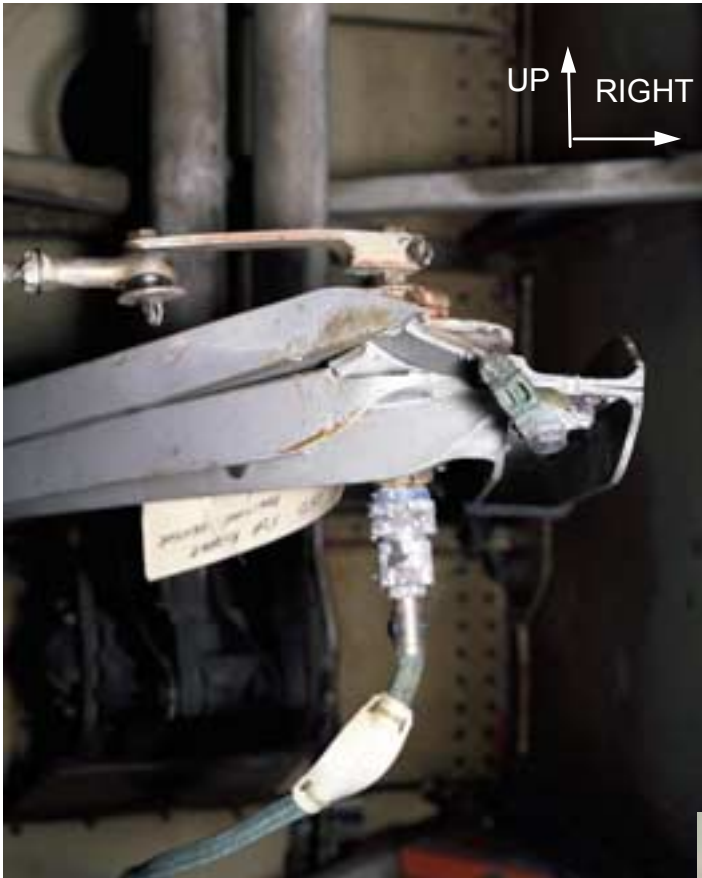
Figure 32. Closer view of the hinge 1 forward fitting fracture.
