# NATIONAL TRANSPORTATION SAFETY BOARD

MATERIALS LABORATORY FACTUAL REPORT

Report No. 02-077

Place : Belle Harbor, New York  
Date : November 12, 2001  
Vehicle : Airbus A300-600, N14053  
NTSB No. : DCA02MA001  
Investigator : Brian Murphy, AS-40

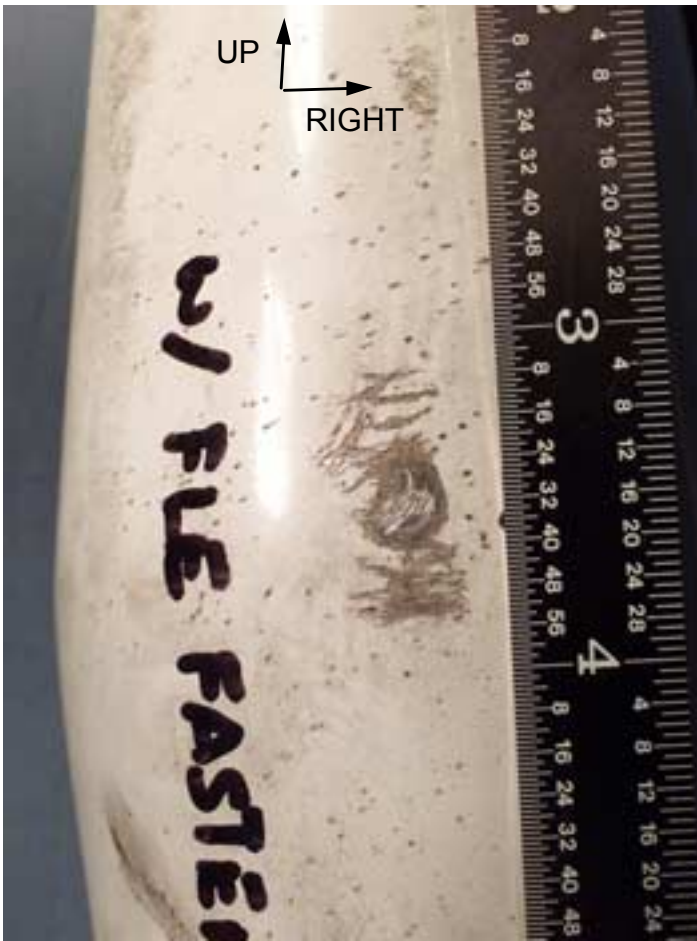
ImageNo:208A0314, Project No:A00386

Figure 39. A closer view of the damage on the upper side of the vertical support strut.

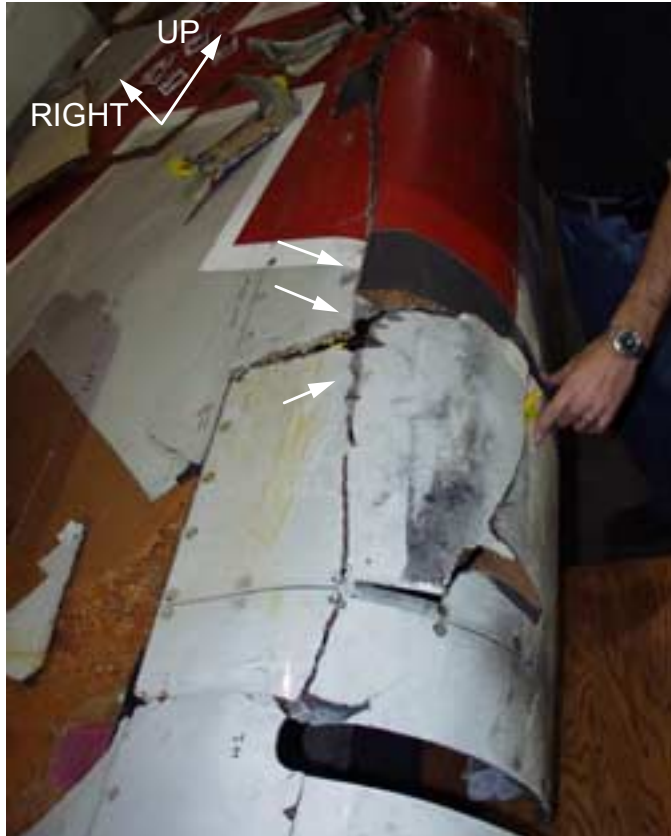
ImageNo: 208A0384, Project No:A00386

Figure 49. View of the right side of the LE fairing at hinge 1 and up to just below hinge 2. Unlabeled arrows indicate where scuffing damage adjacent to the nearly spanwise fracture was greatest.

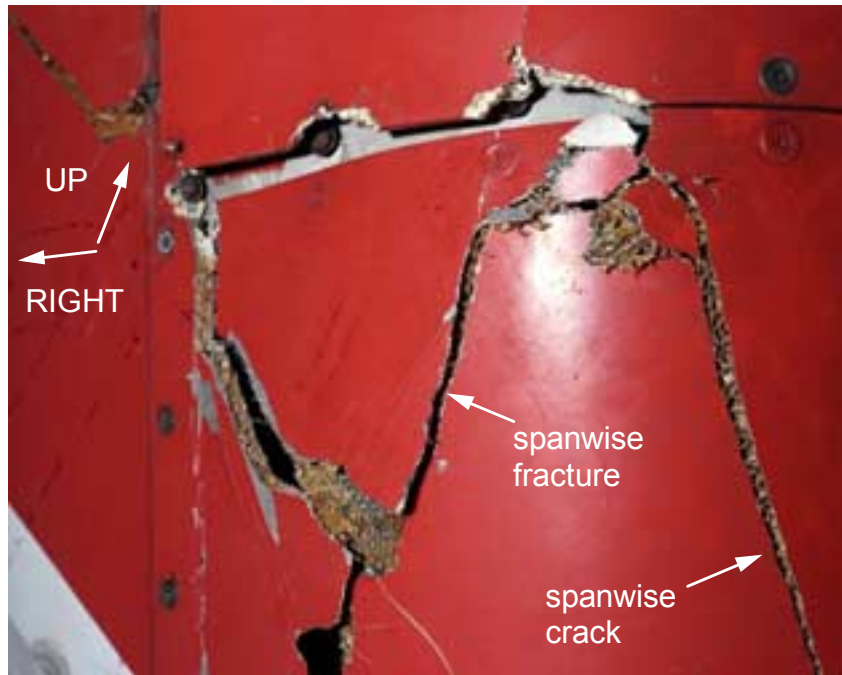
ImageNo:208A0390, Project No:A00386

Figure 50. View of the upper ends of the nearly spanwise fracture and crack on the rudder LE fairing right side just below hinge 2.

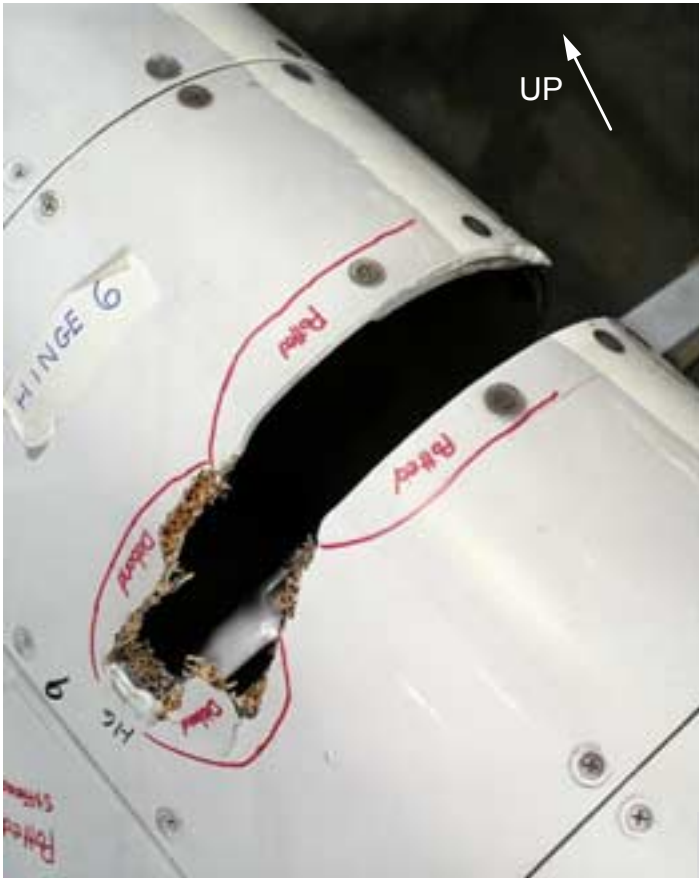
ImageNo:208A0396, Project No:A00386

Figure 54. View of the right side of the LE fairing at hinge 6 showing damage to the right cutout end.

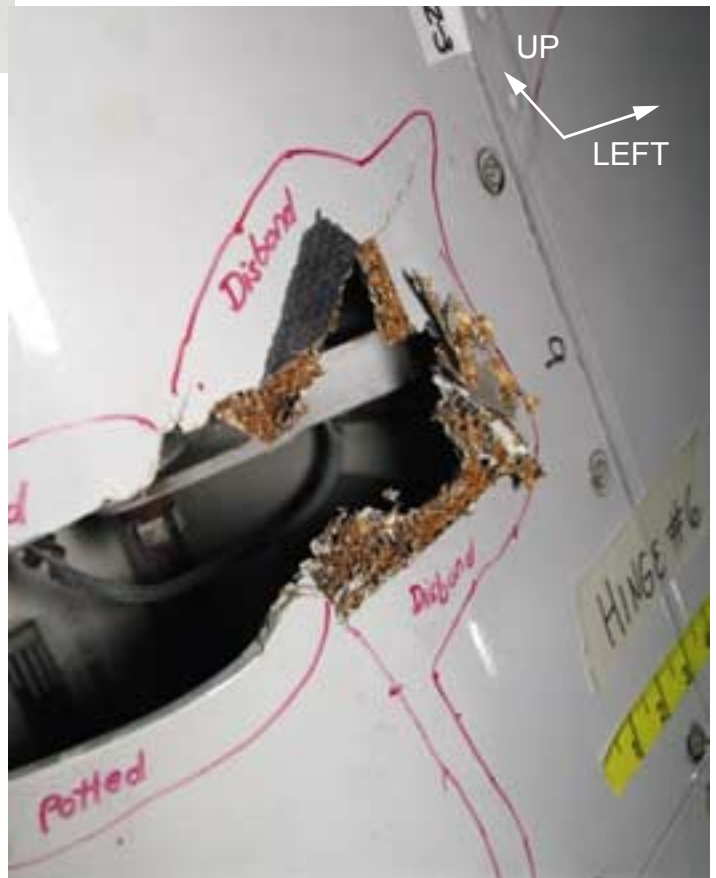
ImageNo: 208A0397, Project No:A00386

Figure 55. View of the left side of the LE fairing at hinge 6 showing damage to the left cutout end.

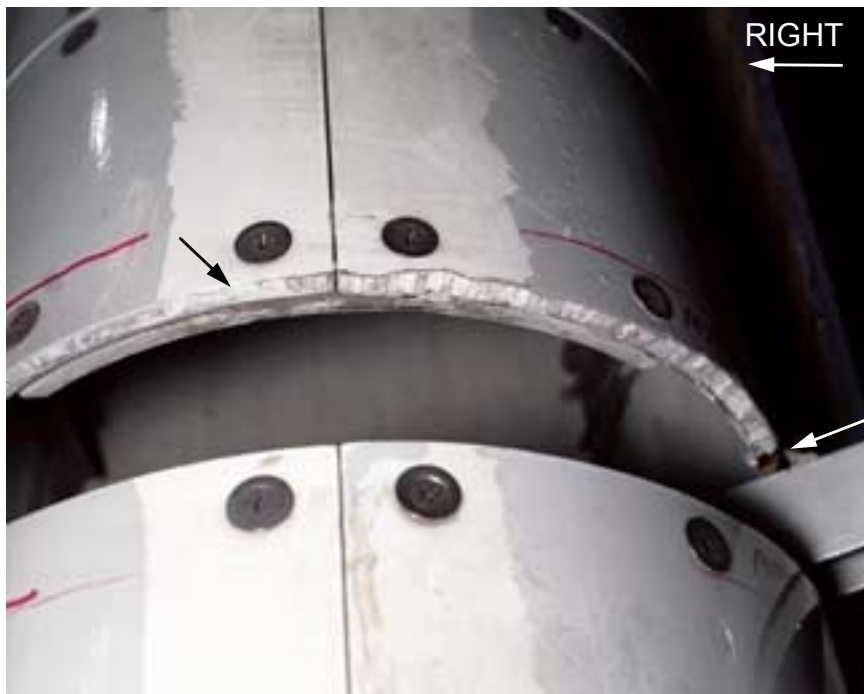
ImageNo:208A0393, Project No:A00386

Figure 56. View of the upper side of the hinge 6 rudder LE cutout. Continuous heavy damage was observed between the unlabeled arrows.

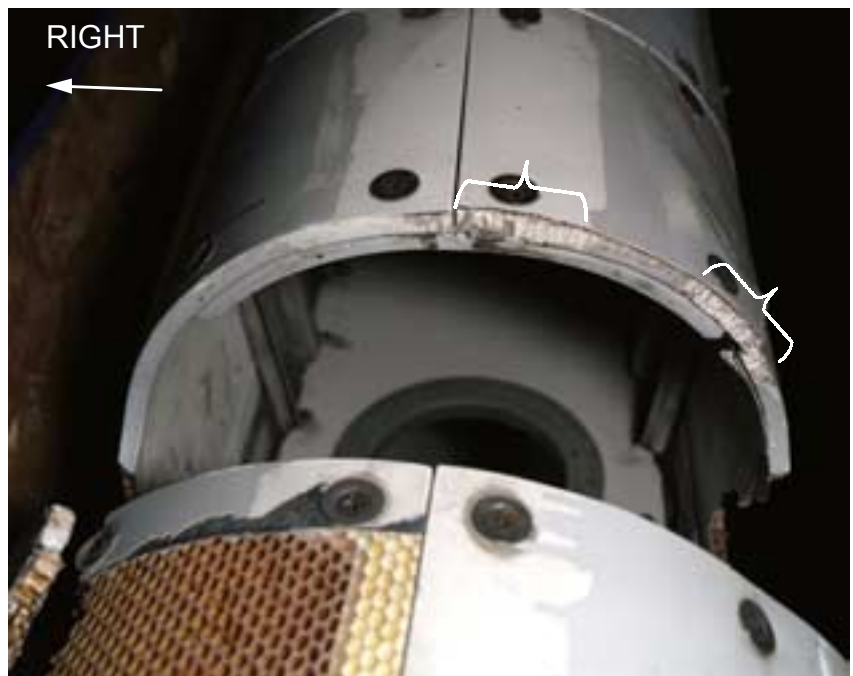
ImageNo: 208A0395, Project No:A00386

Figure 58. View of the upper side of the hinge 7 LE fairing cutout. Brackets indicate areas of damage on the left side.

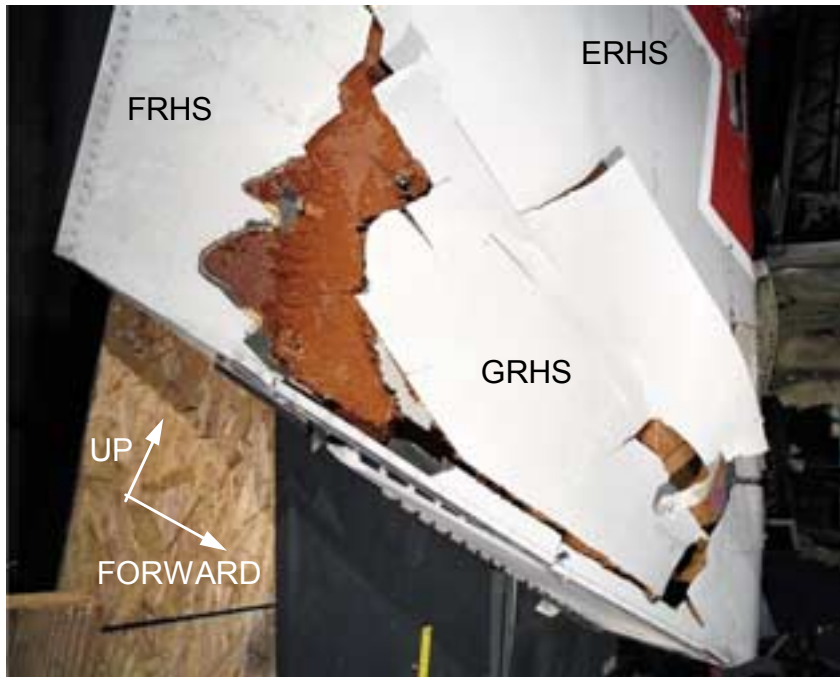
ImageNo:208A0408, Project No:A00386

Figure 59. Closer view of the fractures at the right side lower end of the rudder.

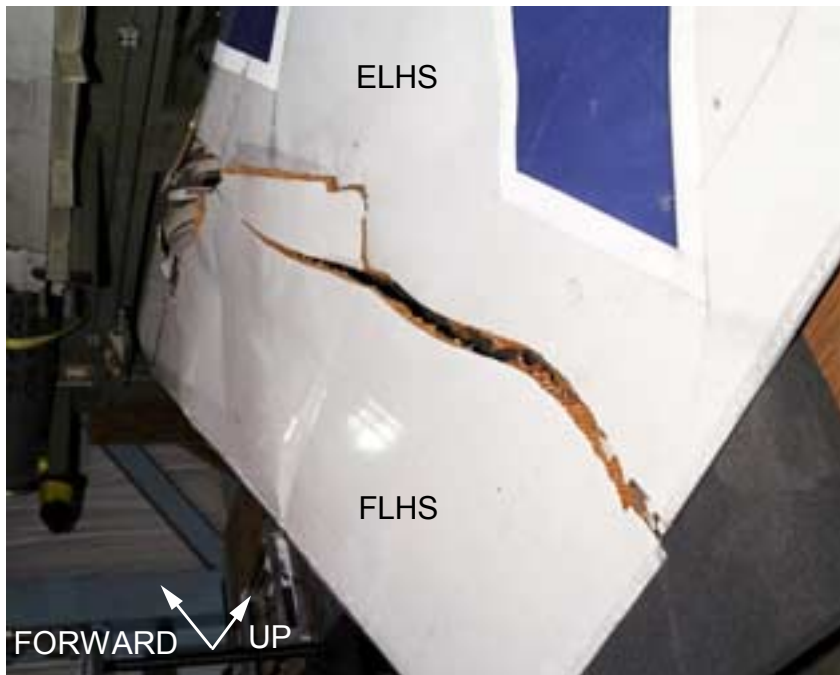
ImageNo: 208A0409, Project No:A00386

Figure 60. Closer view of the fractures on the left side lower end of the rudder.

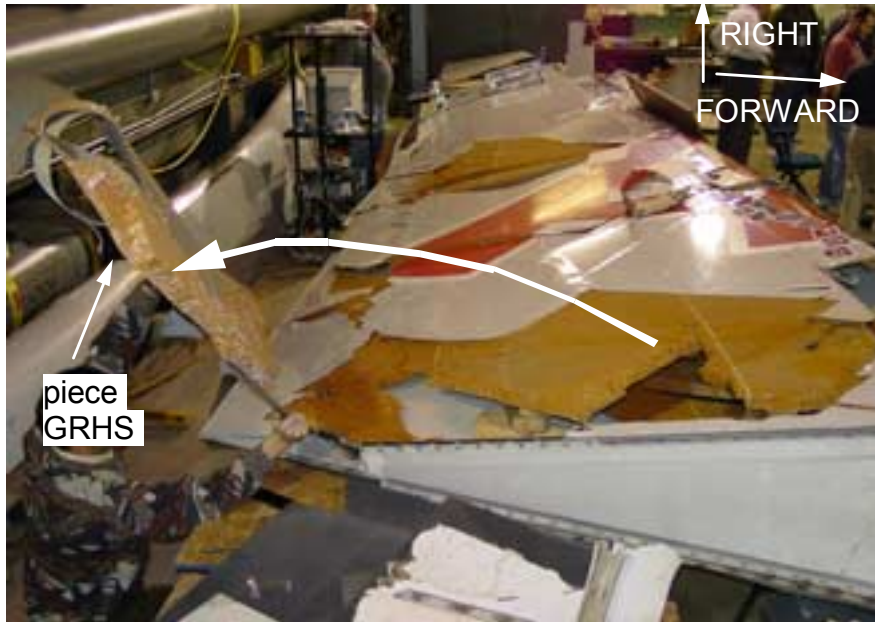
ImageNo:208A0407, Project No:A00386

Figure 61. View of the right side of the lower end of the rudder showing fracture matching of the lower metal retaining strip. The curved arrow indicates the motion of piece GRHS relative to the aft piece of the retaining strip.

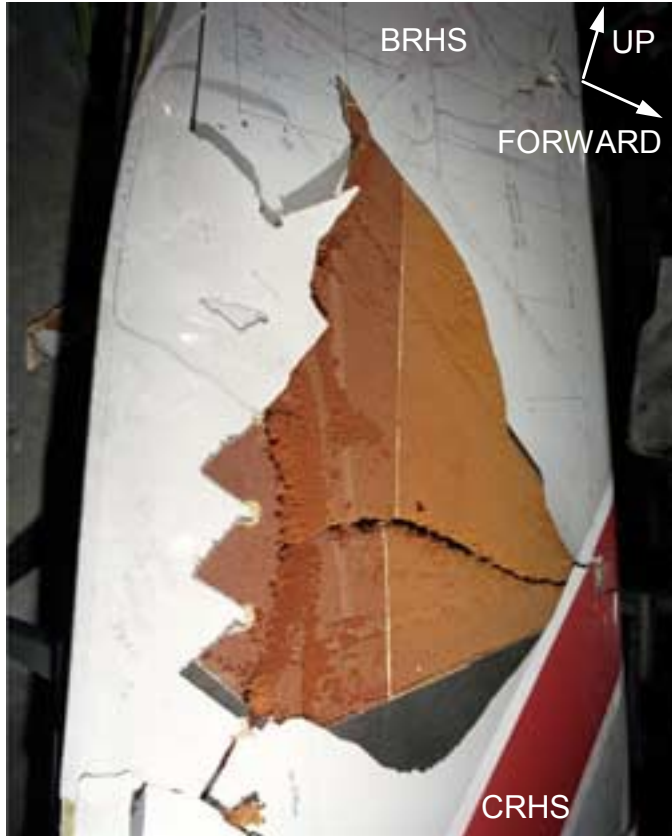
ImageNo: 208A0411, Project No:A00386

Figure 62. View of the fracture where the external facesheet was missing from the right side at the lower end of piece BRHS and the upper end of piece CRHS.

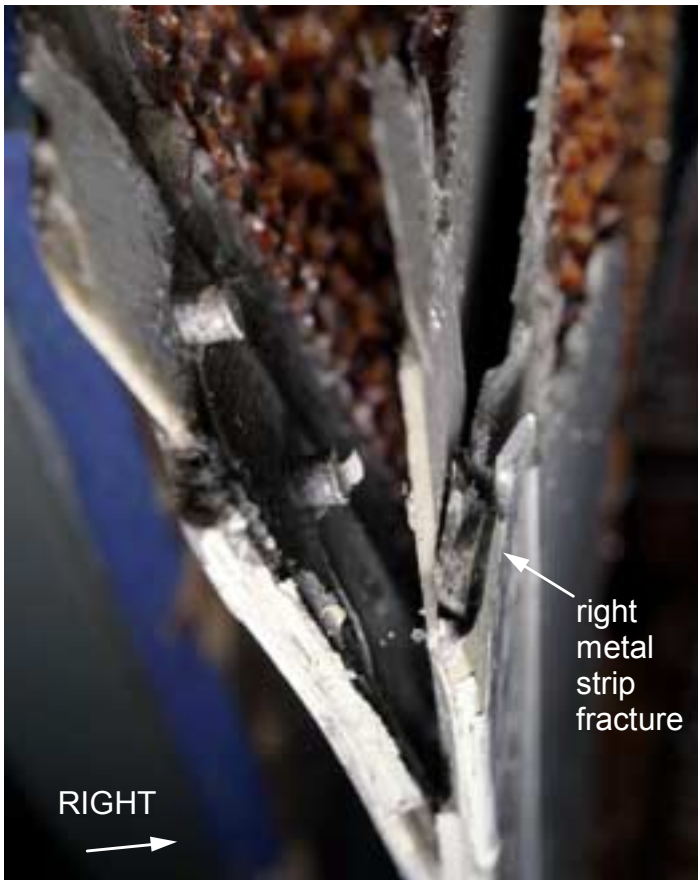
ImageNo:208A0418, Project No:A00386

Figure 65. View looking down at the fracture at the upper end of piece HRHS showing local deformation of the metal trailing edge strips.

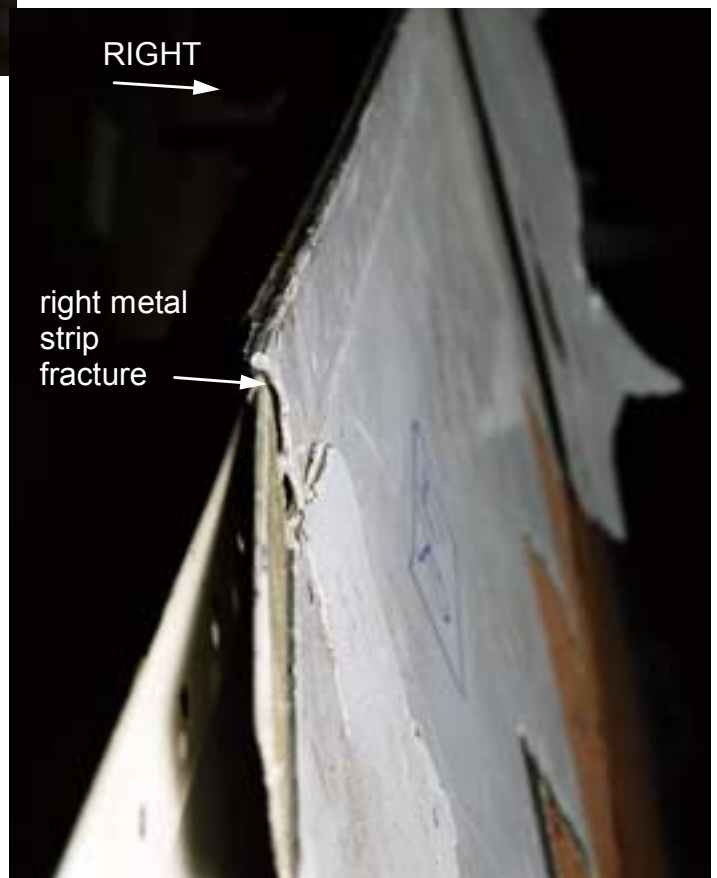
ImageNo: 208A0414, Project No:A00386

Figure 66. View looking up at the fracture at the lower end of piece DRHS showing local deformation of the metal trailing edge strip.

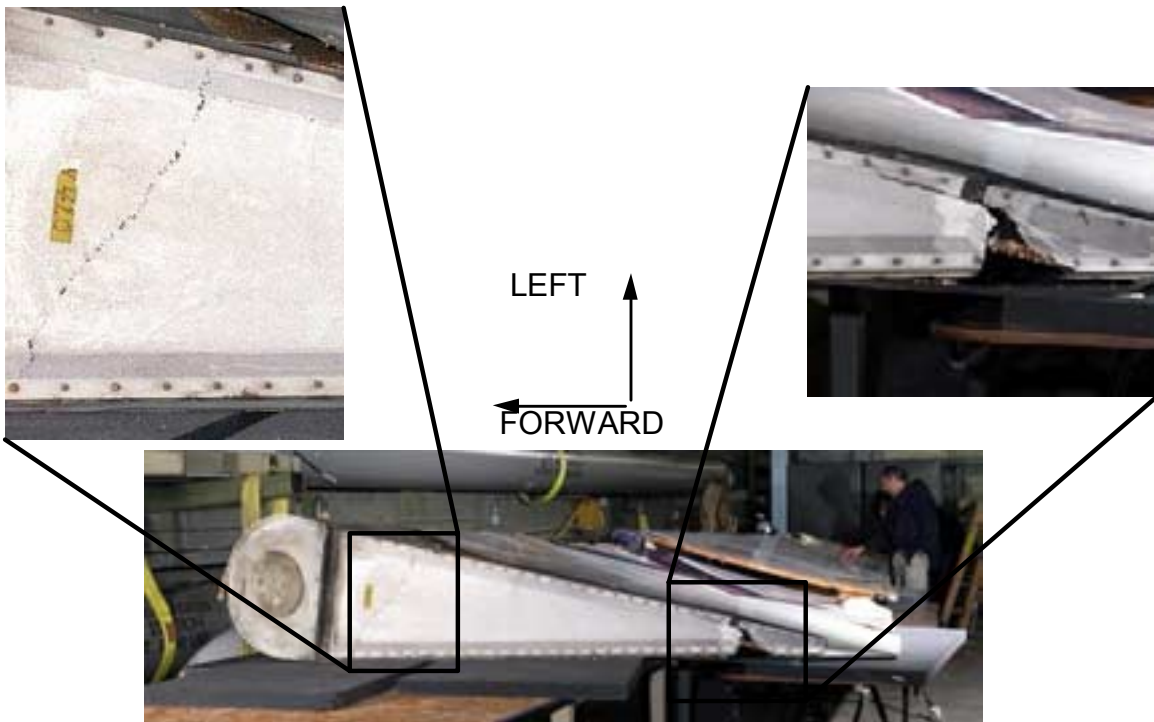
ImageNo:208A0439, Project No:A00386

Figure 69. Overall view of the lower rib of the rudder with details showing the compression fracture near the forward spar and the fracture near the trailing edge.
