**NATIONAL TRANSPORTATION SAFETY BOARD  
OFFICE OF AVIATION SAFETY  
WASHINGTON, D.C. 20594**

**POWERPLANTS GROUP CHAIRMAN'S FACTUAL REPORT**

NTSB ID No.: DCA02MA001

Aircraft: Airbus Industrie A300-605R, N14053, American Airlines flight 587

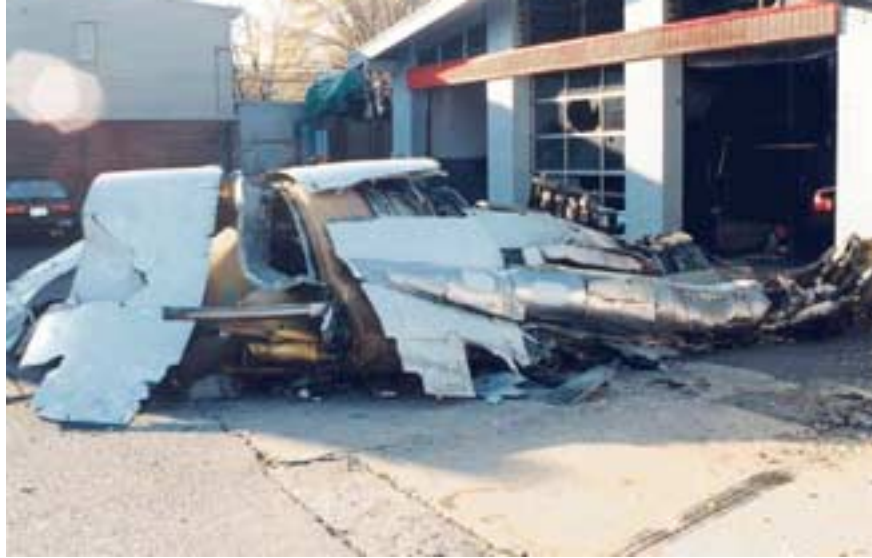
Photo 1: No. 1 engine with pylon still attached in front of gas station

The core of the engine between the fan frame and the LPT case was crushed inward on the left side and the core was bent. Pieces of the translating and core cowl were pushed against the engine's left side, but were mostly broken or cracked around the remainder of the engine with small areas that were burned away. There were no indications of an uncontainment, case rupture, or in-flight fire between the fan case and TRF. There were indications of a ground fire in the vicinity of the accessory gearbox, which was found broken open liberating several of the gears.

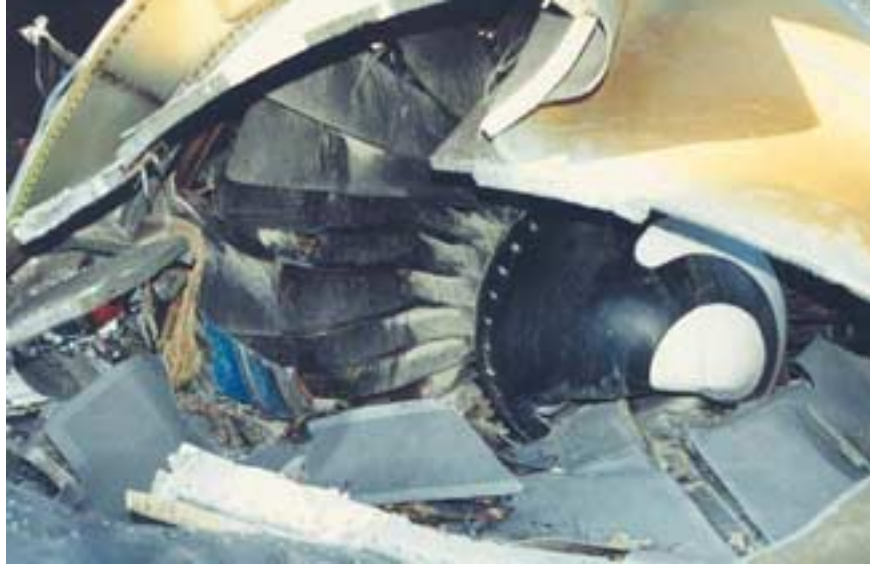
All of the fan blades were in place in the fan disk. There was a continuous arc of fan blades between 5 and 7 o'clock that were fractured transversely across the airfoil between the root platform and the midspan shroud. The remaining fan blades were bent opposite the direction of rotation. The fan blades did not have any soft body impact damage.<sup>7</sup> Additionally, the fan blades did not fluoresce when examined with an ultraviolet light.<sup>8</sup>

Photo 2: Closeup of No. 1 engine's fan blades (FAA)

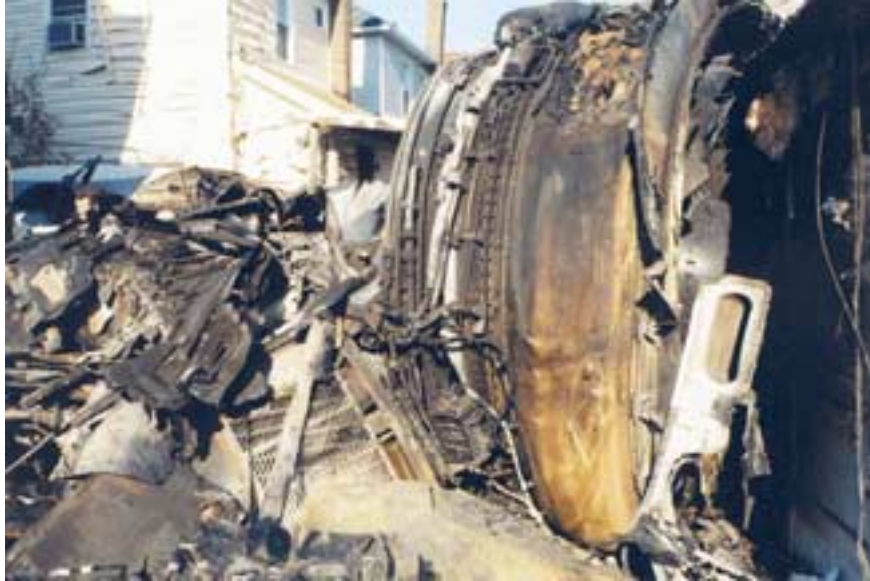
Photo 3: No. 2 engine in back of house

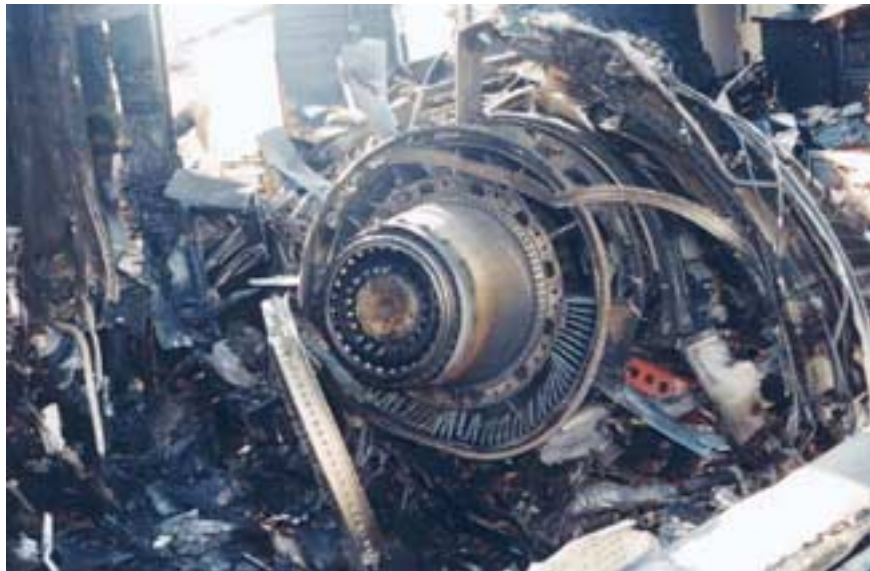
Photo 4: No. 2 engine's core separated from fan

There were pieces of the translating and core cowls that were against the left side of the engine, but the cowls were broken up or burned away from the right side. There were no indications of an uncontainment, case rupture, or in-flight fire.

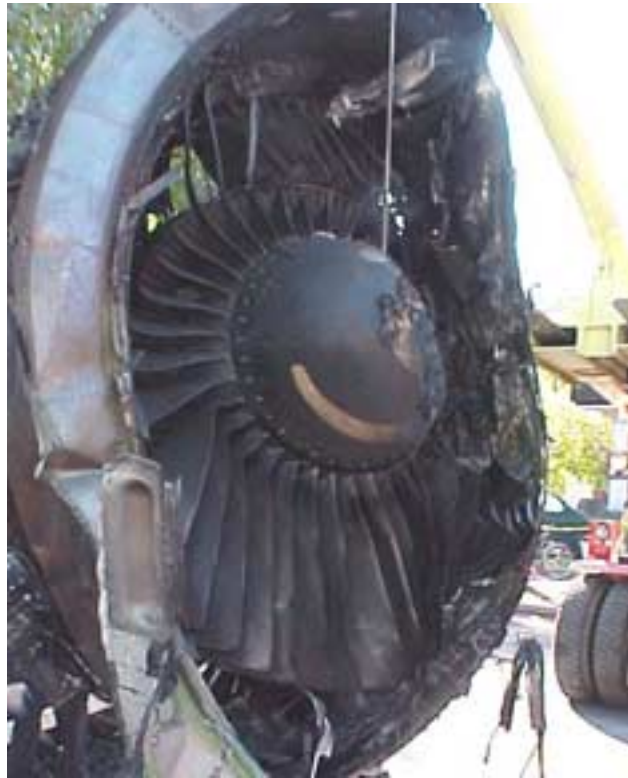
All of the fan blades were in place in the fan disk. There was a 180° arc of fan blades oriented towards the left side of the engine that were fractured transversely across the airfoil from adjacent to the root platform to about 1-inch outboard of the midspan shrouds. The leading edges of the fan blades had only a few small nicks and dents. None of the fan blades had any soft body impact damage. Additionally, the fan blades did not fluoresce when examined with an ultraviolet light.

Photo 5: No. 2 engine's fan blades shown after fan had been picked up (FAA)

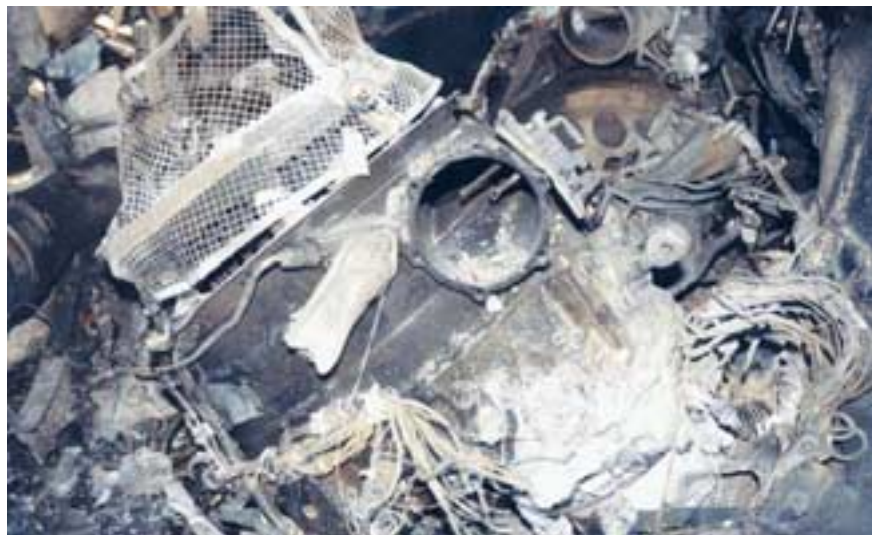
The APU was found in the airplane's tailcone that was found on the southwest corner of Beach 131 Street and Newport Avenue. The APU was broken from its mounts and was found laying in the bottom of the tailcone just inside the opening of the break in the fuselage just forward of the APU's normal position. The tailpipe was separated from the APU and was found on the ground just in back of the tailcone. The APU did not have any indications of an uncontainment or in-flight fire. The area of the tailcone around the normal position of the APU did not have any shrapnel damage.

Photo 6: Auxiliary power unit

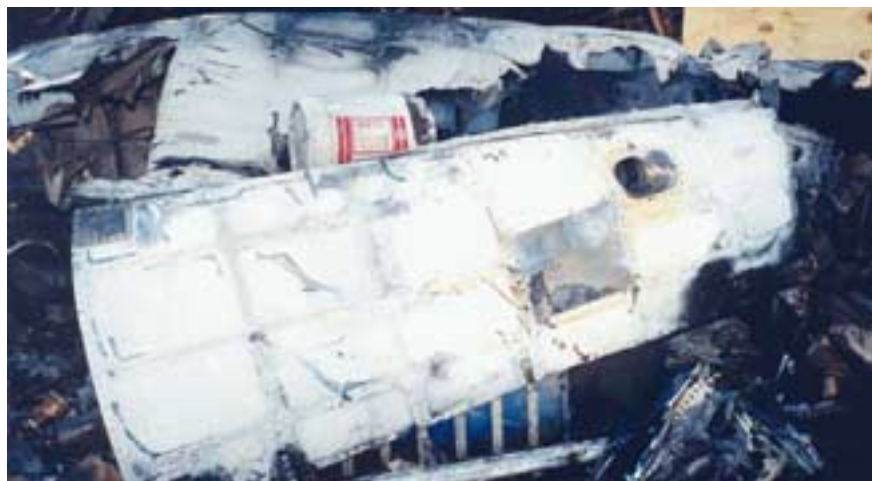
Photo 7: Tailcone over area of APU installation showing no shrapnel damage

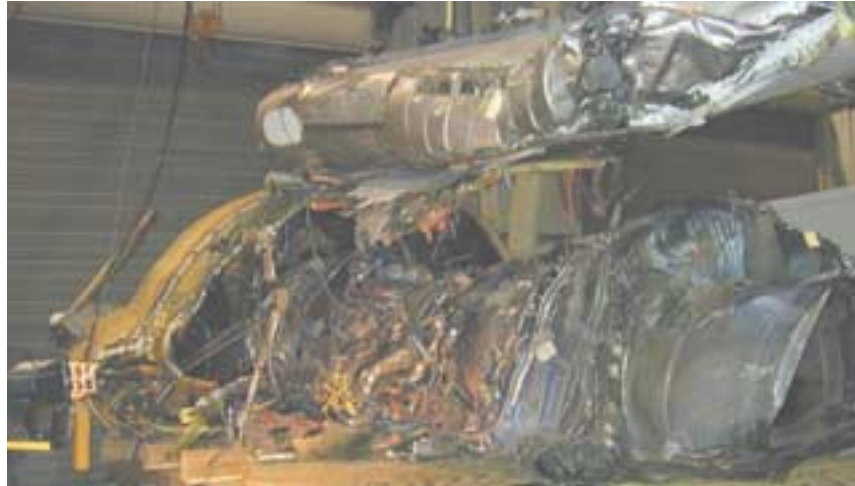
The engine was received with the pylon still in place that was removed to facilitate the disassembly. The engine was crushed on the left side. There was no evidence of an in-flight fire, case rupture, or uncontainment.

Photo 8: As received condition of engine with pylon being removed (American)

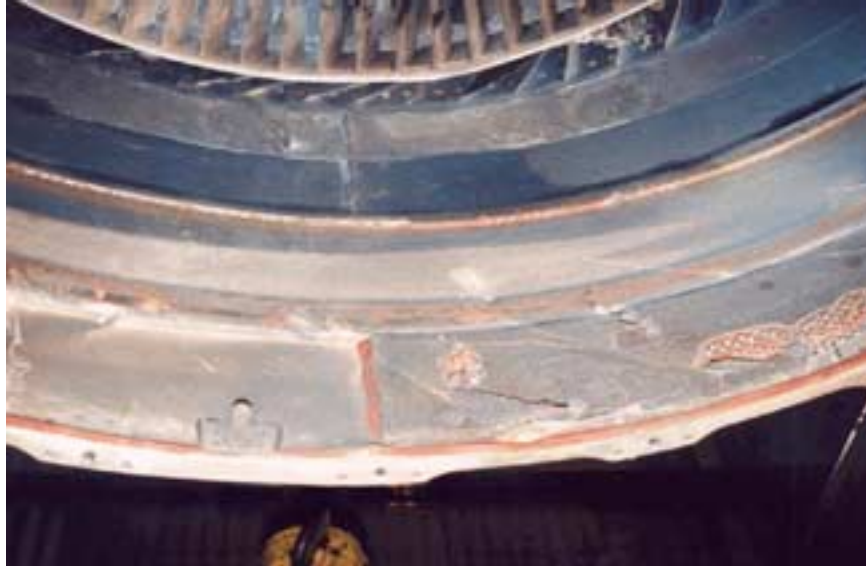
Photo 9: No. 1 engine's fan case and rub strip showing imprint of fan blade tips

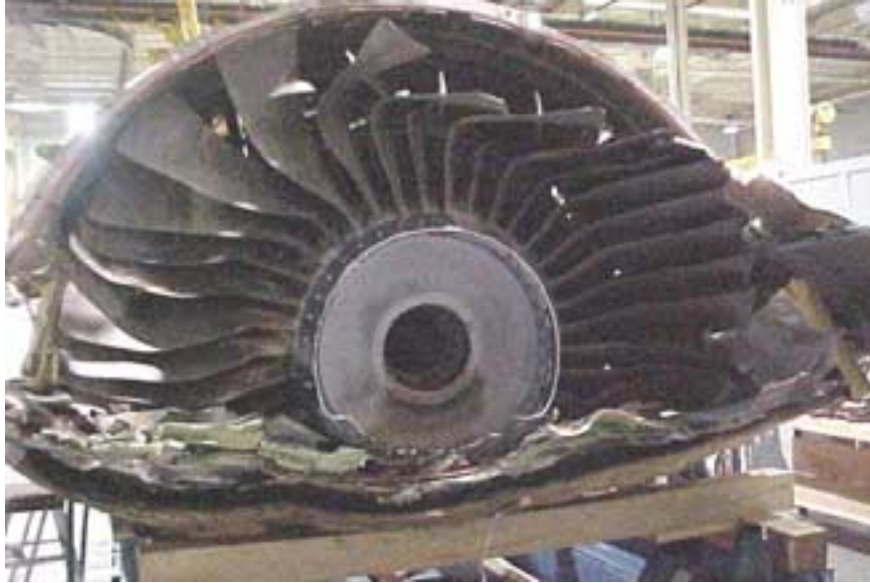
The fan blade dovetails were all in place in the disk. The 10 fan blades that were oriented towards the left side of the engine were fractured transversely across the airfoil adjacent to the blade root platform. All of the remaining fan blades were full length and bent opposite the direction of rotation except for four fan blades, two groups of two adjacent blades that were located almost 180° apart that were fractured across the airfoil around the midspan shroud. The leading edges of the fan blades had a few randomly located small nicks, dents, and tears and no soft body impact damage.

Photo 10: No. 1 engine's fan disk and blades (GE)

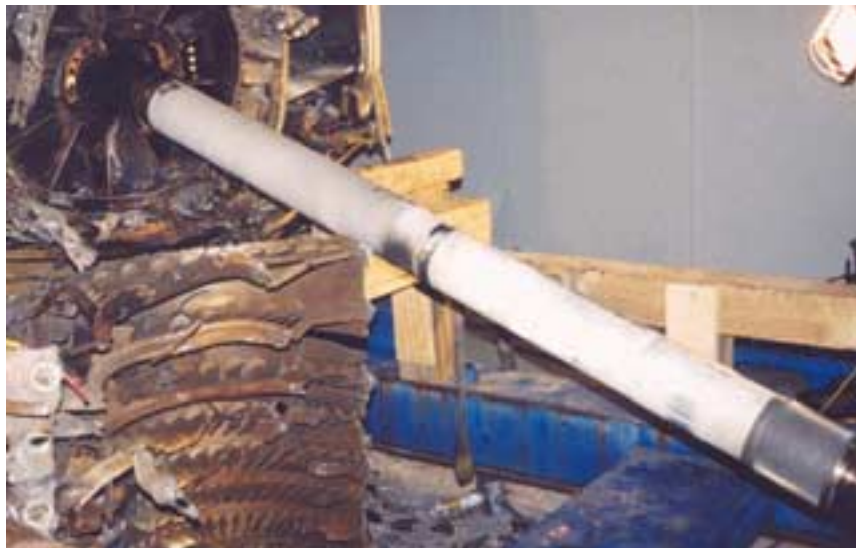
The fan forward shaft and fan mid shaft (FMS) were intact.

Photo 11: No. 1 engine's fan mid shaft

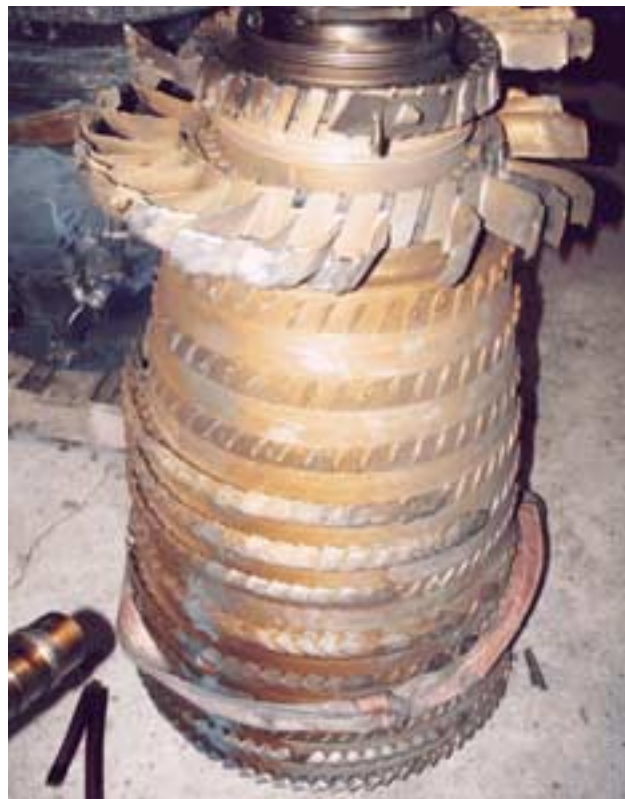
The HPC rotor, stages 1 through 14,<sup>13</sup> was intact except for the HPC stage 11 to 14 spool/shaft cone that was fractured 360° around. The fracture on the spool/shaft cone was irregularly shaped and the fracture surface was coarse and grainy and at a 45° angle to the surface. The blade rub lands on the outside of the HPC rotor had circumferential rub marks. All of the bores and webs on the inside of the HPC rotor were intact.

Photo 12: No. 1 engine's high pressure compressor rotor

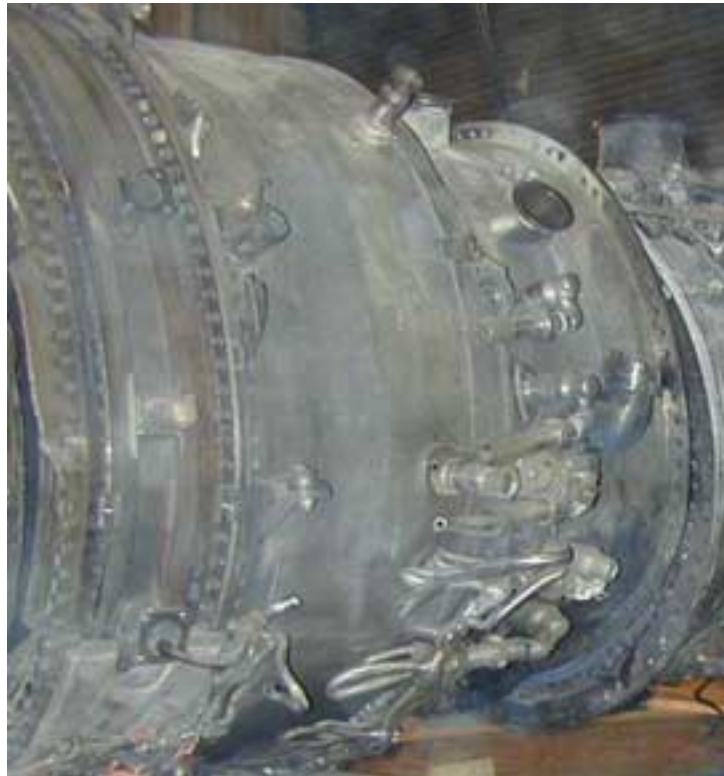
The CRF did not have any indications of thermal distress, case rupture, or in-flight fire. The CRF had a 19-inch long (circumferential) by 1-inch wide (axial) rectangular-shaped hole just aft of the fuel nozzle mount pads from 2 to 4 o'clock. The edges of the hole were not curled outward. The CRF was crushed inward from 6 to 8 o'clock between the front flange and the fuel nozzle mount pads and there were circumferential cracks adjacent to the front flange at 6 o'clock and adjacent to the mount pads at 8 o'clock.

Photo 13: No. 1 engine's compressor rear frame (American)

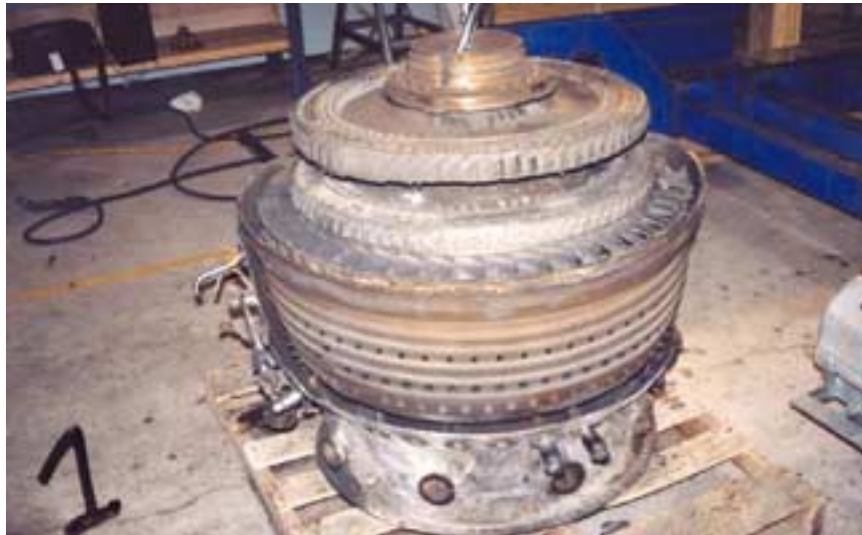
The HPT stage 1 and 2 disks were intact. The disks had circumferential rub marks on the rear faces of the disks' rims.

Photo 14: No. 1 engine's combustor liner and HPT stage 1 and 2 disks

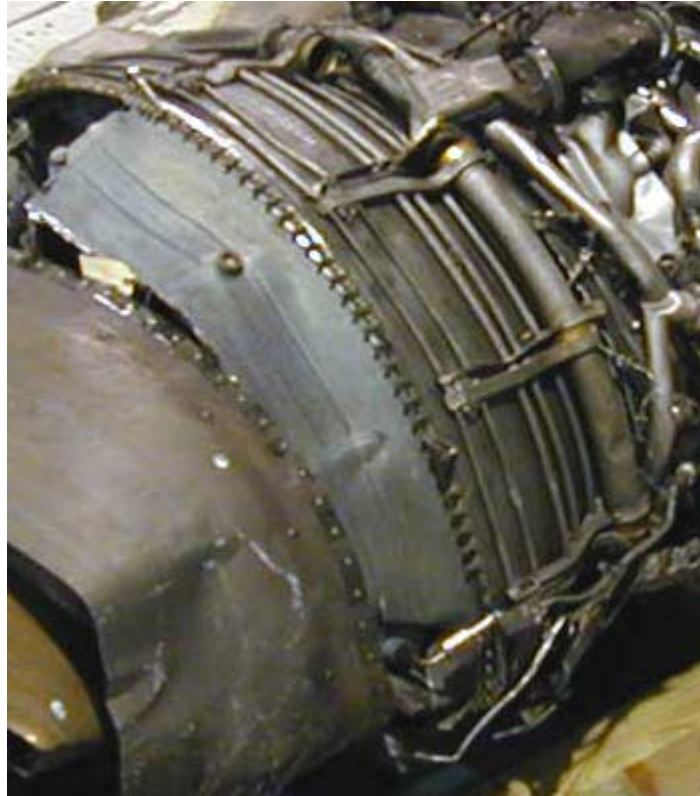
The LPT stator case was crushed inward from 5 to 10 o'clock. The LPT case had a 360° circumferential fracture that varied from 7- to 11-inches rearward from the front flange. The LPT stator case did not have any evidence of an in-flight fire or uncontainment.

Photo 15: No. 1 engine's low pressure turbine case and the broken turbine rear frame (American)

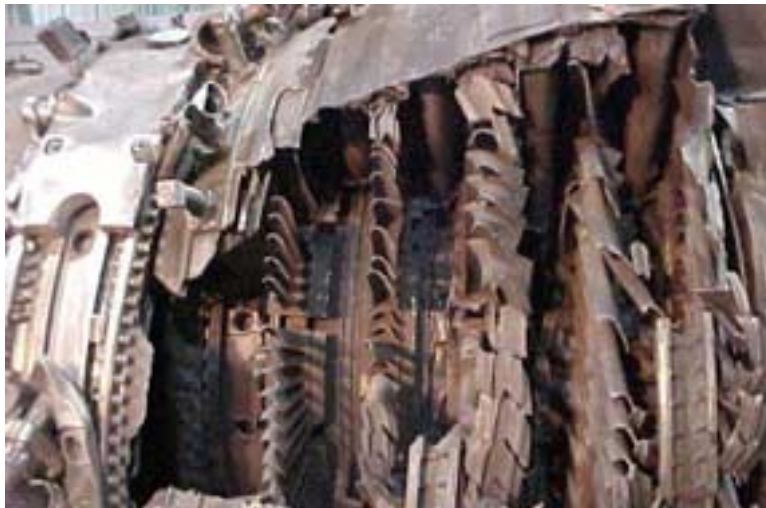
All of the LPT blades were in place in their respective disk blade slots. The LPT stage 1 and 2 blades were almost full length, but were bent slightly and missing the tip shrouds. The LPT stage 3, 4, and 5 were full length except for those blades that were oriented towards the left side of the engine and were broken at various lengths above the blade root platforms. The LPT blades did not have any rub marks or metal spray material on the airfoil surfaces.

Photo 16: No. 1 engine's low pressure turbine case cut away exposing blade and vanes (GE)

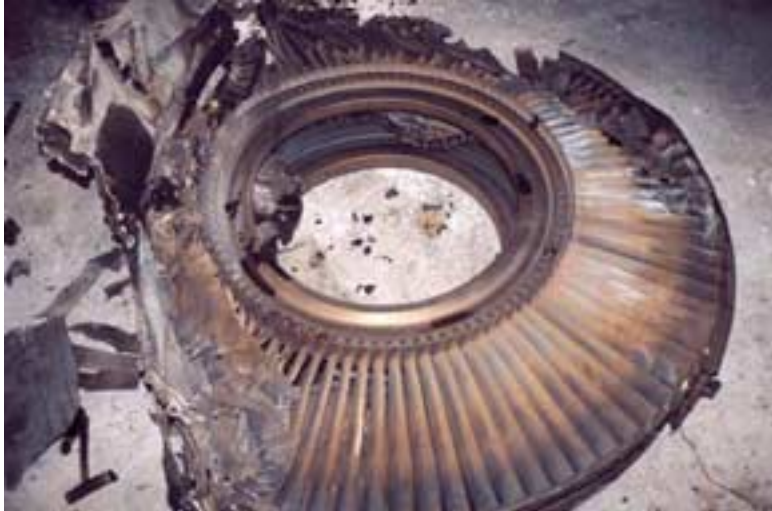
Photo 17: No. 1 engine's LPT stage 5 blades

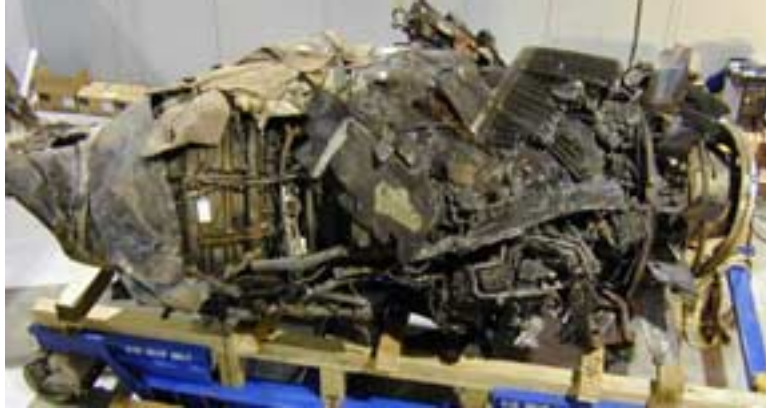
The engine was received in two pieces, the fan and the core, with the pylon still attached to the core. The pylon was removed to facilitate the disassembly. The engine was crushed and bent slightly on the left side around the area of the rear of the HPC. The engine had damage from a ground fire, particularly to the fan module.

Photo 18: As received condition of No. 2 engine minus the fan (American)

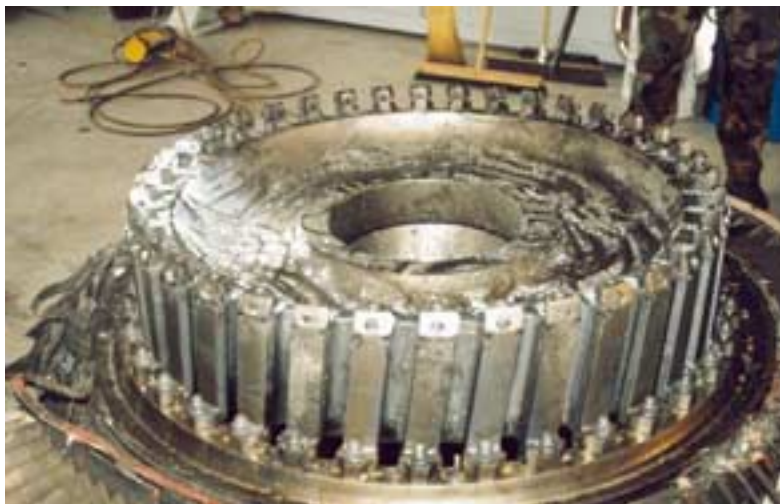
The fan disk was intact, but was separated from the fan forward shaft.

Photo 19: No. 2 engine's fan disk

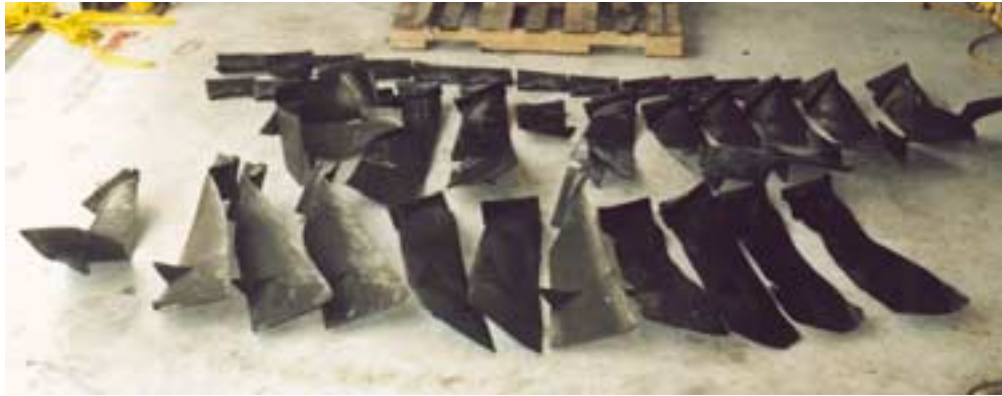
The fan blade dovetails were all in place in the disk. The 16 fan blades that were oriented towards the left side of the engine were fractured adjacent to the root

platform. All of the remaining fan blades were full length and bent randomly, except for one that was fractured near the midspan shroud. The leading edges of the fan blades had a few randomly located nicks and dents.

Photo 20: No. 2 engine's fan blades

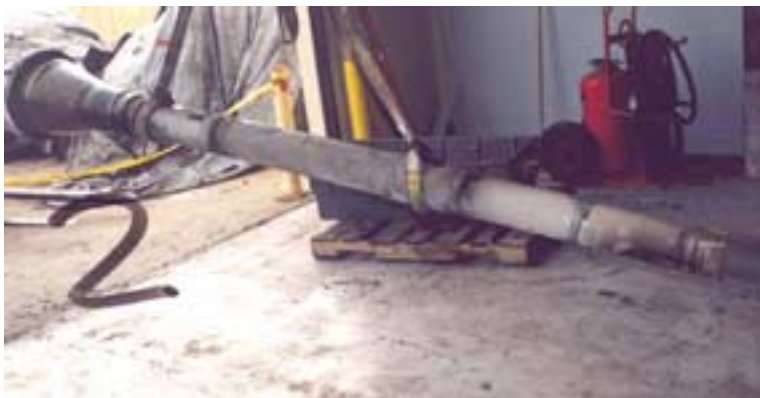
The fan forward shaft and FMS were intact.

Photo 21: No. 2 engine's fan mid shaft

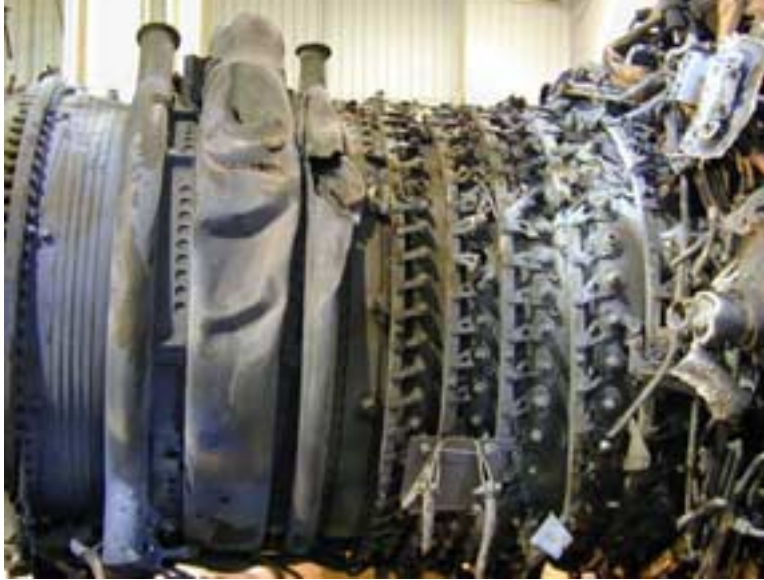
The upper and lower HPC stator cases remained attached to the fan frame and the CRF and the horizontal split lines were secured. The upper and lower HPC stator cases were intact and did not have any indications of an in-flight fire or uncontainment, but the 8<sup>th</sup> and 11<sup>th</sup> stage bleed air manifolds were crushed and buckled from 3 to 12 o'clock. The right and left hand VSV actuation levers were in place and all of the VSV unison rings were still attached. The VSV unison rings were intact and all of the vane levers were in place except for two 5<sup>th</sup> stage VSVs that were missing at 12 and 5 o'clock.

Photo 22: No. 2 engine's high pressure compressor stator case (American)

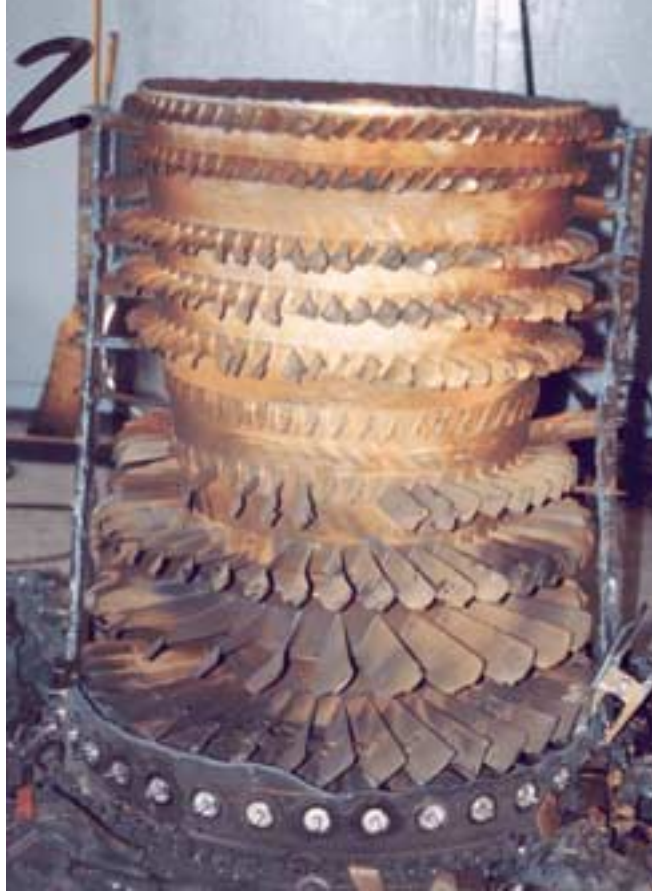
The HPC rotor, stages 1 through 14, was intact. The blade rub lands on the outside of the HPC rotor did not have any circumferential rub marks. All of the webs and bores on the inside of the HPC rotor were intact.

Photo 23: No. 2 engine's high pressure compressor rotor

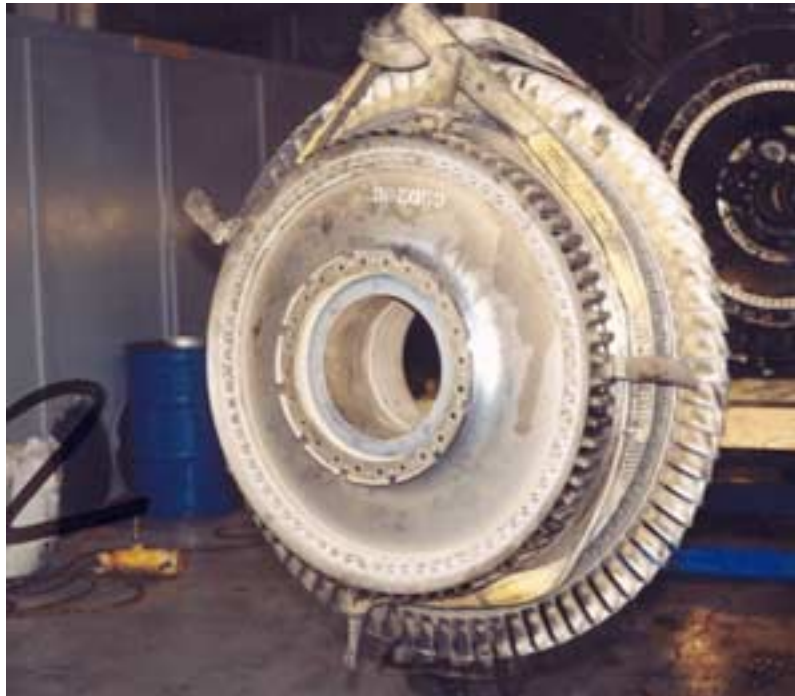
The HPT stage 1 and 2 disks were intact.

Photo 24: No. 2 engine's high pressure turbine stage 1 and 2 disks

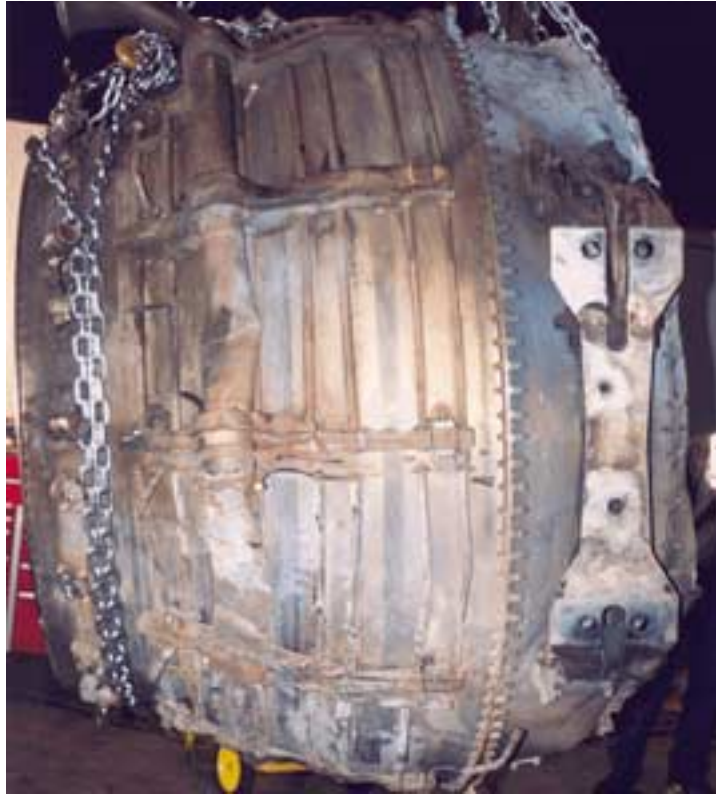
The LPT stator case was intact and remained attached to the HPT stator case and the TRF with all of the bolts in place. The LPT stator case did not have any evidence of an in-flight fire or uncontainment.

Photo 25: No. 2 engine's low pressure turbine case (American)

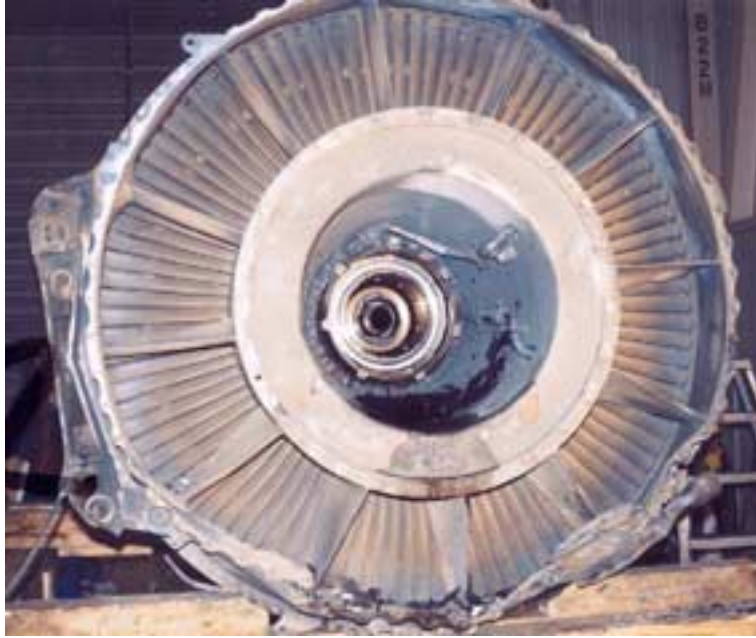
The LPT stage 1 blades were all in place, straight, and did not have any metal spray material on the airfoils. There was an approximately 100° continuous sector of LPT stage 1 blades from 3 to 6 o'clock that had the leading edge of the airfoils up to approximately ½-inch long by ⅛-inch deep and the adjacent tip shroud broken away. The fracture surfaces of the missing material were coarse and grainy and there was no indication of any circumferential rub marks. The LPT stage 5 blades were all in place, straight, and did not have any metal spray on the airfoils.

Photo 26: No. 2 engine's LPT stage 5 blade airfoils

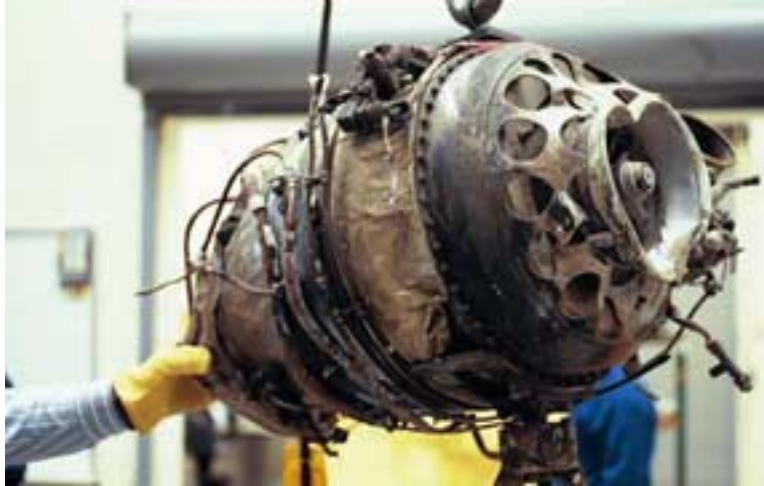
The power section did not have any indications of an in-flight fire, uncontainment, or case rupture.

Photo 27: APU power unit (Honeywell)

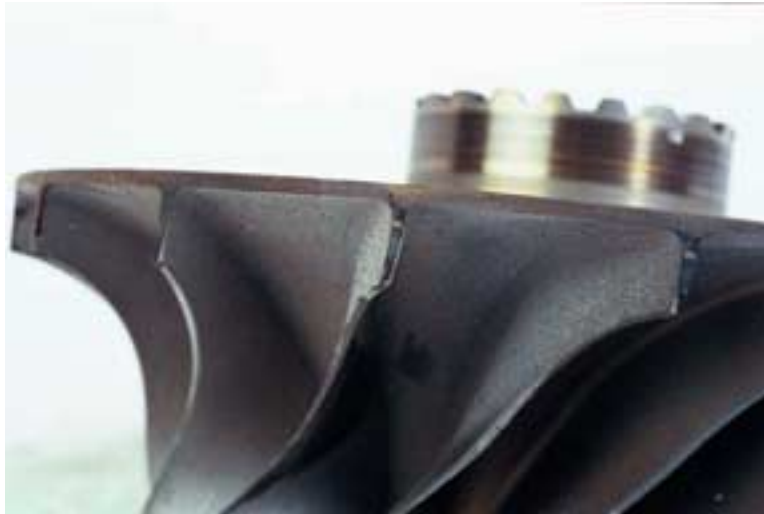
The 1<sup>st</sup> and 2<sup>nd</sup> stage impellers were intact and did not have any circumferential rub marks on the impeller blades. The 1<sup>st</sup> and 2<sup>nd</sup> stage impeller shrouds did not have any circumferential rub marks.

Photo 28: Close up of 1<sup>st</sup> stage impeller showing no circumferential rub marks (Honeywell)

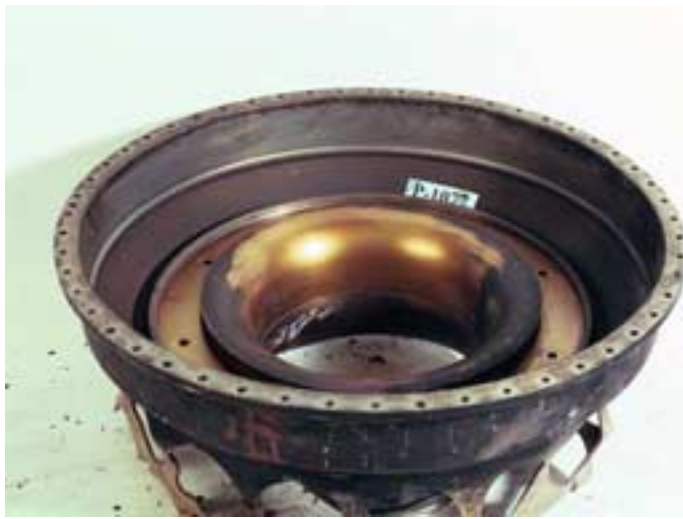
Photo 29: 1<sup>st</sup> stage impeller shroud coated with soot and where soot was wiped away, no impact marks from the impeller (Honeywell)

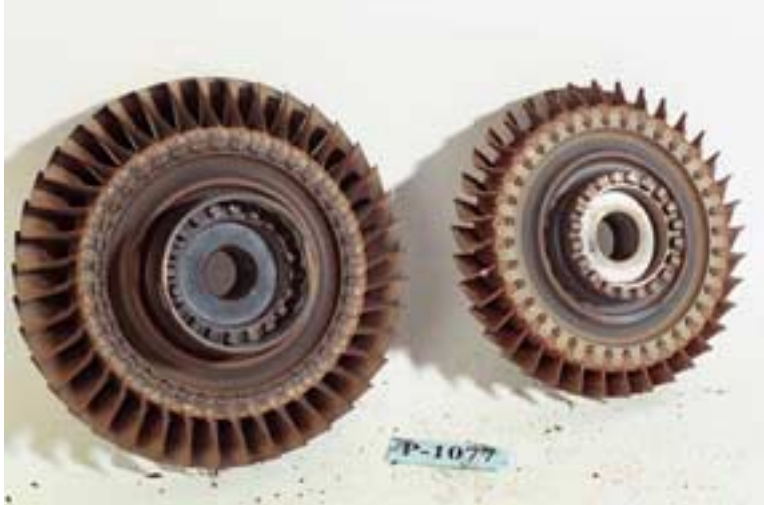
Photo 30: 1<sup>st</sup> and 2<sup>nd</sup> stage turbine disks showing no bent blades (Honeywell)

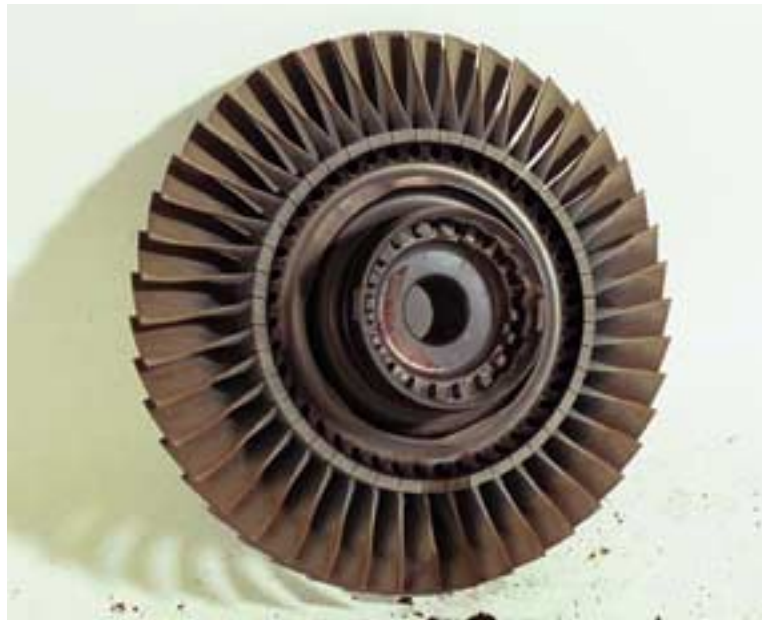
Photo 31: 3<sup>rd</sup> stage turbine wheel (Honeywell)

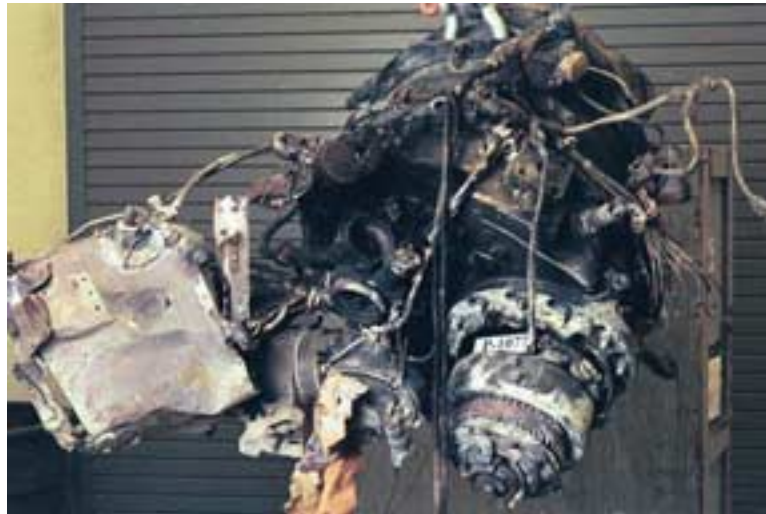
As received, the gearbox and load compressor was separated from the power section. The gearbox and load compressor housing did not have any holes or penetrations, but was sooted. The inlet guide vane actuator was detached. The generator housing was missing, exposing the generator windings. The gearbox was not disassembled. The oil cooler was missing. The filter housing was cracked and the filter bowl was separated from the housing. The gearbox sump was not drained or checked for residual oil.

Photo 32: Gearbox and load compressor broken away from APU power section (Honeywell)

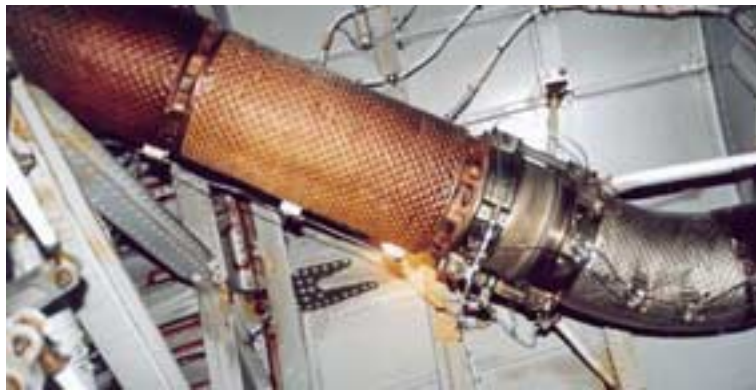
Photo 33: Example of APU bleed air duct exiting firewall in tailcone showing overheating detection wires in American Airlines A300 N70054

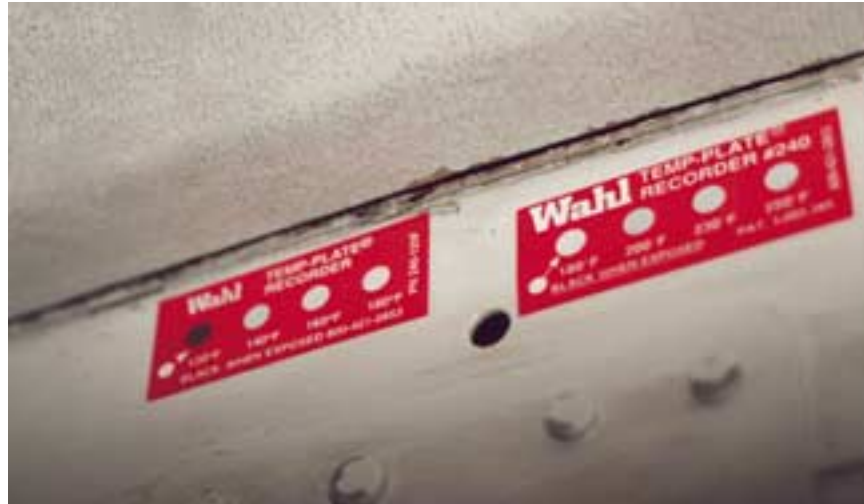
Photo 34: Temp tabs on frame C83 showing exposure to 120°F

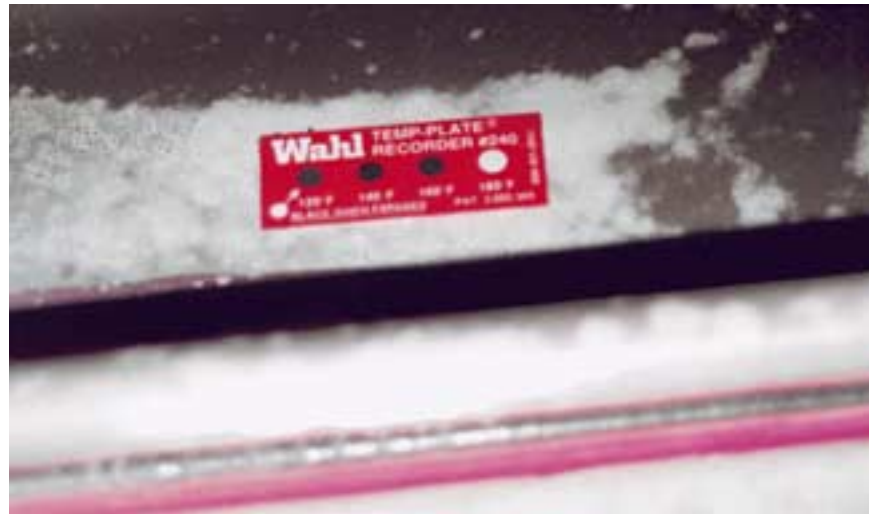
Photo 35: Temp tab over bleed air duct on left side of fuselage showing exposure to 160°F

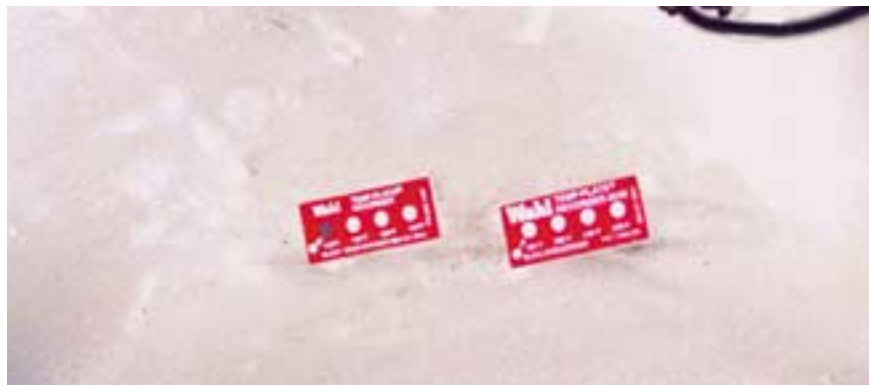
Photo 36: Temp tabs on vertical stabilizer access cover showing exposure to 120°F
