**F. APPENDIX B**

## INSPECTION PROTOCOL

ESWNG-70032/02

**Subject:** Fin box and rudder inspection on aircraft A300-600, MSN 420 at NASA Langley Research Center in Hampton, Virginia / USA.

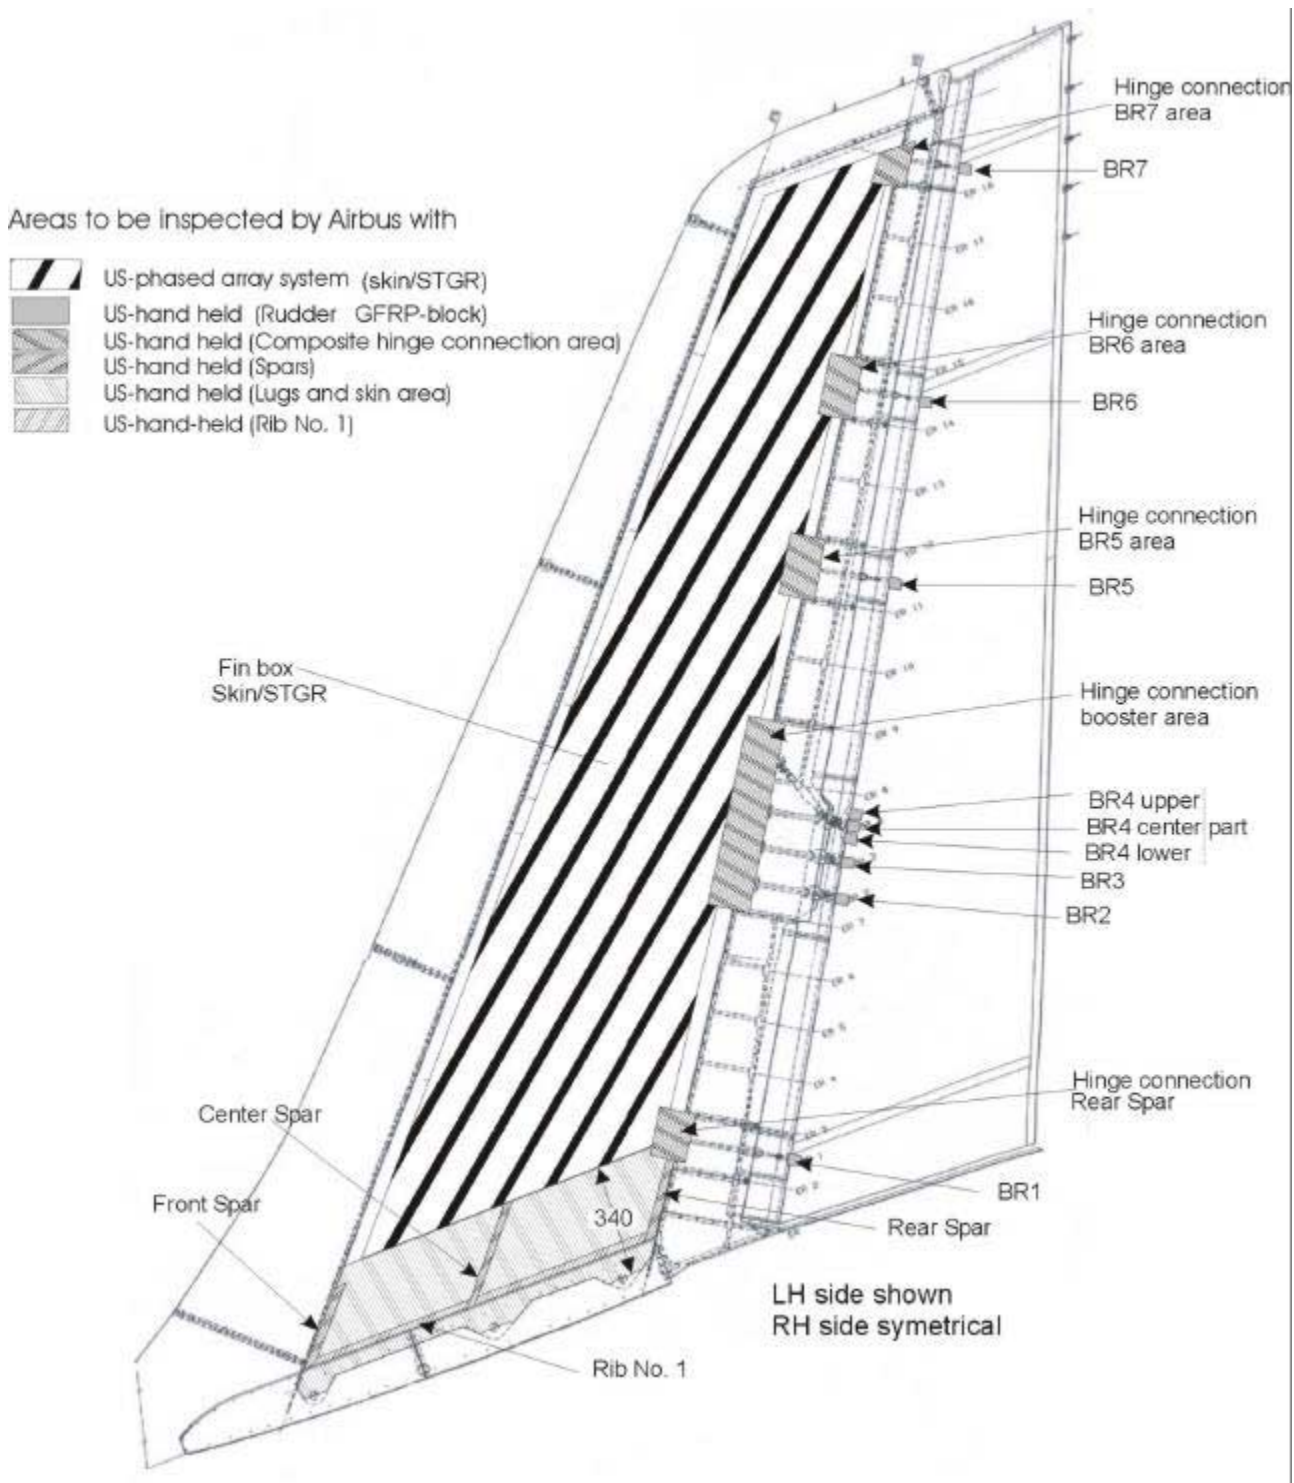
FIG. 01: Areas to be inspected by Airbus ESWNG at Vertical Stabilizer of MSN 420

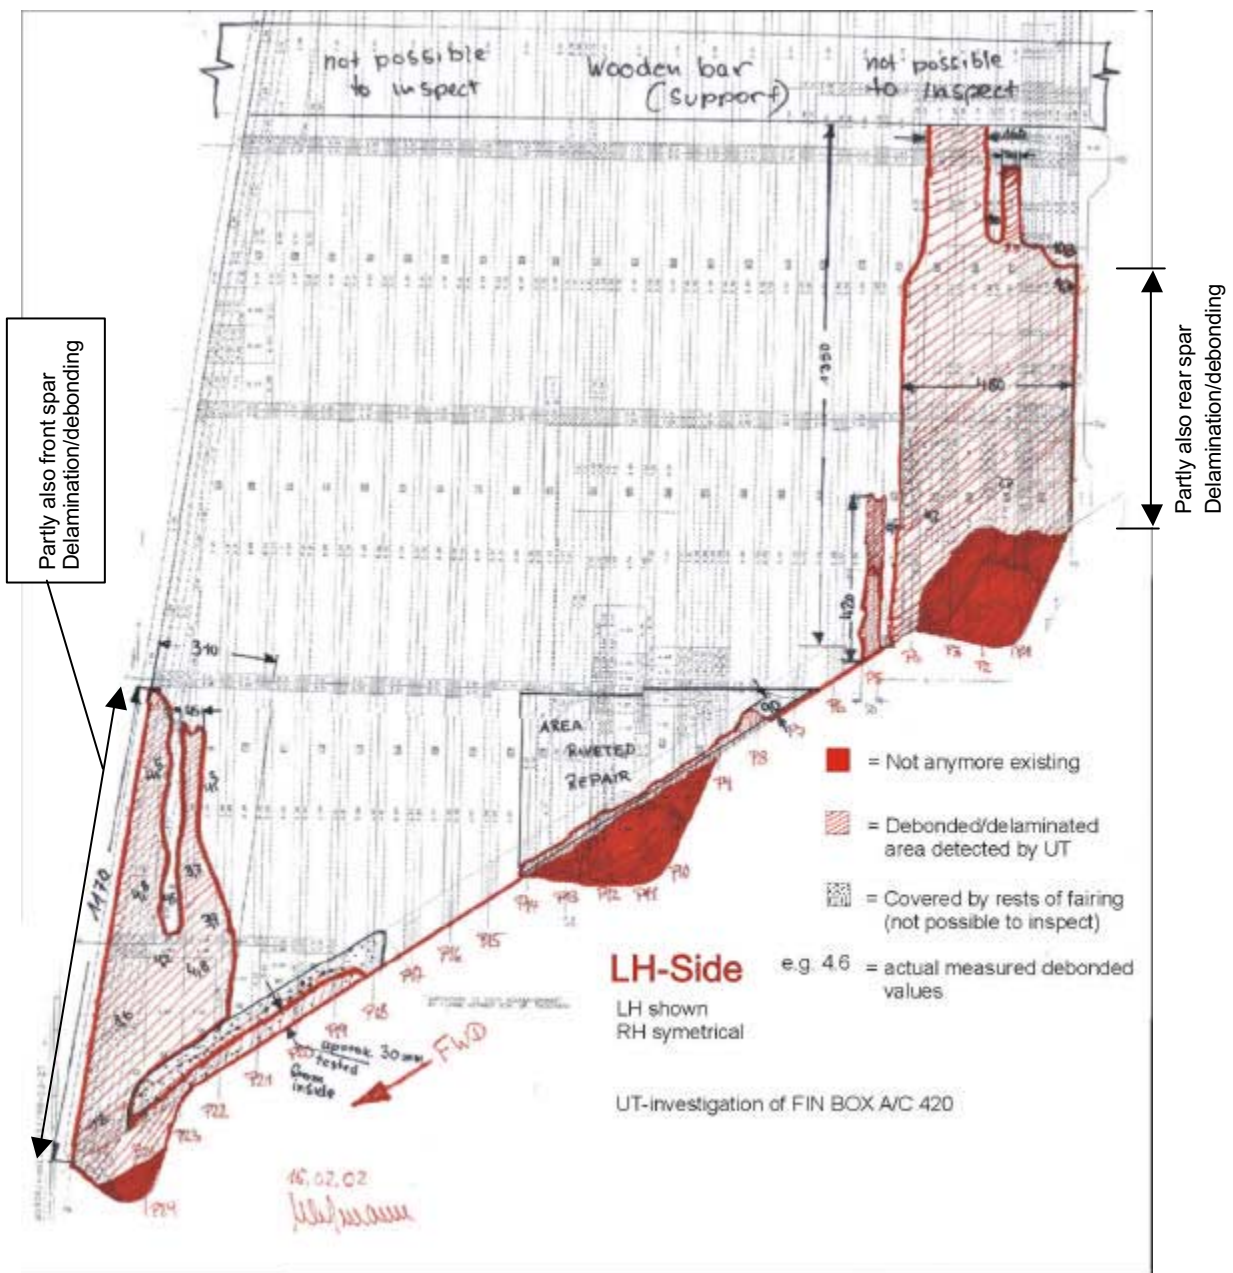
(a1) LH side

Fig.02: Test Results of Lug region from LH-side and shell above the lugs

- (b1) Front Spar /Stiffener No. 1 (see also photo no. 1)  
 ! Length Dimension of debondings between Skin and Front Spar angle are illustrated in Fig. 02/03

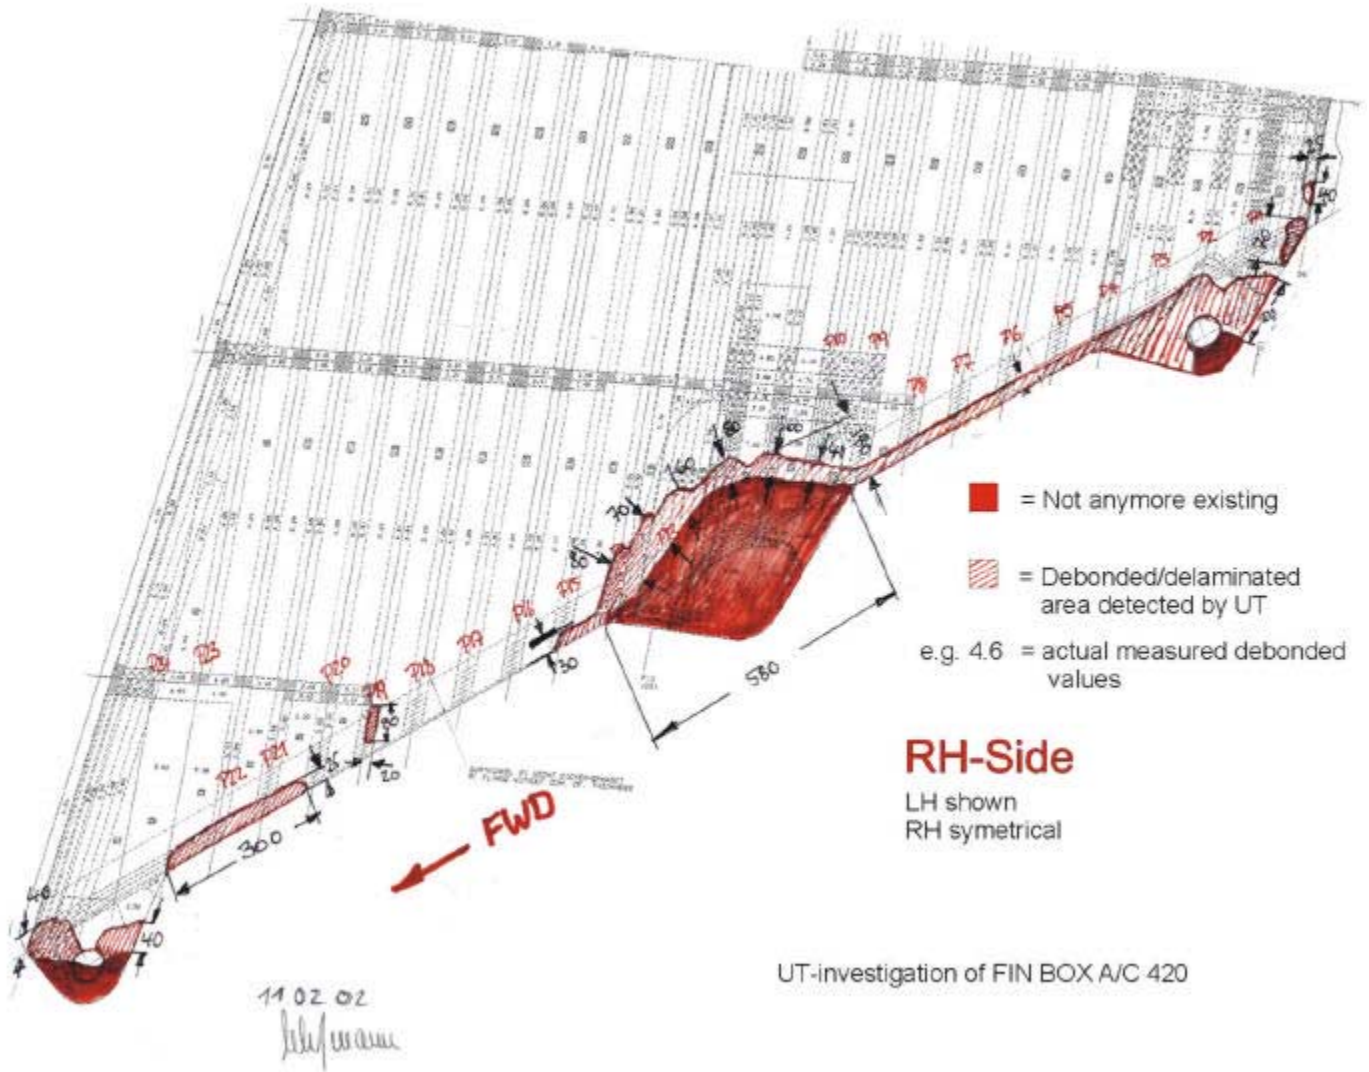
(a2) RH side

FIG. 03: Test Results of Lug region from RH-side and shell above the lugs

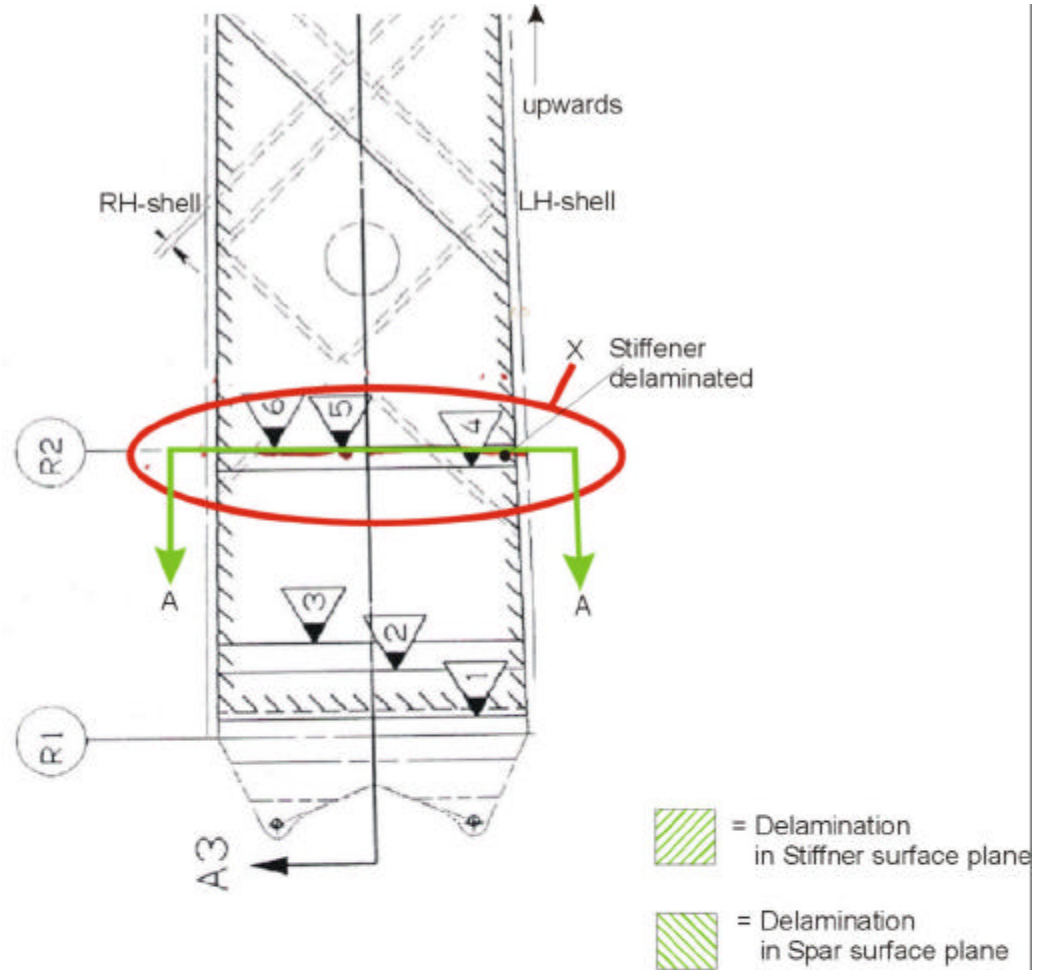
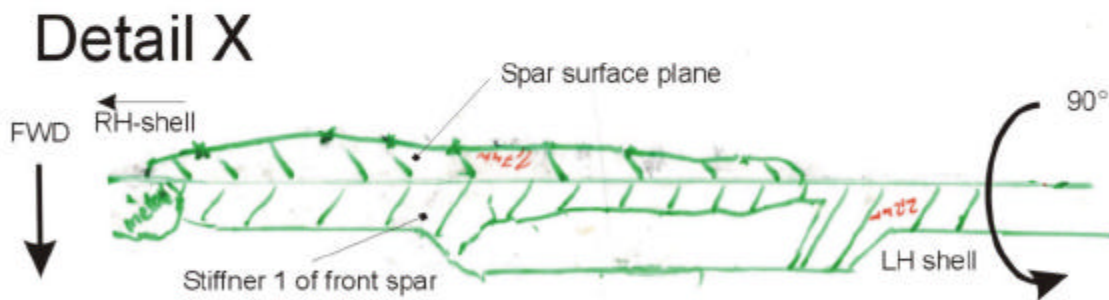
FIG. 04: Test results of front spar ; stiffener no. 1

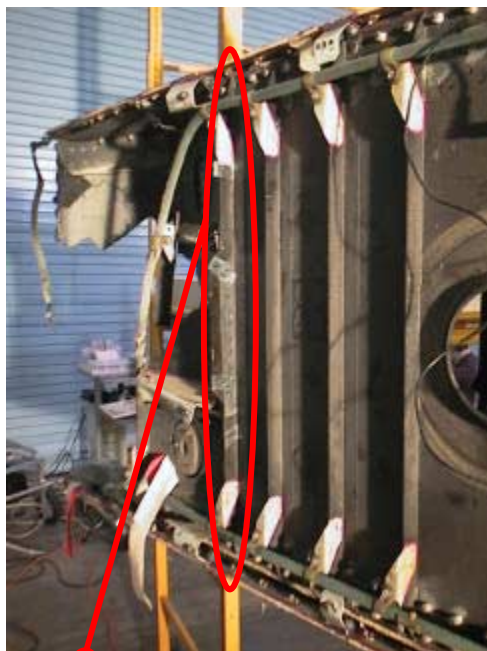
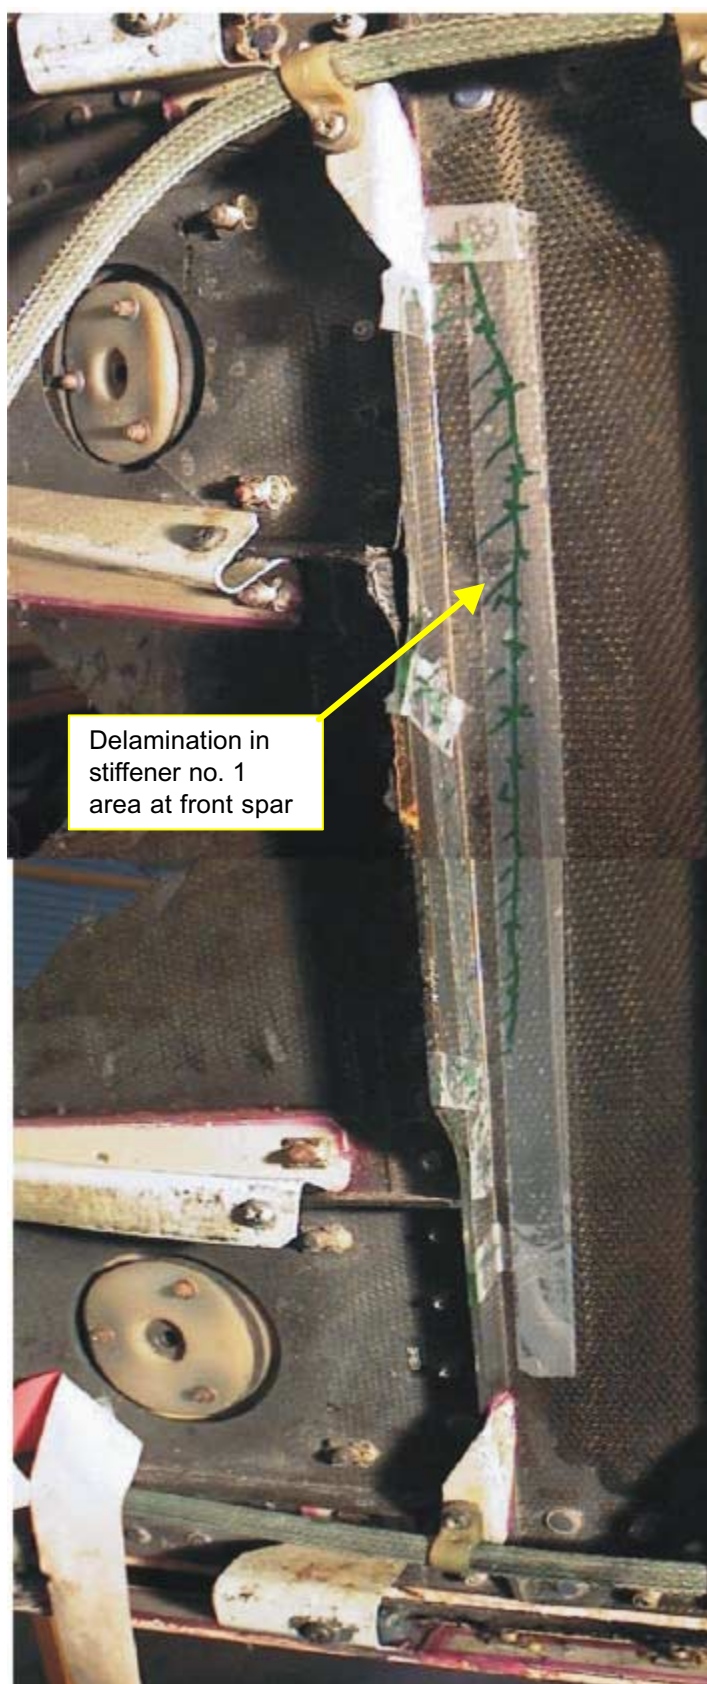
Stiffener no.1 / front spar

Delamination in stiffener no. 1 area at front spar

Photo no. 01: Delamination at front spar; stiffener no. 1

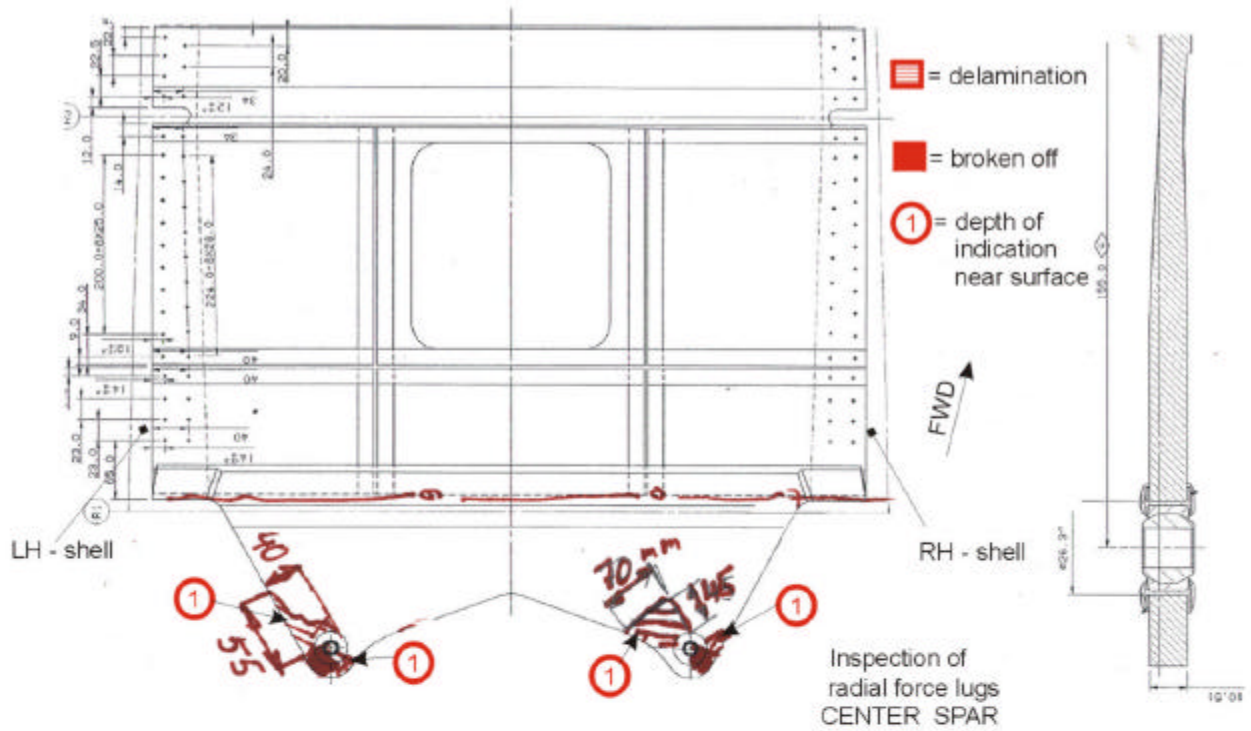
FIG. 05: Test results of center spar radial force lugs

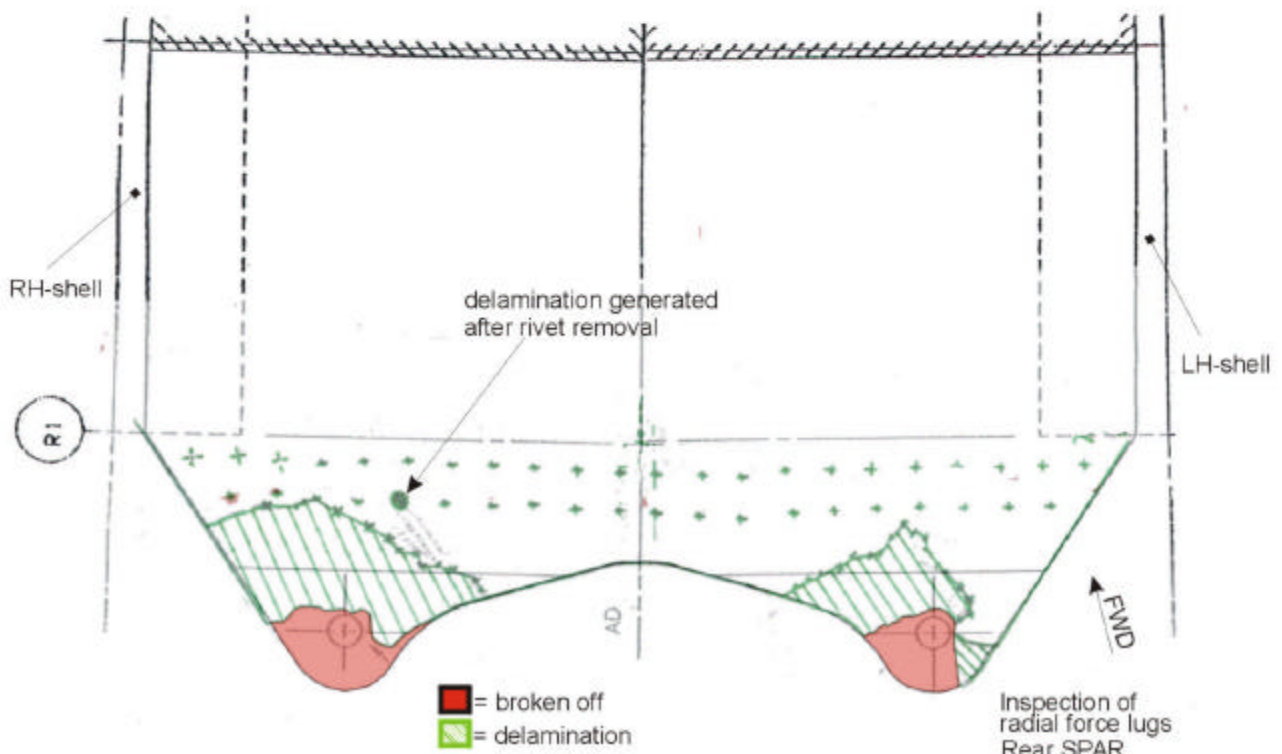
Fig.06: Test results of rear spar (radial force lugs)

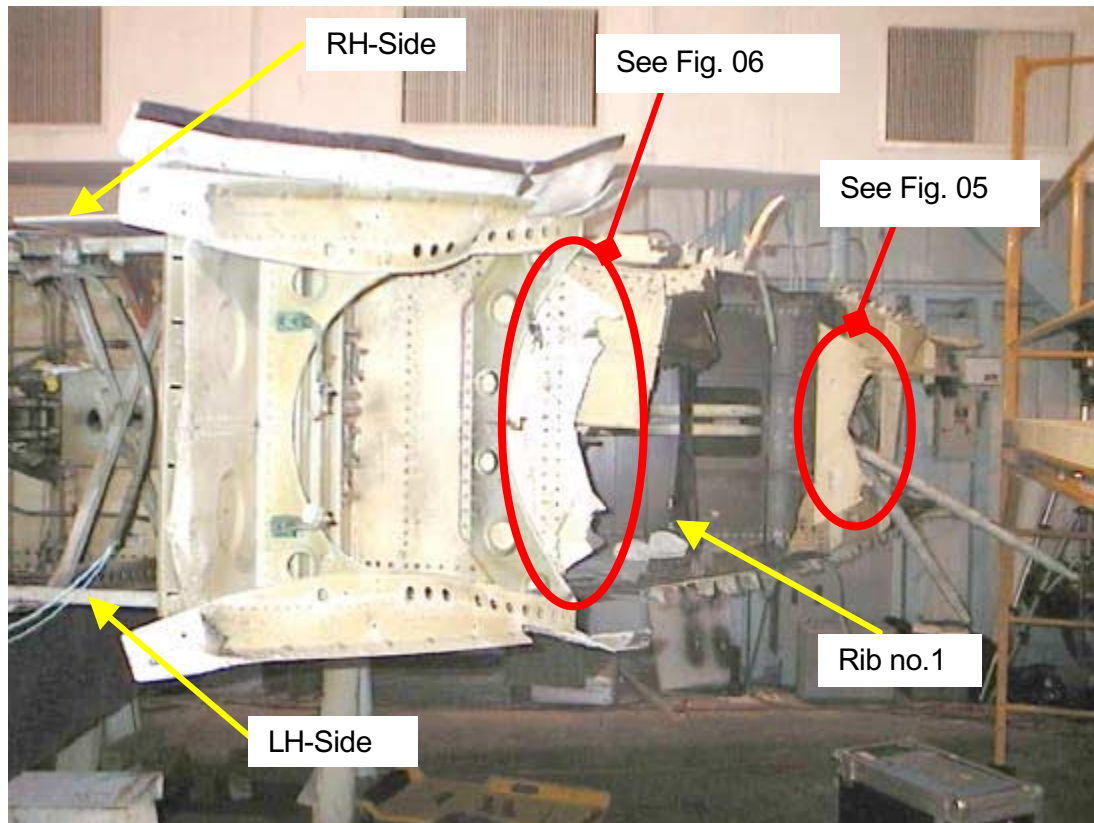
Photo No. 2: Inspection area Rib no. 1 and radial force lugs (see also Fig. No. 5 & 6)

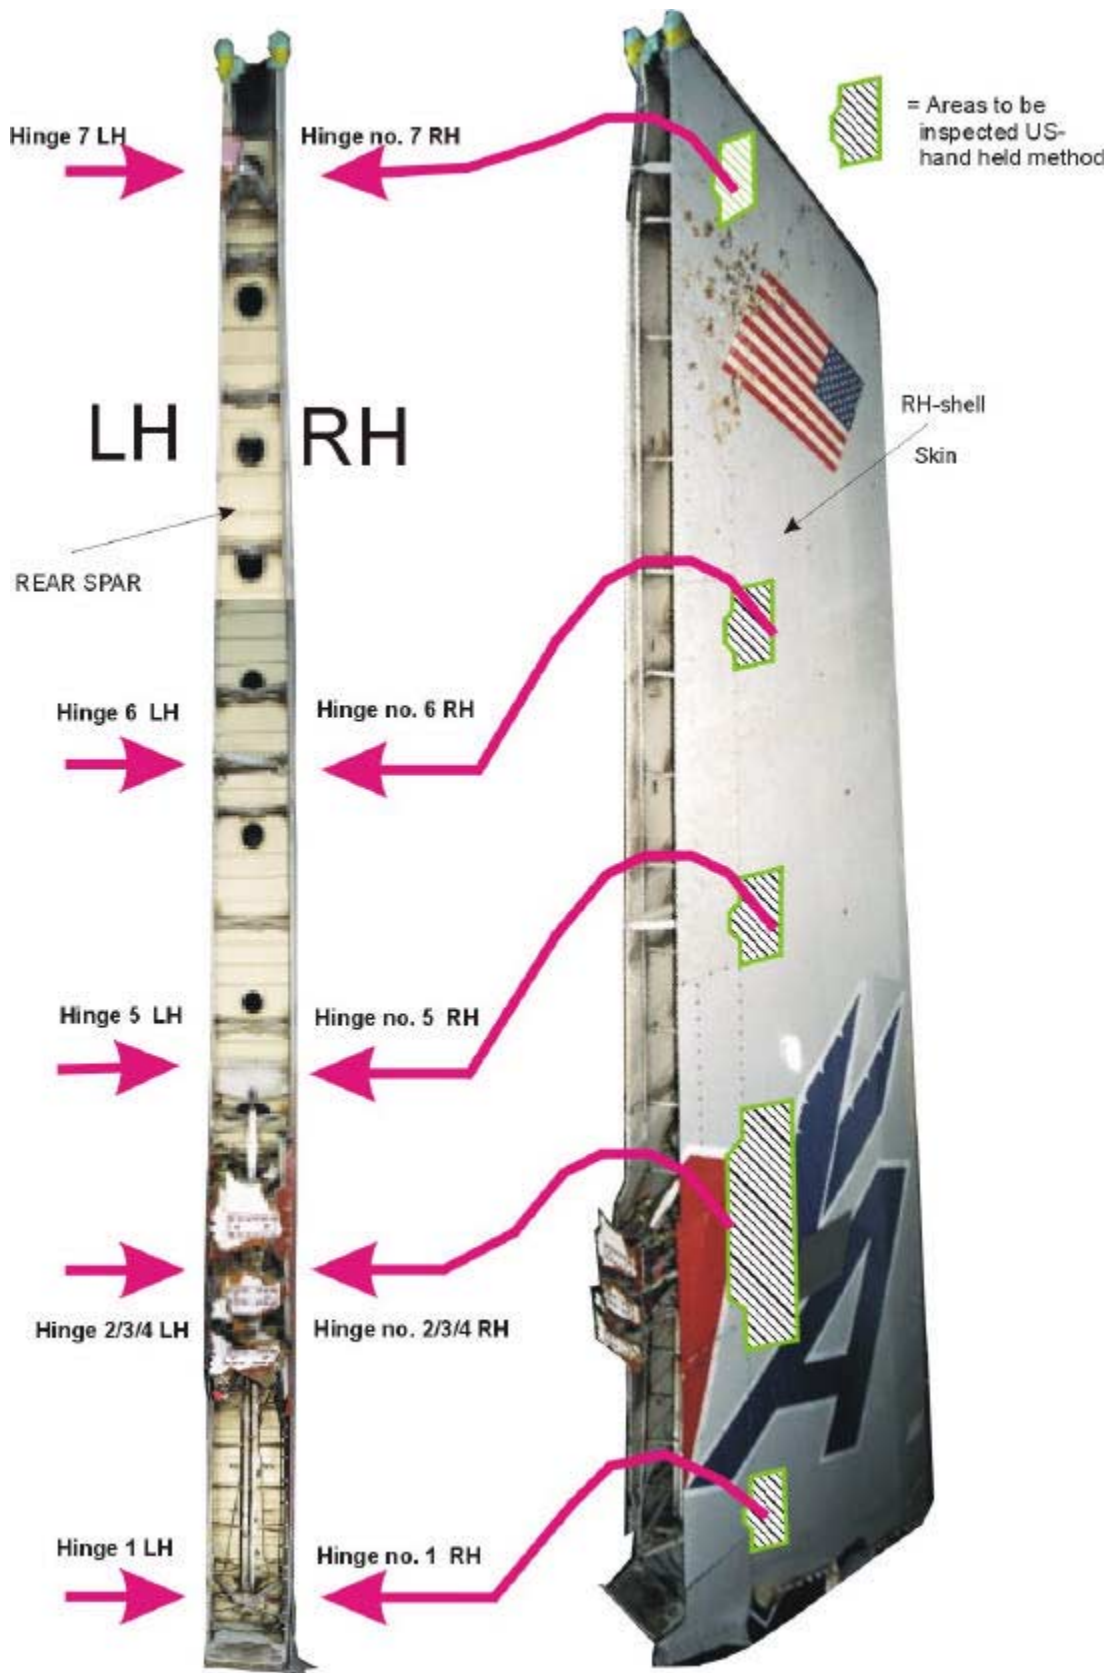
On RH-side and LH-side within the hinge connection the areas in shell have been inspected completely in a distance of  $\pm 200\text{mm}$  from hinge center line.  
Based on still partly attached rear fairing on left hand side the inspection of these covered areas could not be performed. All other rear fairing attachment areas were inspected .

Test result: **NO DELAMINATIONS** in the inspected areas.

Fig no. 07 : Hinge connection areas to be inspected

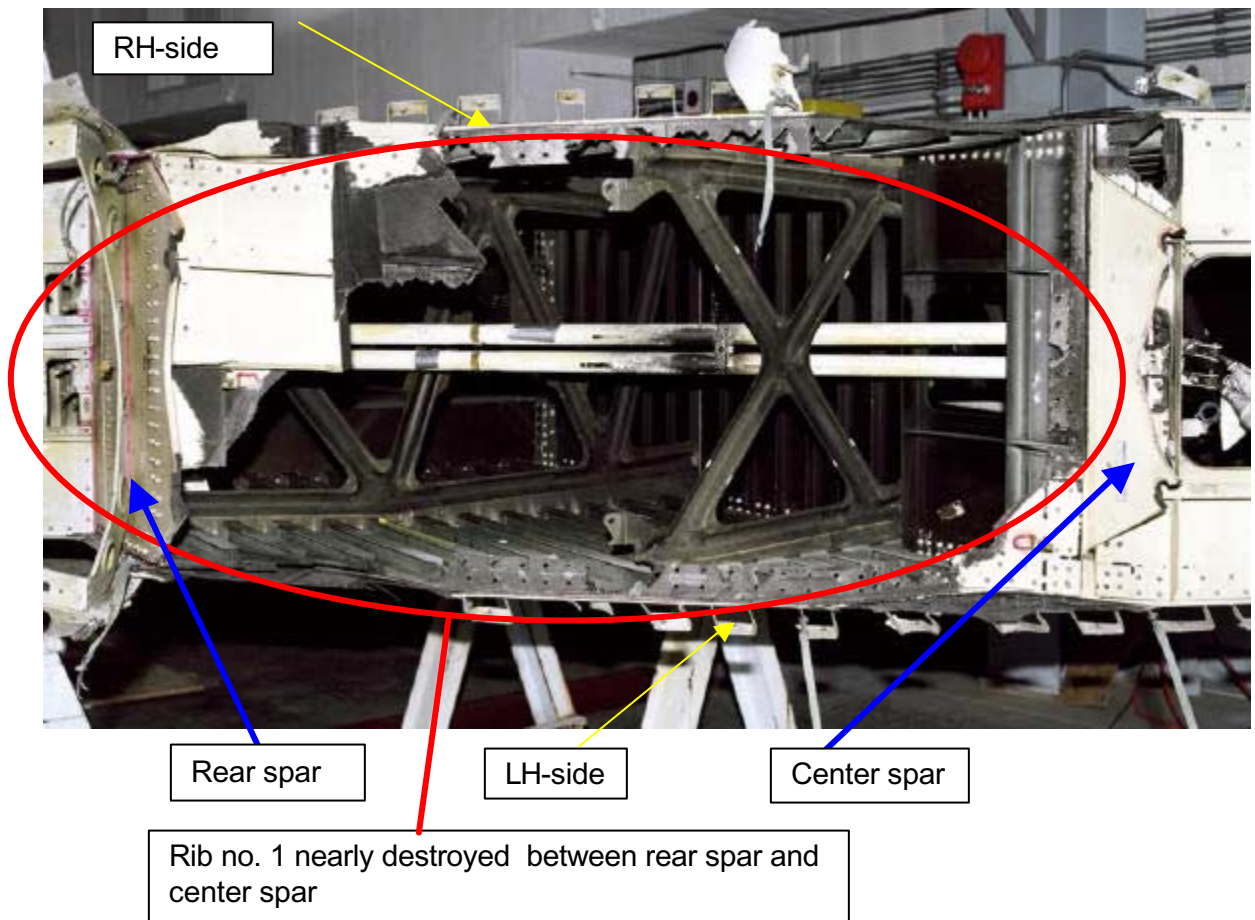
- (d1) The rib no. 1 was nearly complete destroyed in area between Rear Spar position and Center Spar position therefor a UT-inspection made no sense in the still present parts.  
(Refer to Photo no. 3)

Photo no. 03: View of destroyed rib no.1 between rear spar position and center spar position

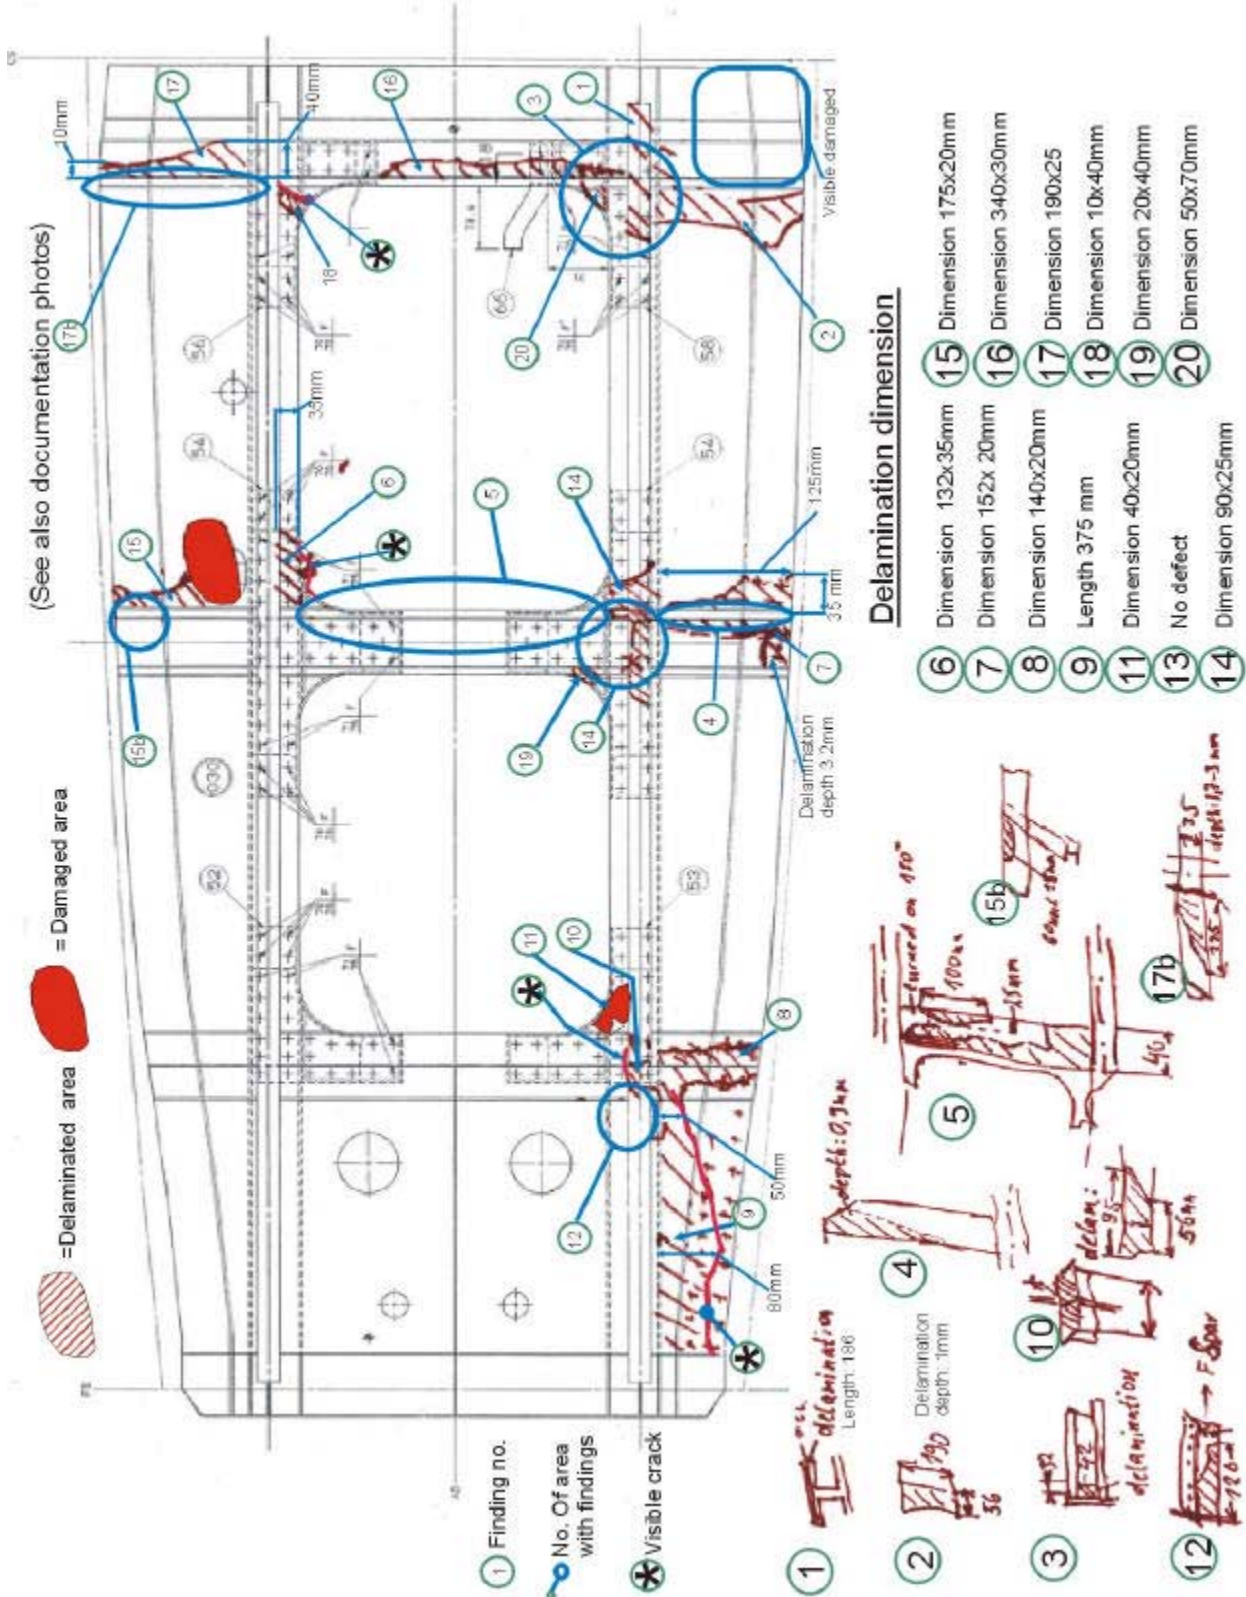
(d2) UT-results from rest of rib no. 1 between center spar and front spar (refer to Fig.08 and documentation photos).

FIG.08: Delamination areas; damages in the area of rib no. 1 between center spar and front spar

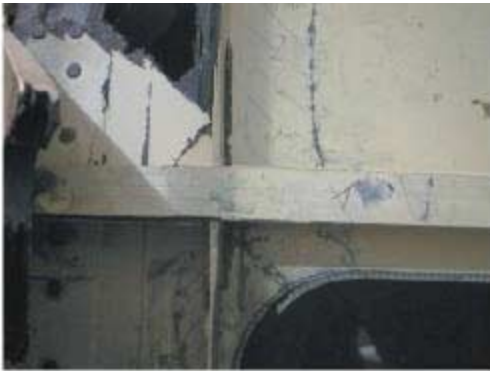
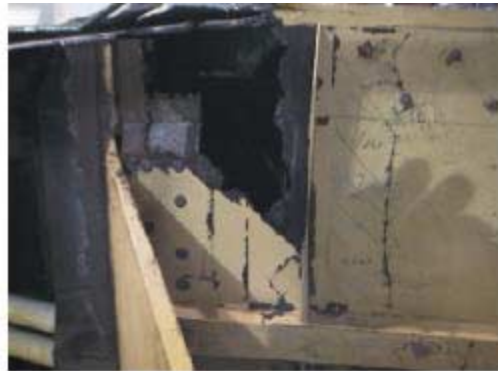
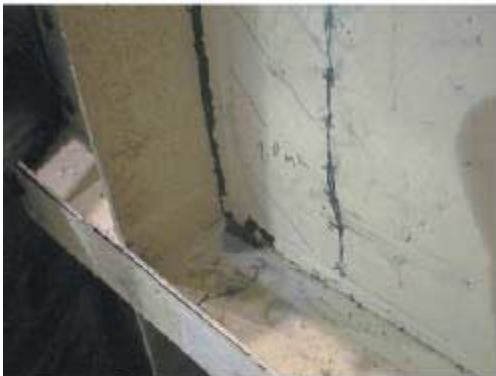
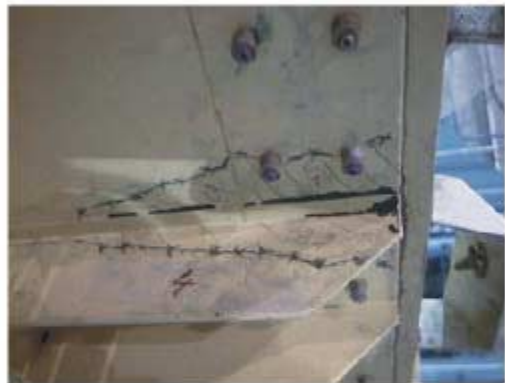
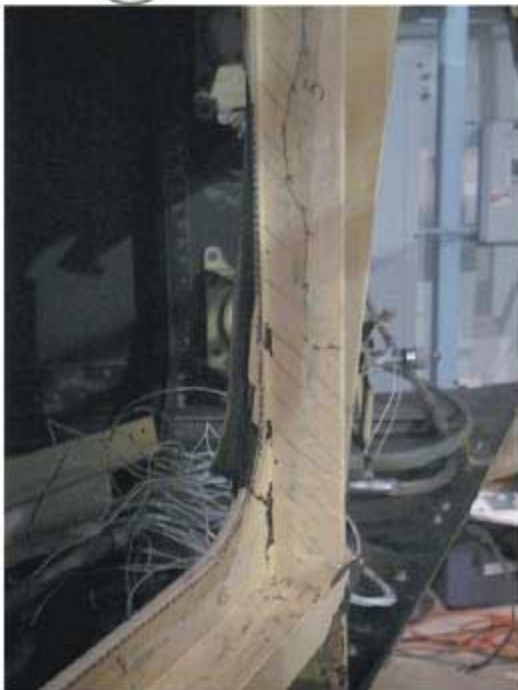
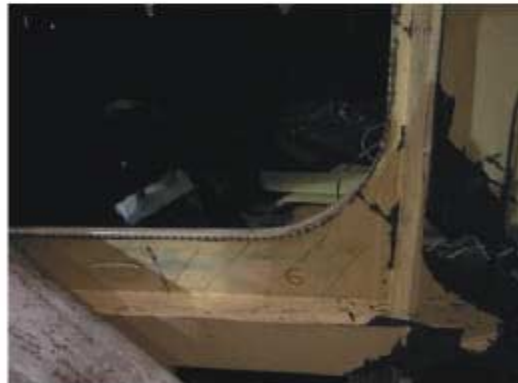
Fig.09: Photo documentaion of Findings 1-6 between center spar and front spar

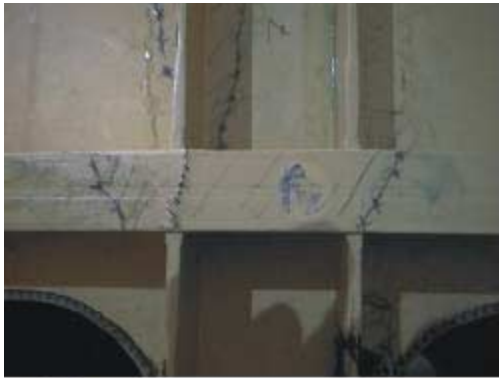
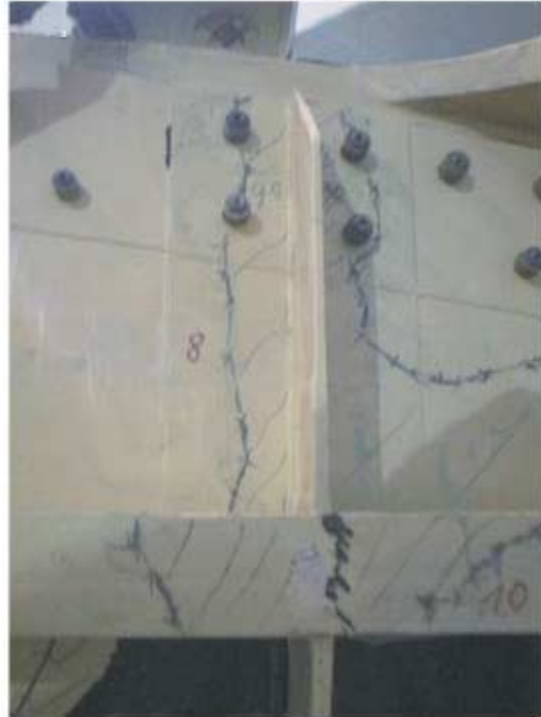
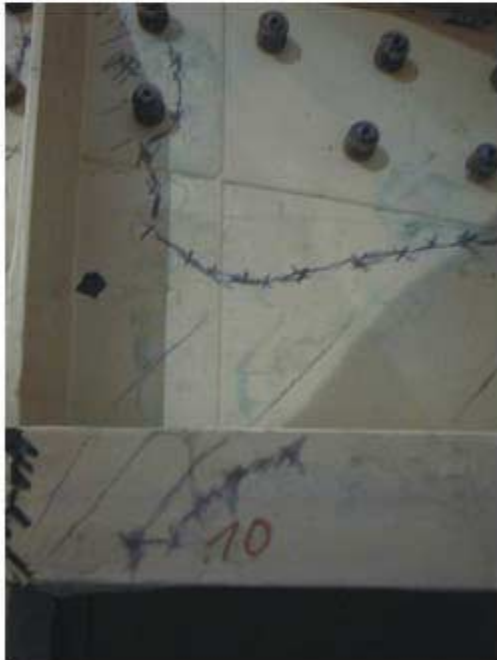
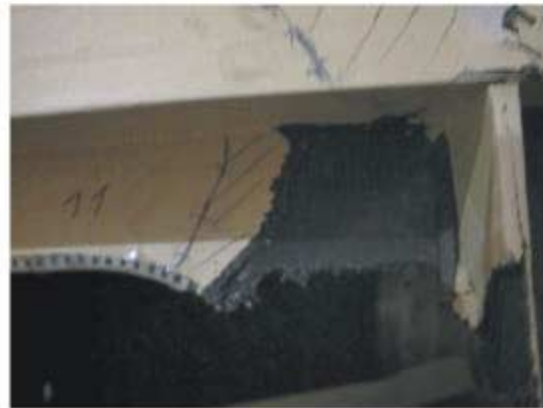
Fig.10: Photo documentaion of Findings 7-11 between center spar and front spar

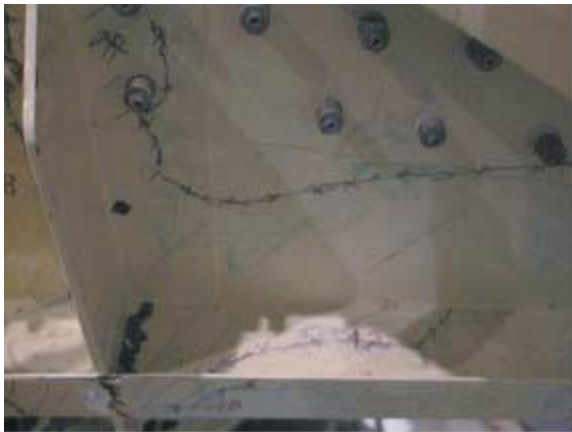
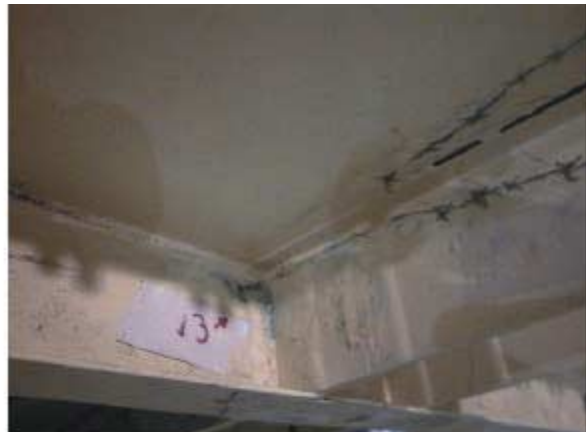
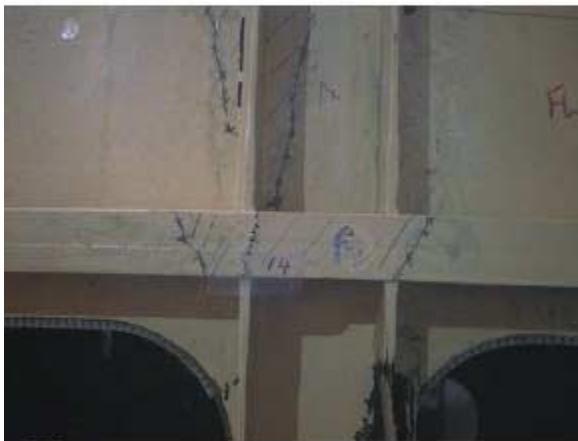
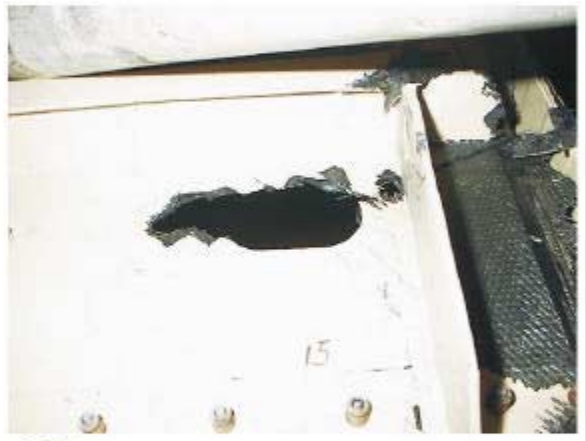
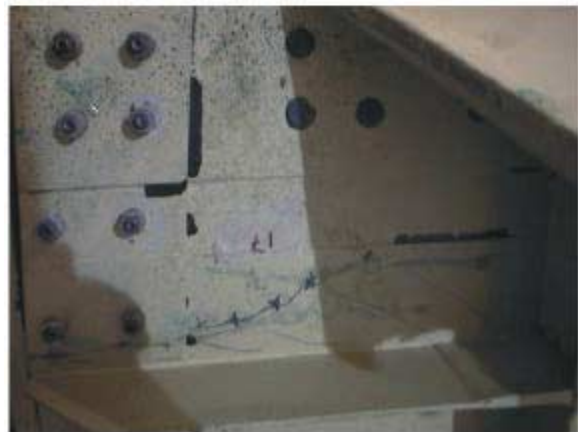
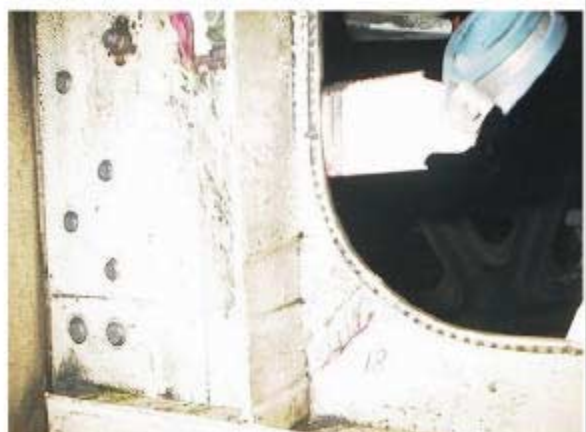
Fig.11: Photo documentaion of Findings 12-18 between center spar and front spar

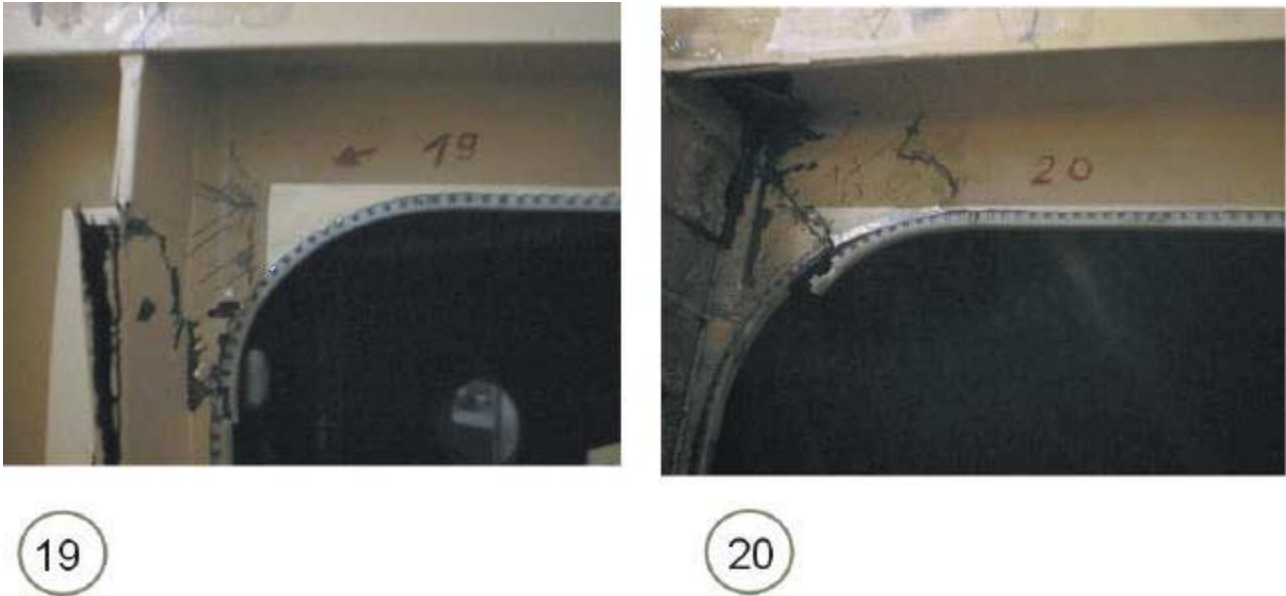
Fig.12: Photo documentaion of Findings 19-20 between center spar and front spar

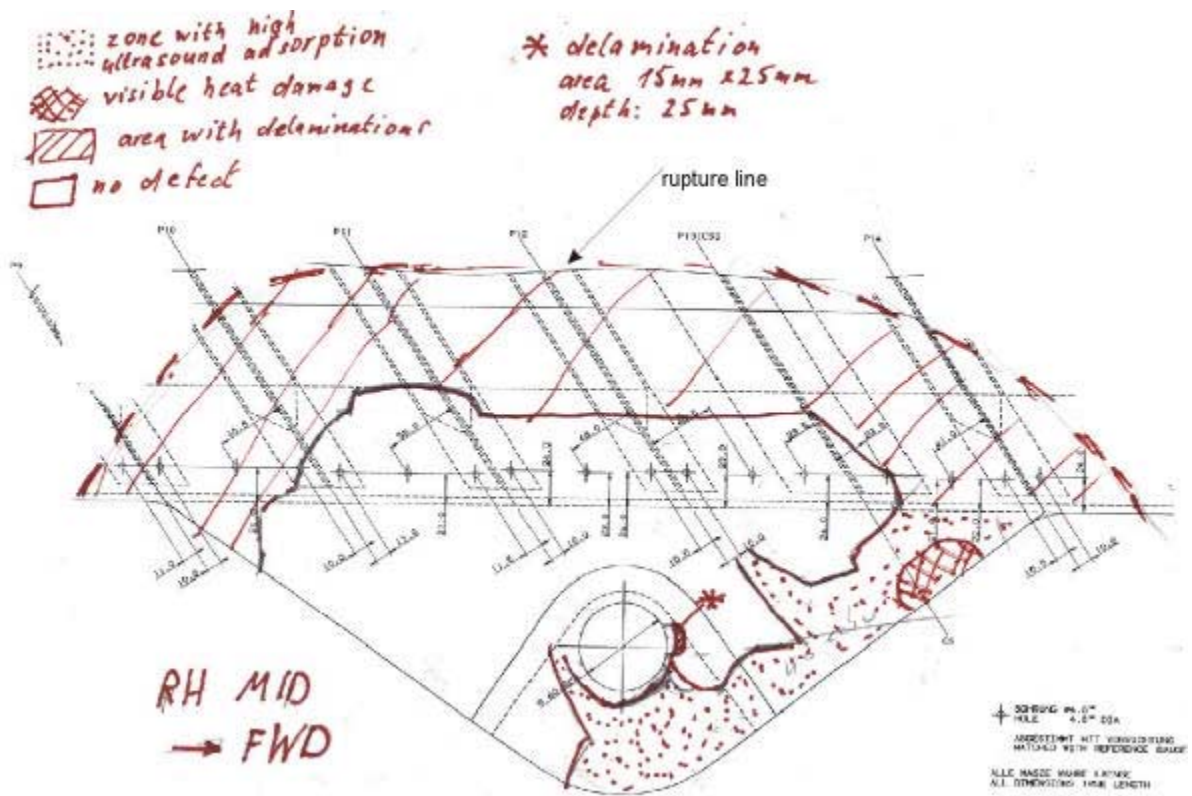
Fig. 13: Test results of UT-inspection at separated center lug / RH

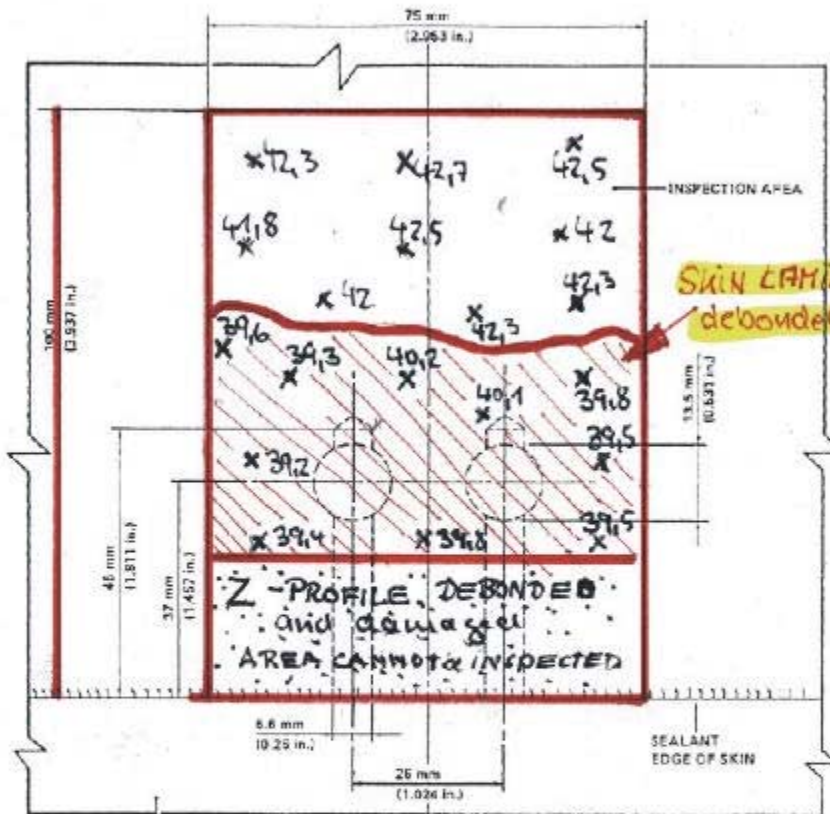
BR-1-LH

Z-PROFILE DEBONDED

DEBONDING/DELAMINATION

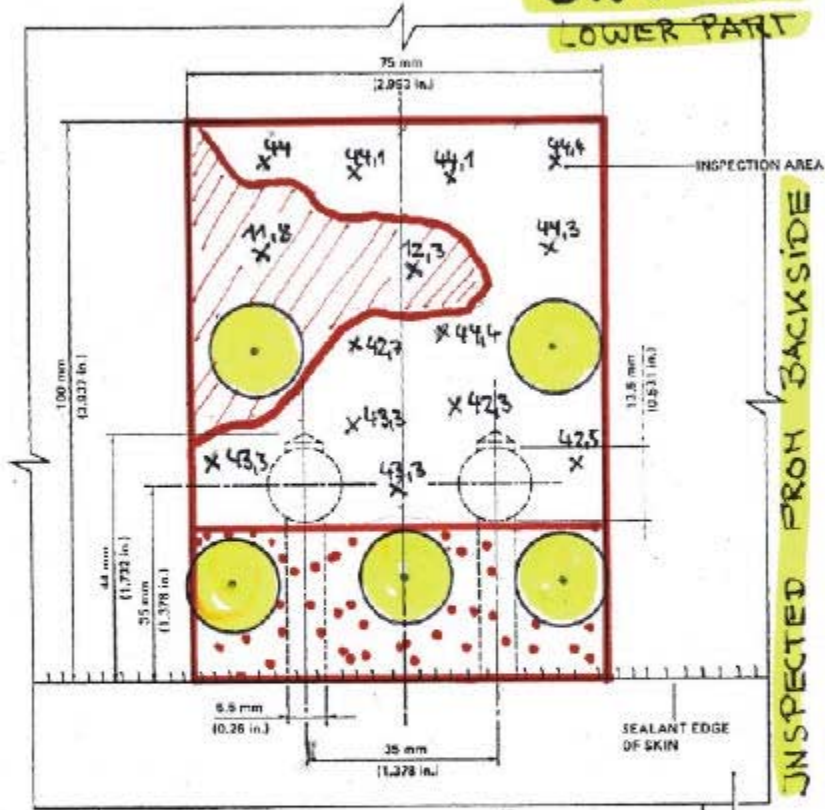
**LOWER PART**

**FWD**  
**Not inspectable (space between bolts)**
